1651 L STREET

CED CASE # E21-11874

FFD INCIDENT # 21-075838

Source of Fire

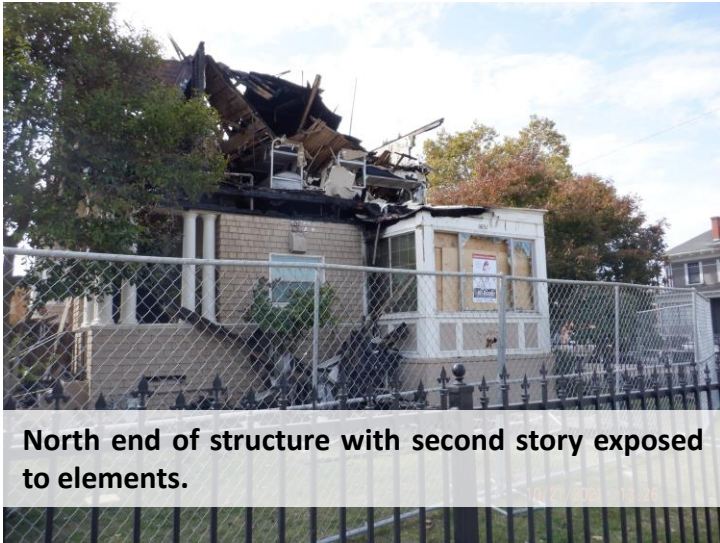
North end of structure with second story exposed to elements.

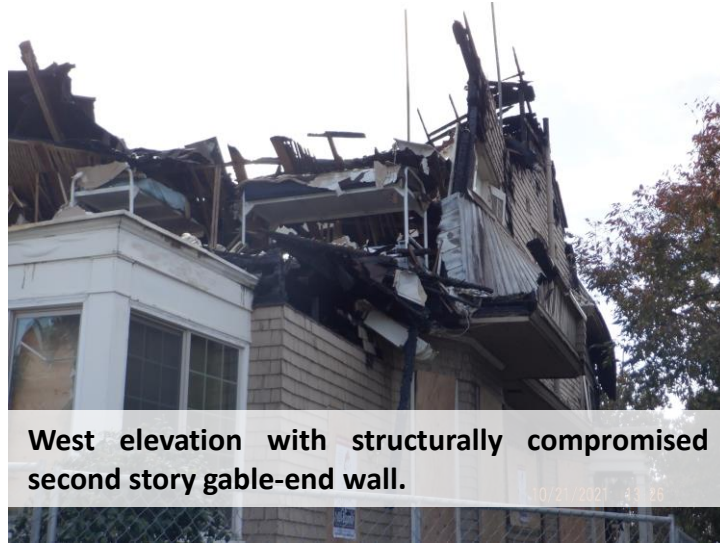
West elevation with structurally compromised second story gable-end wall.

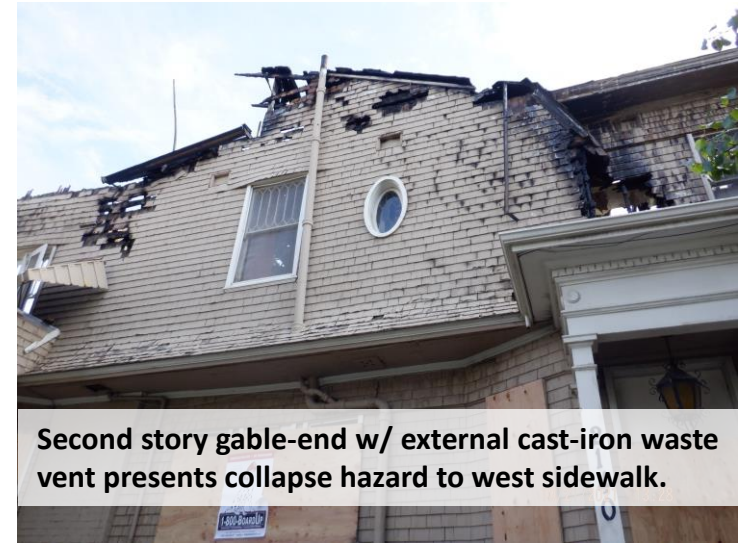
Second story gable-end w/ external cast-iron waste vent presents collapse hazard to west sidewalk.

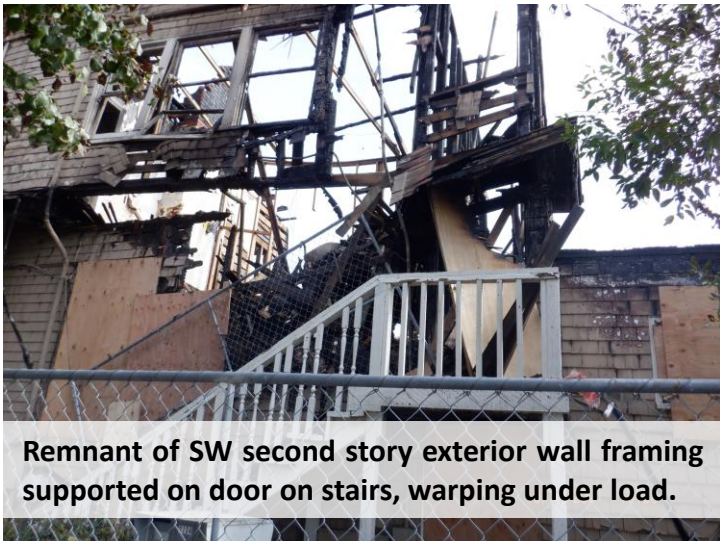
Remnant of SW second story exterior wall framing supported on door on stairs, warping under load.

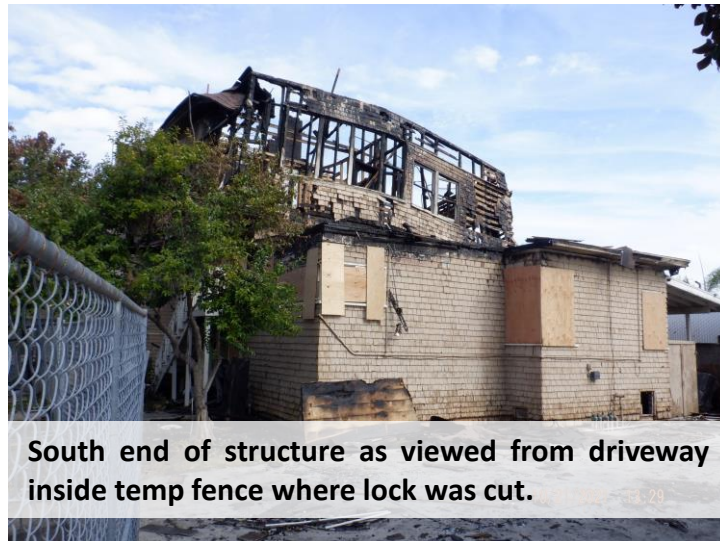
South end of structure as viewed from driveway inside temp fence where lock was cut.

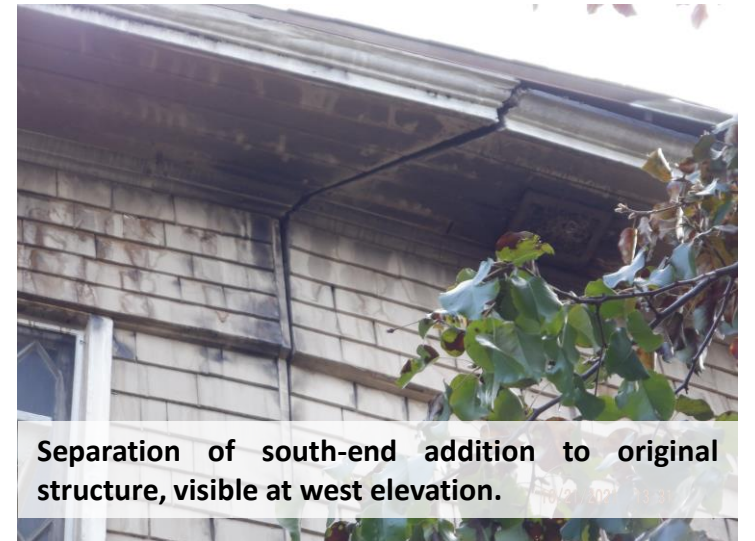
Separation of south-end addition to original structure, visible at west elevation.

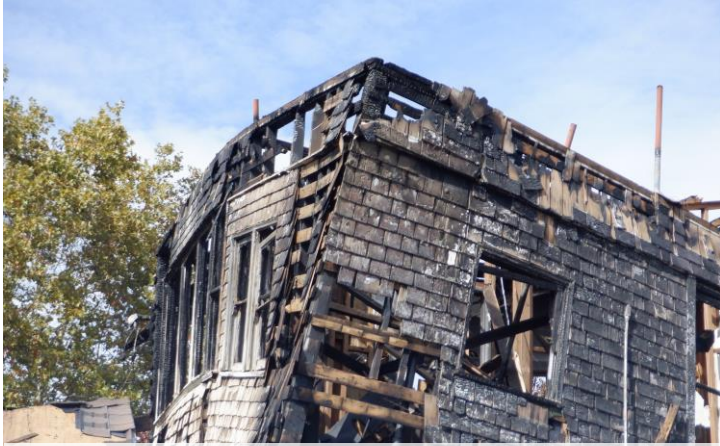
South-east corner as viewed from east neighboring property.

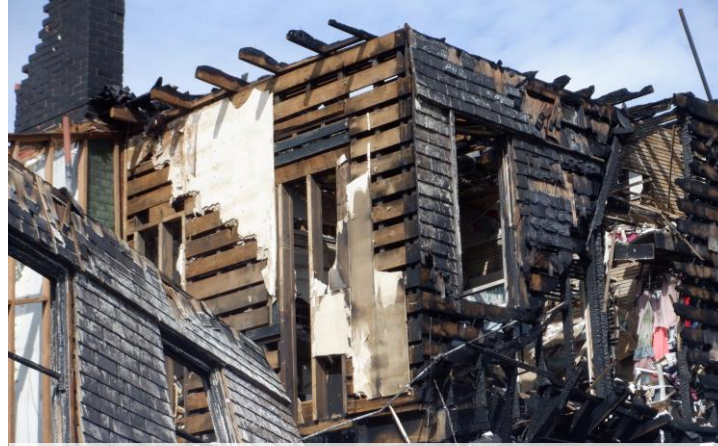
View of east second story exterior and interior walls, as viewed from neighboring east property.

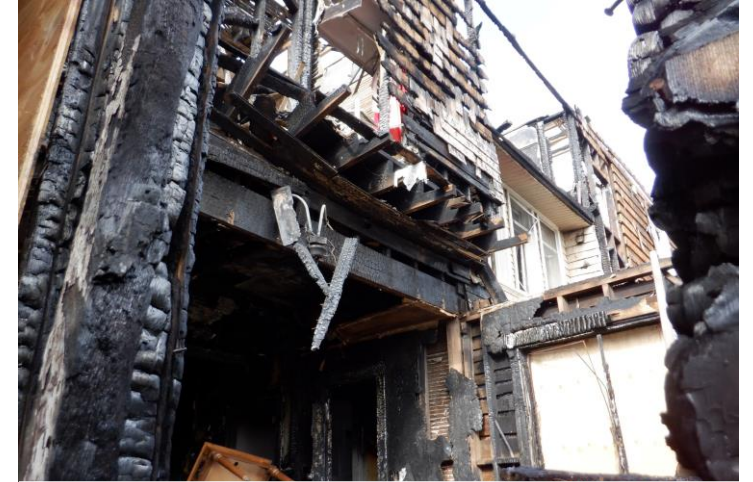
Fire-damaged exterior and interior structure.

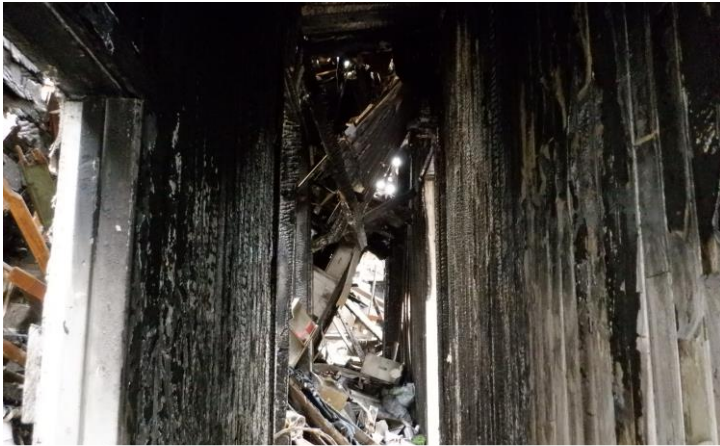
First story interior structural, fire, water and smoke damage.

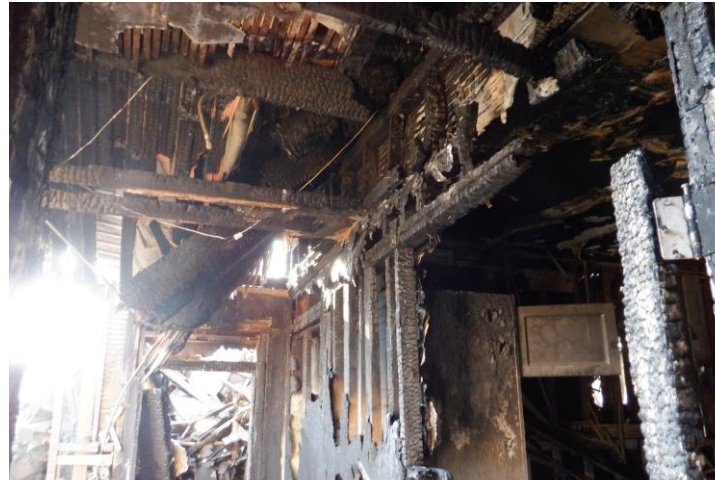
First story interior damages.

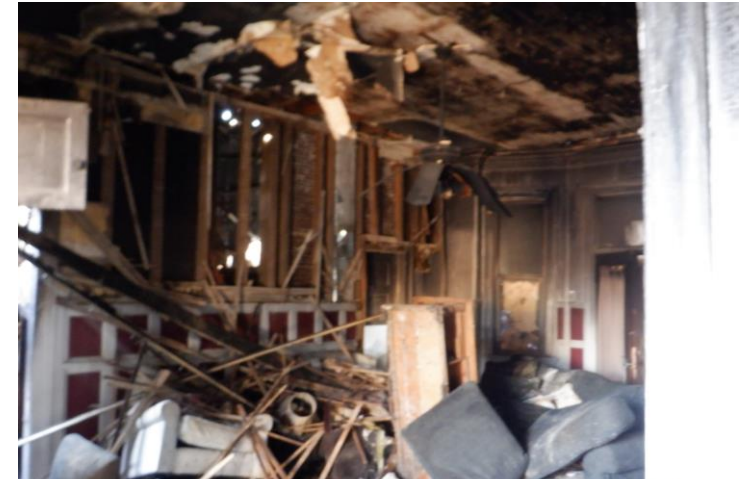
First story interior damages.

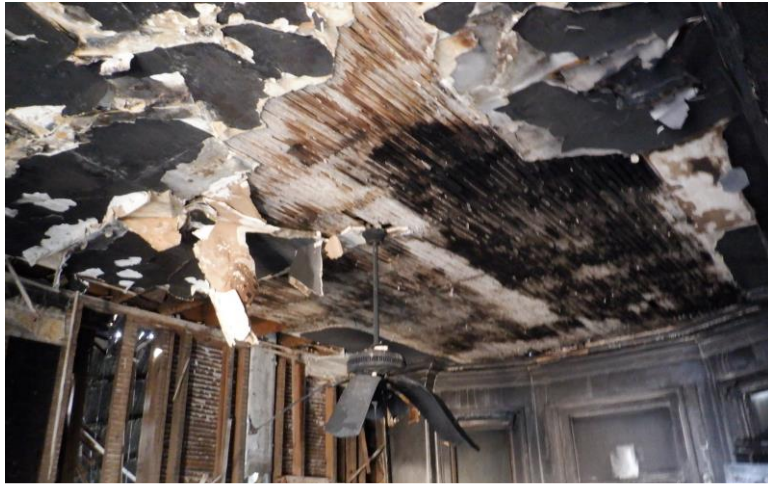
Ceiling of first-story dining room. Fire, smoke and water damage.

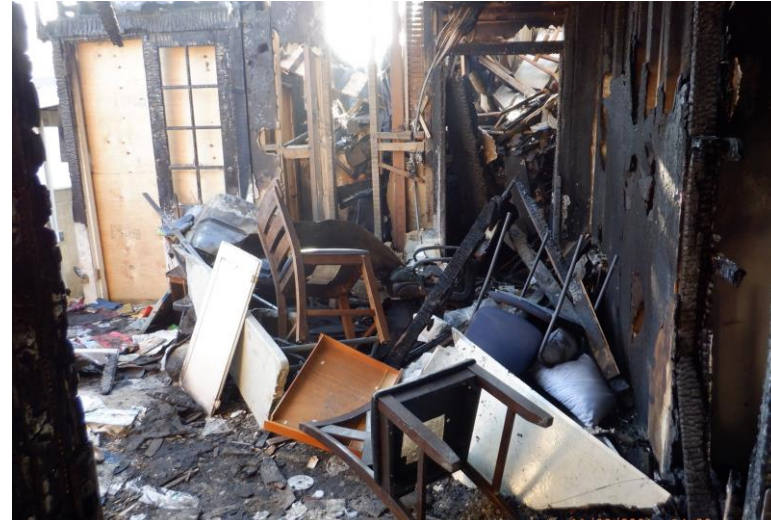
First story interior.

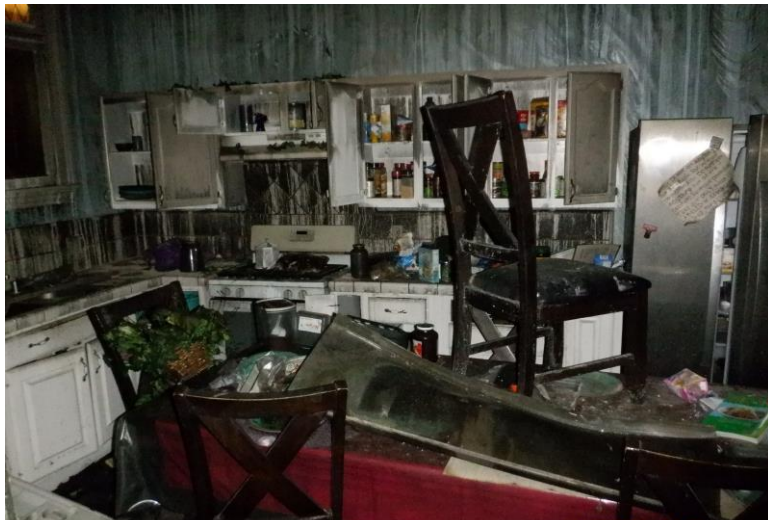
First story kitchen.

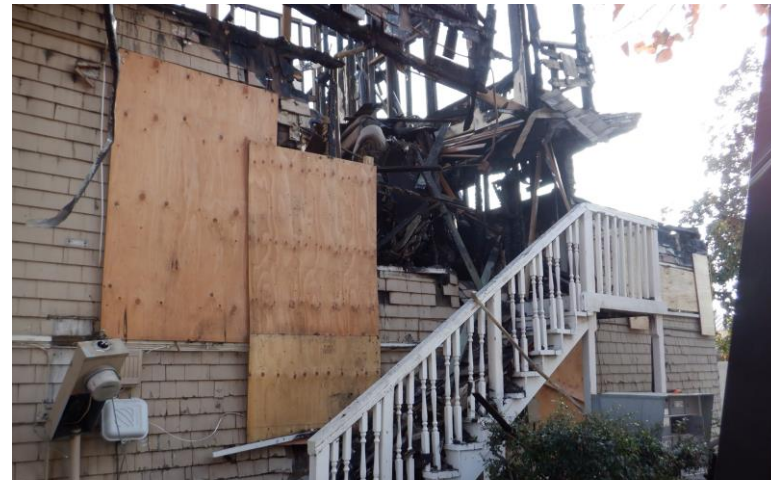
Remnant of SW second story exterior wall framing supported on door on stairs, warping under load.

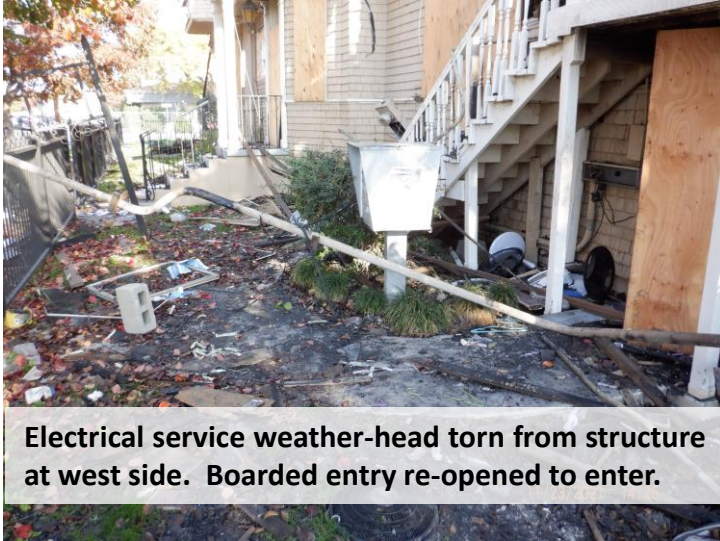
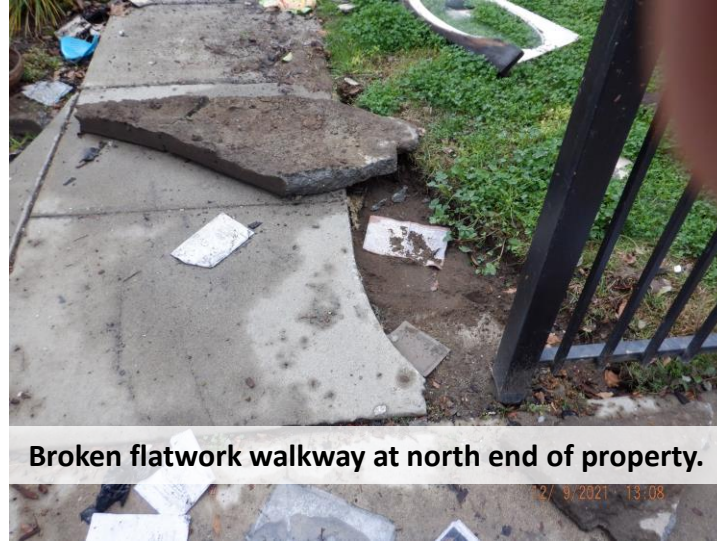
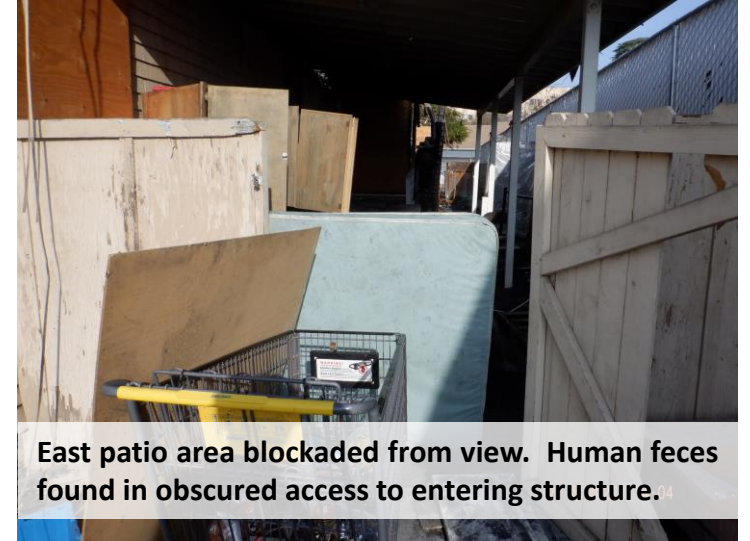
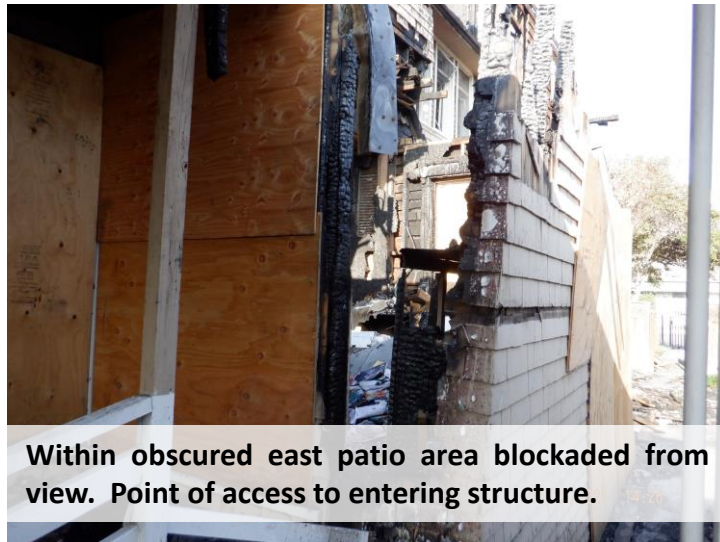
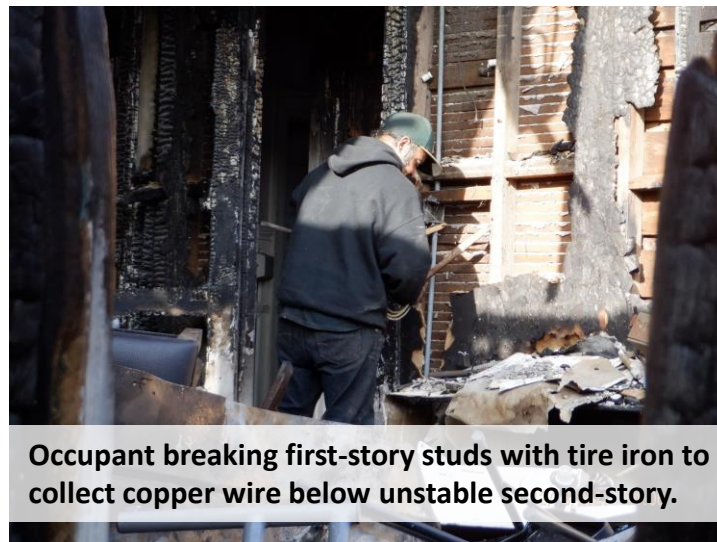
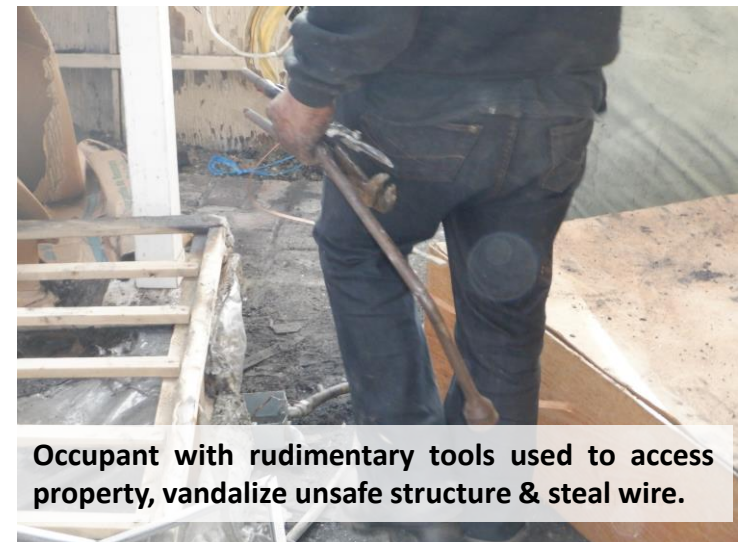
ONGOING VANDALISM

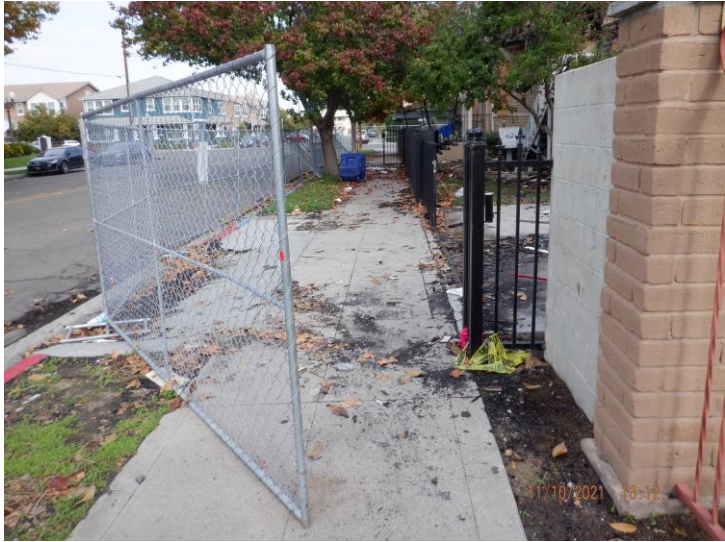
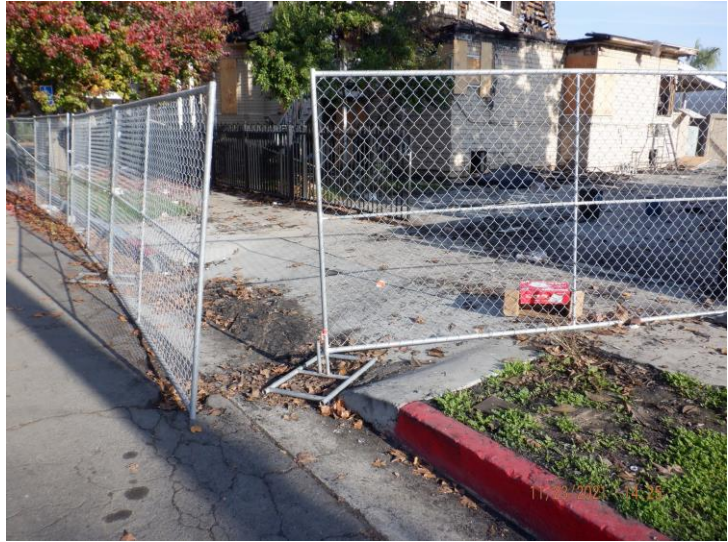
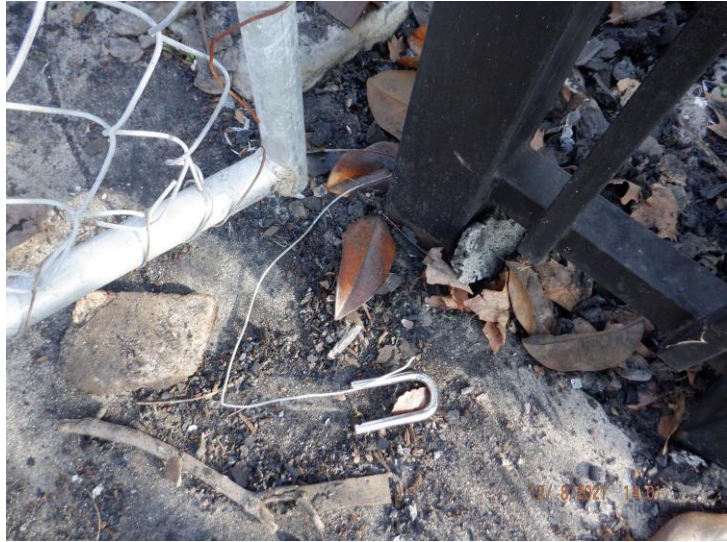
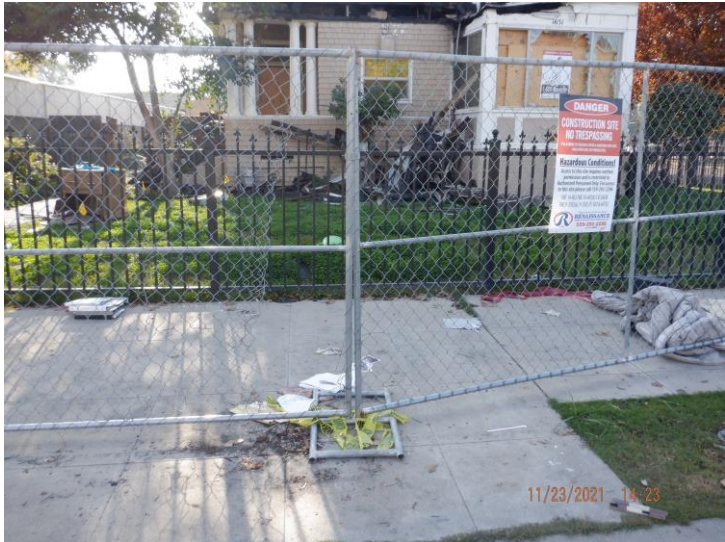
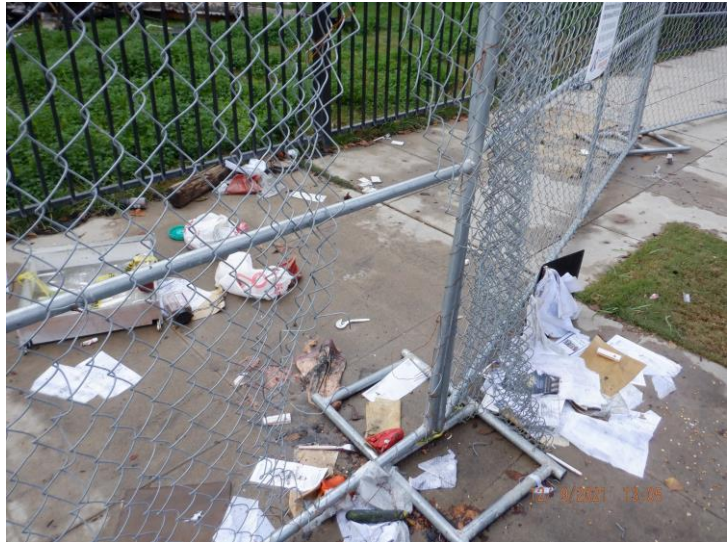
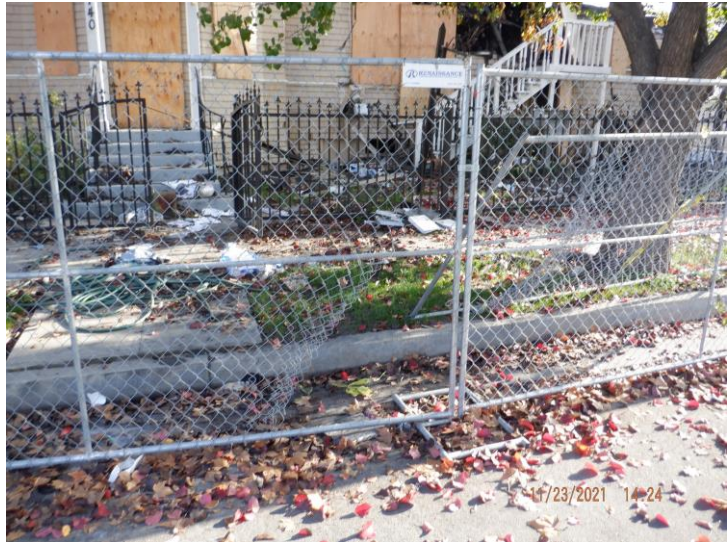
ONGOING ACCESS
