## FFD INCIDENT SUMMARY REPORT

**DATE:** Sunday, October 17, 2021 at 1305 hours  
**LOCATION:** 2140 San Joaquin St., Fresno, CA 93721 (Business address: 1651 L St., Fresno)  
**PROPERTY TYPE:** Commercial  
**CLASSIFICATION:** Accidental  
**INCIDENT #:** FFD 21-075838  
**VICTIM:** Property Owner – Light House Recovery Program Inc  
Vikki Luna - CEO  
**REPORTING OFFICER:** Tracy, Jay #F685  
**REPORT #:** 21-075838 JT

### SYNOPSIS

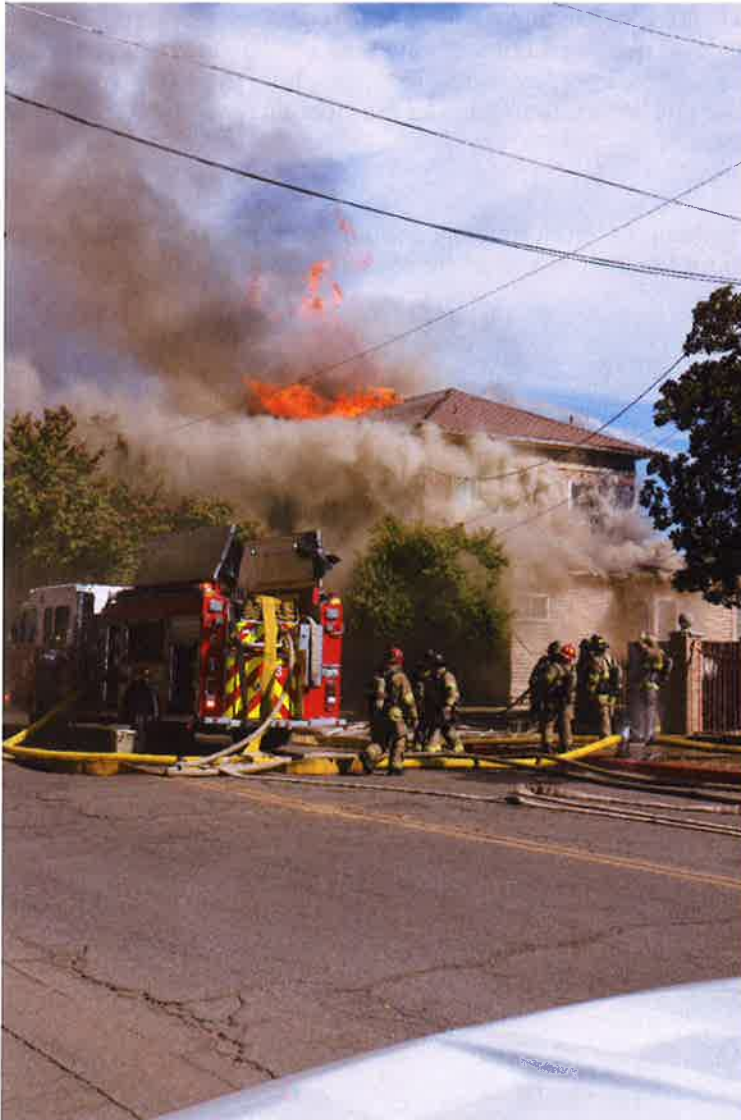
On San Joaquin facing L St (A-D corner)

Fire Damage:

The fire extended from the ground level patio roof, upwards. The building techniques utilized in the era of the building's initial construction could have included balloon frame construction which would have allowed for unabated extension upward to the attic of the structure. The building materials used for the exterior aided in extension and could have exacerbated fire

spread. A majority of the attic area was involved in fire which in turn damaged the roof trusses and roof covering. There was a partial collapse of the second level into the first level near the center of the structure. The majority of the fire damage was external and within the attic area. Any interior burning was predominately extension from the exterior to the interior or drop down. The structure also sustained major smoke and water damage. The fire operations went defensive and an interior investigation was prohibited due to safety concerns.

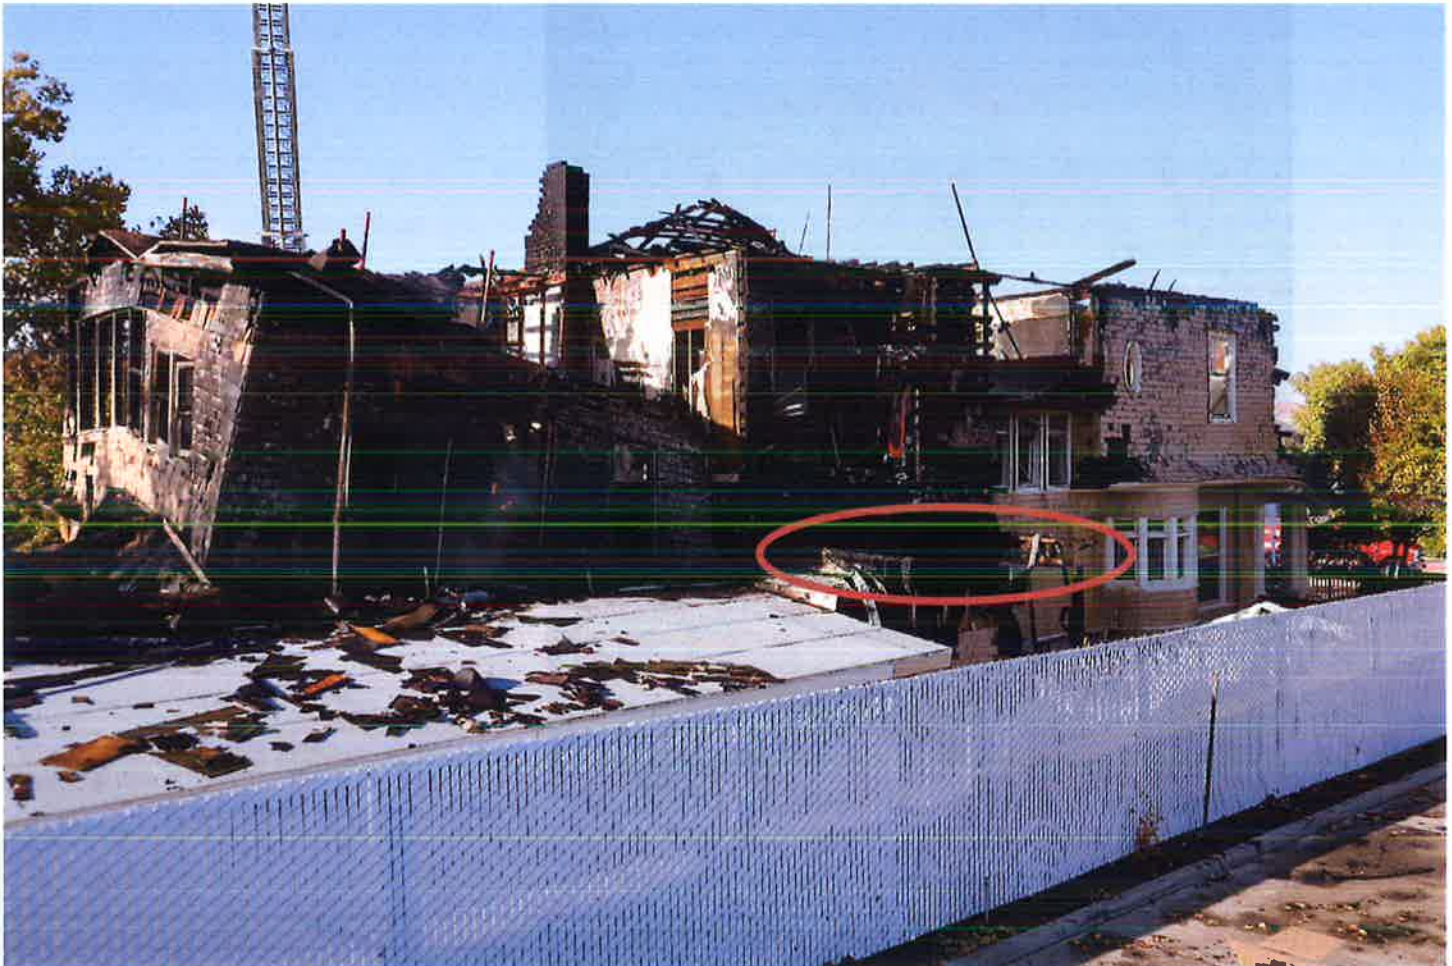
#### **AREA OF ORIGIN (AOO)**

Based on my training and experience, witness statements, work recently performed and physical findings that corroborate the preceding, I believe the fire originated on the roof of the patio near the area that it connects to the main structure.

I searched the area of origin from the exterior for any type of competent ignition source and/or heat source that would be capable of causing this fire. There were no other ignition sources or heat sources identified within the area of origin. The only possible cause for this fire was the open flame which was carried away by the workers on the roof at the time of ignition. It is my opinion, based upon the scene examination, witness statements and my training and experience and the information known to me at this time that this fire was:

1. Ignition Source:
  - a. Propane torch
2. Material First Ignited:
  - a. Structural members of the patio roof and/or siding of the structure
3. Oxidant:
  - a. Surrounding air
4. Event Which Brought Ignition Source in Contact with Material First Ignited:
  - a. While utilizing a hot torch method to repair/replace the roof of the patio the structural members and/or siding of the structure was heated to its ignition temperature.
