SUBJECT: UNIQUE QUALIFICATIONS OF BROOKS RANSOM ASSOCIATES TO PROVIDE DESIGN AND CONSTRUCTION SUPPORT SERVICES FOR ROESSLER WINERY BUILDING PROJECT

Project No 23067

Subject: Roessler Winery Structural Report

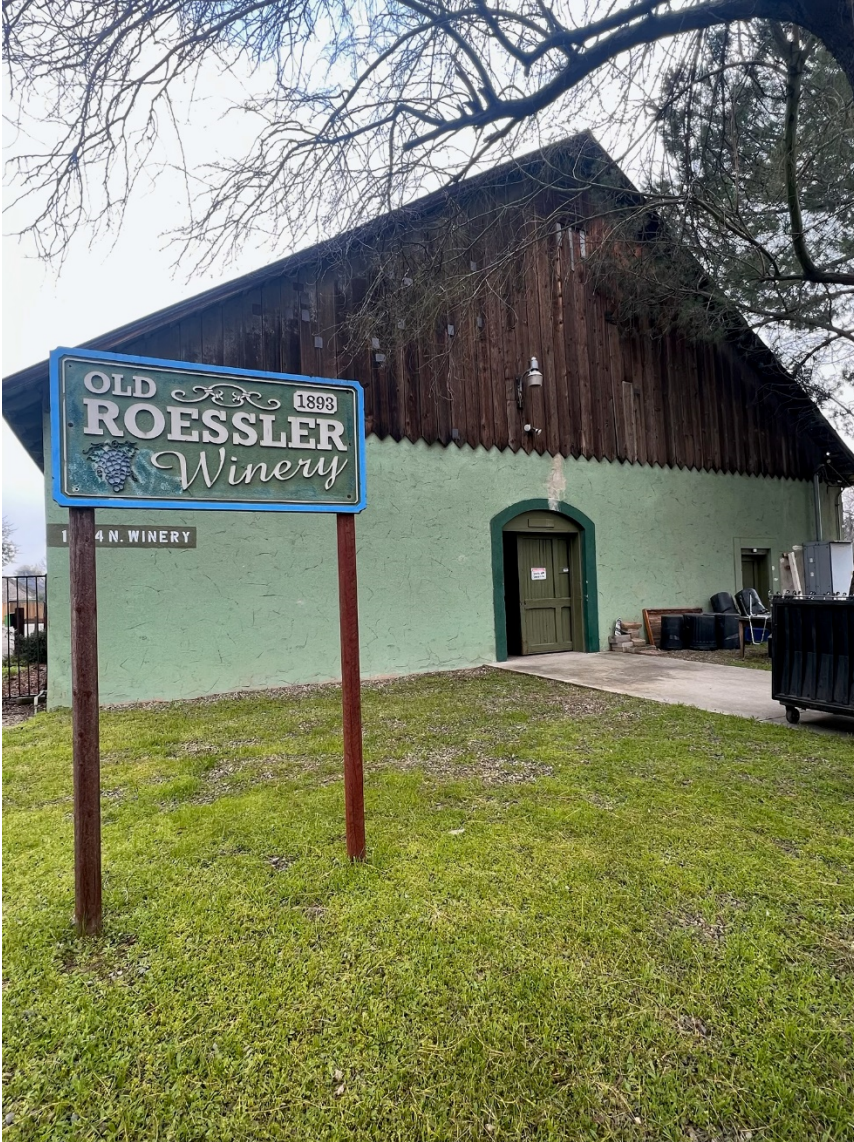
Photograph No. 1
View from the street

The construction of the structure at the 1902 N. Winery is as follows: All four walls of the structure are unreinforced adobe brick (**See Photo No. 1**). The walls terminate at an approximate elevation of 14'-10" above finish floor and transition to a 1x8 finish to the roof elevation. The floor framing consists of 8x8 beams supported by 8x8 posts. In some instances, the beams appear to be 8x12 still supported by 8x8 posts. The floor framing consists of 2x12 joists at 16"o.c spacing (**See Photo No. 3 and Exhibit No. 1**). In some bays of the structure the floor framing switches to 32"o.c. spacing, but these areas would need to be infilled to have a consistent floor framing system at 16"o.c. The floor sheathing itself appears to be 1x8 straight sheathing. The roof framing is field built trusses at 48"o.c. consisting of 2x6 top chords, 2x4 bottom chords and 1x8 web members (**See Photo No. 2 and Exhibit No. 2**). There is a post and beam system helping to support the roof trusses at both the north and south lines of the

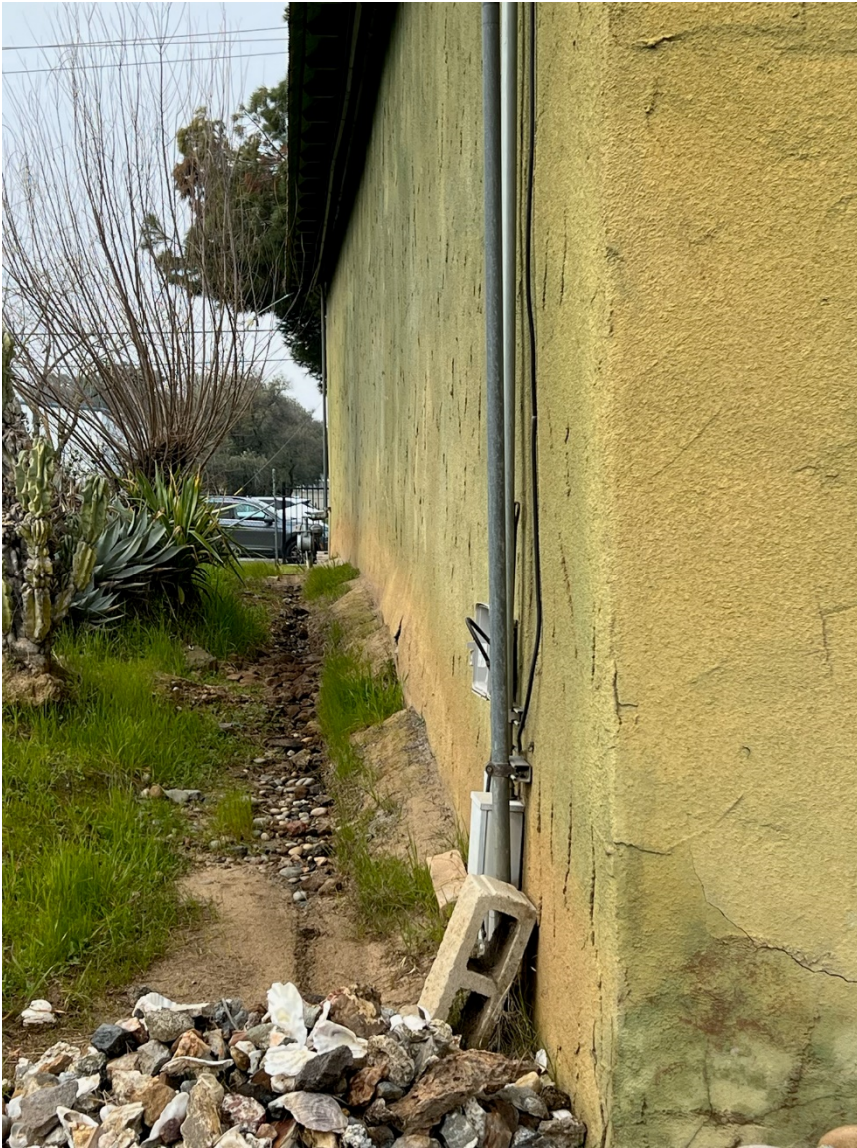
On the north and south sides of the building, settlement occurs at the foundation level (**See Photo. No. 4**). No measures have been taken to mitigate the settlement. A soils engineer should be retained to perform a site investigation and provide a soils report to be utilized in the final design of the rehabilitation. The existing rubble foundations do not provide structural capacities to bridge the settlement issues. See the structural retrofit recommendations for more information on new foundations that will undermine the existing rubble foundations to stabilize the structure.

Photograph No. 4
Adobe walls covered by
plaster

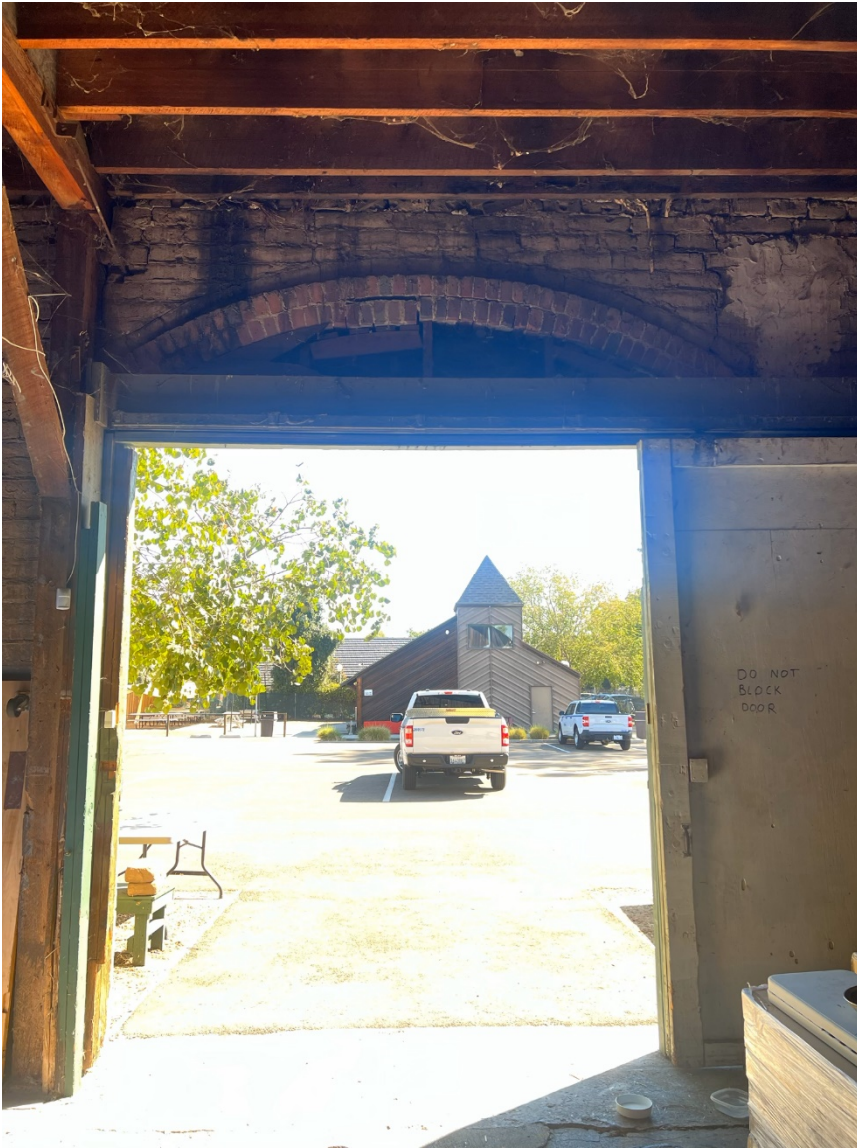
Severe cracks and deflection appear on the east and west ends of the building at the archways (**See Photo No. 5**). Both archways are primarily adobe brick with some red brick infill. Based on the appearance of the archways it is our professional opinion to structurally reinforce the openings. Our recommendation is to design and install steel lintels that will only be visible from the interior of the building. The lintels can be installed with post-installed anchors into the adobe brick. Most likely the reinforcing will need to be on both the lintel and the jambs, encompassing three sides of the opening. Alternative solutions would involve completely rebuilding the lintels with masonry or concrete, but those solutions would involve the removal of the existing adobe bricks.

Photograph No. 5
Adobe and brick archway
presenting cracks and
deflection

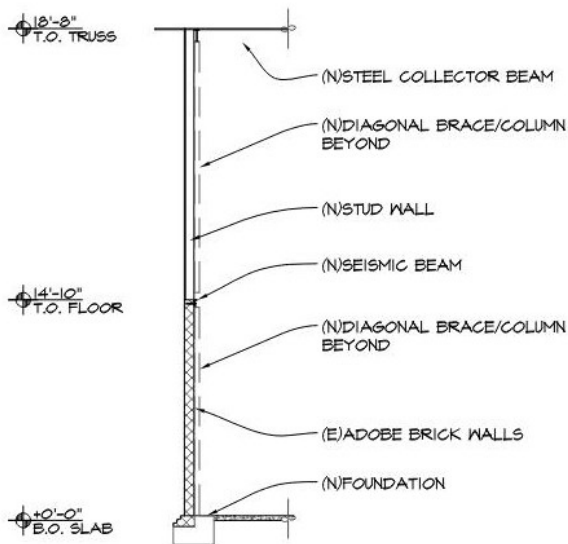
The third system involves installing a steel brace frame system as the main lateral force resisting system. Steel columns and beams would be used to stabilize the gravity system.
(See Exhibit No. 4)

Exhibit No. 4
Wall section with proposed structural system

Based on site investigation and conversations with the City of Fresno it is our professional opinion that a steel brace frame, steel columns, and steel beams would be the best system for this type of structure. Plywood floor sheathing will need to be installed to provide a structural diaphragm for the new lateral force resisting system. Rod-bracing can be utilized at the roof level to act as a structural diaphragm, but still allowing the existing sheet metal roof to be seen from the underside. New foundations would be recommended to stabilize the existing walls. Based on limited information, the existing foundations would need to be undermined by the new foundations.
