# MASTER PLAN REPORT

**FAX Transit Operations & Maintenance Facility**  
Fresno FAX  
Fresno, California

November 21, 2014

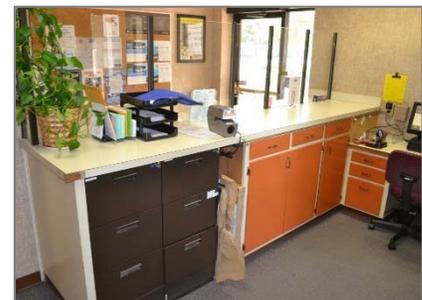
Reception Counter

- Transaction counter is 42 inches tall. Current code requires minimum of 36 inches of counter length to be maximum of 34 inches high. Millwork is otherwise in fair condition.
- Only one of the two offices appeared to be in use.

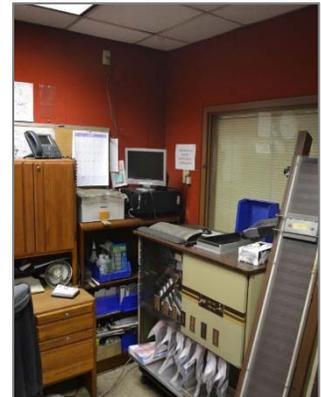
Workstation & Sorting Equipment

- Room is too small for fare counting functions. Sorting equipment must be moved into place during use.
- Rooms are in poor condition, finishes are very worn and past typical lifespan.
- Doors in room do not have proper code clearances.
- Lighting is inadequate for detailed work done in this room.
- Hollow metal framed window into Operations Manager office may not provide proper acoustic separation between rooms.

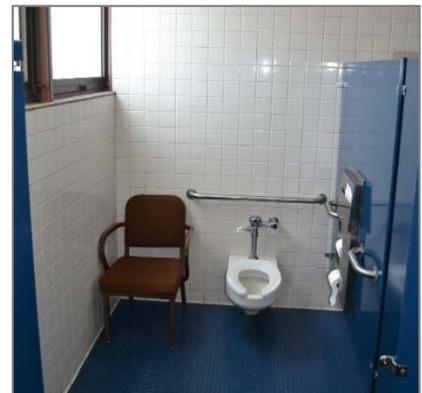
Women's Toilet

- Men's and Women's rooms have not been updated to current accessibility standards.
- Accessible toilet stalls do not have sufficient clearances within stall. Per current Code, a minimum of one accessible stall should be provided in each toilet room.
- Toilet paper and paper towel dispensers are not mounted within Code required height ranges.
- Sink drains do not have code required pipe covers.
- Bottom of mirror height should be 40 inches maximum at all locations.
- Fixtures and showers appear to be in working condition, but in need of cleaning.

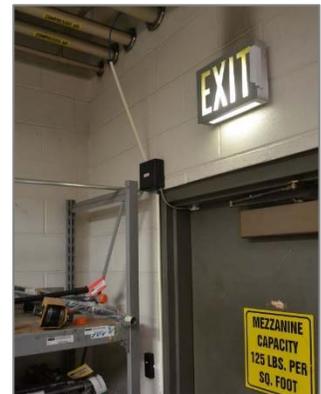
Typical Card Reader Wiring

- Card readers have been added to various doors throughout the facility. Cabling to card readers has been installed in plastic cable covers. Low-voltage equipment should be concealed within appropriate conduit.
- Maintenance Management and Supervisors functions do not have a separate break room or kitchenette. Numerous microwaves, refrigerators, and other appliances are located throughout the facility. Appliances and break spaces should be consolidated into specific areas.
- Finishes are generally in good condition, unless noted otherwise. Most areas have significant wear typical of maintenance facilities.
- Computer, servers, and general IT equipment has not been assessed, unless noted otherwise.

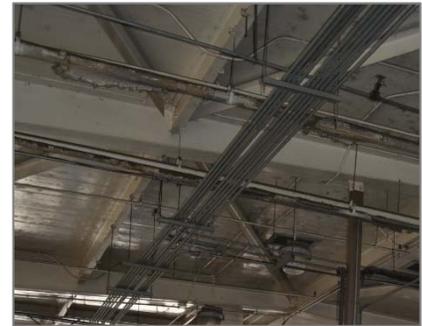
Pipe Insulation

- Pipe insulation on various piping is significantly deteriorated and should be replaced.
- Refrigerator, vending machine, drinking fountain, and water cooler are located within service aisle. Equipment should be located within proper break room.
- Removable pipe rails along service aisles have been removed. Rails are not required if lower level area is closed.

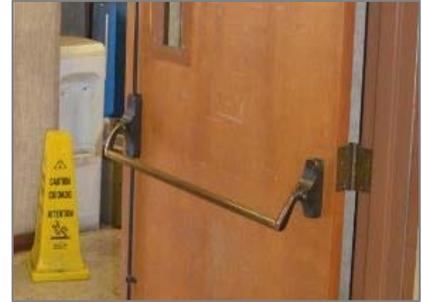
Typical 'Cross-Bar' Exit Device

- Cross-bar exit devices, where located, do not meet current codes for exiting devices. Non-compliant exit devices should be replaced with new push bar style.
- Door knob hardware does not meet current accessibility requirements and should be replaced with current level type door hardware.
- At various entry doors, IT rooms, card readers have been added for access control.

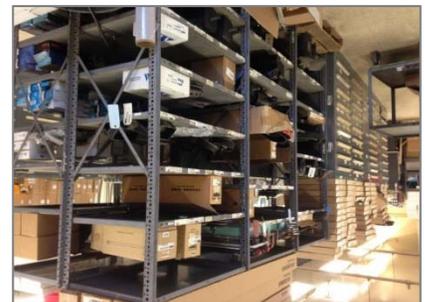
Tall shelving

Large objects appear to be generally anchored, but falling hazards may still exist. Objects may slide off of shelving, a large water tank may not be sufficiently anchored, and an exhaust stack is anchored to a duct.

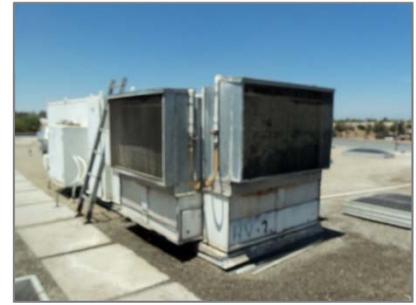
HV-2 Unit Leaking to Roof

- ✓ Observation: Evaporative coil leaking onto roof and has build-up. Fans were running at the time of site visit.

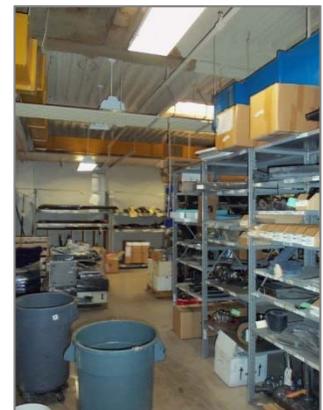
Leak from HV-5 to Floor below

- ✓ Observation: Leaking to floor below. Evaporative section requires maintenance, currently has water only running across top section of coil.

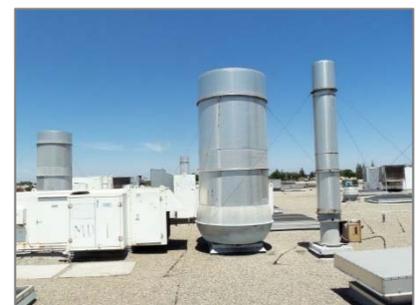
MU-1 Intake near EF-15 & EF-11 (serving parts cleaning rooms)

- MU-1: 9,700 CFM; 5HP;460/3/60; Gas burner: 500 MBH, serving steam cleaning make-up air
  - ✓ Observation: Intake shown on opposite side of design documents. Please see photo. FAX expressed concern about areas where re-entrainment was potentially happening; especially when painting booth exhaust is on, other areas in building smell the fumes.
- MU-2: 8,000 CFM; 5 HP; 460/3/60; Gas burner: 500 MBH; serving parts cleaning rinse booth make-up air

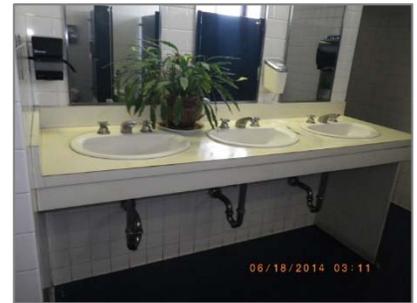
One of the water closets in one of the restrooms is leaking.

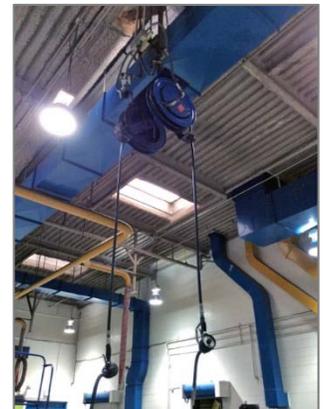
Hose Reels

Lubrication hose reels observed throughout the repair and inspection bays had visible wear on the reels, flexible hoses and connections between the hard tubing and reels. Fluid buildup observed on the majority of reel banks was consistent with the age of the system. Lubrication reels, hoses and dispensers within the Inspection Pits were either not working or in a considerable wear state.

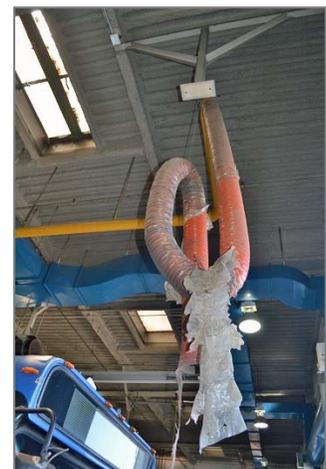
Non-Operational Hose Drop

Having an operating vehicle exhaust system allows bus engines to run while inside the facility with simultaneous inspection or testing to be performed. The facility was designed with two separate vehicle exhaust extraction systems consisting of exhaust hose drops intended to be connected to bus tail pipes, overhead mechanical ductwork and rooftop mounted exhaust fans. Refer to the mechanical assessment for discussion on exhaust fans. The exhaust extraction systems are divided between the East Repair Bays and Inspection Shop and the

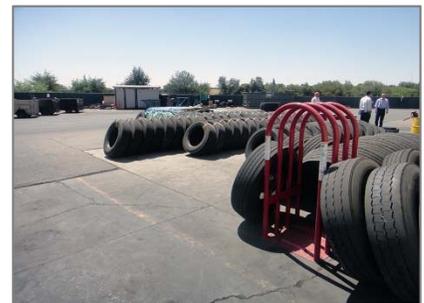
Tires stored on apron

New and used and both mounted and un-mounted tires are generally stored within the tire shop. FAX stated that the Contractor is storing more tires on-site than allowed. Tires were also observed stacked outside adjacent to the Tire Shop on the bus apron. Tires are stacked at the interior of the bay blocking one of the single-post in-ground lifts. In addition to blocking one of the single-post lifts, stacked tires are prone to topple over when struck or during an earthquake. Along the south wall of the shop, a permanently fixed two-tiered tire rack is capable of holding up to 98 tires. The rack is custom built and anchored to the floor and block wall. Tires are accessed from the rack by overhead 500-lbs. hoist that runs the length of the rack on a monorail track. The tire rack, overhead track and hoist are fairly new additions and are in good condition.
