FACILITY CONDITION ASSESSMENT

CITY OF FRESNO MUNICIPAL SERVICES CENTER

2012 G Street

EMG

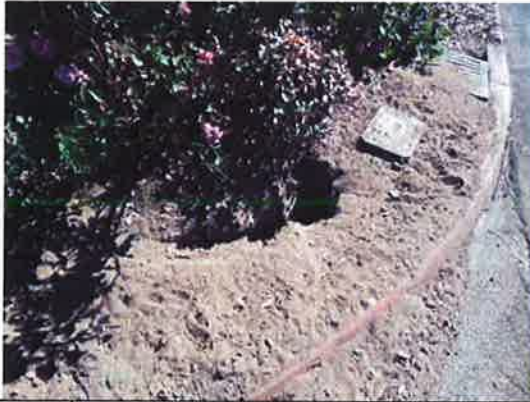
Photo #7: Isolated irrigation leak

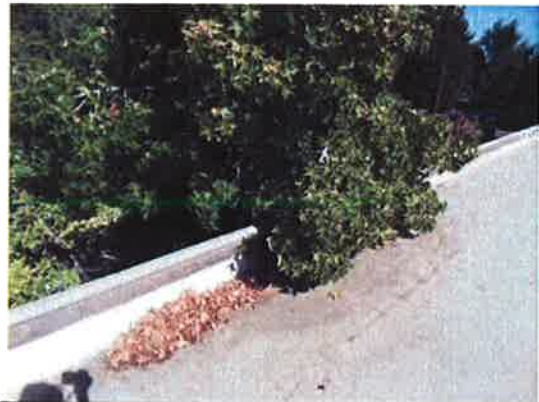
Photo #8: Overgrown trees on roof

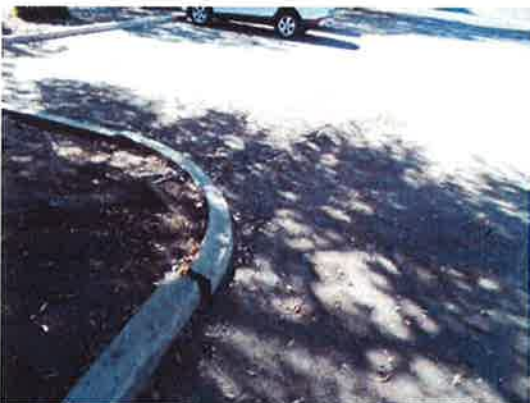
Photo #9: Cracked curbing

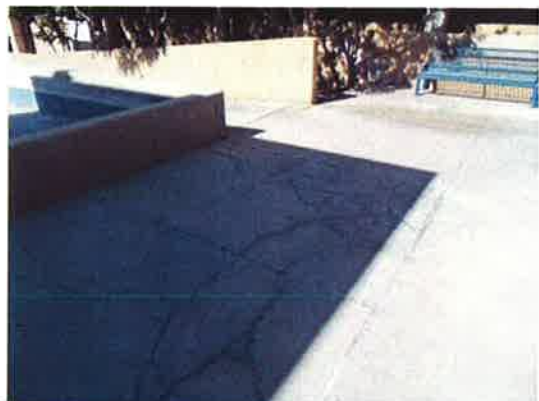
Photo #16: Cracking near Building A fountain causing leak below

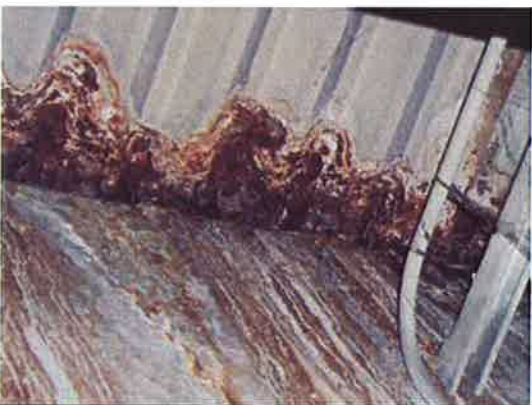
Photo #17: Leak at metal deck Building A

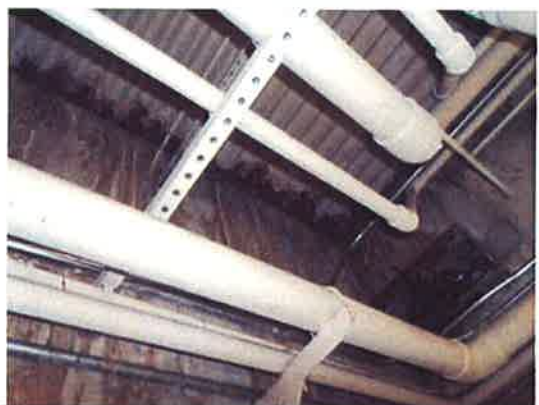
Photo #18: Leak at metal deck Building A

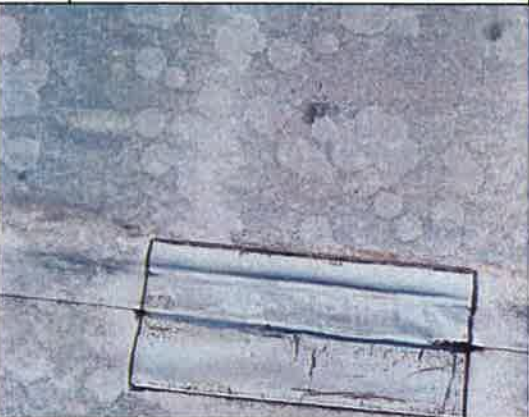
Photo #23: Roofing at Y- Close up of small split at a seam

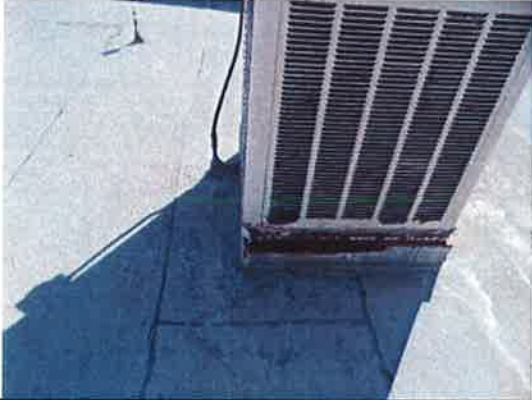
Photo #25: Roof at Building T with rust at evaporative cooler connection

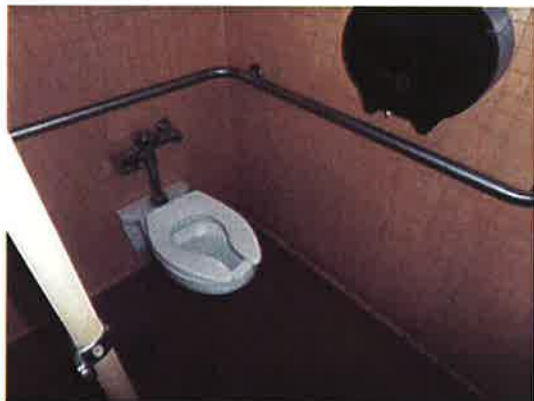
Photo #52: Toilet stall at Building B is too narrow

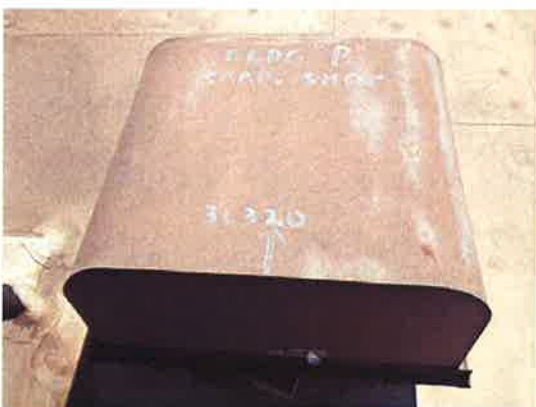
Photo #567: Older exhaust fan

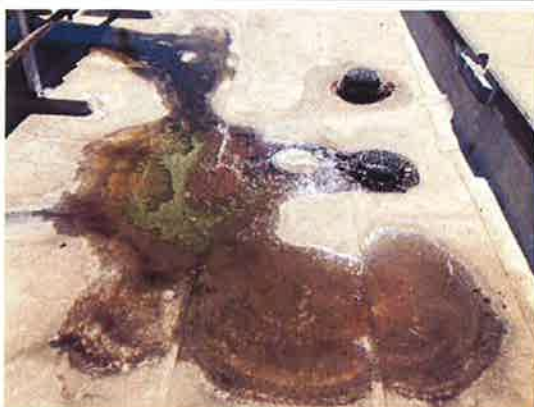
Photo #60: Condensate water leaking and ponding at Building B

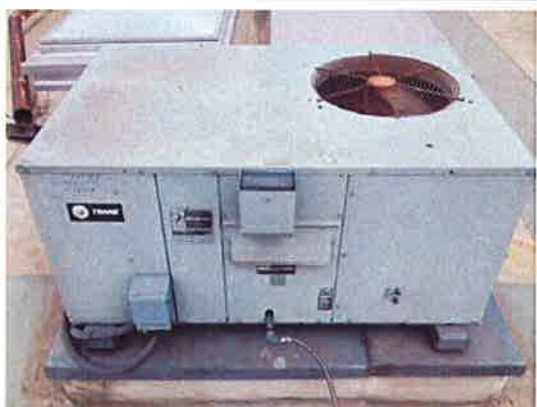
Photo #66: Older package unit
