**735, 739, and 741 H Street,
Fresno, California**

**Analysis of Brownfield Cleanup
Alternatives**

March 23, 2023

Project No.: 185755542

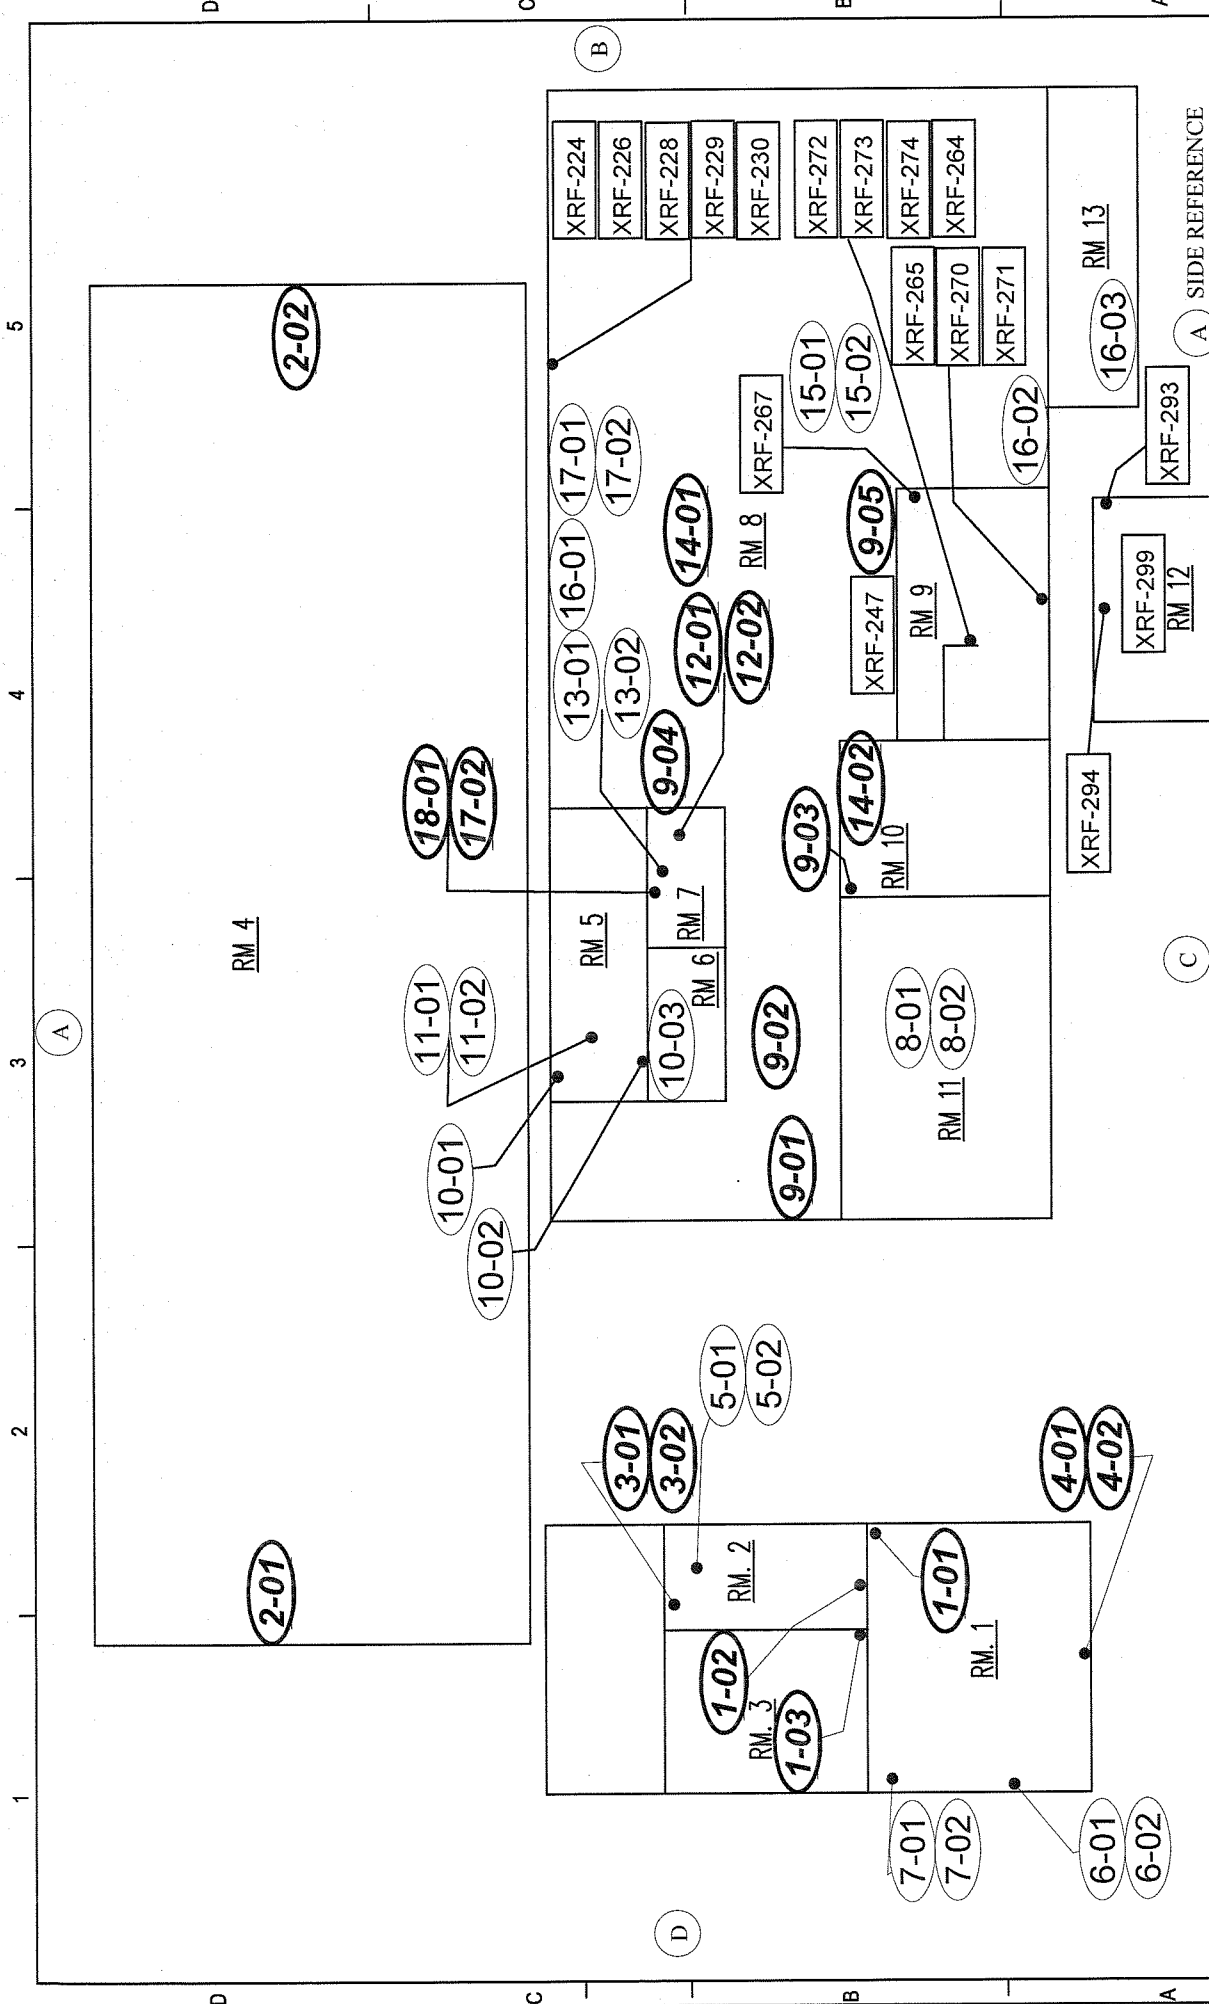
SAMPLES AS REFERENCED ON THE KEY BELOW ARE DETERMINED TO BE LEAD-BASED PAINT IN FAIR, POOR OR PEELING CONDITION AND REQUIRE CORRECTIVE ACTION. SAMPLE LOCATIONS ARE SHOWN ON THE PLAN.

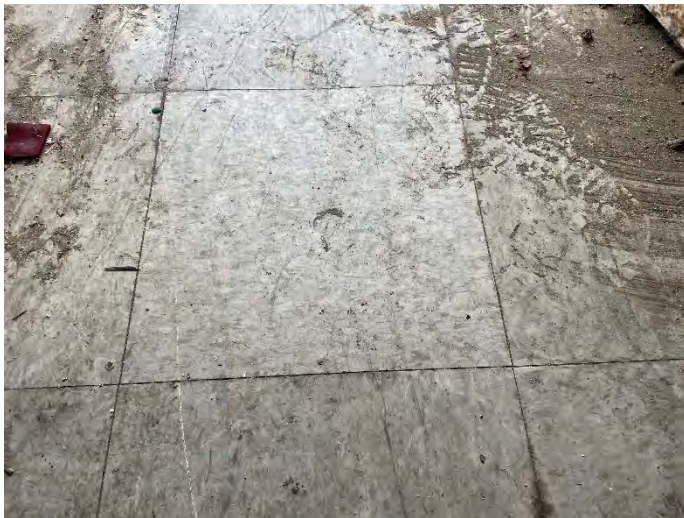
Loading Dock Concrete - Damaged

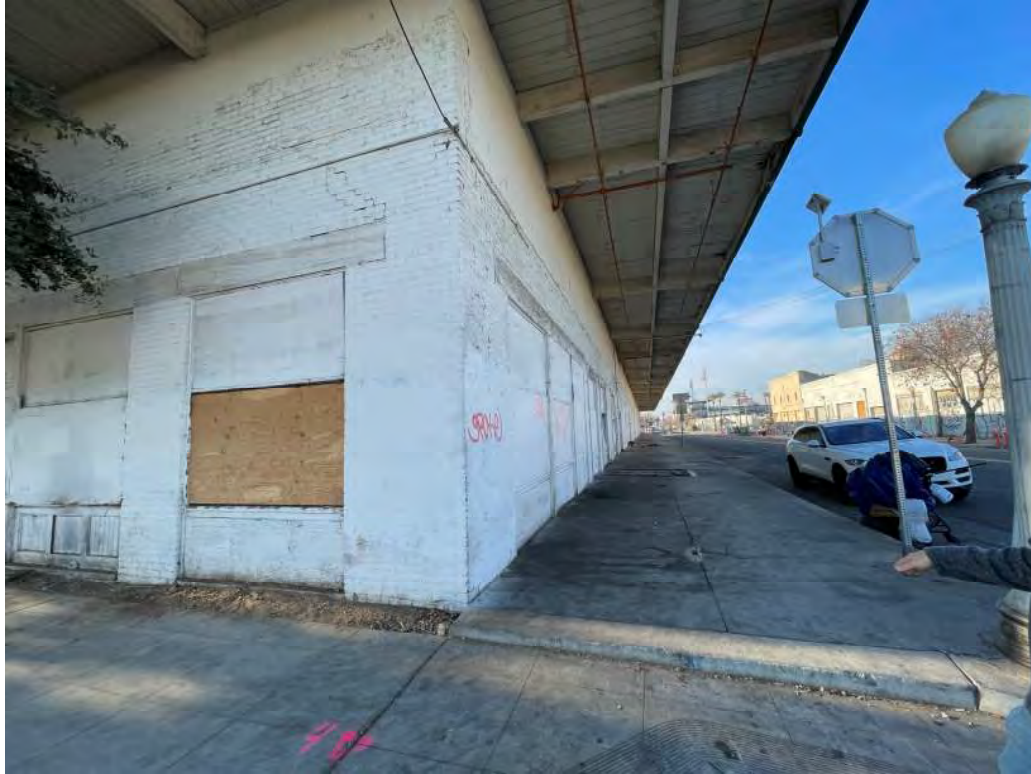
PHOTO # 1	COMMENTS : View of southeast corner at Mono St. and H St.
--------------	---

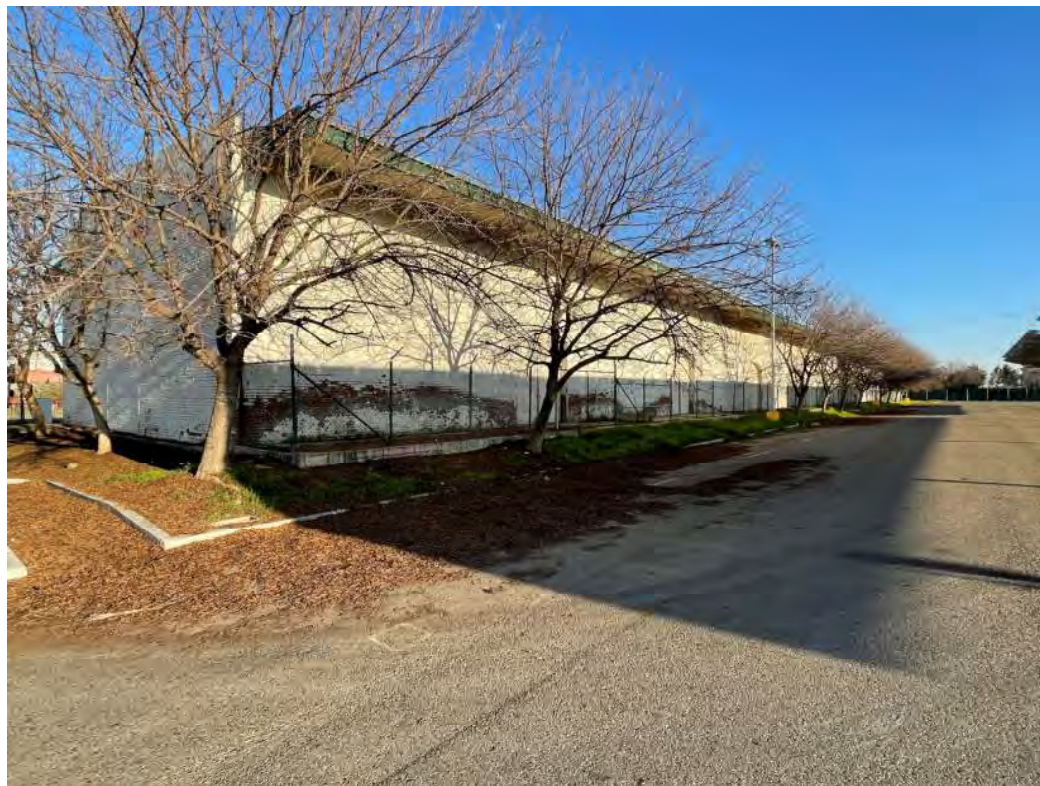
PHOTO # 2	COMMENTS : View of west (back) side of building.
--------------	--

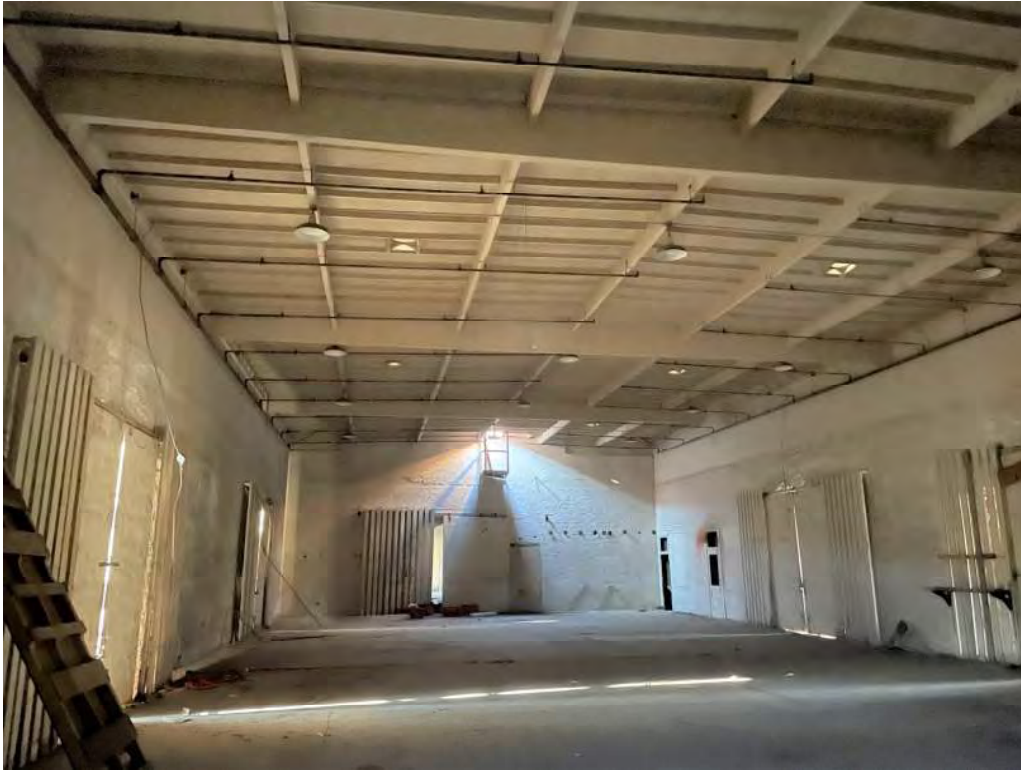
PHOTO # 3 COMMENTS : View of interior.

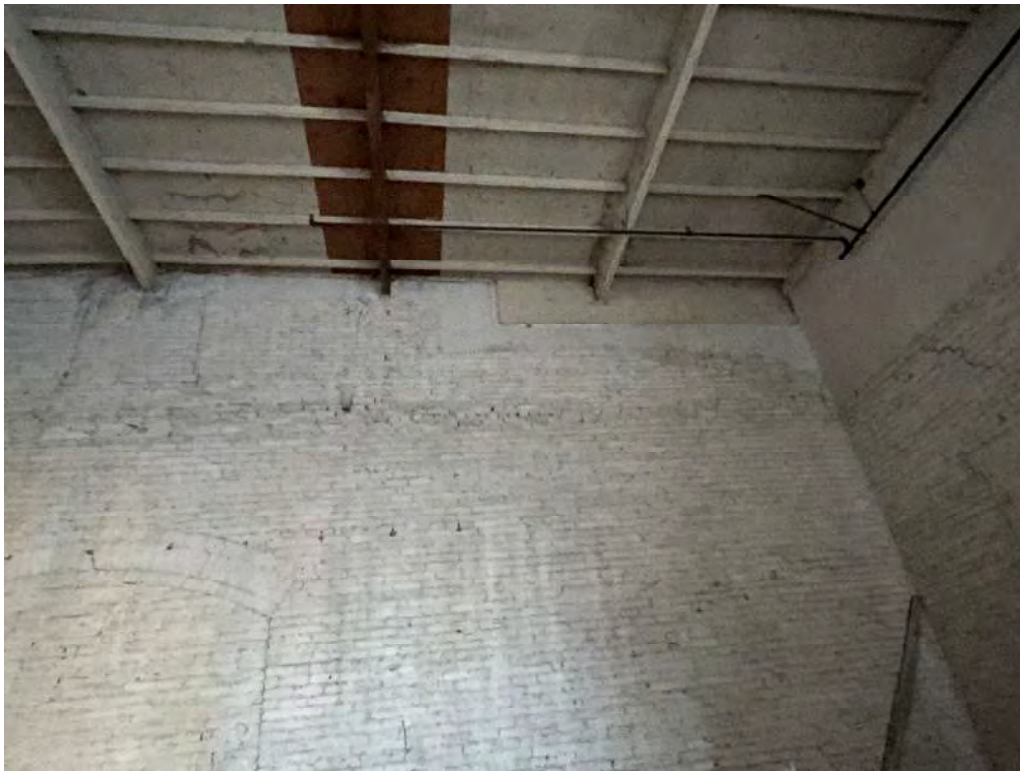
PHOTO # 4 COMMENTS : View of roof purlins supported at the north end wall and glu-lam outrigger beam. Note the newer unpainted roof plywood and purlin.

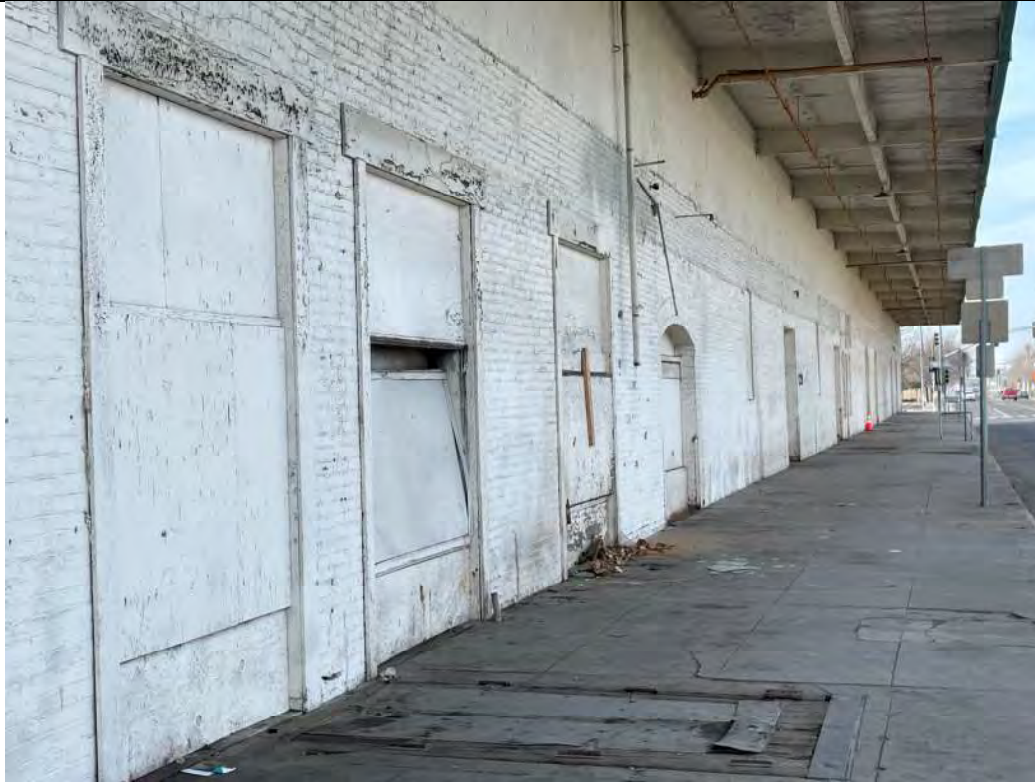
PHOTO #
5

- The report noted that the wall extension may have been constructed following a major fire that damaged the roof, but that the 38% to 60% increase in the original wall height resulted in a 90 to 150% increase in the stress level of the original wall when subjected to out-of-plane wind or seismic loads, and an "extreme increase in seismic/wind risk from the original intended construction."

COMMENTS : View of east exterior wall, looking north. Note the upper portion of wall that appears to be an extension of the height of the original building.

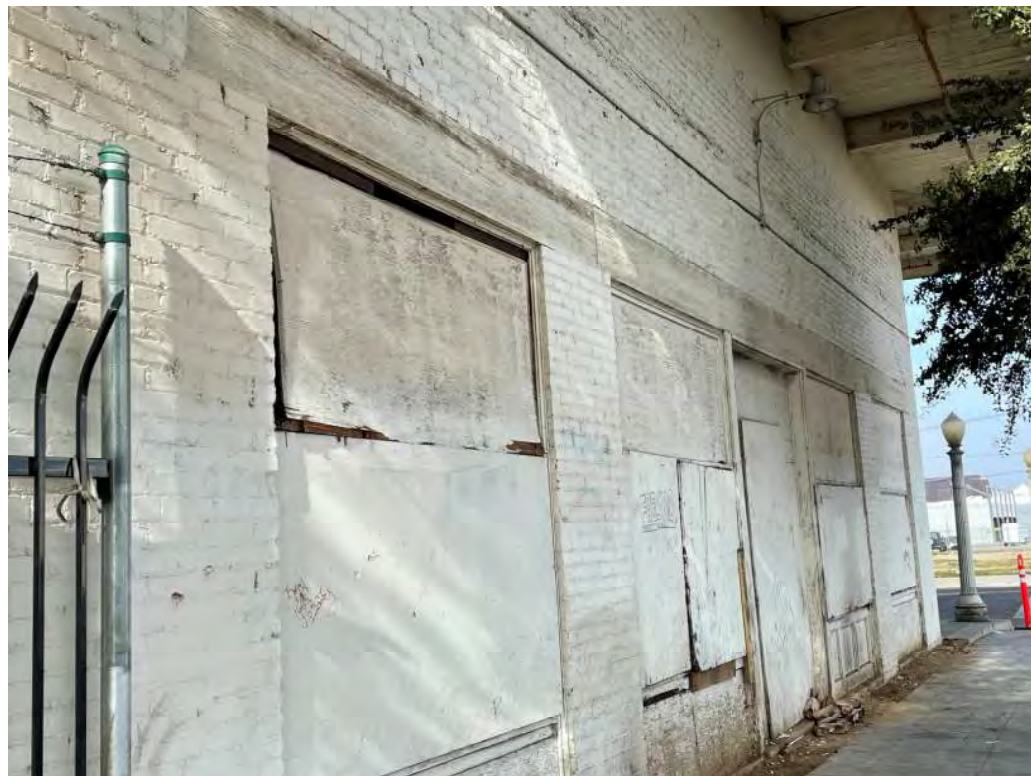
PHOTO #
6

COMMENTS : View of south exterior wall, looking east. Note the number of openings closed up with plywood. This wall has very minimal seismic shear resistance. Note the headers inlaid to the brick piers.

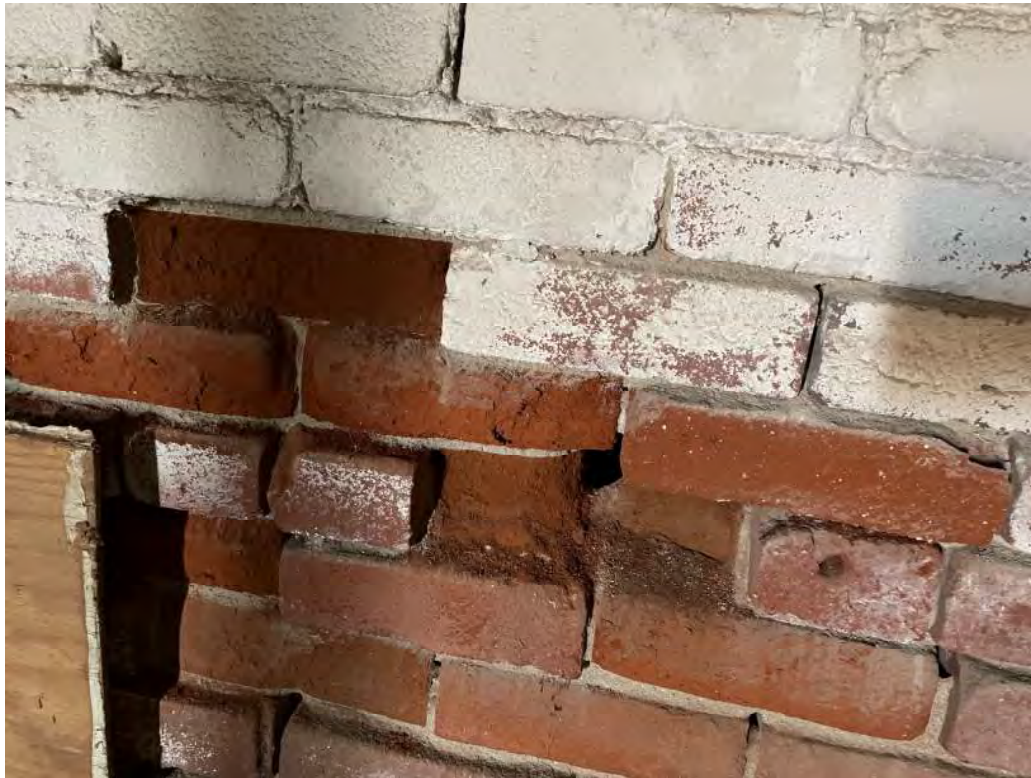
PHOTO # 7	COMMENTS : Brick exfoliation at interior surface of the west wall. Note the extreme degree of deterioration of both brick and mortar.
--------------	---

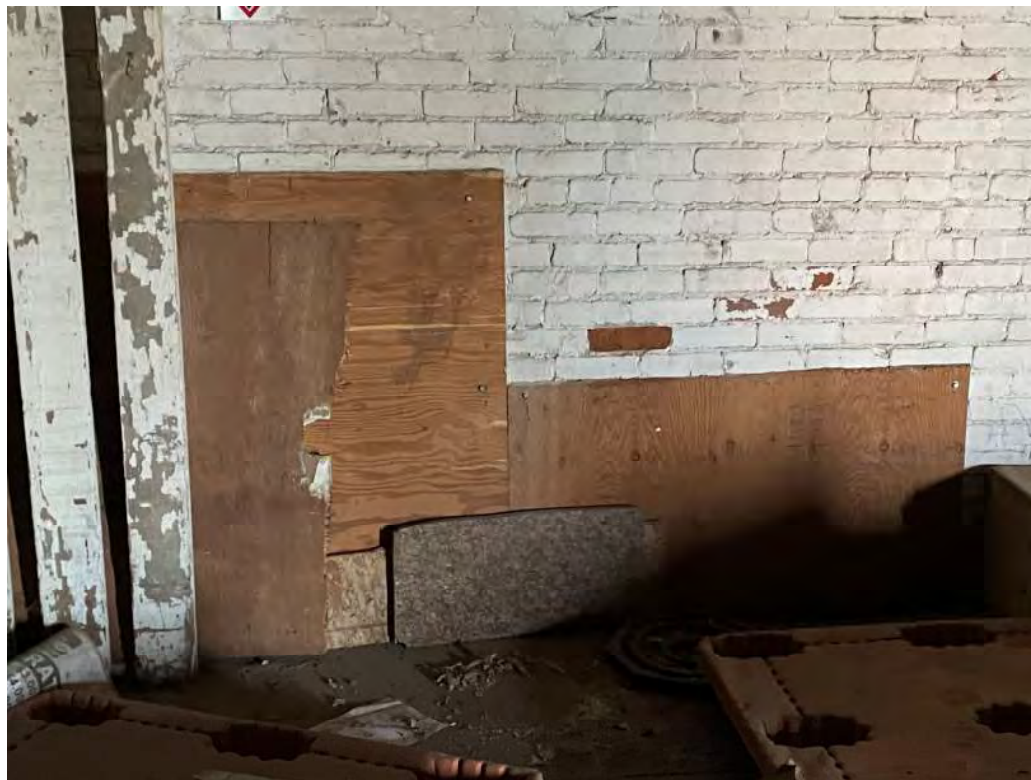
PHOTO # 8	COMMENTS : Interior of west wall with plywood to cover over extreme deteriorations of the brick and mortar.
--------------	---

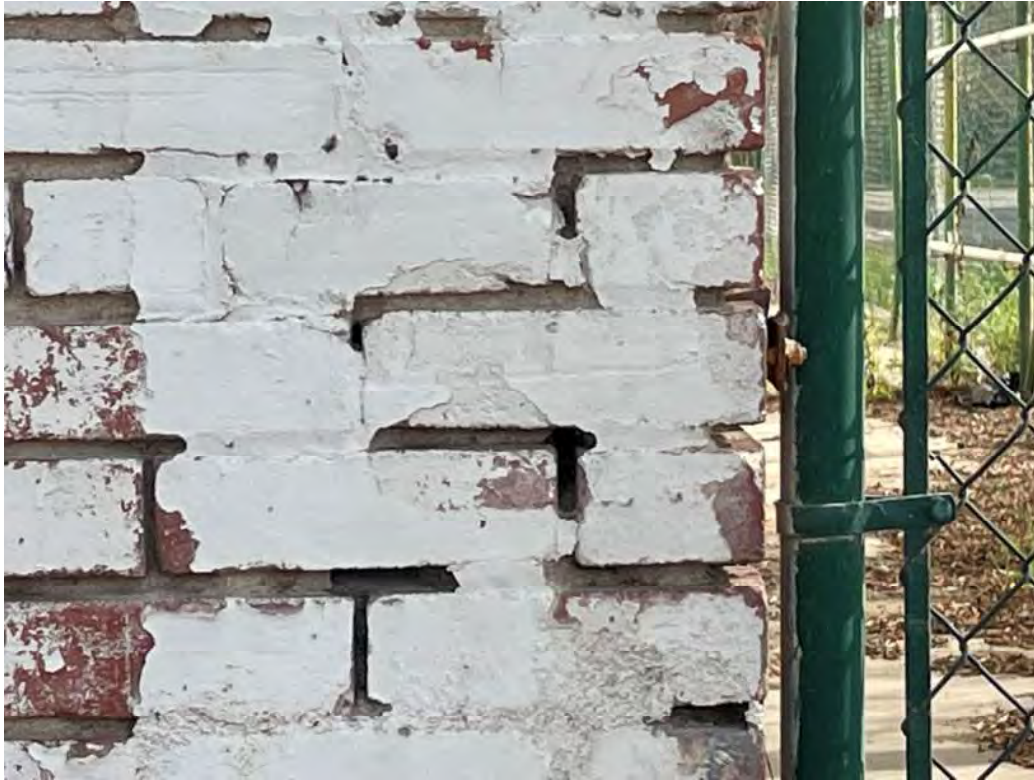
PHOTO #
9

COMMENTS : Northwest exterior corner. Note the mortar completely missing from joints.

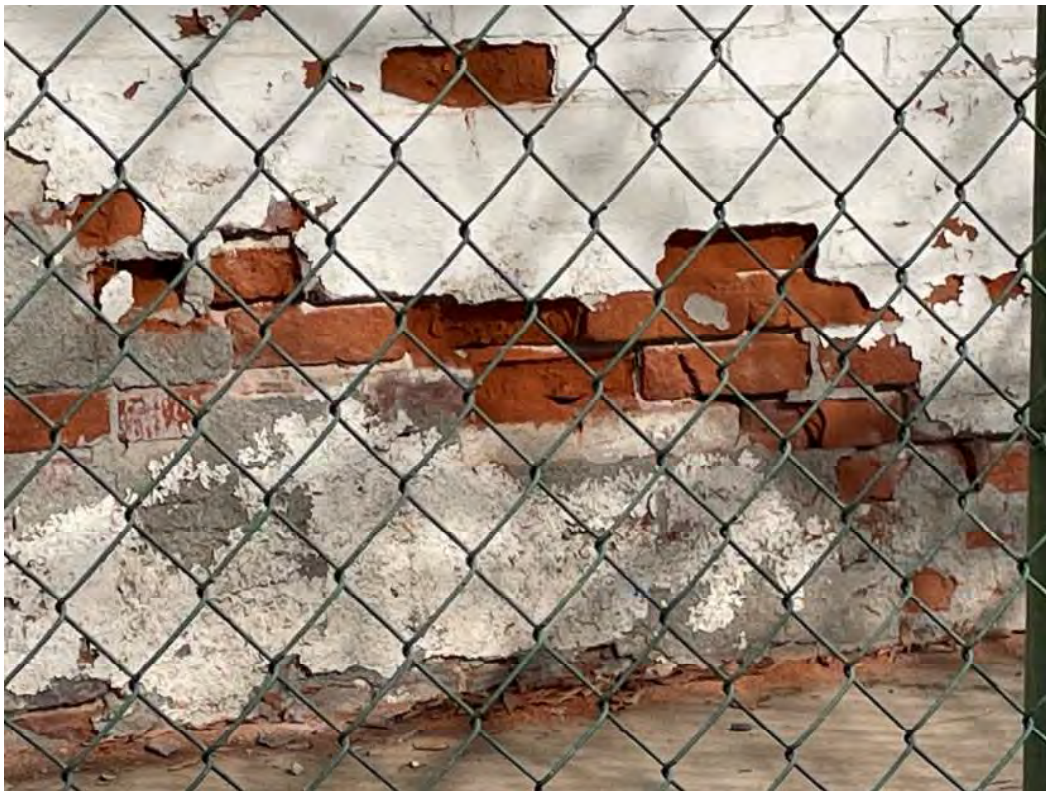
PHOTO #
10

COMMENTS : Exterior of west wall. Note the extreme deterioration of the brick and mortar, and the plaster coat at the bottom applied to help prevent further damage.

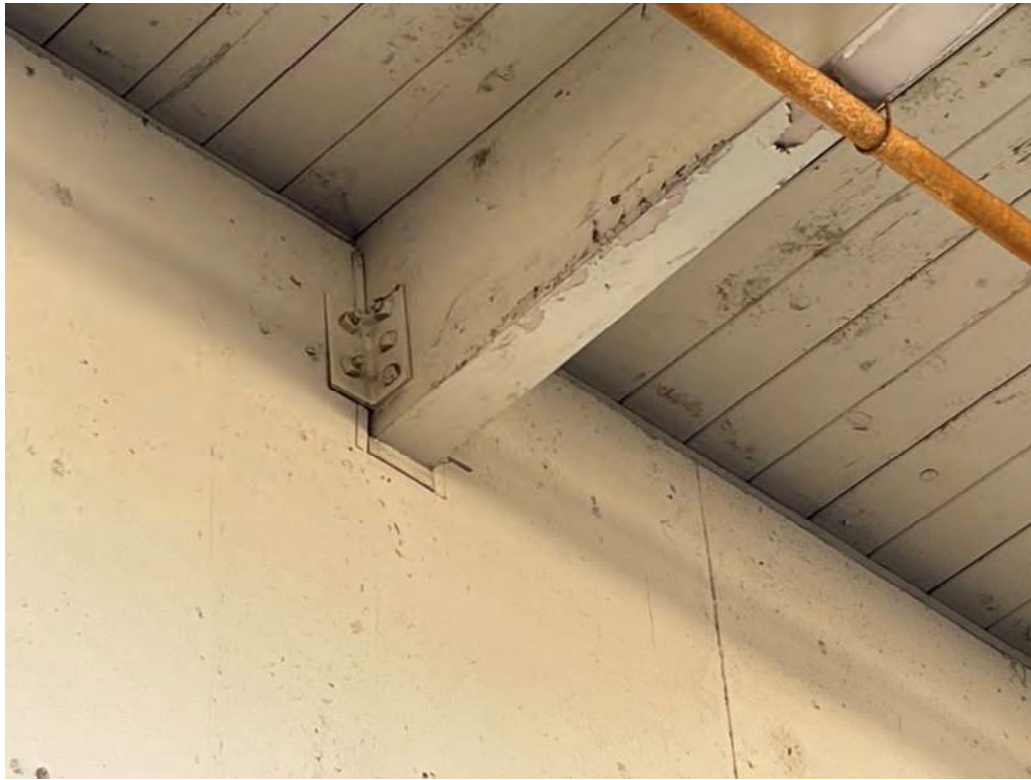
PHOTO # 11	COMMENTS : Glu-lam girder extending through pocket in exterior wall. Note the clip angle bolted to the wall and beam (each side). This is the only method of connection of the exterior walls to the roof structure.
---------------	--

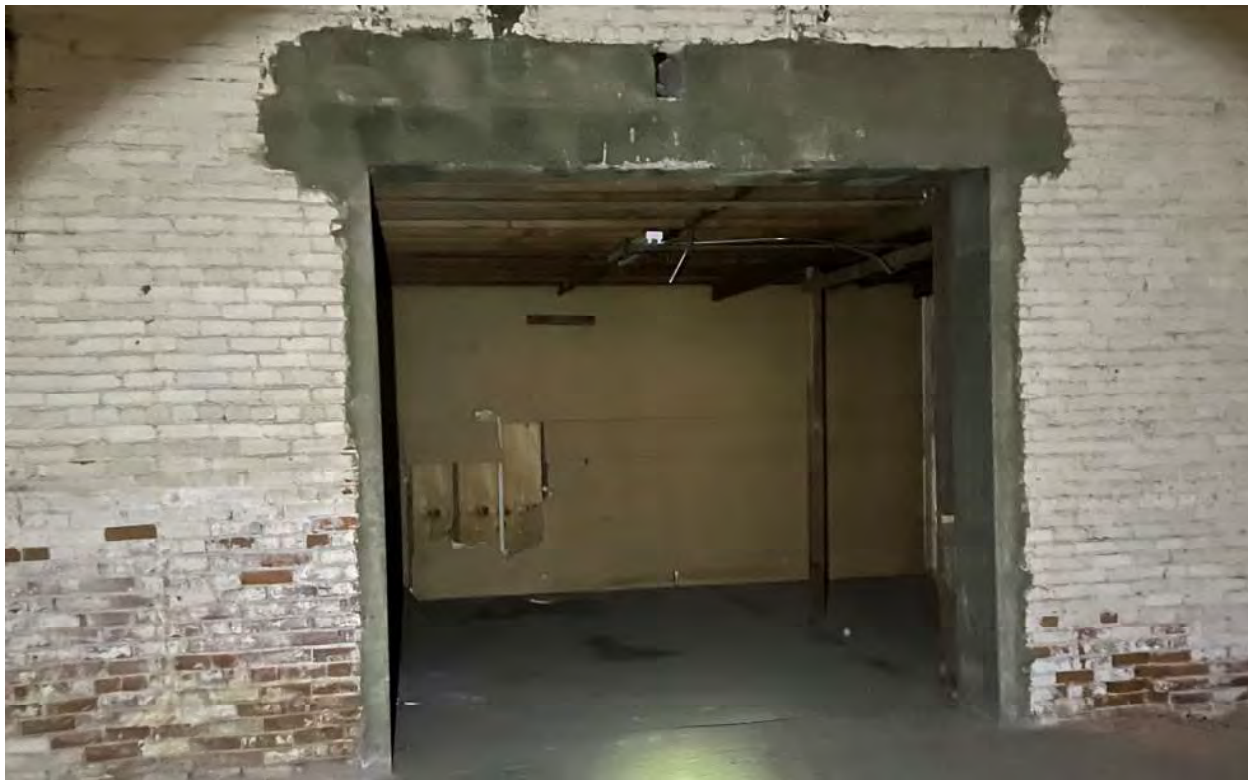
PHOTO # 12	COMMENTS : Interior opening between areas of the building. Note the grout at the header indicating a repair or replacement of the original header system.
---------------	---

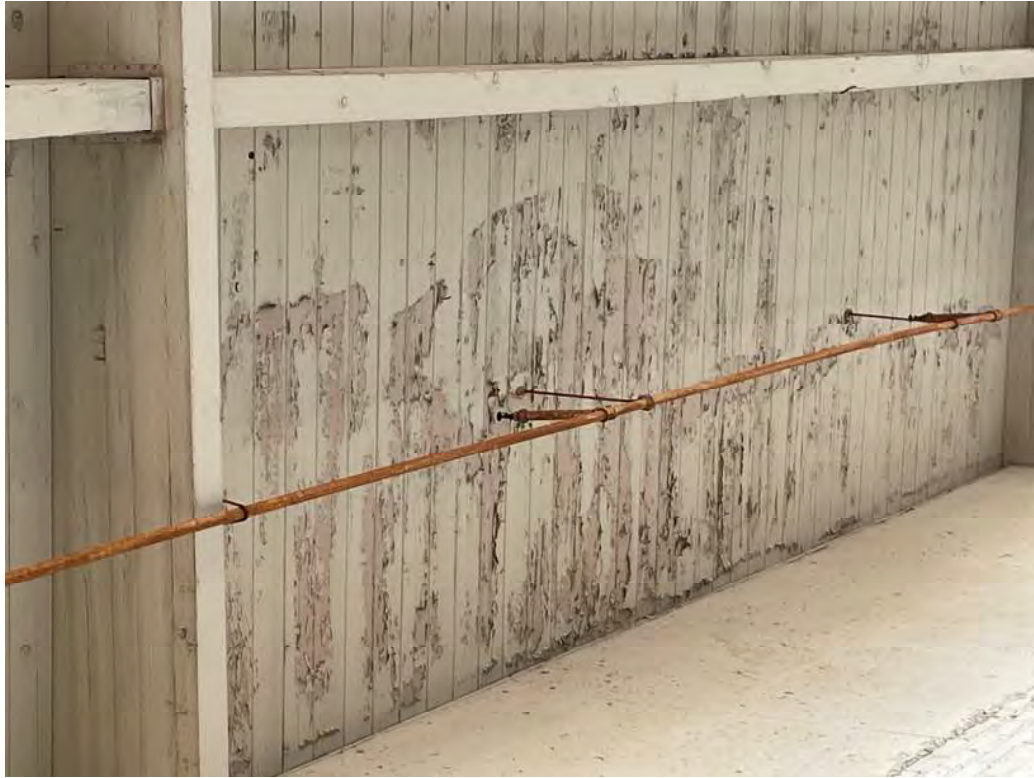
PHOTO # 13	COMMENTS : View of the underneath of the east roof deck over the loading dock. Staining and peeling of the paint is due to moisture infiltration to the roof structure.
---------------	---

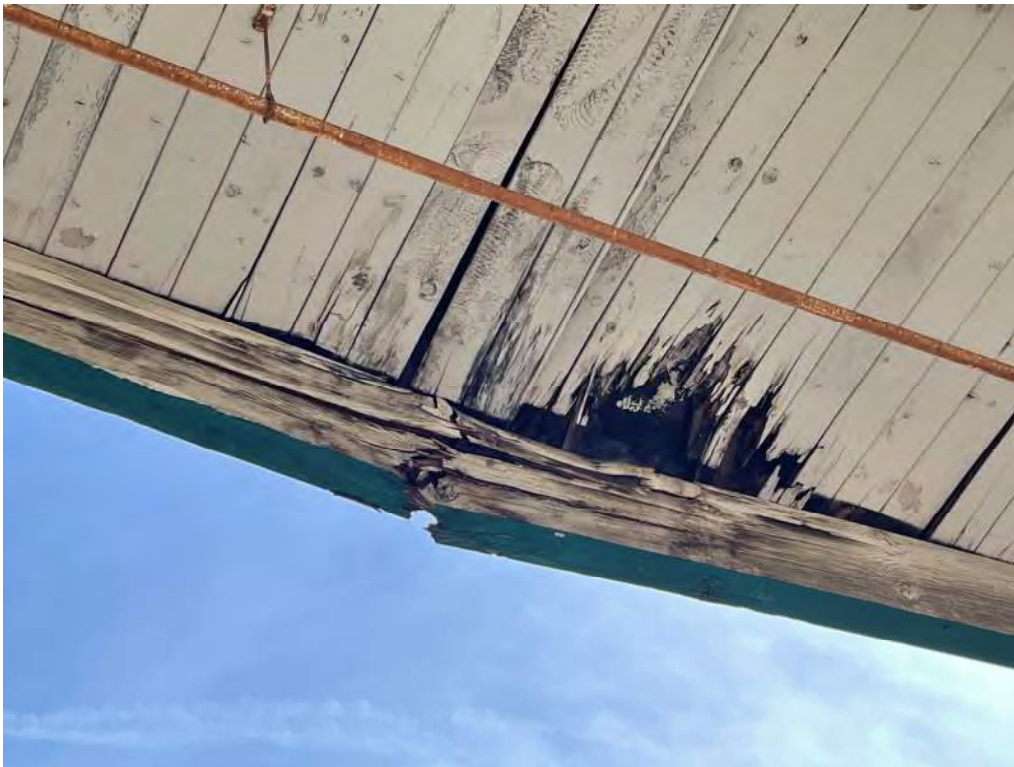
PHOTO # 14	COMMENTS : East roof overhang. Rotted roof deck and fascia beam.
---------------	--

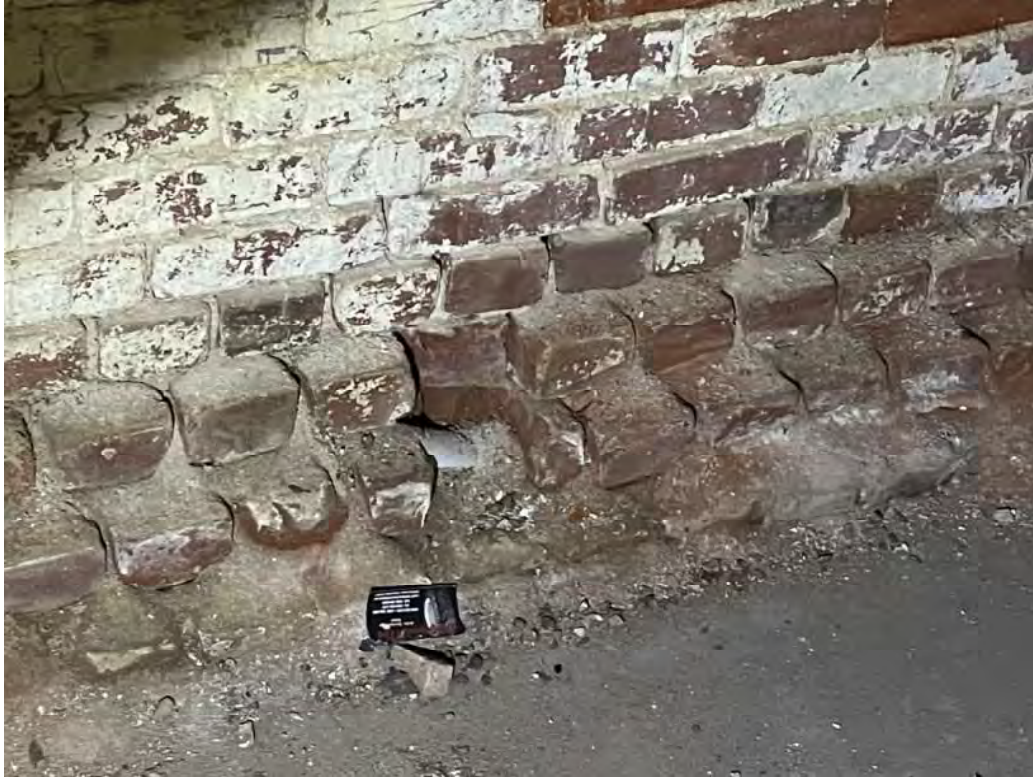
- The two basement areas are constructed with brick walls and concrete floors. The report noted extreme deterioration to the bricks and mortar forming the walls.

PHOTO # 15	COMMENTS : View of the bottom of a portion of the basement wall. Extreme brick and mortar deterioration.
---------------	--

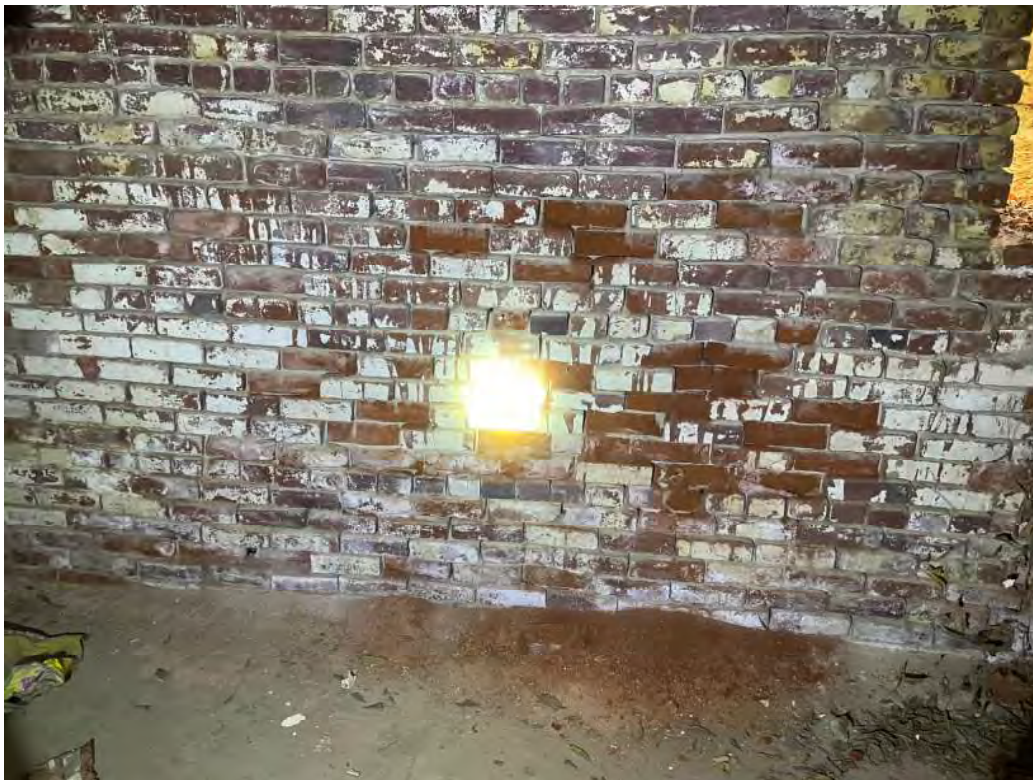
PHOTO # 16	COMMENTS : A typical basement wall surface with extreme brick and mortar deterioration. Note the 'Red Dust' piled at the bottom of the wall. Evidence of a very long term condition beyond repair.
---------------	--

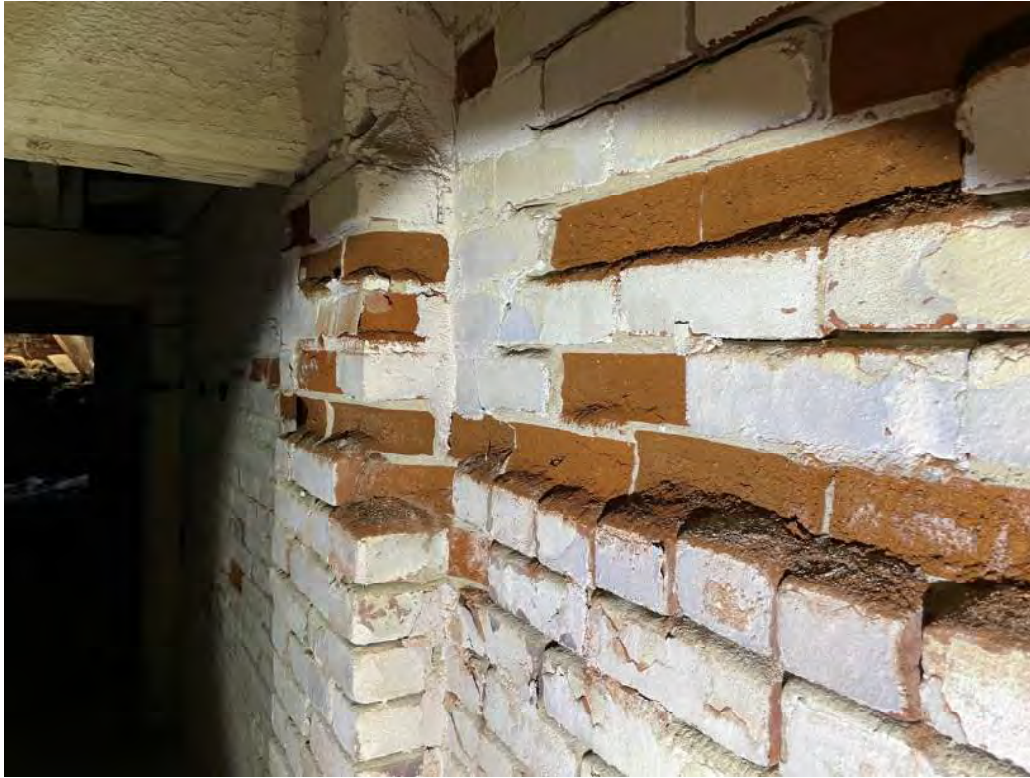
PHOTO # 17	COMMENTS : Basement wall deterioration in pilaster supporting a main floor beam.
---------------	--

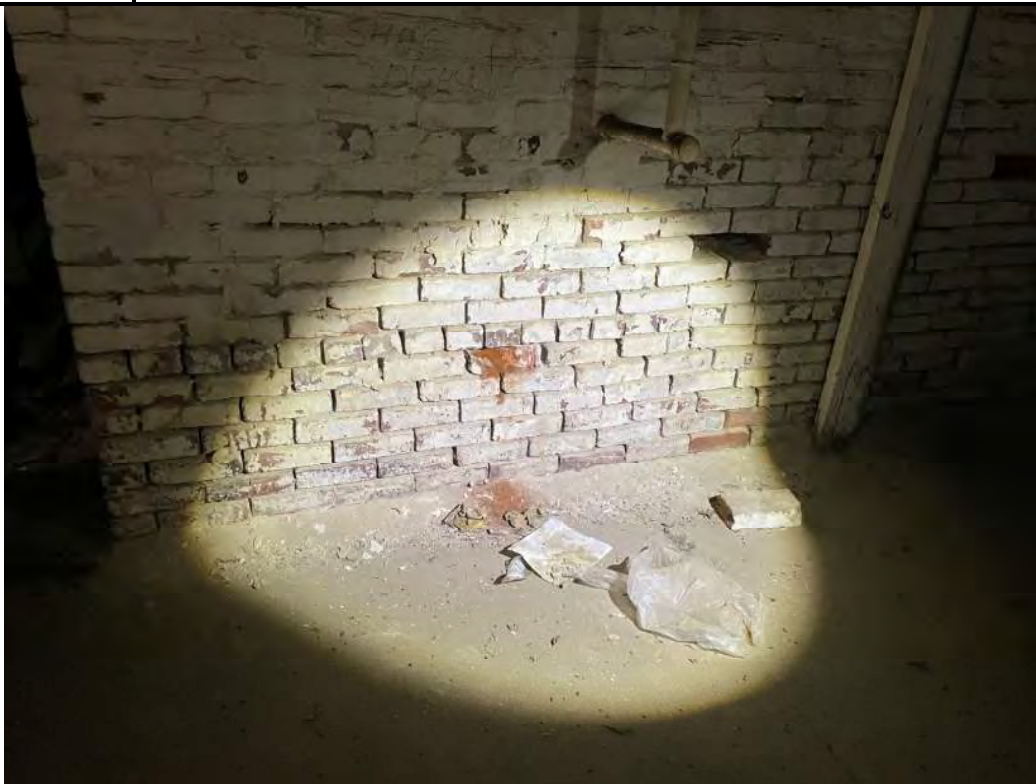
PHOTO # 18	COMMENTS : Basement wall brick and mortar deterioration. The brick on the floor was easily removed by hand.
---------------	---

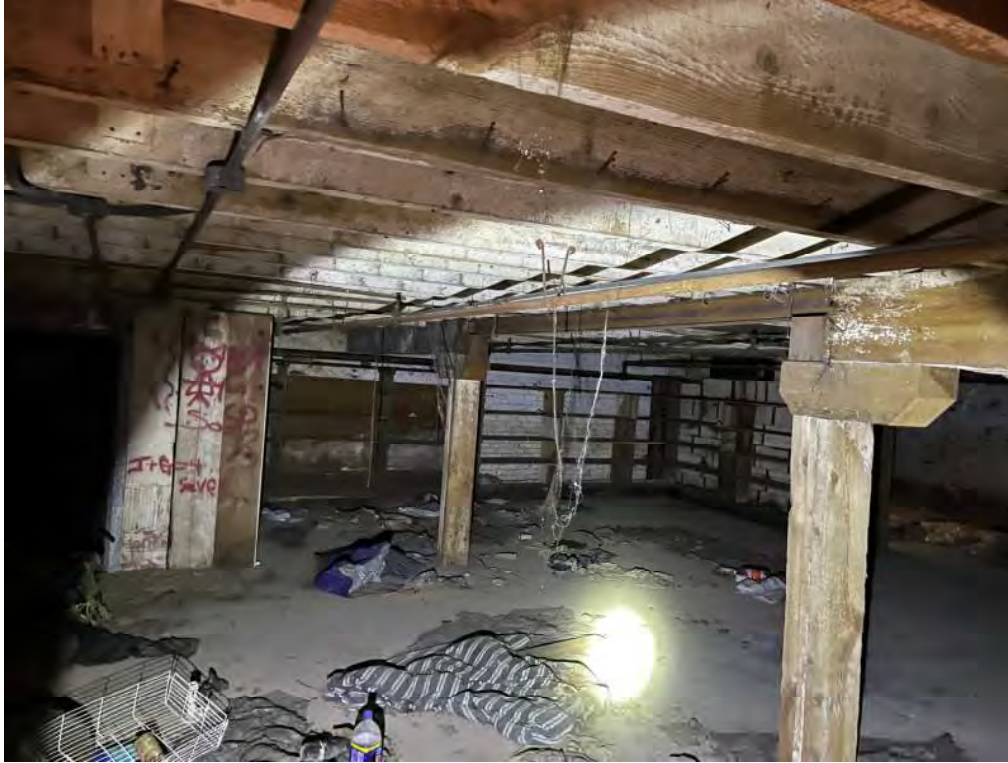
PHOTO # 19	COMMENTS : South basement floor framing. Unconventional floor beam supports.
---------------	--

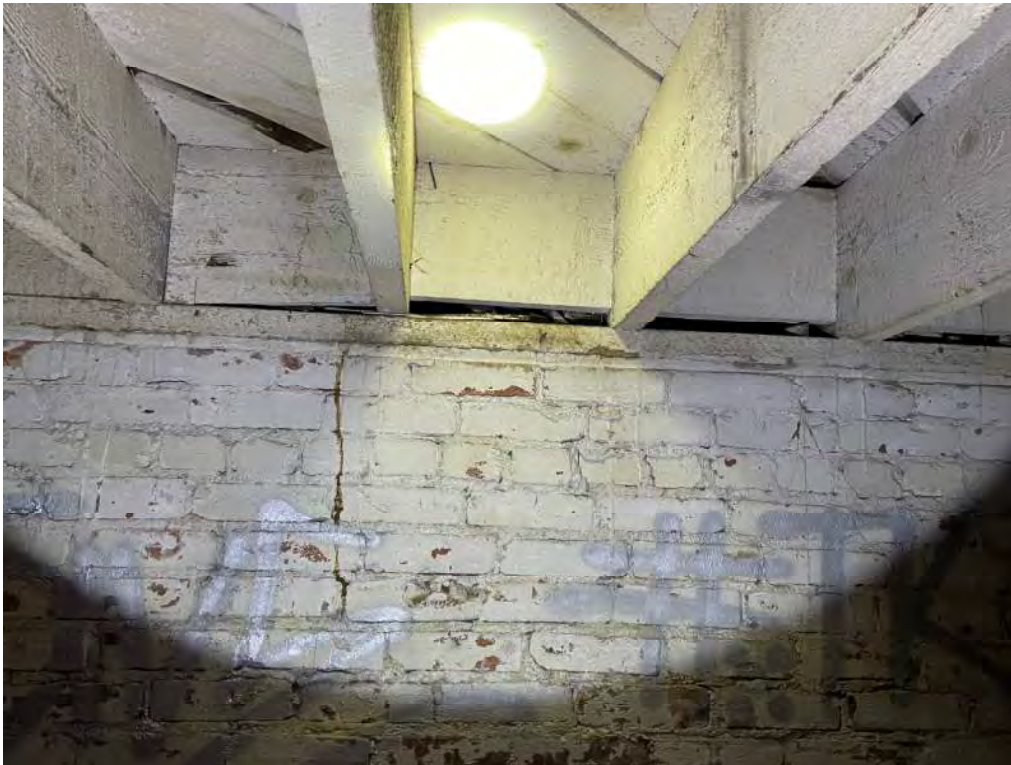
PHOTO # 20	COMMENTS : View of floor joists setting on basement wall wood plate. Blockings between joists do not have connections to the wood plate. Not shear resistance exists between the floor and the basement wall.
---------------	---

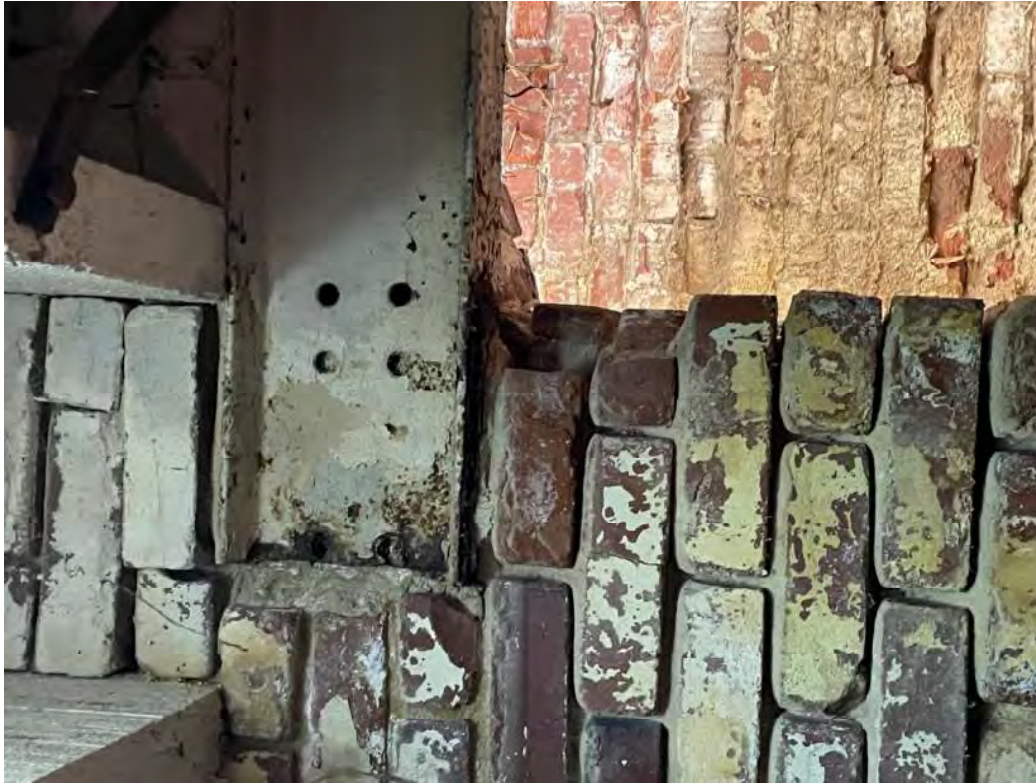
PHOTO # 21	COMMENTS : Steel header beam in basement. Note the extreme deterioration of the brick and mortar intended to support the header.
---------------	--

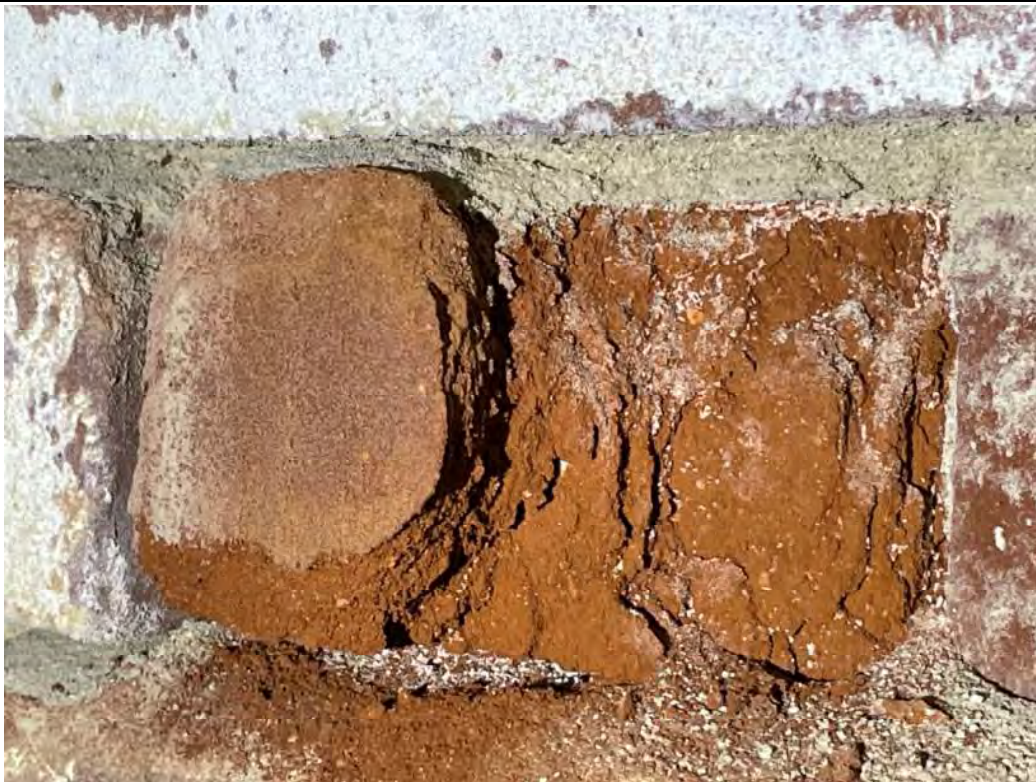
PHOTO # 22	COMMENTS : Closeup view of laminar exfoliation of a brick occurring over a long period of moisture infiltration and evaporation. This type of damage is non-reparable and can eventually result in collapse of the wall.
---------------	--

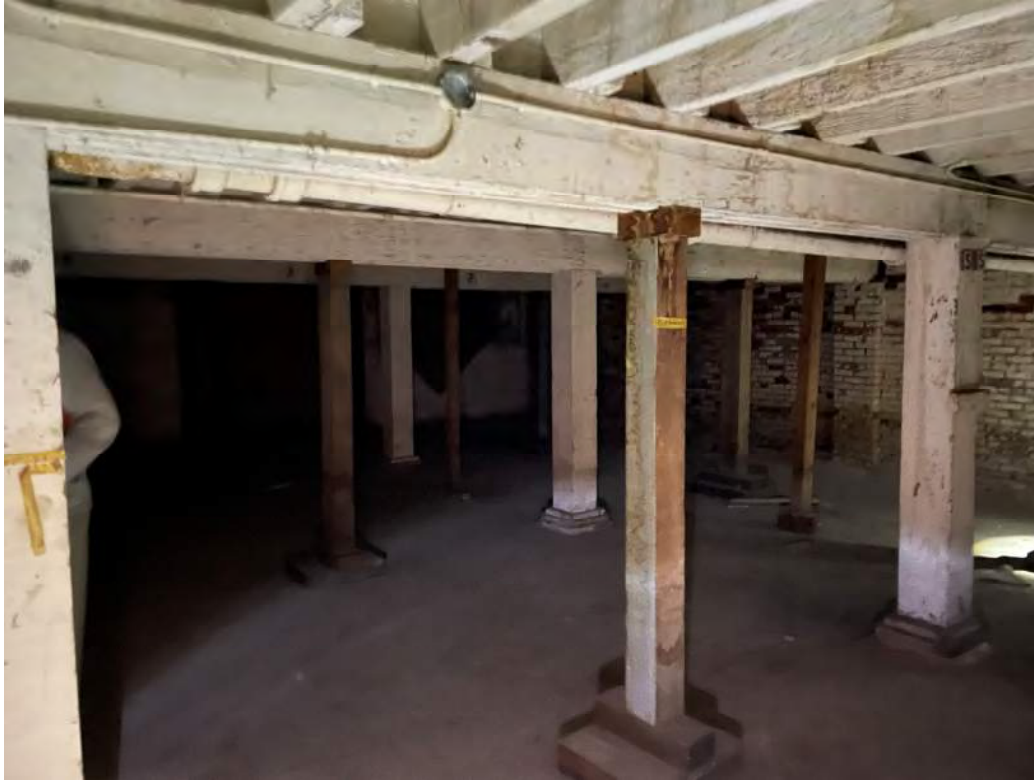
PHOTO #
23

COMMENTS : The unpainted post has been added since the original construction. These added posts are typical throughout the north basement and were added at mid-span of the floor beams.
