**735, 739, and 741 H Street,
Fresno, California**

**Analysis of Brownfield Cleanup
Alternatives**

March 23, 2023

Project No.: 185755542

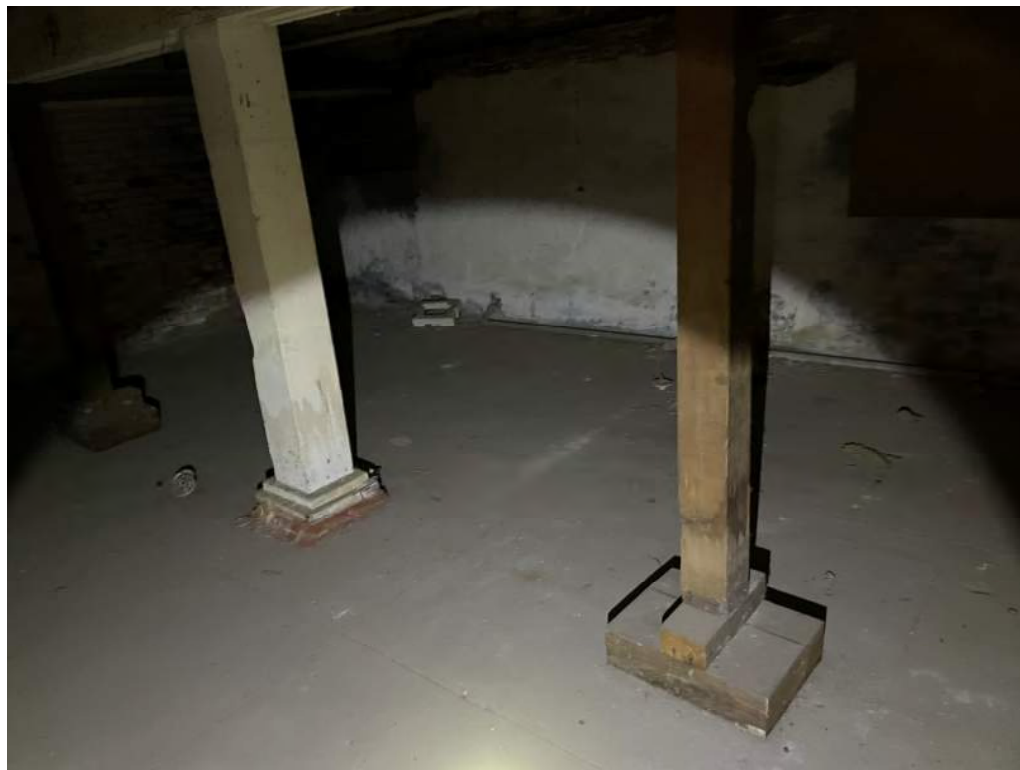
PHOTO #
24

COMMENTS : The white painted post is an original post supporting a floor beam and sets on a wood shim and brick spreader on the slab. The unpainted post was added after original construction and is setting on wood blocks on the slab. It could not be verified if there were dedicated footings under the slab at the original posts.

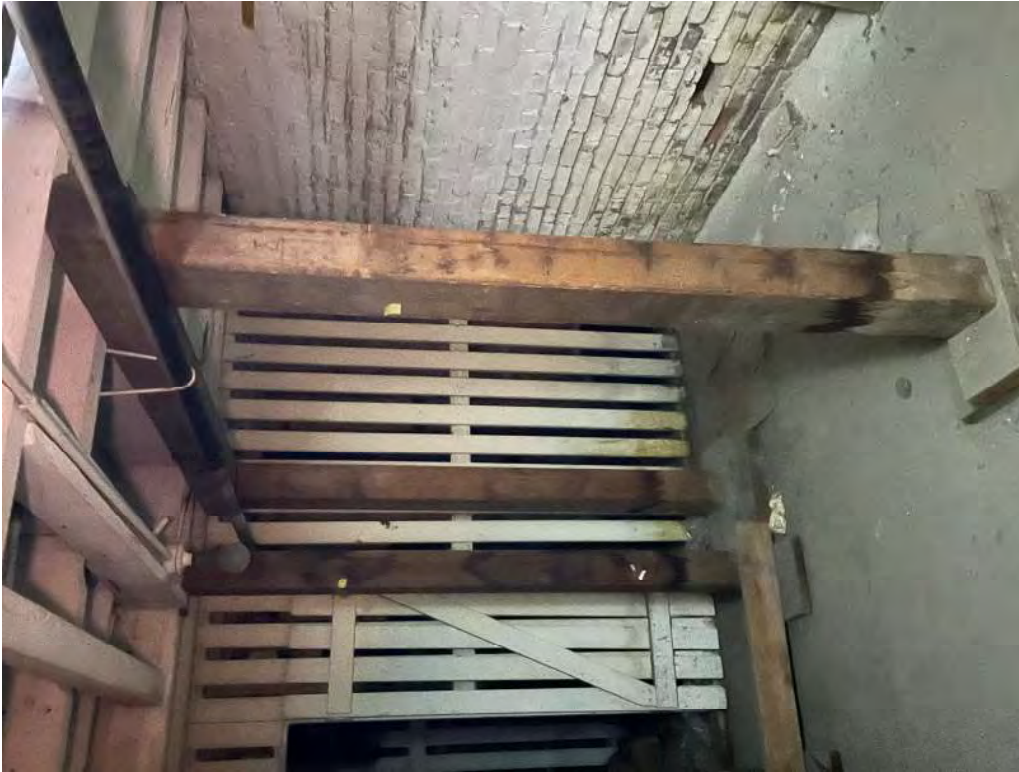
PHOTO #
25

COMMENTS : A beam and post repair effort for broken floor joists.

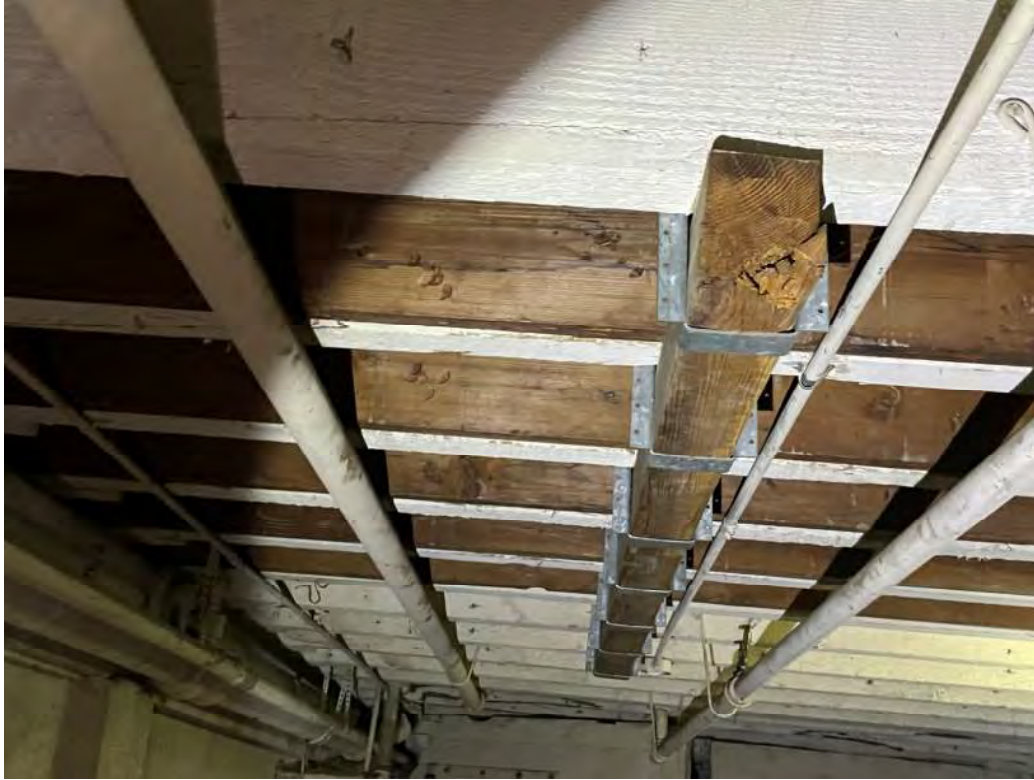
PHOTO # 27	COMMENTS : An added 'strongback' with doubled joists to spread the load from broken joists to unbroken joists.
---------------	--

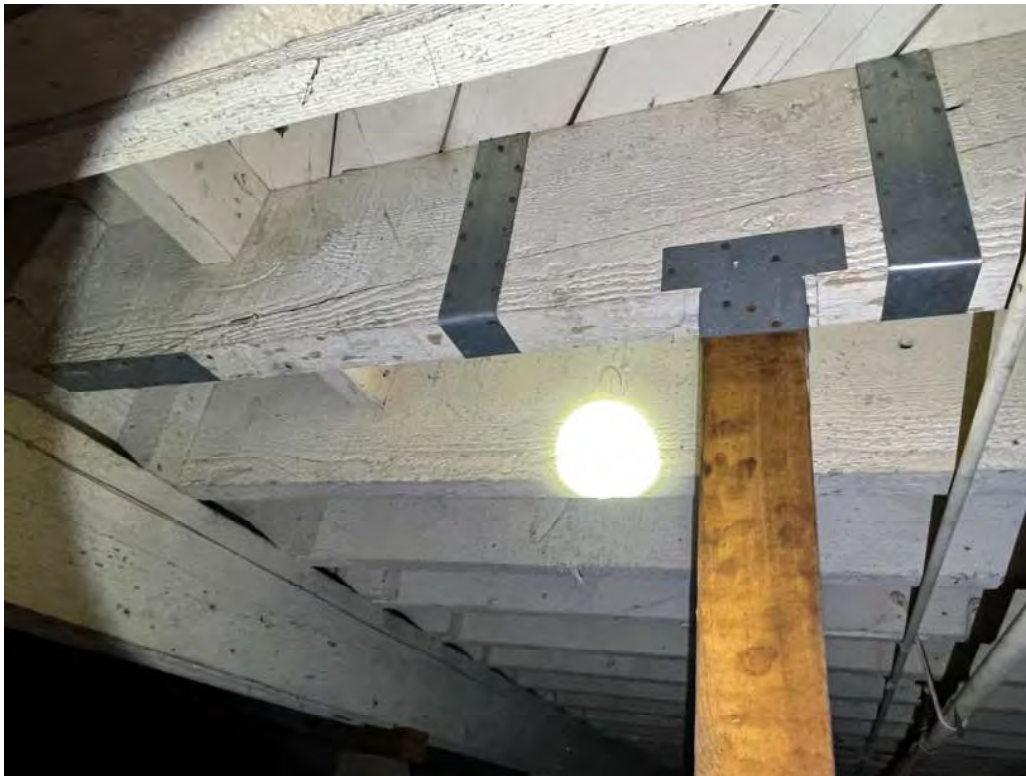
PHOTO # 28	COMMENTS : Another type of broken floor joist repair.
---------------	---

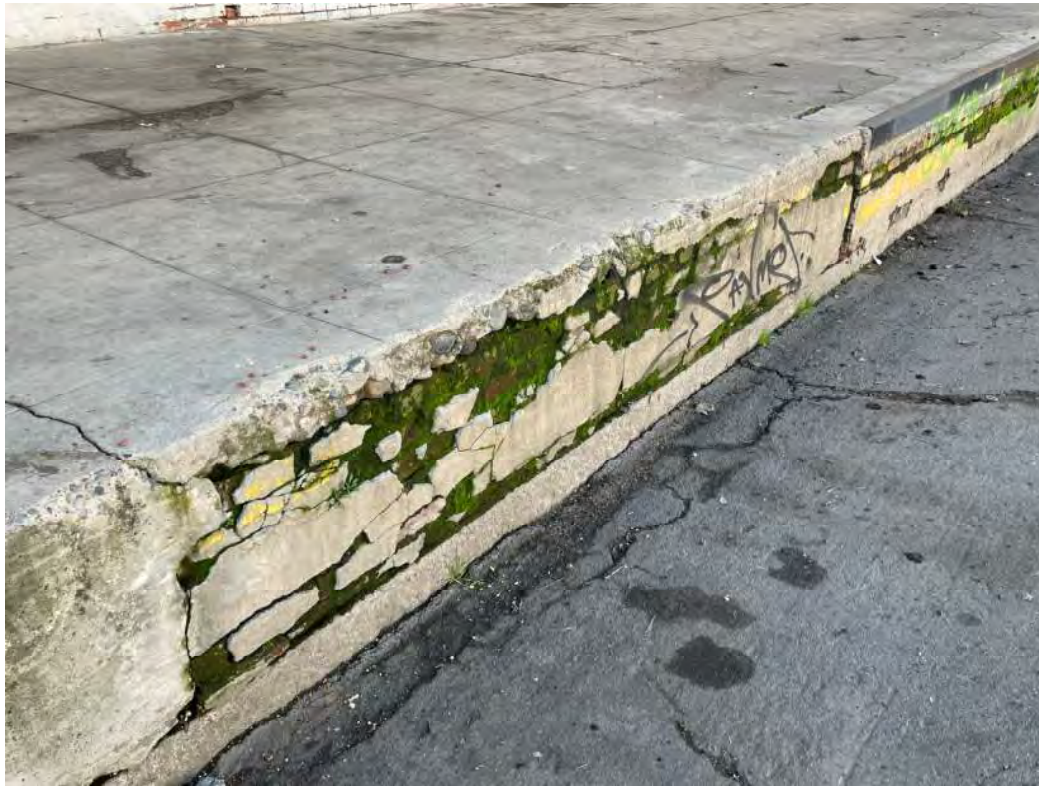
PHOTO # 29	COMMENTS : A typical view of the face of the loading dock retainment wall. The cement coating, which was probably applied to protect the brick from further deterioration, has fallen apart. Brick is behind the green moss.
---------------	--

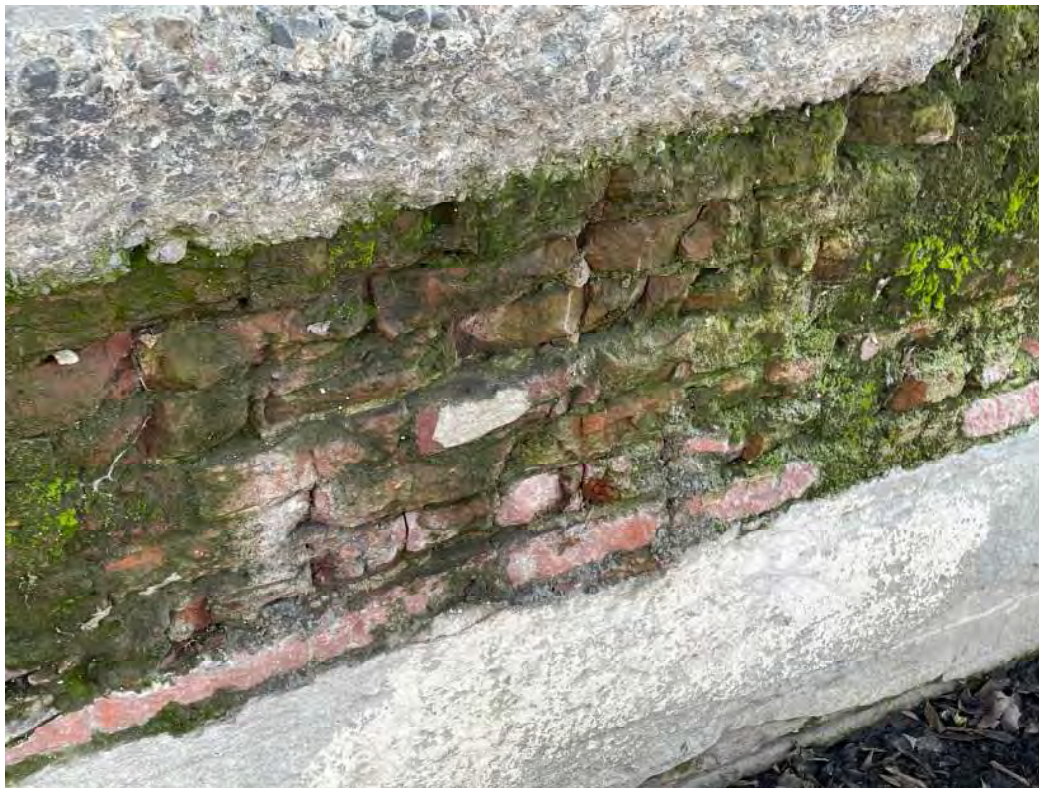
PHOTO # 30	COMMENTS : Close-up of the condition of the loading dock wall brick behind the plaster coating.
---------------	---

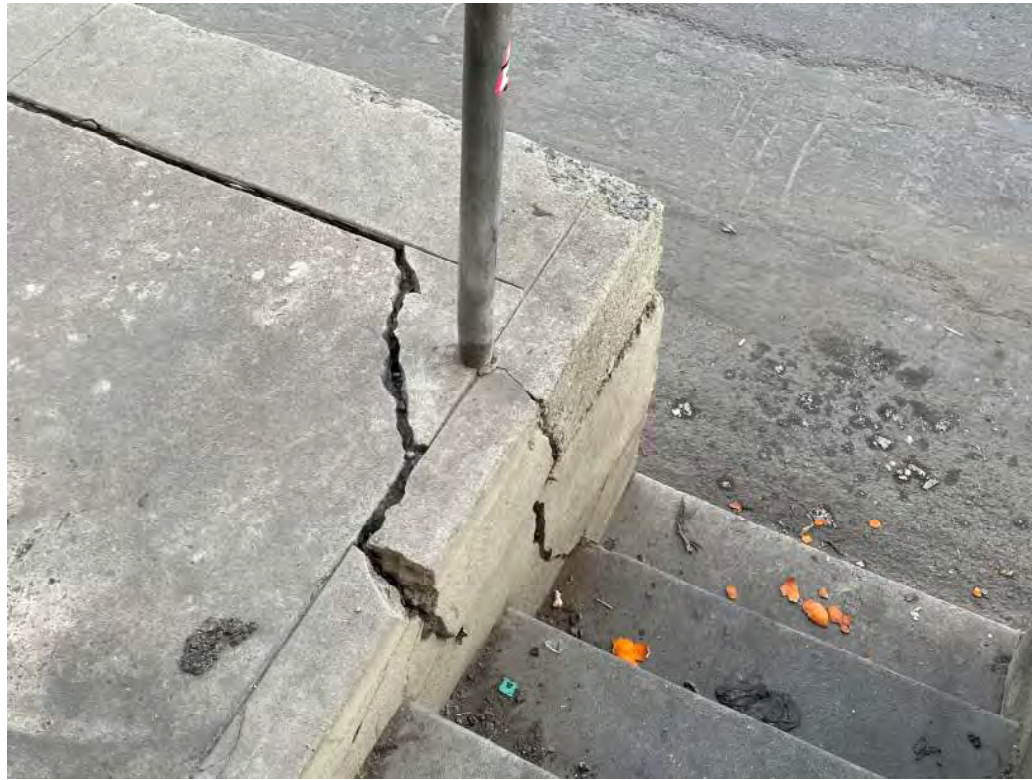
PHOTO # 31	COMMENTS : Failure of the concrete slab breaking away from the loading dock at the H St. wall.
---------------	--

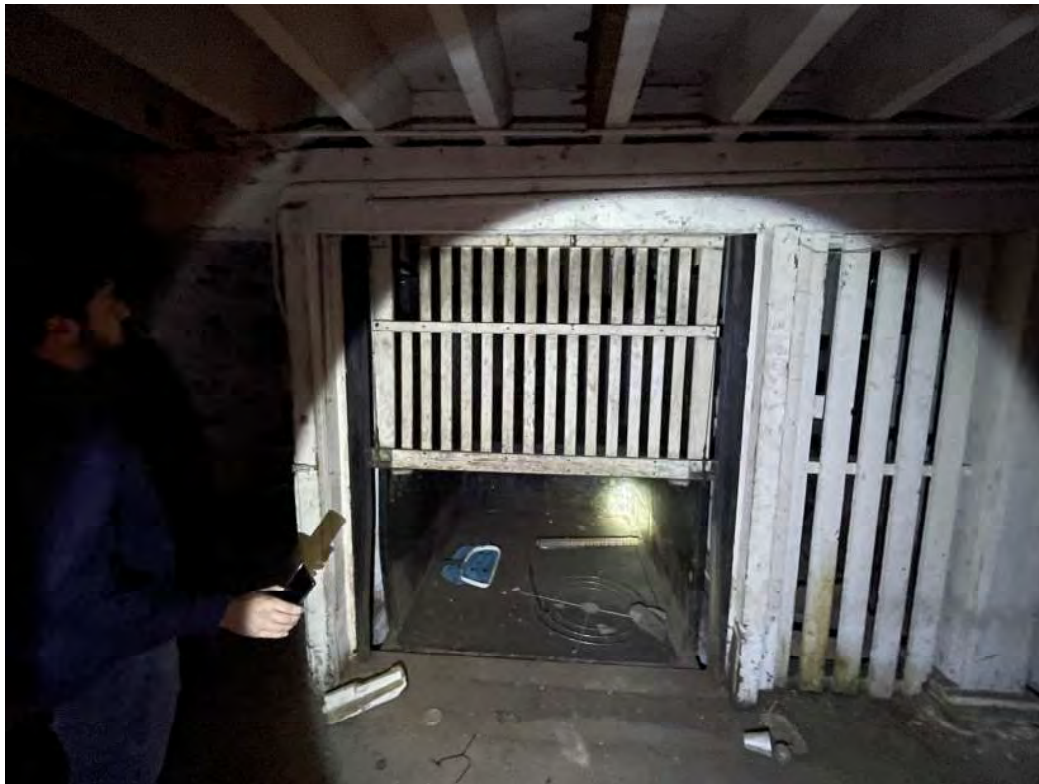
PHOTO # 32	COMMENTS : Elevator lift in the basement. The pit and walls could not be observed.
---------------	--
