MASTER PLAN REPORT

FAX Transit Operations & Maintenance Facility Fresno FAX Fresno, California

November 21, 2014

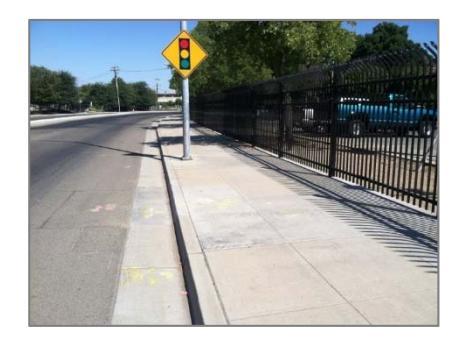
- Good condition, even surface free of cracks or abrupt changes in level
- Black wrought iron fencing recently installed along the entirety of the FAX Operations and Maintenance Facility frontage at the back of walk

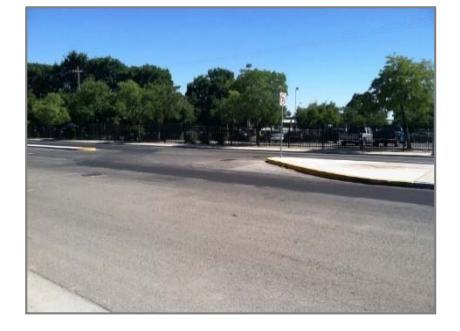
New Left Turn Pocket in G Street Median

- Left turn pocket recently constructed within the median of G Street to allow for left turn off northbound G Street for future entrance into FAX employee parking lot
- Visual Observations and City records indicate that G Street is in good to very good condition

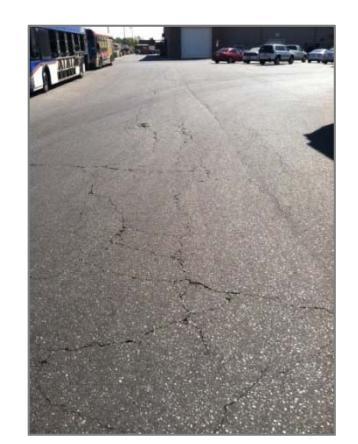
Asphalt pavement displays evidence of thermal cracking, and early stages of fatigue cracking

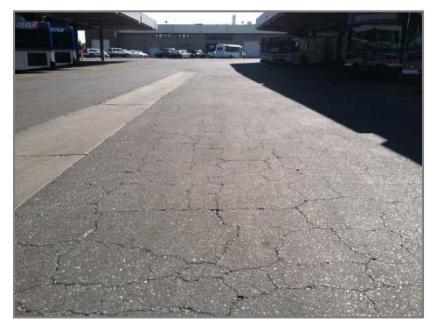
Drive aisle between covered middle and southerly parking bays

- Asphalt severely distressed with fatigue cracking extending the length of the concrete ribbon gutter
- Cracking is most severe near the gutter and reduces with distance. Width of cracking is approximately 13 feet to north and 10 feet to south of gutter

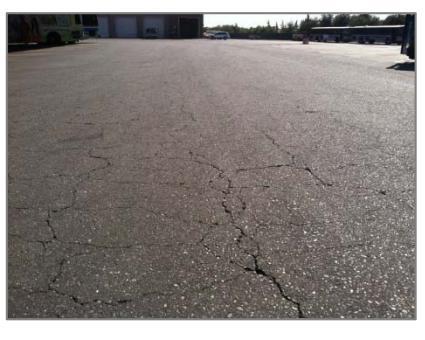
Drive aisle between northerly (uncovered) and middle (covered) parking bays

• Asphalt displaying signs of fatigue cracking and structural failure of pavement

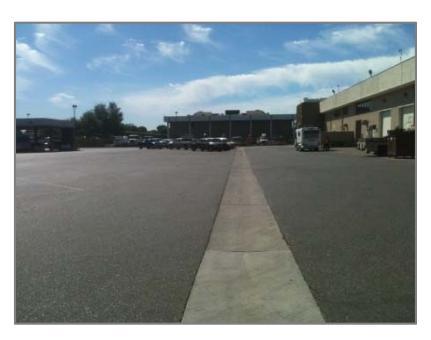
• Asphalt in generally good condition

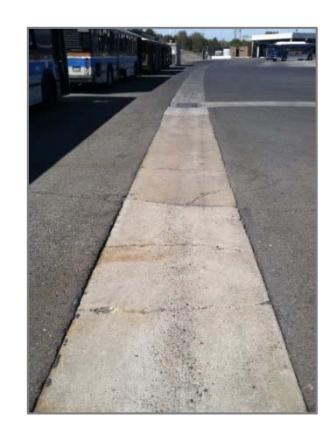
Drive aisle to northwest of Maintenance Building

- Asphalt is weathered with minor cracking
- Concrete ribbon gutter is severely cracked which may lead to water intrusion in the asphalt pavement, thus reducing the lifespan of the asphalt pavement

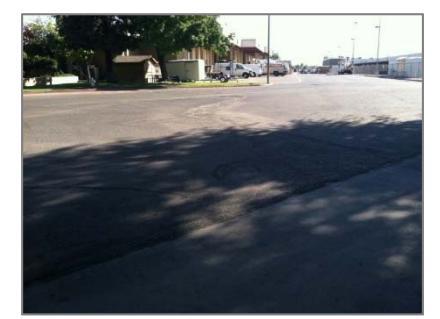
• Use of the fire hydrant to fill City vehicles has led to water consistently running over the asphalt pavement which has damaged the integrity of the pavement

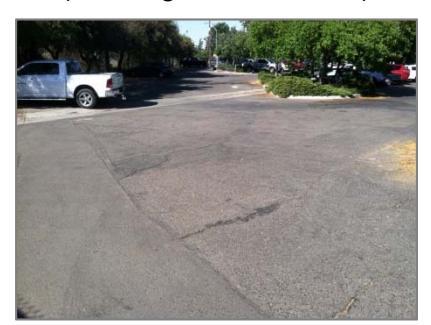
Main Employee Parking (southerly)

• Asphalt in generally good condition becoming progressively more distressed with increased proximity to drainage devices (ribbon gutters or inlets)

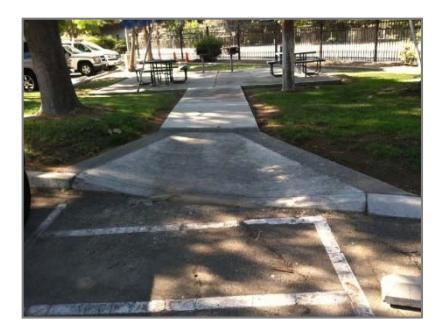
- Good condition, surface is free of cracks or abrupt changes in level
- Ramp leading to picnic area is convenient, but it does not comply with current accessible codes for curb ramp as it lacks detectable warning surface and the slope of the wings exceeds 10 percent; additionally, there is no connection to a pedestrian path of travel

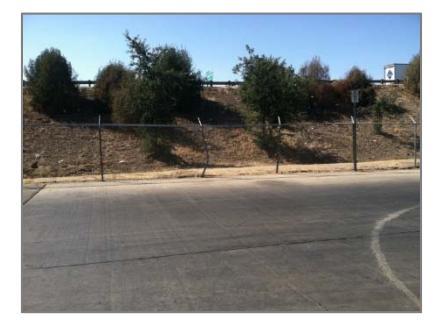
Perimeter Fence along Highway 99 and 180

- Chain link fencing and barbed wire, with and without mesh screening
- Generally good condition
- One bent post observed near bus wash facility

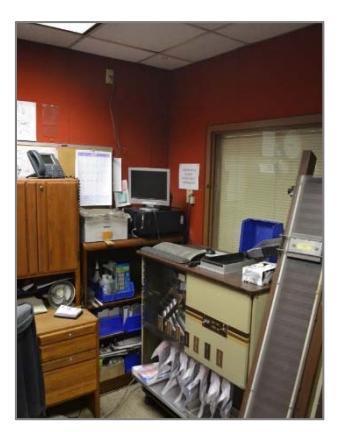
Workstation & Sorting Equipment

- Room is too small for fare counting functions. Sorting equipment must be moved into place during use.
- Rooms are in poor condition, finishes are very worn and past typical lifespan.
- Doors in room do not have proper code clearances.
- Lighting is inadequate for detailed work done in this room.
- Hollow metal framed window into Operations Manager office may not provide proper acoustic separation between rooms.

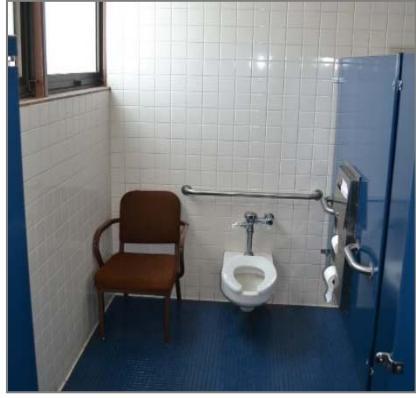
Women's Toilet

- Men's and Women's rooms have not been updated to current accessibility standards.
- Accessible toilet stalls do not have sufficient clearances within stall. Per current Code, a minimum of one accessible stall should be provided in each toilet room.
- Toilet paper and paper towel dispensers are not mounted within Code required height ranges.
- Sink drains do not have code required pipe covers.

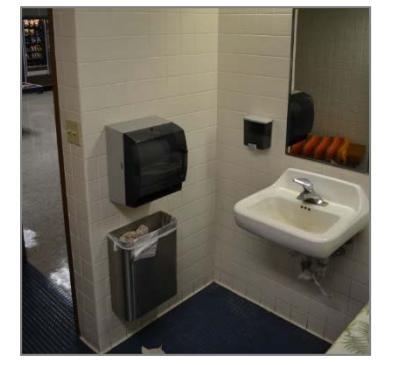
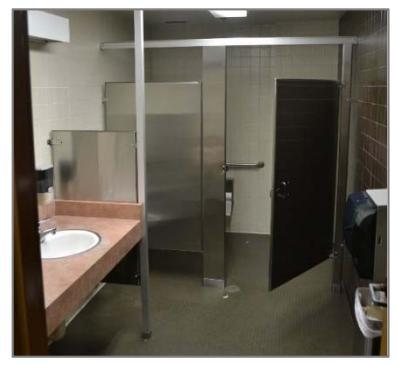
• Finishes are generally in good condition with the exception of the tile floor in Women's - 201 has lost its bond with the sub-floor in one observed location.

- Sink drains in rooms 201 and 202 do not have proper pipe guards and should be replaced.
- Fixtures appear to be in working condition.
- Drinking fountain outside second floor restrooms does not have proper accessibility clearances, should be minimum of 18 inches from adjacent wall.

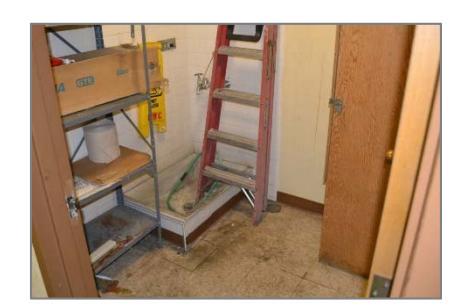
Janitors Room - 145

- Rooms are generally in good condition, but floor finishes are in poor condition. Janitor rooms should have tile finish on floor.
- Sinks appear to be in working condition.

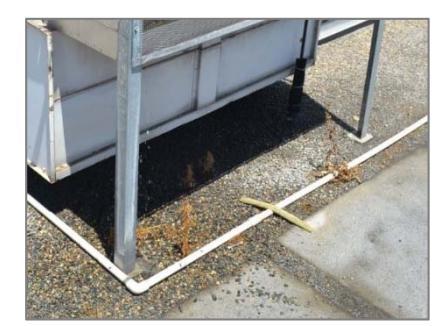
Overflow from Evap Cooler

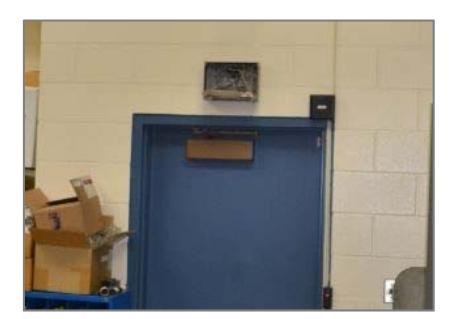
Missing Exit Sign

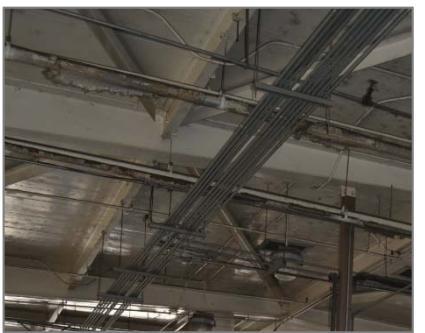
- Pipe insulation on various piping is significantly deteriorated and should be replaced.
- Refrigerator, vending machine, drinking fountain, and water cooler are located within service aisle.
 Equipment should be located within proper break room.

Pipe Insulation

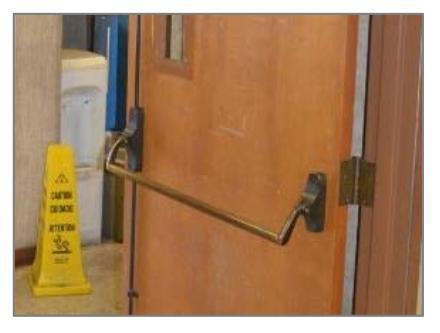
- Cross-bar exit devices, where located, do not meet current codes for exiting devices. Non-compliant exit devices should be replaced with new push bar style.
- Door knob hardware does not meet current accessibility requirements and should be replaced with current level type door hardware.

Typical 'Cross-Bar' Exit Device

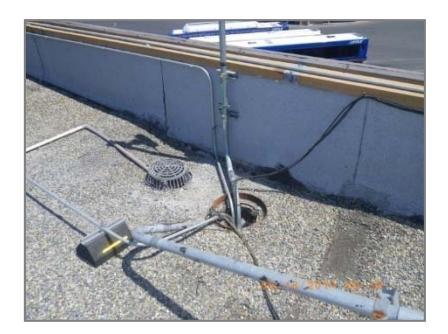
Overflow roof drain was used as conduit for cables. We recommend rerouting the cable and return the overflow roof drain to its intended usage.

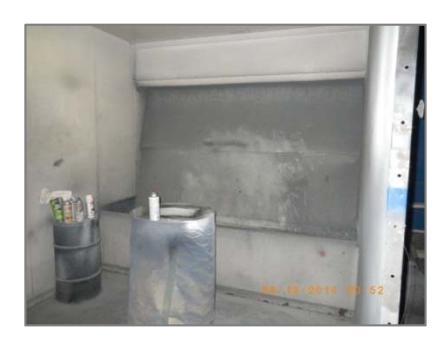
There is a wet filter system for a small fixed paint booth to the exhaust; it is currently not working and not in use. We recommend replacing the wet filter system with dry filters if the filter system will be required in the future.

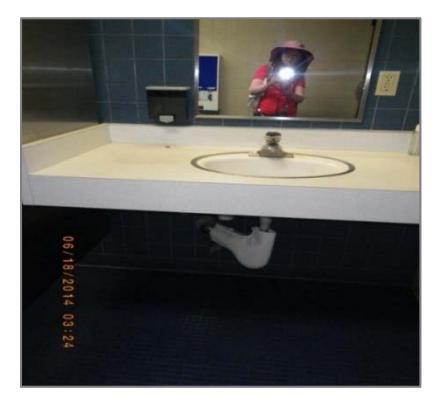
The faucet and drain are leaking in Women's restroom.

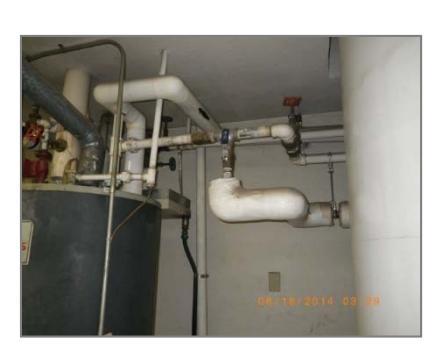
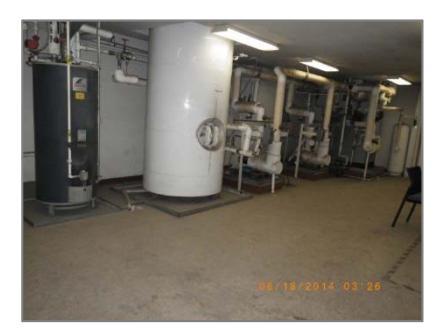
'Solar pre-heating' system for domestic hot water system is incomplete. There is a tank, with piping from ceiling and circulation pump, but there is no solar panel on the roof. The incomplete system is piped to pre-heat the domestic water to the heaters. It seems that the

valves are open - this 'solar' system is currently connected to the

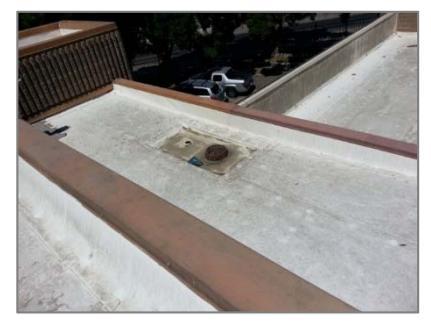
Overflow drain of the new addition are missing strainers. We recommend adding strainers.

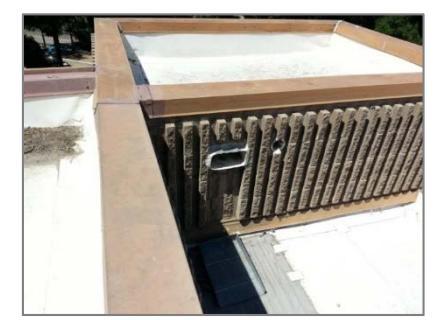
Overflow scuppers seem undersized (should be the same size as the primary).

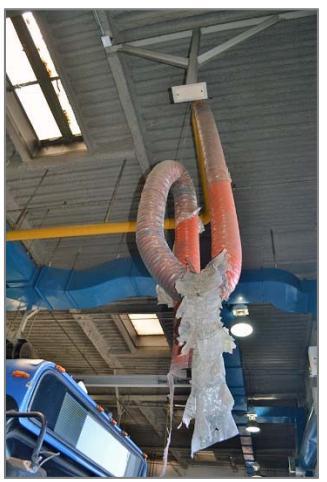
Non-Operational Hose Drop
