**2316 South Elm Avenue, Fresno,
California**

**Analysis of Brownfield Cleanup
Alternatives**

December 21, 2021

Project No.: 185704673

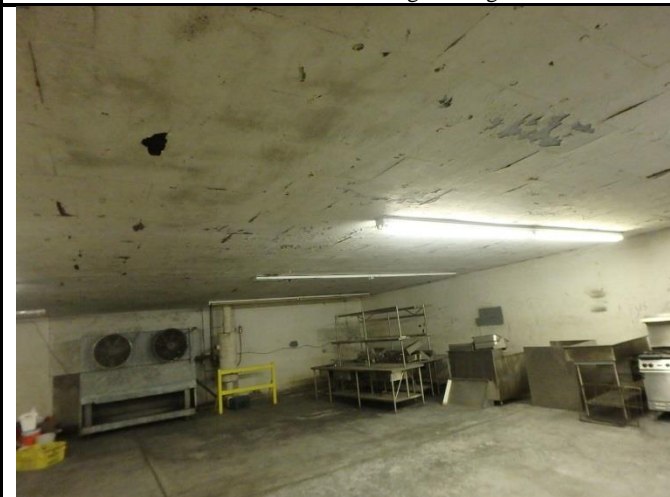
Photo 3: View of storage room 2 with ACM skimcoat

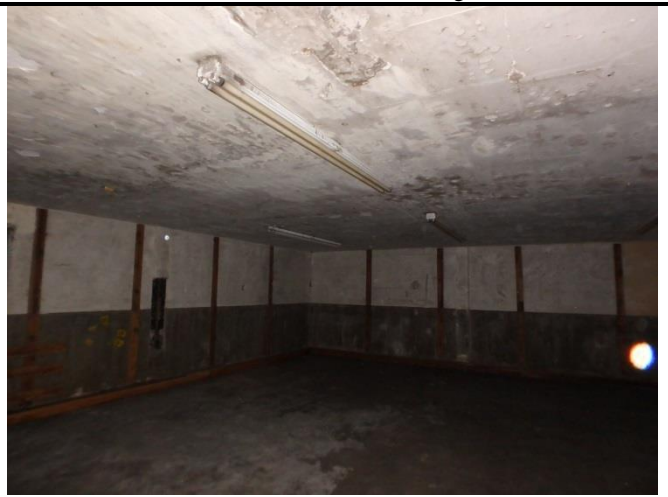
The most significant ACM requiring abatement within the building is a skim-coat over foam insulation containing 1.2% chrysotile which is present on the upper walls and ceiling of the two storage rooms, and covering surfaces with an estimated area of 5,720 square feet. The ceilings (with an area of approximately 4,600 square feet) show signs of water damage and the skim-coat was damaged in many areas. This material was classified as a regulated ACM. Mold was also documented to be present on the ceiling areas.

Photo 6: View of storage room 1 with ACM skim coat on the upper walls and ceiling

1. Inspecting and repairing the roof.
2. Establishing appropriate containment, barrier, and air-filtration systems as necessary for workers in appropriate protective clothing to work in areas subject to mold and ACM.
3. Removing the ceiling and disposing of appropriately as regulated ACMs
4. Repairing or rerouting any plumbing or water lines located in areas above the ceiling.
5. Treating all exposed framing and studs with evidence of mold with a microbial cleaning agent.
6. Constructing a new ceiling with required structural reinforcements.
7. Abating limited ACM in other areas of the building as needed.
