FRESNO STATION EARLY WORKS - HISTORIC DEPOT

CITY OF FRESNO - HISTORIC PRESERVATION COMMISSION PRESENTATION
August 25, 2025

SCOPE OF RENOVATION

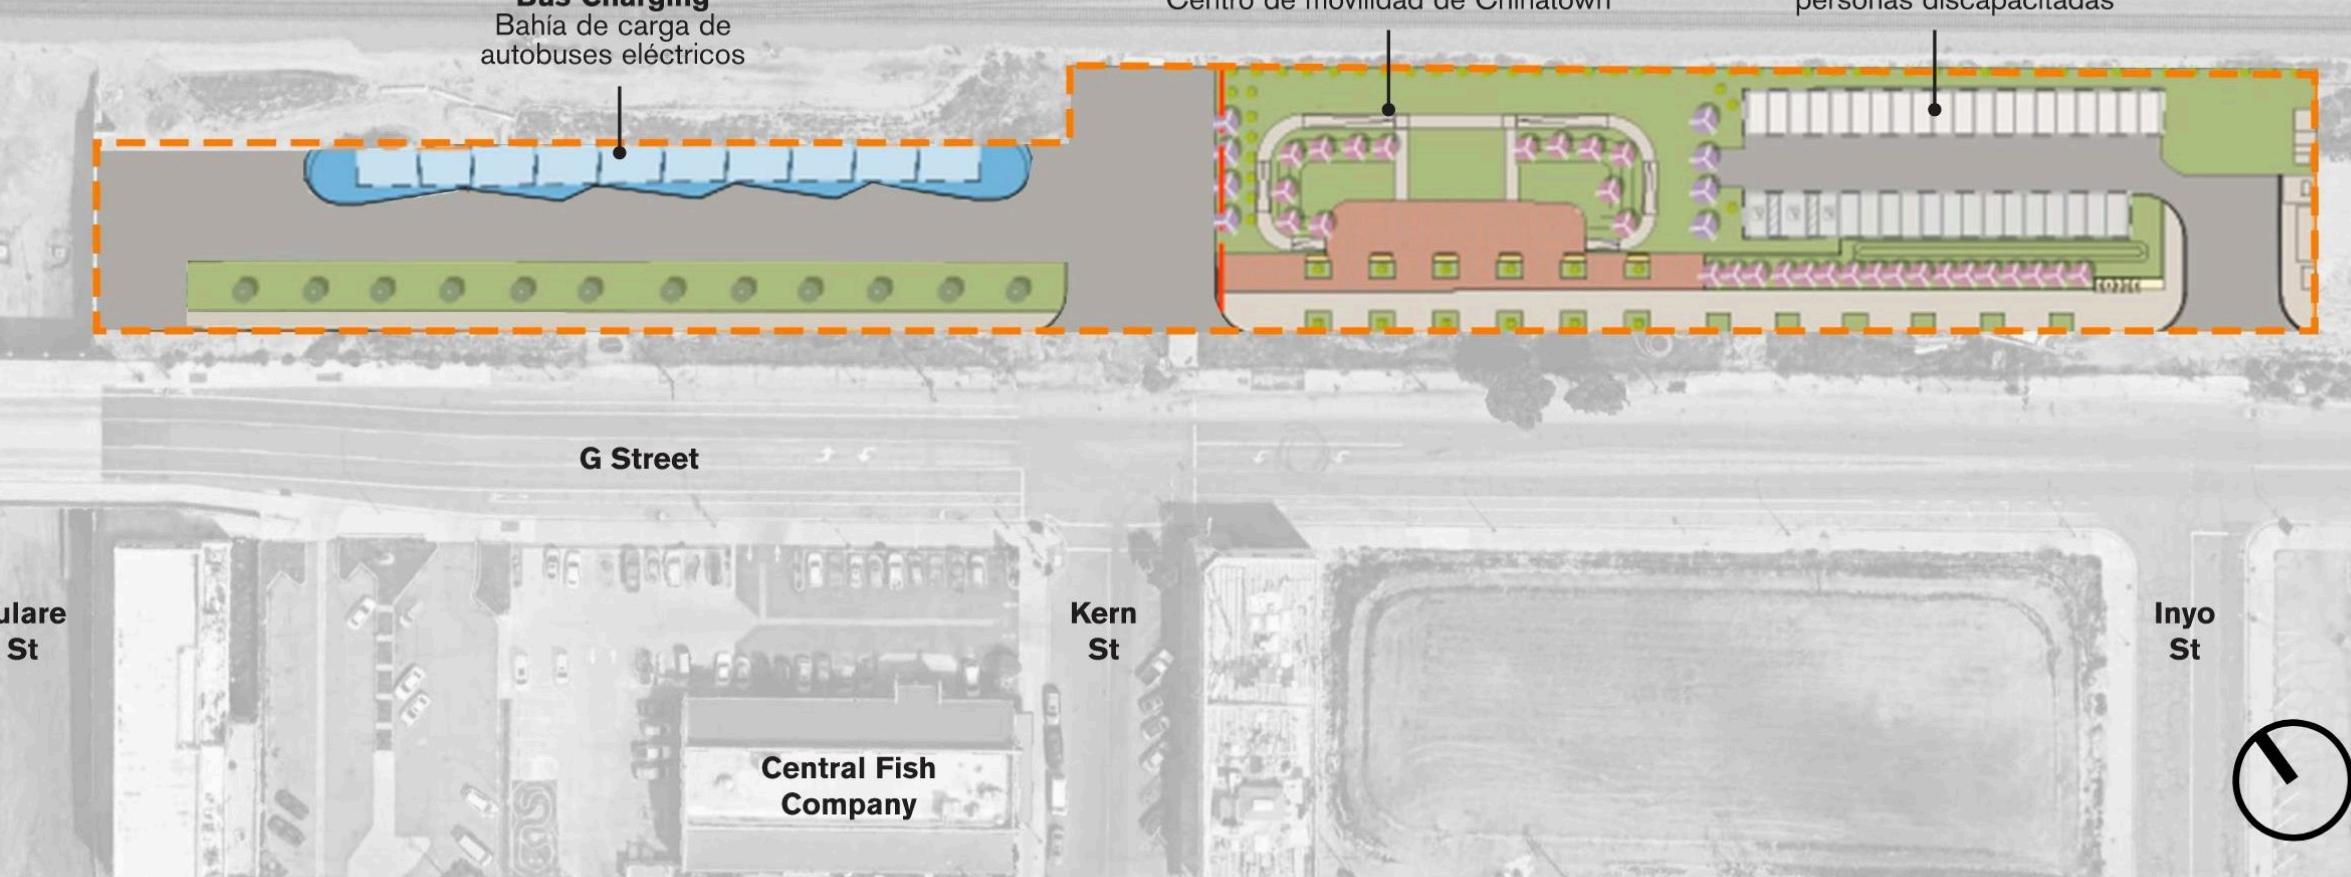
SITE PLAN - Courtesy of Foster+Partners / Arup Joint Venture

Chinatown Mobility Hub

Electric Transit Bus Charging
Bahía de carga de autobuses eléctricos

Chinatown Mobility Hub
Centro de movilidad de Chinatown

Electric Vehicle & ADA Parking with Solar Canopy
Estacionamientos con techo solar para vehículos eléctricos y personas discapacitadas

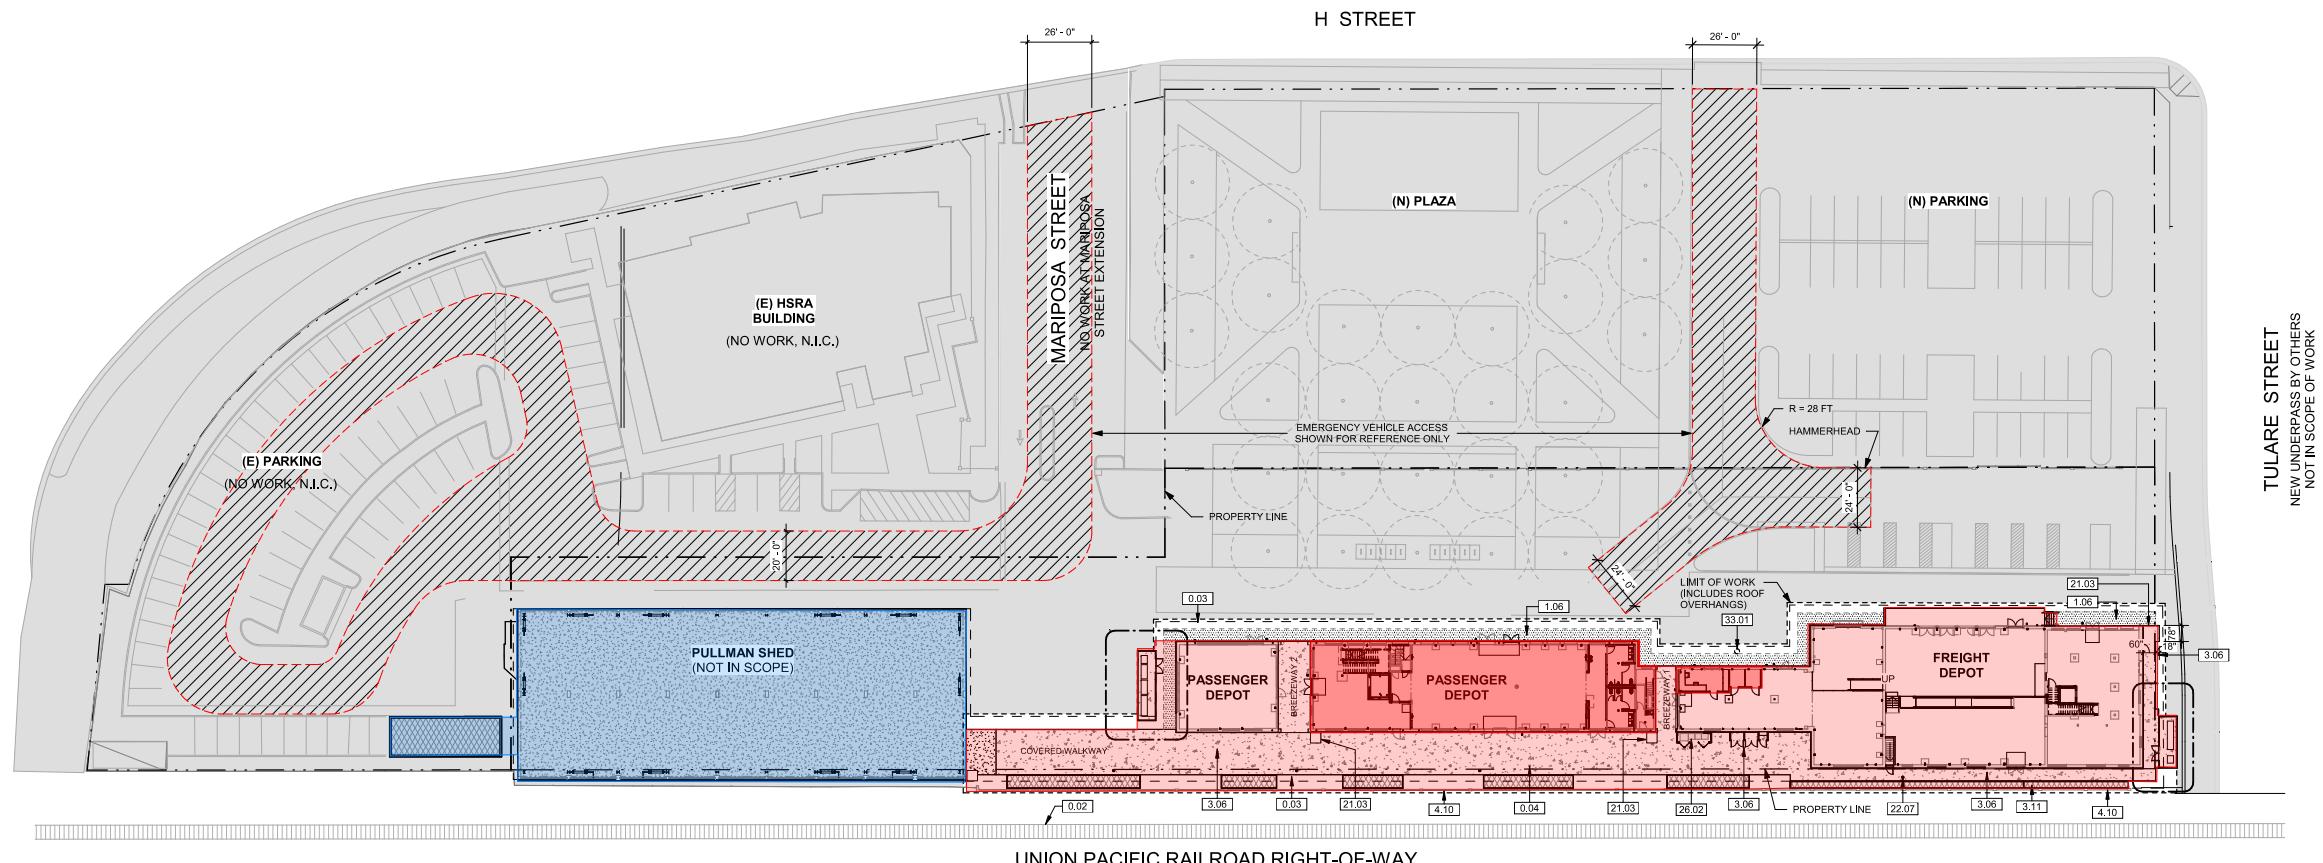
PROPOSED SITE PLAN

█ FINISHED SPACE, FULL SERVICES
█ WARM SHELL
█ OPEN AIR SHED

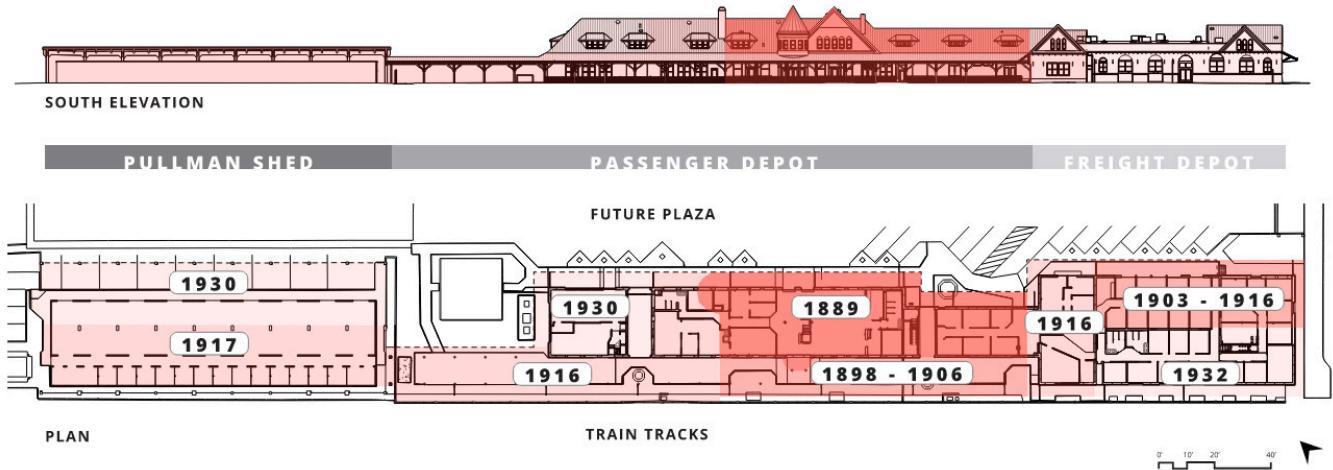
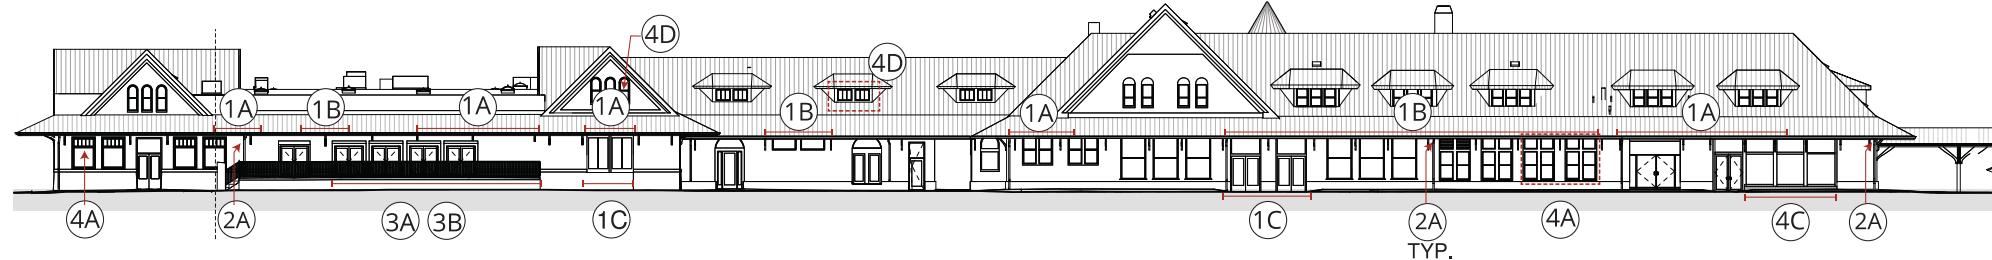
NORTH ELEVATION

- Wood: Repair, replace as needed, repaint
- Gutter: Replace
- Cement Plaster: Patch, repaint
- Wood Windows: Repair, reseal, repaint
- Roofing: Replace
- Chimneys: Rebuild

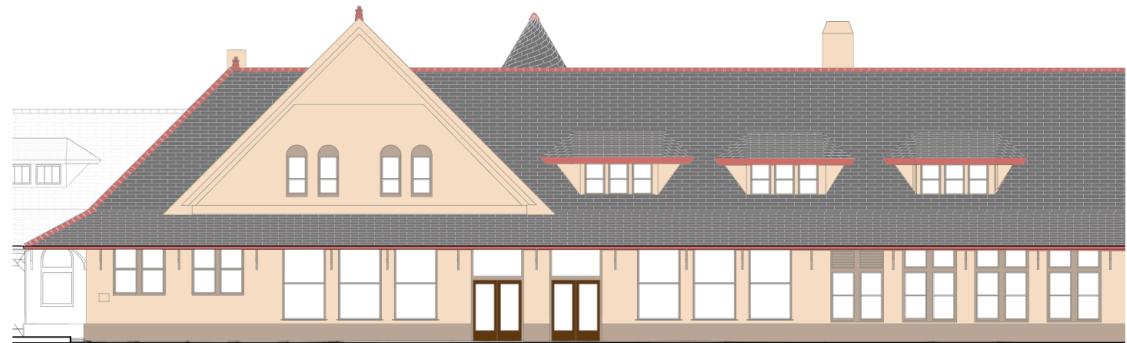
Existing elevation with dark gray roofing

- Existing roof is asphalt shingle. Original roof was slate.
- Replacement asphalt shingles with LEED compliant "cool roof" features
- Existing historic ridge tiles and finials to be maintained and replaced if damaged.
- Several styles of ridge tile and finial are present
 - Ridge tiles are primarily clay
 - Some ridge tiles appear to be painted concrete replicas

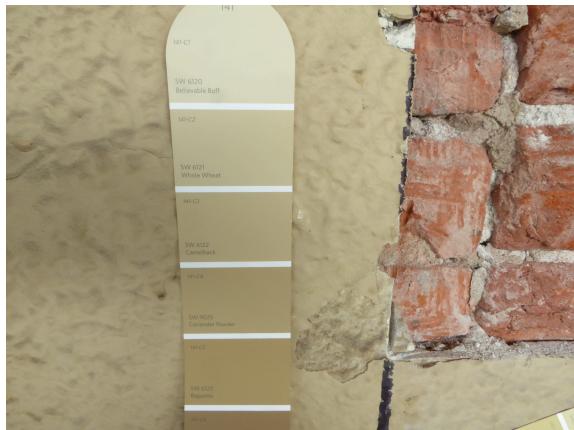
Painted cement plaster

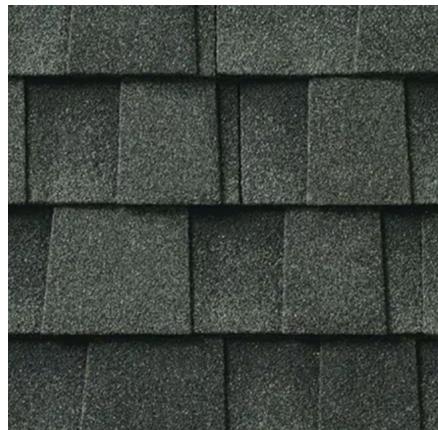
Charcoal colored asphalt shingle

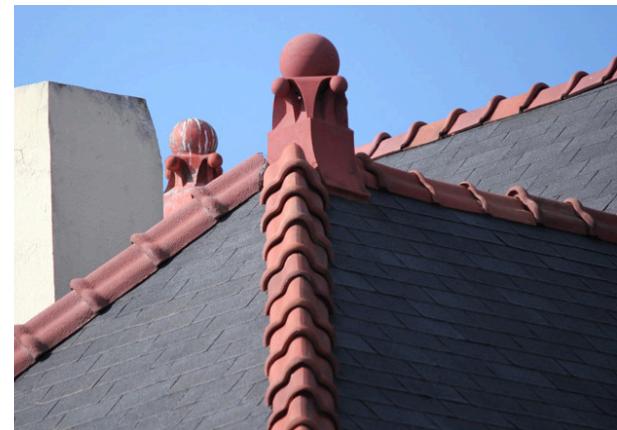
Existing ridge tiles and finials

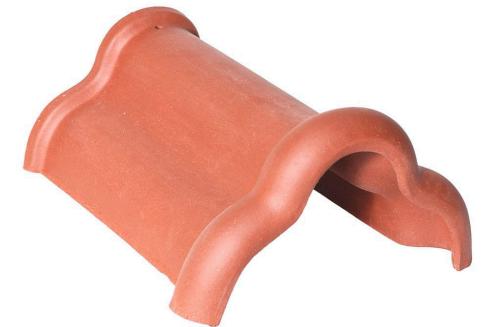
Replacement material:
Ludowici Ridge Tile 206

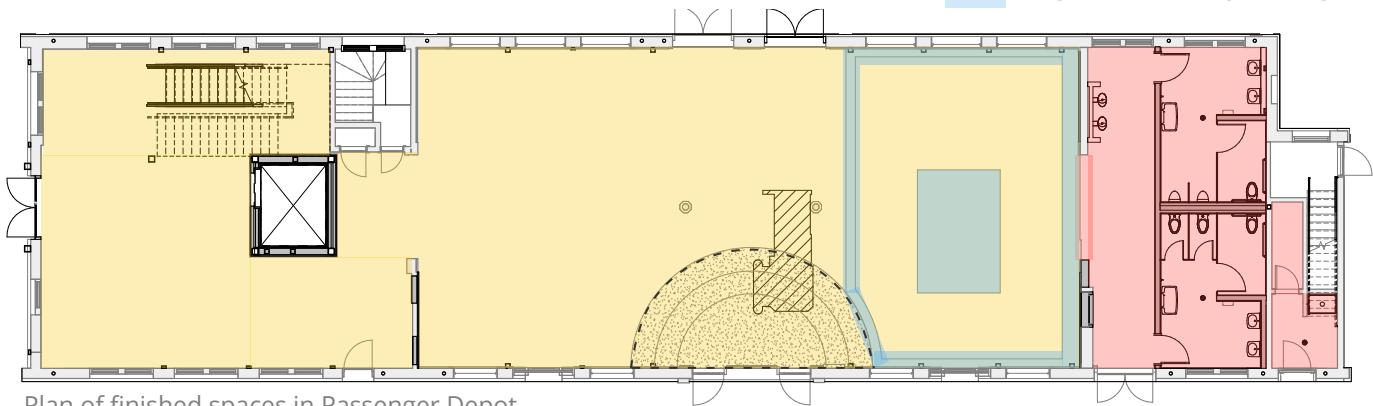
NEW TILE
HISTORIC TILE RESTORATION
(E) TERRAZZO TO REMAIN
BROWN MATERIAL TO BE REMOVED

Plan of finished spaces in Passenger Depot

- Historic hexagon porcelain tile believed to date ca. 1916
- Brown material to be removed and patched.
- Terrazzo floor area at south doors to remain.
- Existing non-historic tile, occurring at areas that will become the restrooms and corridor, to be removed and replaced with new tile.
- New tile at the corridor should be visually compatible with existing finishes at the Passenger Waiting Room.

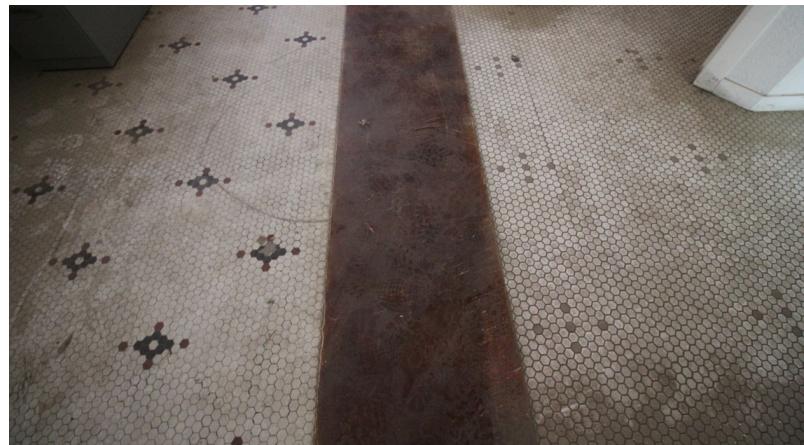
Passenger Waiting Room existing conditions

Left - Historic Tile, to be restored

Center - Brown Material. Remove and patch to match historic.

Right - Non-historic tile. Remove and replace with new tile.

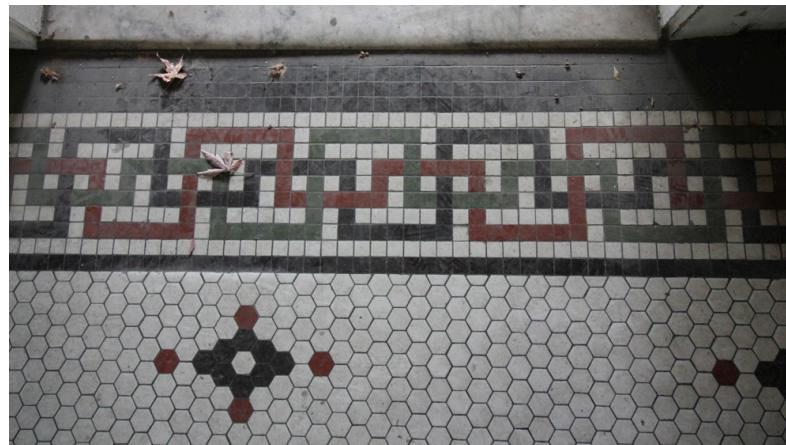
Historic mosaic pattern with border

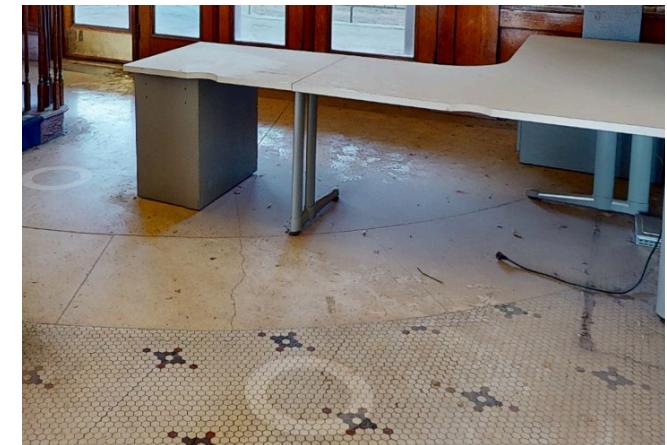
Existing Terrazzo floor (semicircle shape) at south doors

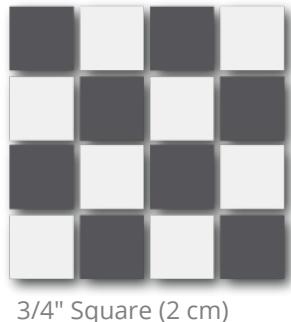
Heritage Tile unglazed color-through porcelain or approved equal

3/4" Square (2 cm)

- Damaged areas to be patched and repaired with matching porcelain tile to extent feasible

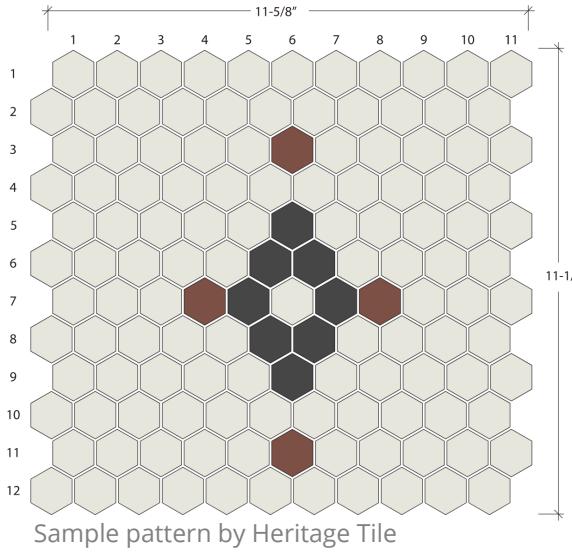
Sample pattern by Heritage Tile

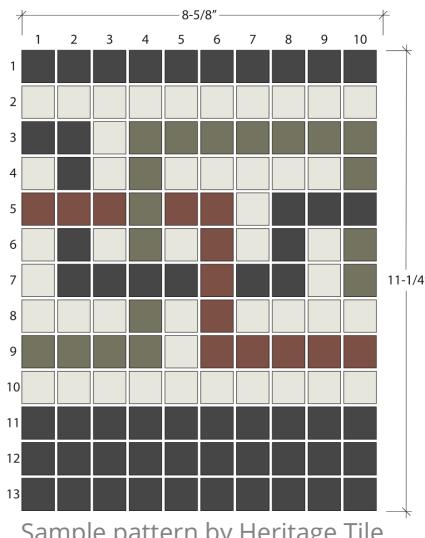
Sample pattern by Heritage Tile

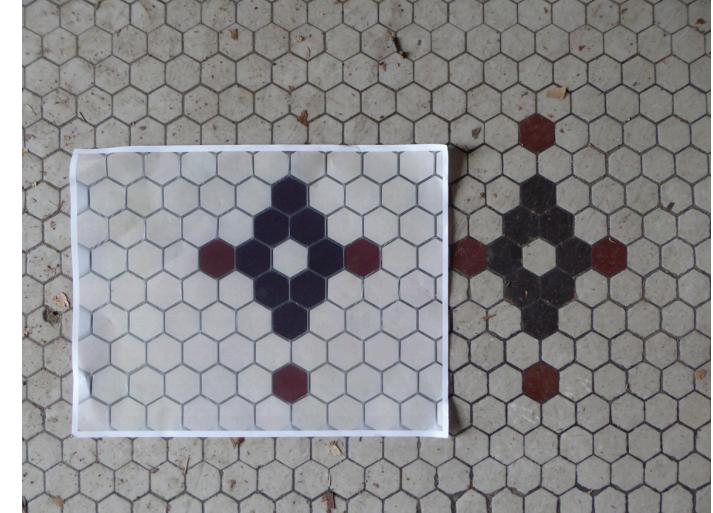
Full scale photocopy of tile sample overlaid on actual floor

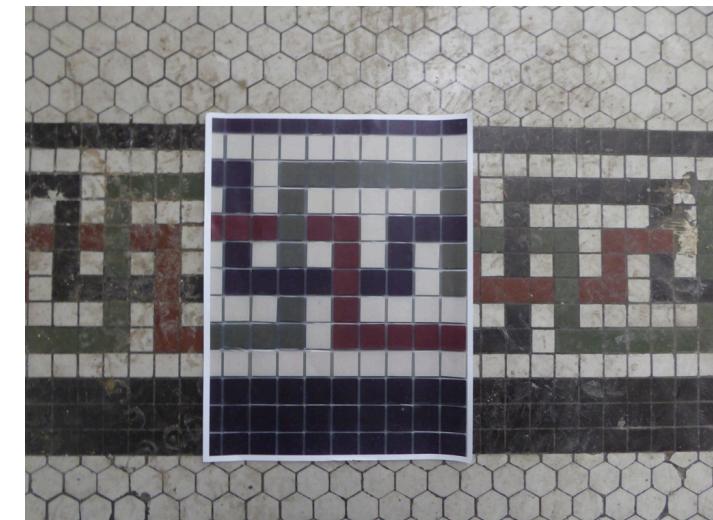
Full scale photocopy of tile sample overlaid on actual floor

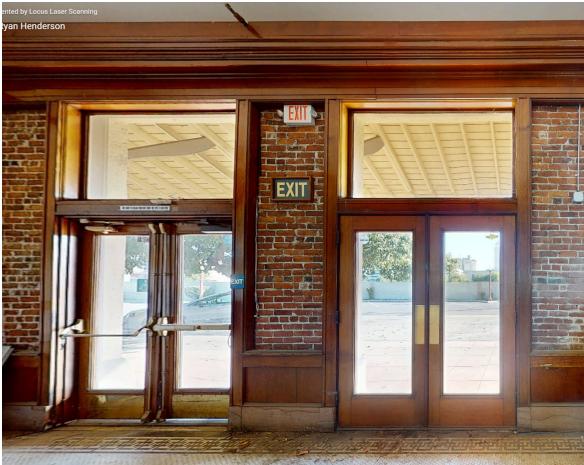
North wall with extensive existing wood trim

- Repair damage to existing crown trim, opening trim, wainscoting, and window trim
- Reproduce missing wainscoting at east and west walls
- Clean, repair and infill marble baseboard

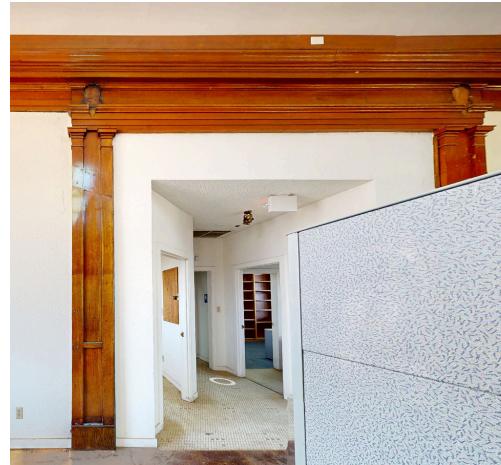
Opening trim at east wall

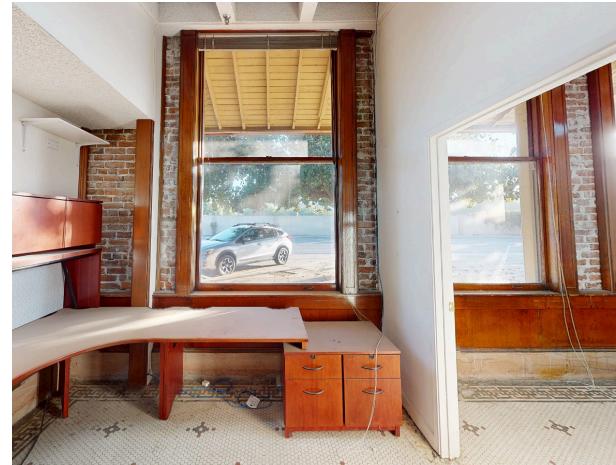
Example of area likely to require repairs after demo

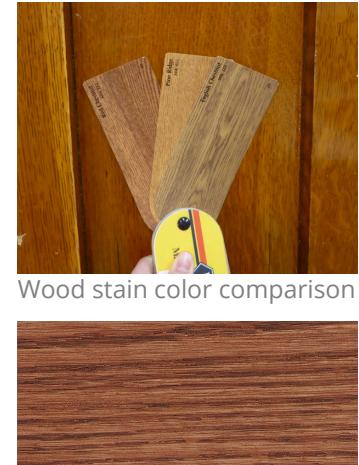
Wood stain color comparison

Minwax "Red Chestnut"

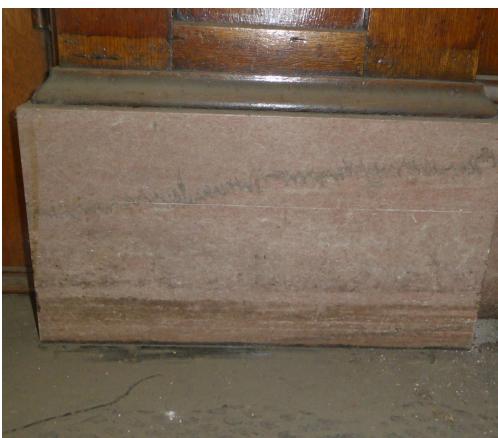
Tennessee Pink Marble Baseboard

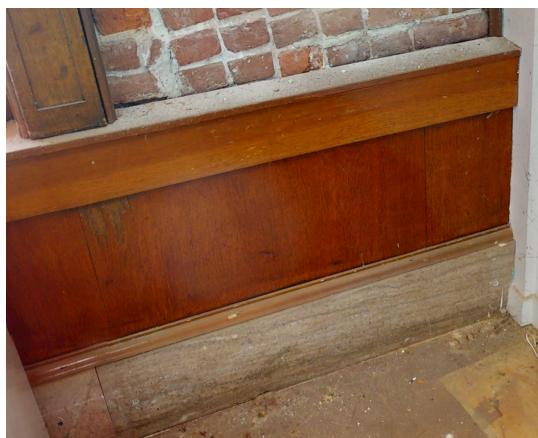
Wainscoting

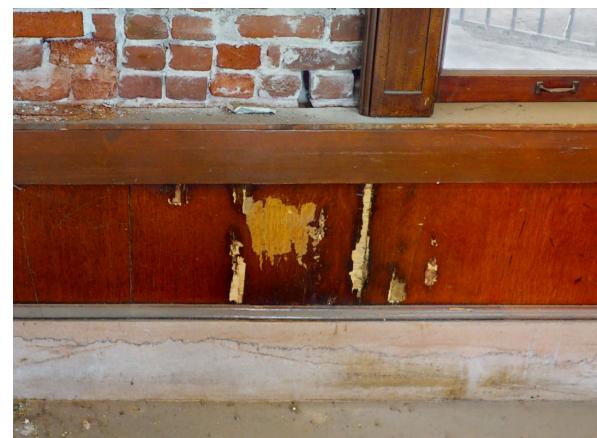
Example of existing damage at wainscoting

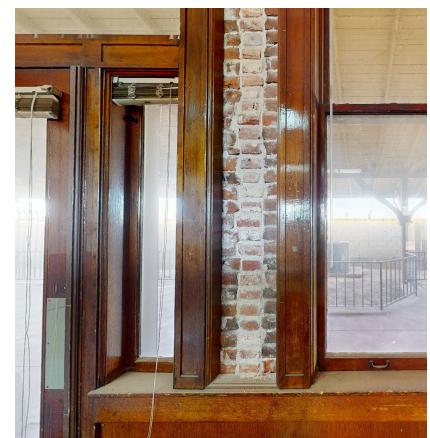
Trim at windows

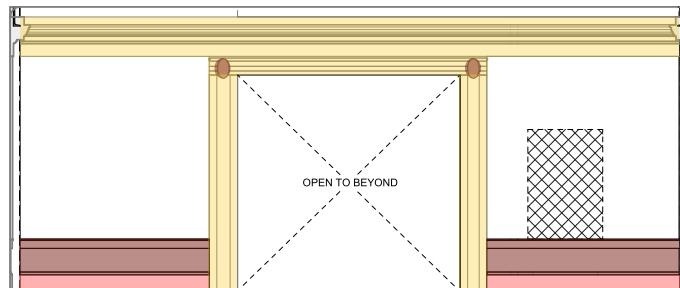
4 PASSENGER WAITING ROOM - EAST
1/4" = 1'-0"

- MISSING MARBLE TO BE REPLACED
- EXISTING WOOD ELEMENTS TO BE REPAIRED
- MISSING WOOD ELEMENTS TO BE REPRODUCED

- Repair damage to existing crown trim, opening trim, wainscoting, and window trim
- Maintain existing wood stain, match stain color at repair material
- Reproduce missing wainscoting at east and west walls, approx. 30 linear ft
- Repair and replace missing sections of marble baseboard

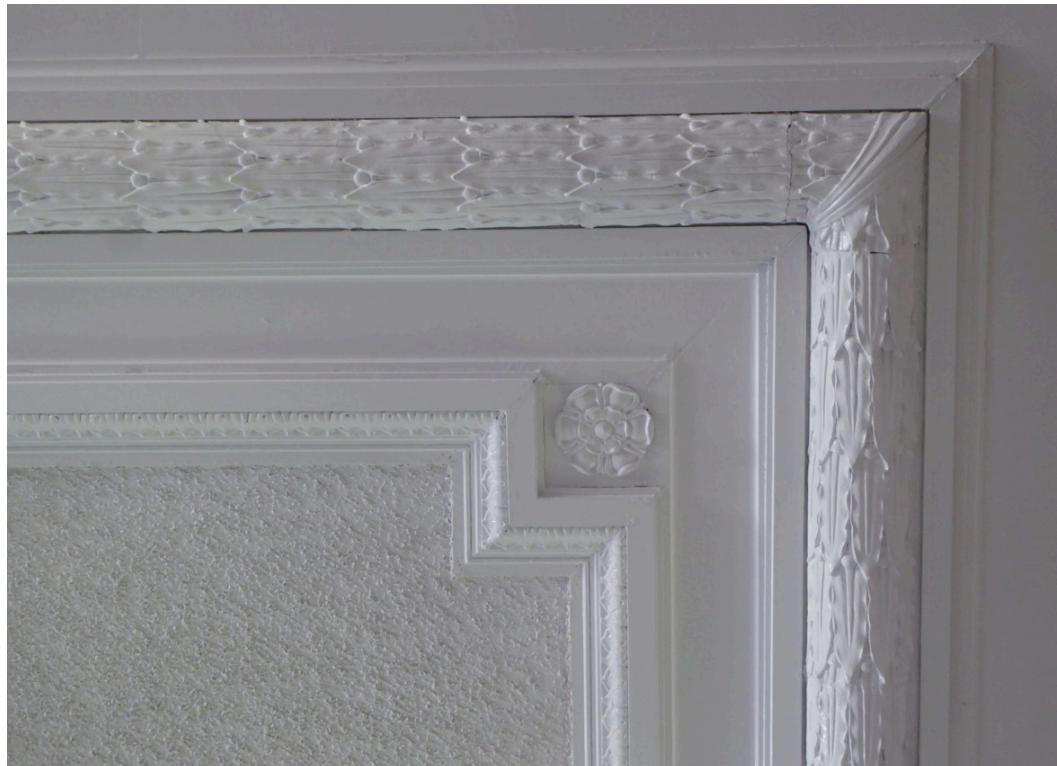
Existing plaster ceiling ornament with wood trim elements and non-historic acoustic texture

- Maintain historic plaster ornament, reconstruct if necessary for structural work
- Maintain historic ceiling cove, reconstruct if necessary for structural work
- Demolish acoustic texture and replace with smooth finish

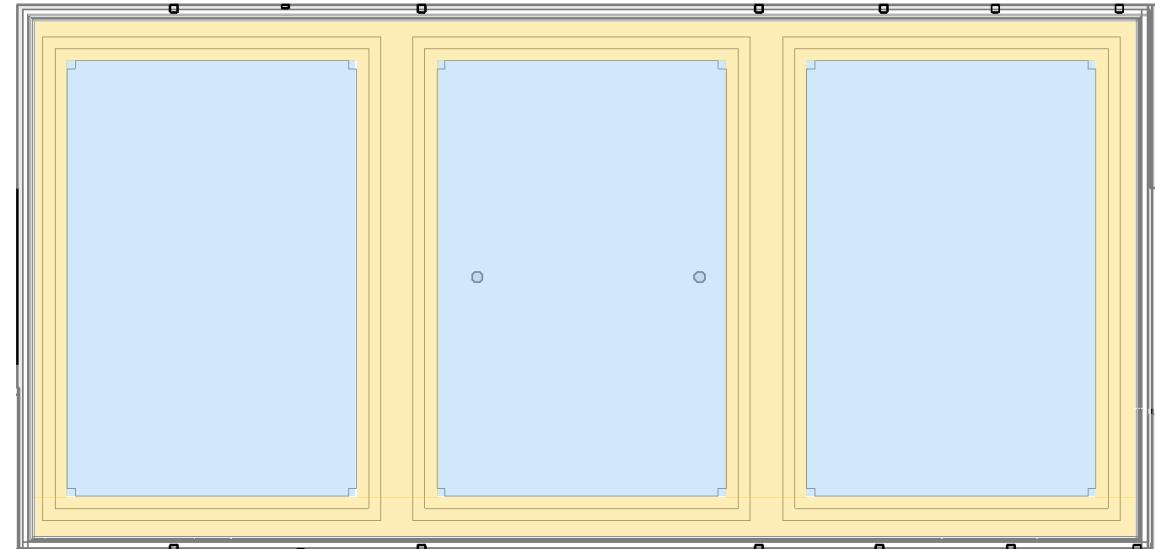
Passenger Waiting Room - Ceiling Plan with decorative plaster

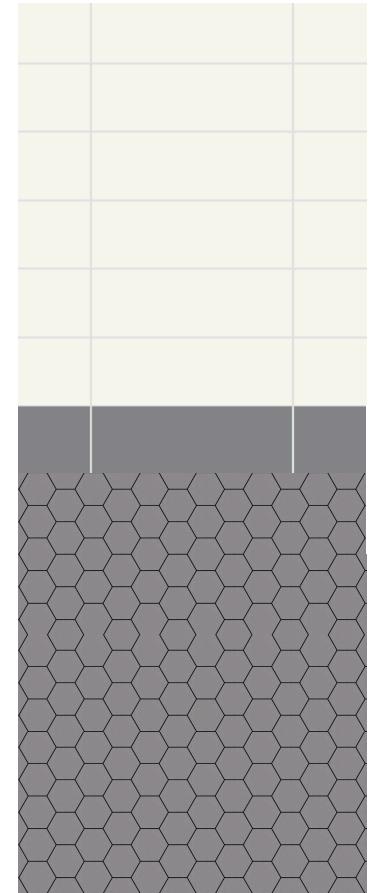
Floor | Wall

S44C9MOD / 4 x 12 Bullnose (on 12" side)

4 x 12 Wall Tile

A34C1MOD / 4 x 12 Flat Top Cove Base

2" Hexagon Tile

Daltile Color Wheel Linear ceramic tile

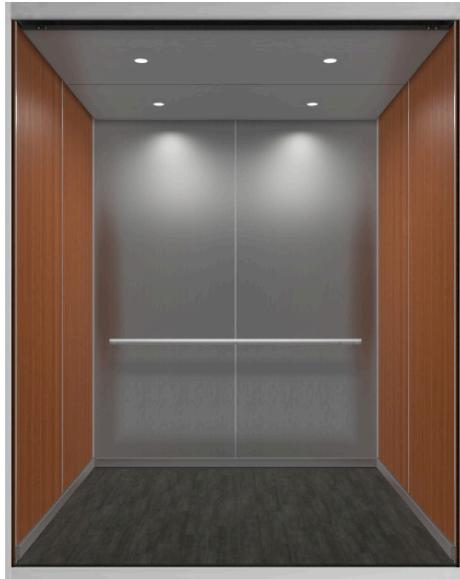
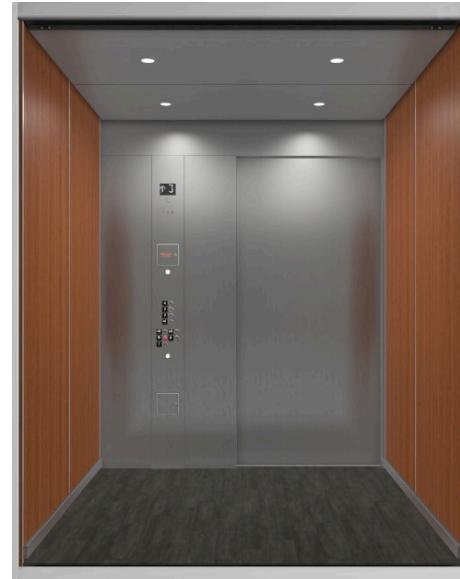
- Kone Monospace 300 DX
- Traction elevator with control room at level 2, side opening
- Brushed stainless and wood laminate panel interior

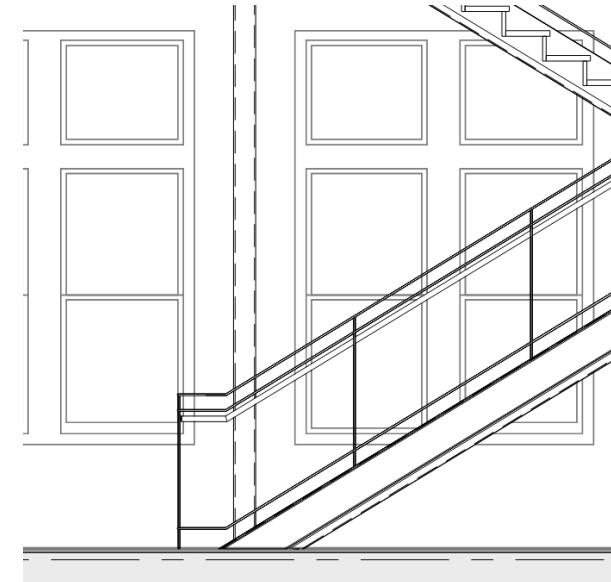
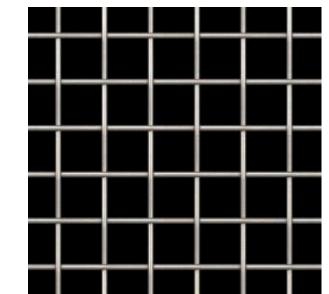
- Painted steel stringer with stained wood treads and plate steel risers
- Painted guard rail and hand rail
- Painted steel wire mesh infill panels
