**ANALYSIS OF BROWNFIELD CLEANUP  
ALTERNATIVES**

Chandler Airport  
716 West Kearney Boulevard  
Fresno, California 93706

January 6, 2026

Prepared by:  
Stantec Consulting Services Inc.  
2250 Douglas Boulevard, Suite 260  
Roseville, California 95661

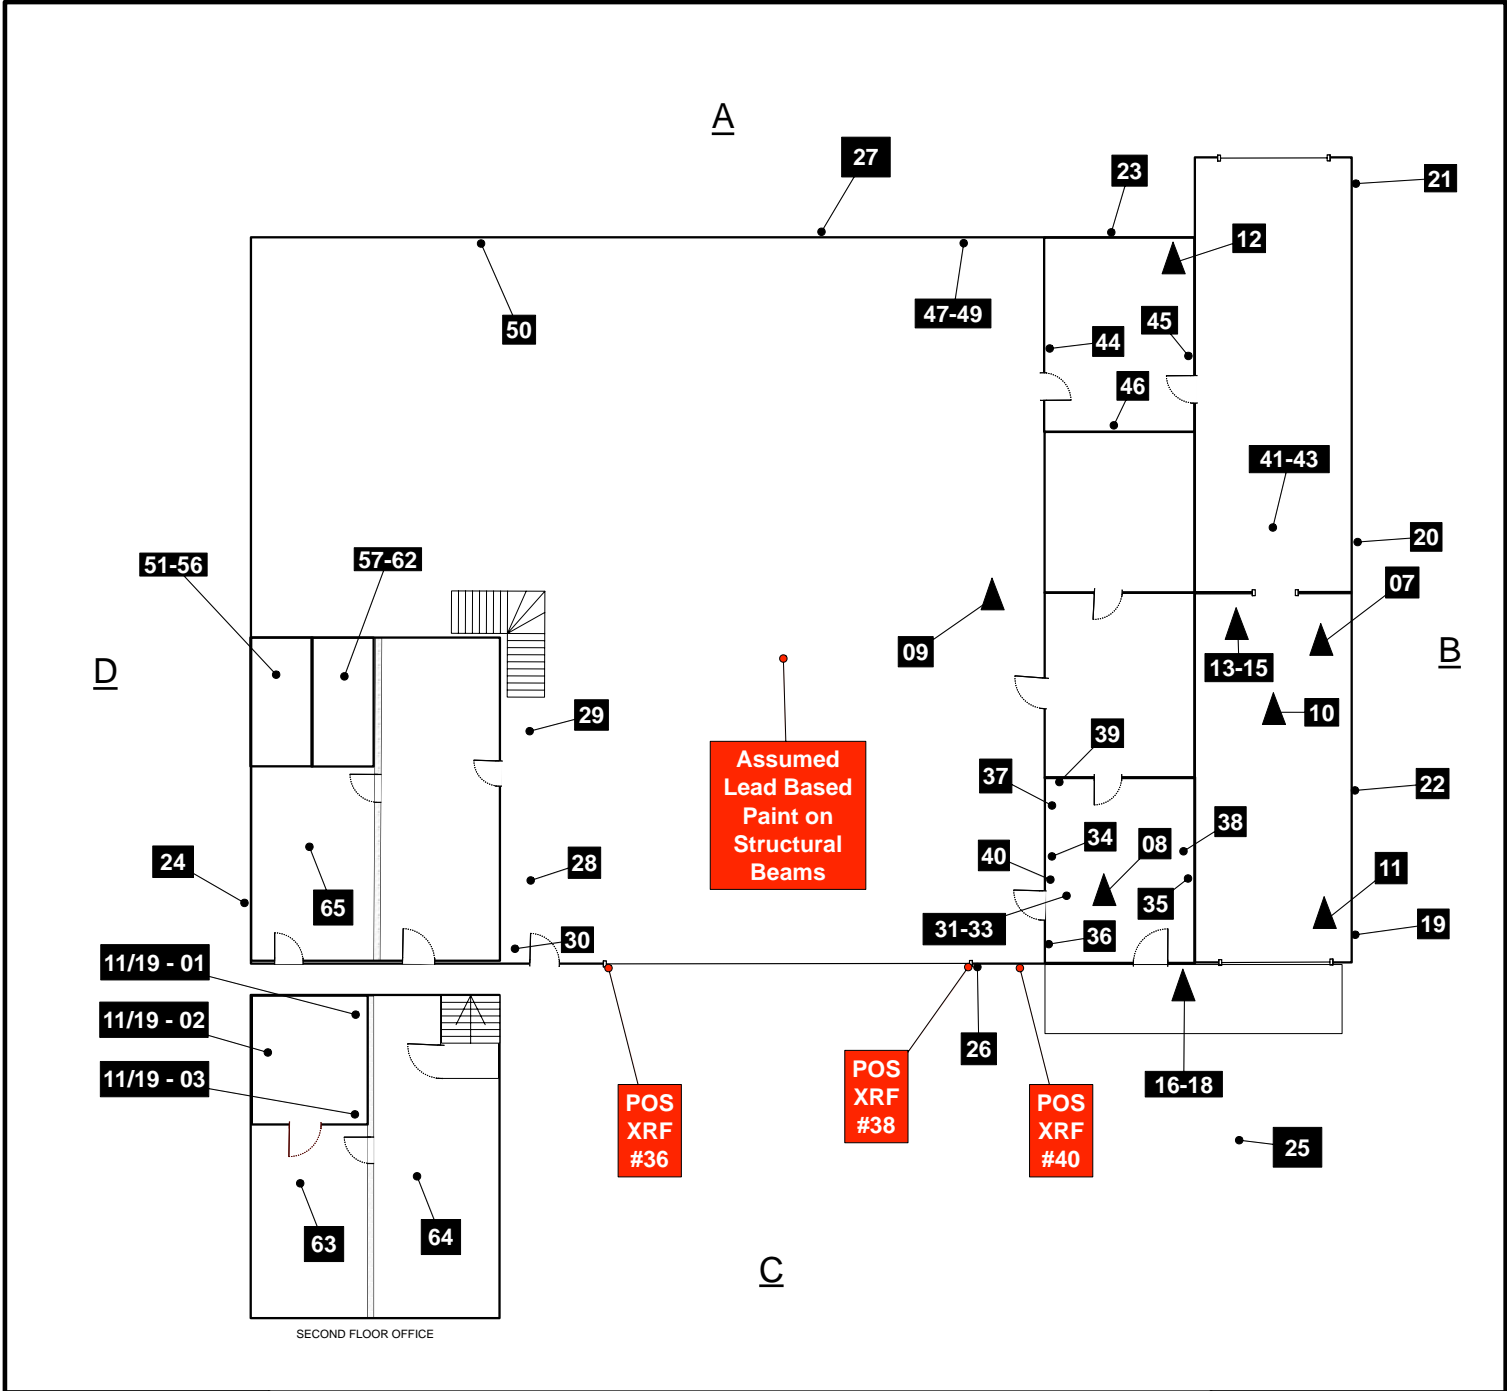
ASBESTOS & POSITIVE XRF SAMPLE LOCATION MAP

Group Delta collected 71 bulk samples of suspect ACM which were analyzed by PLM analysis. The suspect ACM sampled during this survey are summarized below. The analytical laboratory results for sampled suspect ACMs are listed in Appendix A – Analytical Laboratory Reports. Material sample locations can be found in the attached Figures.

Group Delta performed a total of 74 XRF lead tests including calibrations from the areas that may be impacted by renovation/demolition. The following is a summary of building components tested and found to be positive for LBP by XRF:

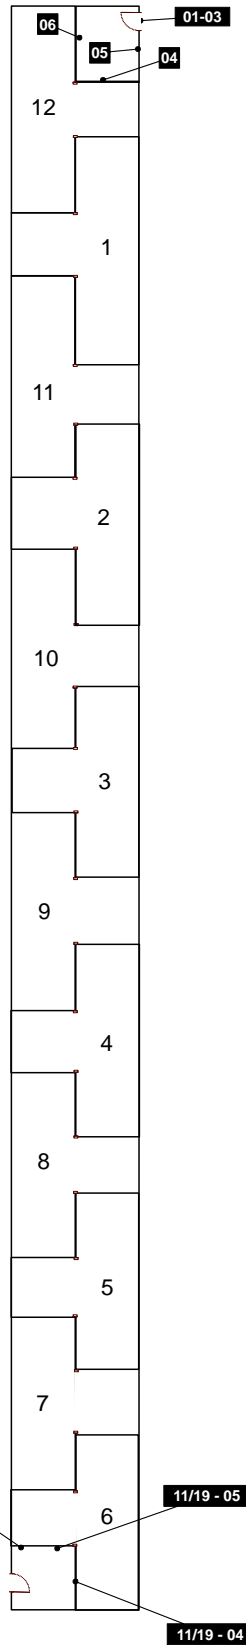
ASBESTOS SAMPLE LOCATION MAP

Customer: City of Fresno  
 Project# EN8461A  
 Location: Chandler Executive Airport  
 Area: Ex Hanger  
 Sampled by: David Raver  
 Sample Date: 10-10-2024 & 11-19-2024

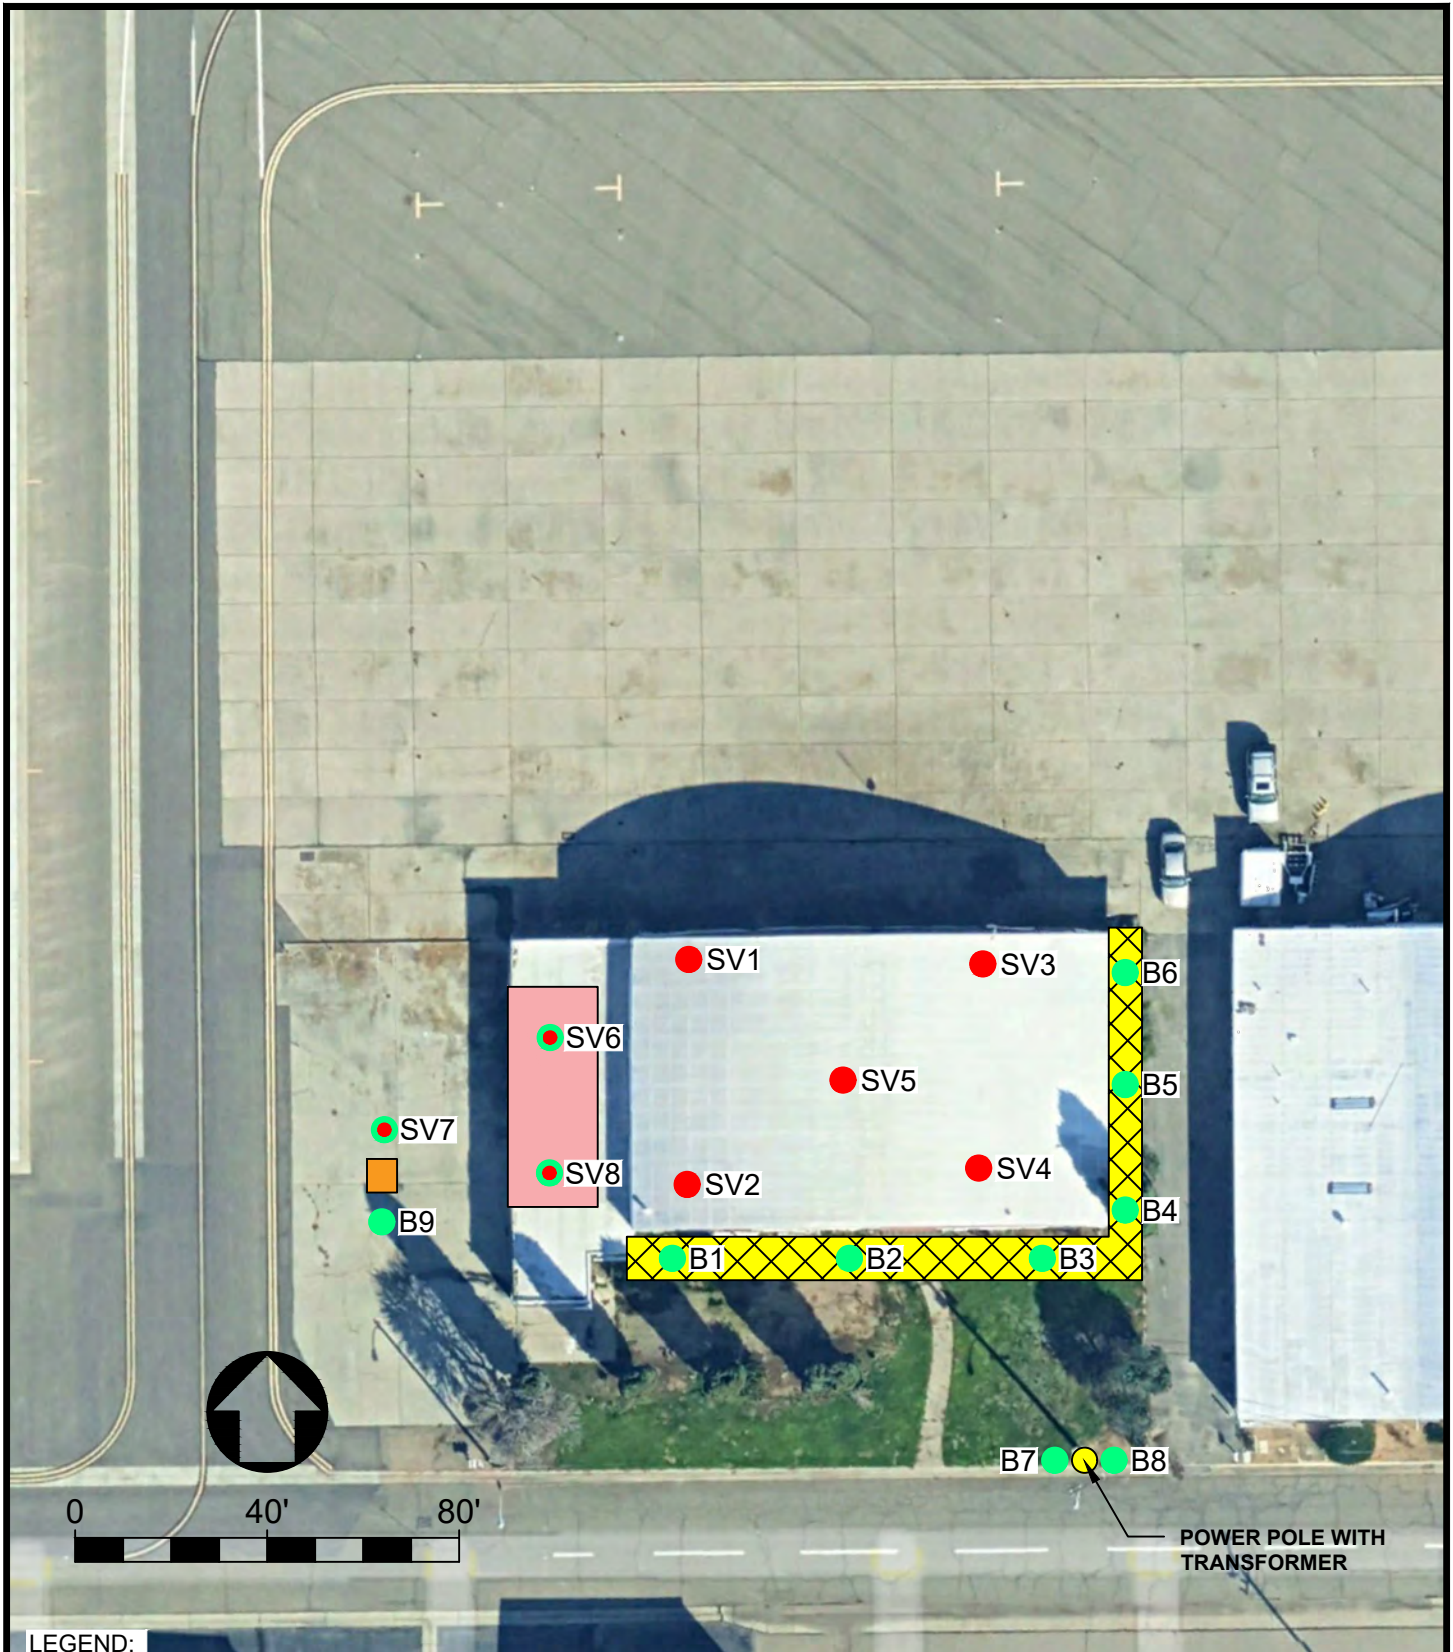
The only soil samples exceeding regulatory screening levels were those analyzed for total lead that were collected within the dripline of the existing hangar building. Five of the twelve samples collected within the dripline exceed the DTSC Screening Level (SL) of 80 milligrams per kilogram (mg/kg) for unrestricted site use. Based on soluble lead concentrations, several of the soil samples would qualify as California hazardous waste if the soils are excavated (Group Delta 2025). Stantec developed a preliminary estimate of the potential volume of lead-impacted soil based on the impacted area depicted on the Group Delta Soil Sample Location Map and assuming concentrations exceeding the DTSC SL (80 mg/kg) extend to an average depth of 3 feet bgs. This estimated volume is 3,780 cubic feet or 140 cubic yards. This would equal approximately 210 tons (assuming an average soil density of 1.5 tons per cubic yard).

- SOIL VAPOR LOCATION
- SOIL SAMPLE LOCATION
- SOIL VAPOR / SOIL SAMPLE LOCATION
- REC2 - DRAIN/OIL WATER SEPARATOR
- REC3 - PAINT BOOTH
- OEC1 - AREA OF LEAD-BASED PAINT IN EXPOSED SOIL
