FRESNO CITY COUNCIL

Contents of Supplement: Final Camp Fresno Condition Assessment

CAMP FRESNO & CAMP FRESNO JR.
CONDITION ASSESSMENT

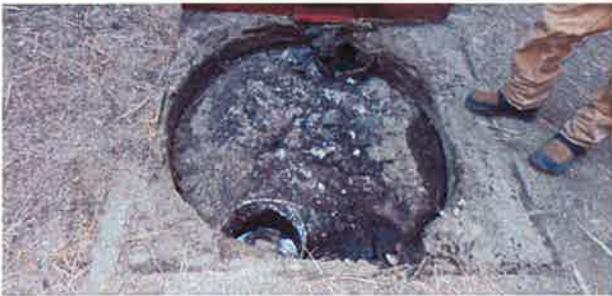
Septic tank near restroom No. 2

The sewage treatment and disposal system consists of septic tanks and leach fields. There are an estimated 8 septic tanks present at Camp Fresno. The majority of the septic tanks are located near the restroom/shower buildings. The below ground septic tanks appear to be constructed of steel and vary in size from 750 to 1,000 gallons and most are equipped with unsecured steel lids. The septic tanks are pumped dry annually following camp closure. During the time of inspection, the tanks were at/near full operational capacity (see photo on page 6). For this reason the present condition of the tank wall and bottom is unknown. The vendor that was present during the pumping operation confirmed the presence of tank wall and floor corrosion. Due to the present condition of the septic tanks, we recommend that the tanks be replaced; however, there are no indications of immediate need as the present condition of the tanks appears to

be unchanged from previous years. For the purpose of estimating cost, we have included the cost for installing new high-density, polyethylene, below-ground tanks with plastic lids at the existing tank locations.

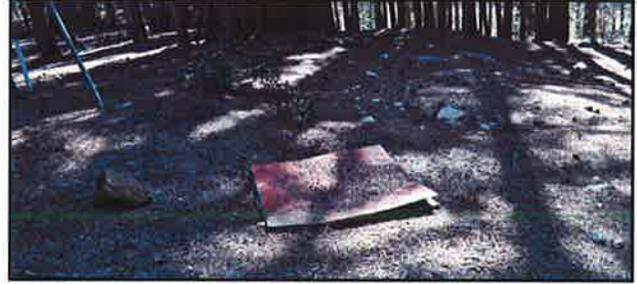
Unsecured lid on existing septic tank

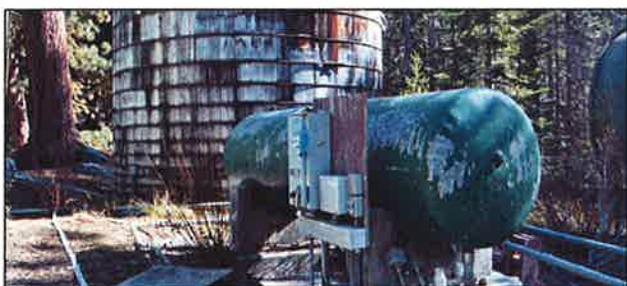
Existing water storage tanks

The site has two water storage tanks; one constructed of wood and the other of steel. The wooden tank volume is estimated to be 10,000 gallons but appears to be of a significant age. Due to damage resulting from woodpeckers, the tank was modified to receive a rubberized liner that appears to also be leaking. The existing steel tank, once used as a pressure vessel, provides an estimated storage volume of 5,000 gallons.

The total camp water storage volume is unknown as the leakage within the wooden tank causes the tank to require constant well pumping during normal camp occupancy.

Our assessment recommends the replacement of the existing water storage tanks with NSF, potable water approved, pre-manufactured, high density polyethylene tanks. Two each 10,000 gallon tanks are used in this assessment for the purpose of costing.

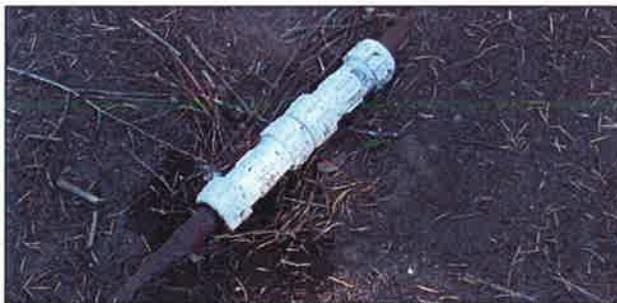
Ad-hoc repair to exposed pipeline

The distribution pipelines vary in size from $\frac{3}{4}$ inch to 2 inch in size. The majority of the pipelines that were visually inspected are steel galvanized pipe. The pipelines have been exposed due to ground erosion and lifting by large tree roots. Exposed pipelines have become tripping hazards and experience frequent damage from surface activities.

In summary, the existing water distribution pipelines are in poor condition. Years of frequent ad-hoc repairs has led to the overall reduced reliability and nearly constant repair by the vendor.

The assessment recommends the replacement of all onsite water distribution pipelines. The location of the pipelines that may have been replaced is unknown due to the lack of as-built information. A site map was created and measurements were taken to determine the total length and size of the pipelines necessary to prepare the overall replacement cost estimate included in Appendix B.

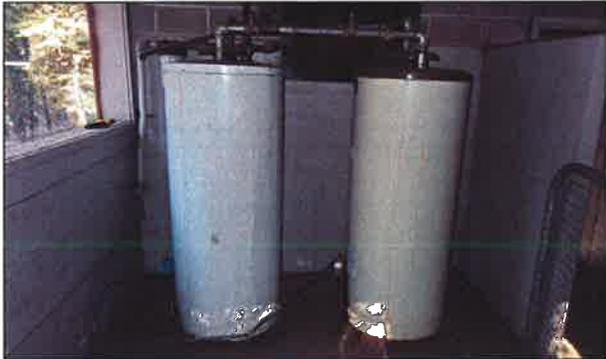
Water heaters in Shower Building #1

The water piping with the restrooms and shower buildings appears to be moderate condition. Much like the cabins, much of the pipes are exposed which easily facilitates repairs. The shower buildings utilize two each, 100-gallon propane water heaters. Although these tanks provide an ample volume of hot water, the overall age of the tanks has questioned their energy efficiency. Replacing the tanks should be considered but is not included as part of the evaluation as the annual use of these tanks occur only a fraction of the year and most likely required an extensive period of return for recapturing the initial investment cost of replacement.

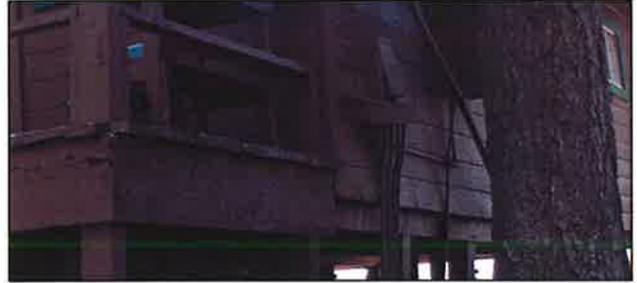
Damaged electrical sub panel

As with the sewer and water pipelines, existing below ground electrical conduits and sub panels have been uplifted by tree roots. Also, sub panels have been damaged by the structures that have shifted due to failing foundations (see photo above).

The assessment recommends repairing all conduits and sub-panels that have been damaged by roots or shifting structures, and to make any repairs necessary to maintain a safe environment for campers. The maintenance cost estimates are included in Appendix A and B.

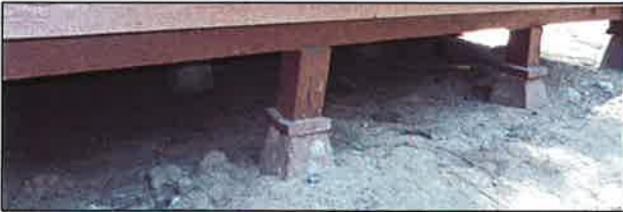
The majority of the structures (except for the caretaker's houses at Camp Fresno) are un-insolated wooden plank sided structures that are more than 50 years old. Over the years, many of these structures have been damage by tree roots and heavy winter snow loading. The wood within the siding and structural members has frequent dry rot. In general, for the exception of Camp Fresno's clubhouse and the caretaker's houses and Camp Junior's pavilion, all of the structures are in poor or near poor condition.

Damaged raised foundation elements at cabin #65

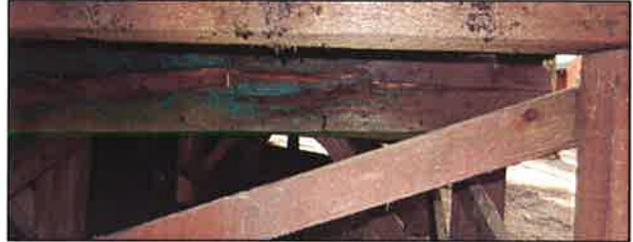
Dry rot at cabin #71

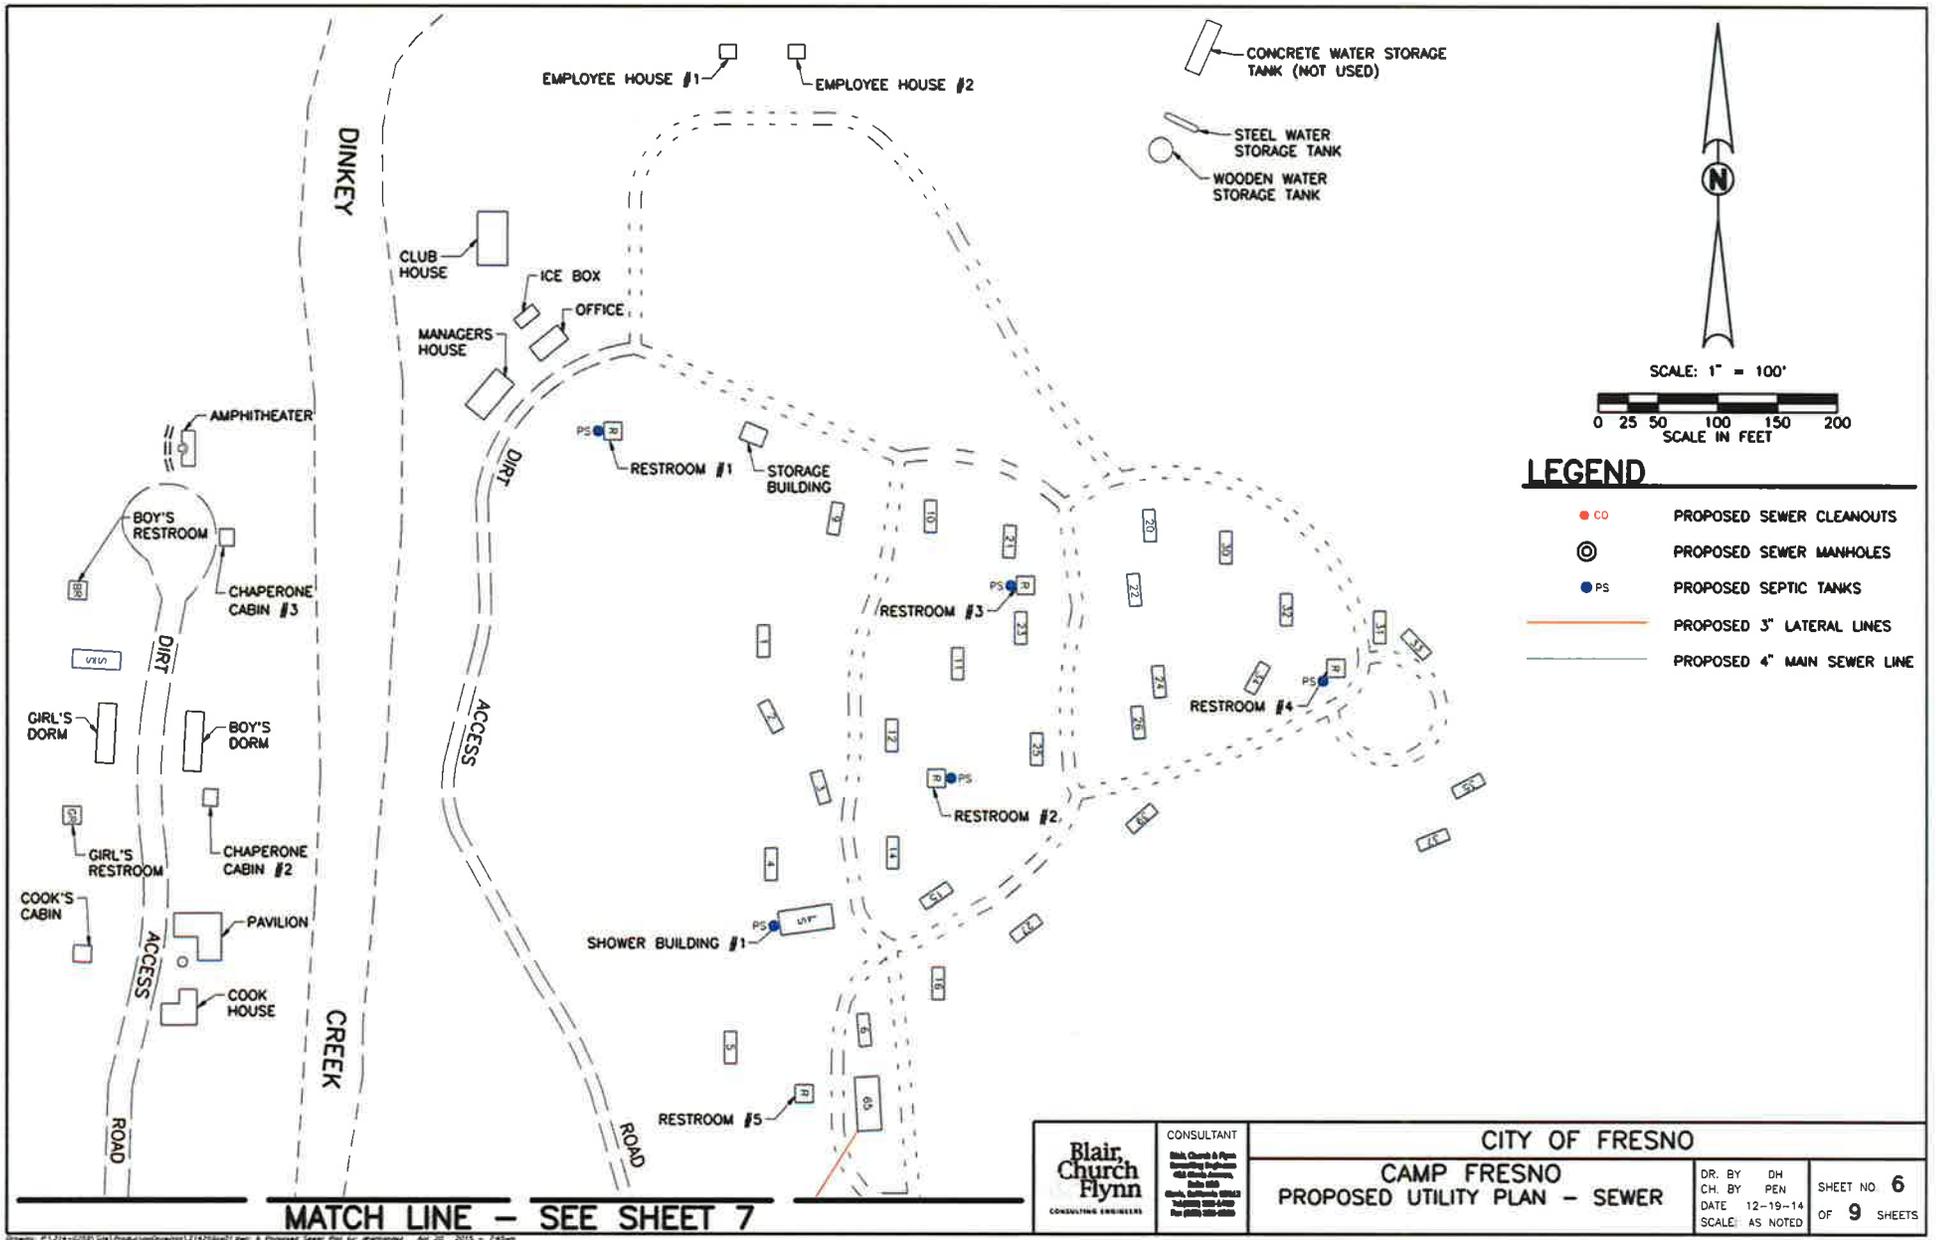
CONSULTANT Blair, Church & Flynn Consulting Engineers 422 West Broadway Suite 200 Fresno, California 93704 Telephone: 558-4400 Fax: 558-4400	CITY OF FRESNO CAMP FRESNO PROPOSED UTILITY PLAN - SEWER		DR. BY: DH CH. BY: PEN DATE: 12-19-14 SCALE: AS NOTED	SHEET NO. 6 OF 9 SHEETS

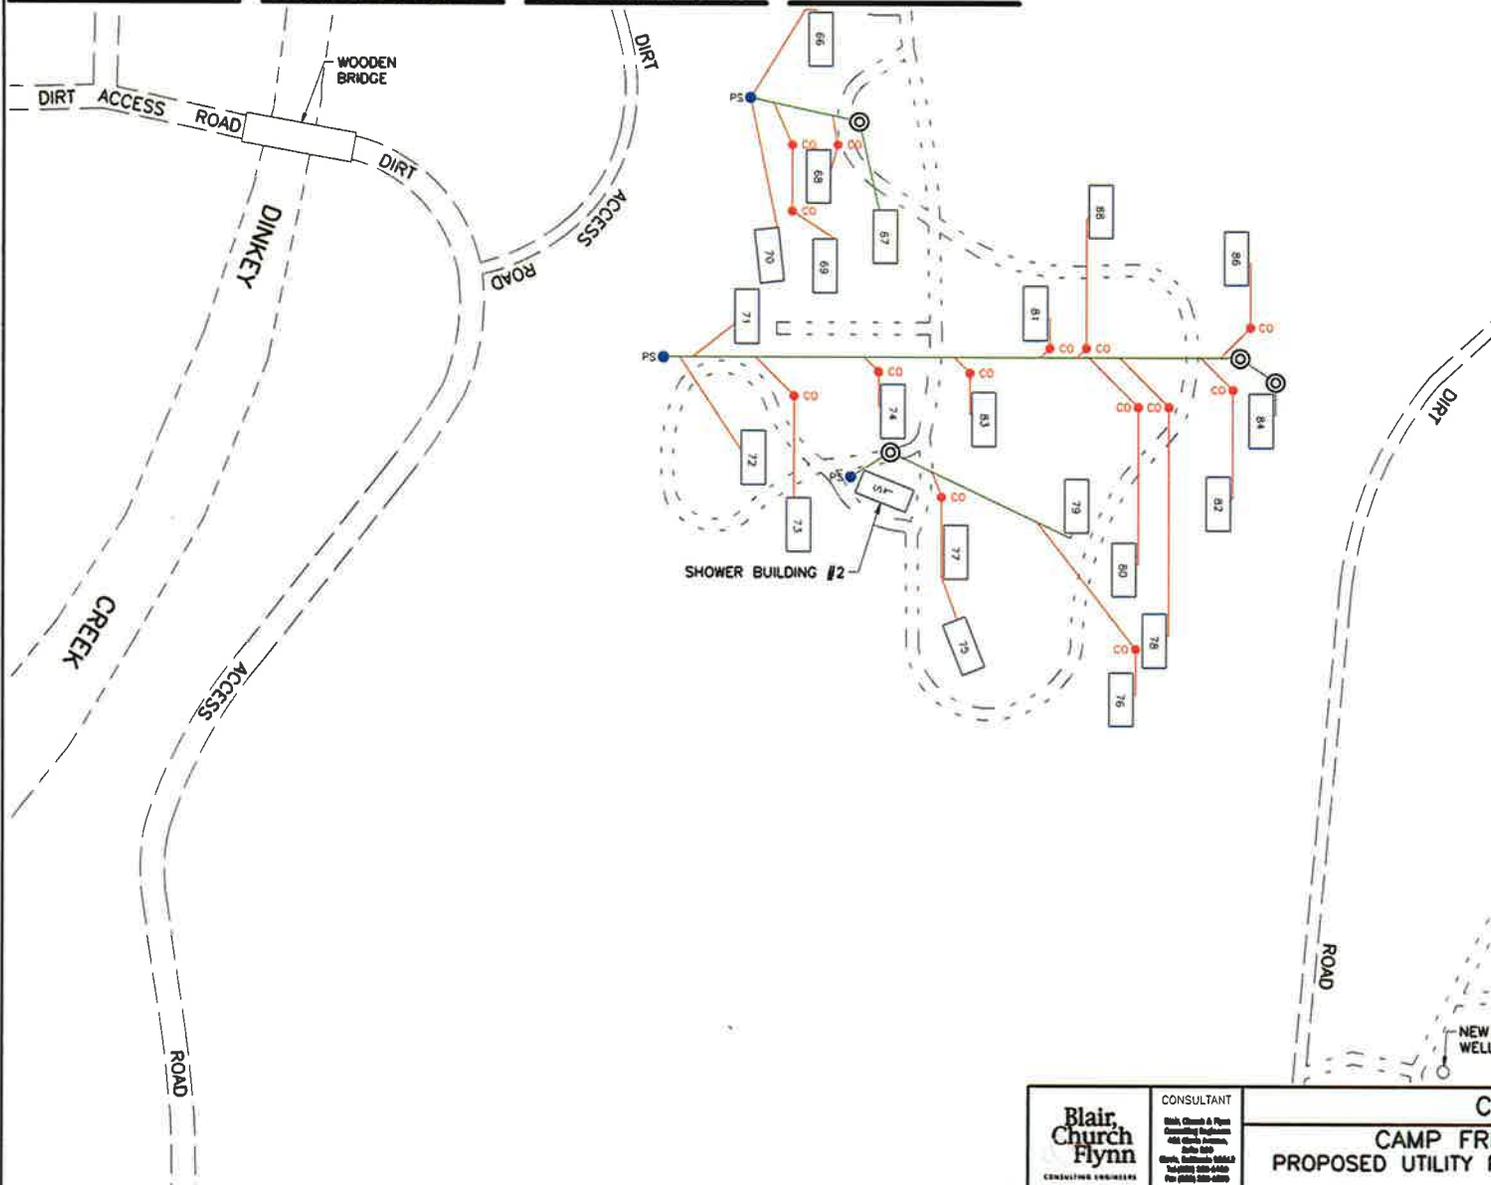
- CO PROPOSED SEWER CLEANOUTS
- ⊙ PROPOSED SEWER MANHOLES
- PS PROPOSED SEPTIC TANKS
- PROPOSED 3" LATERAL LINES
- PROPOSED 4" MAIN SEWER LINE

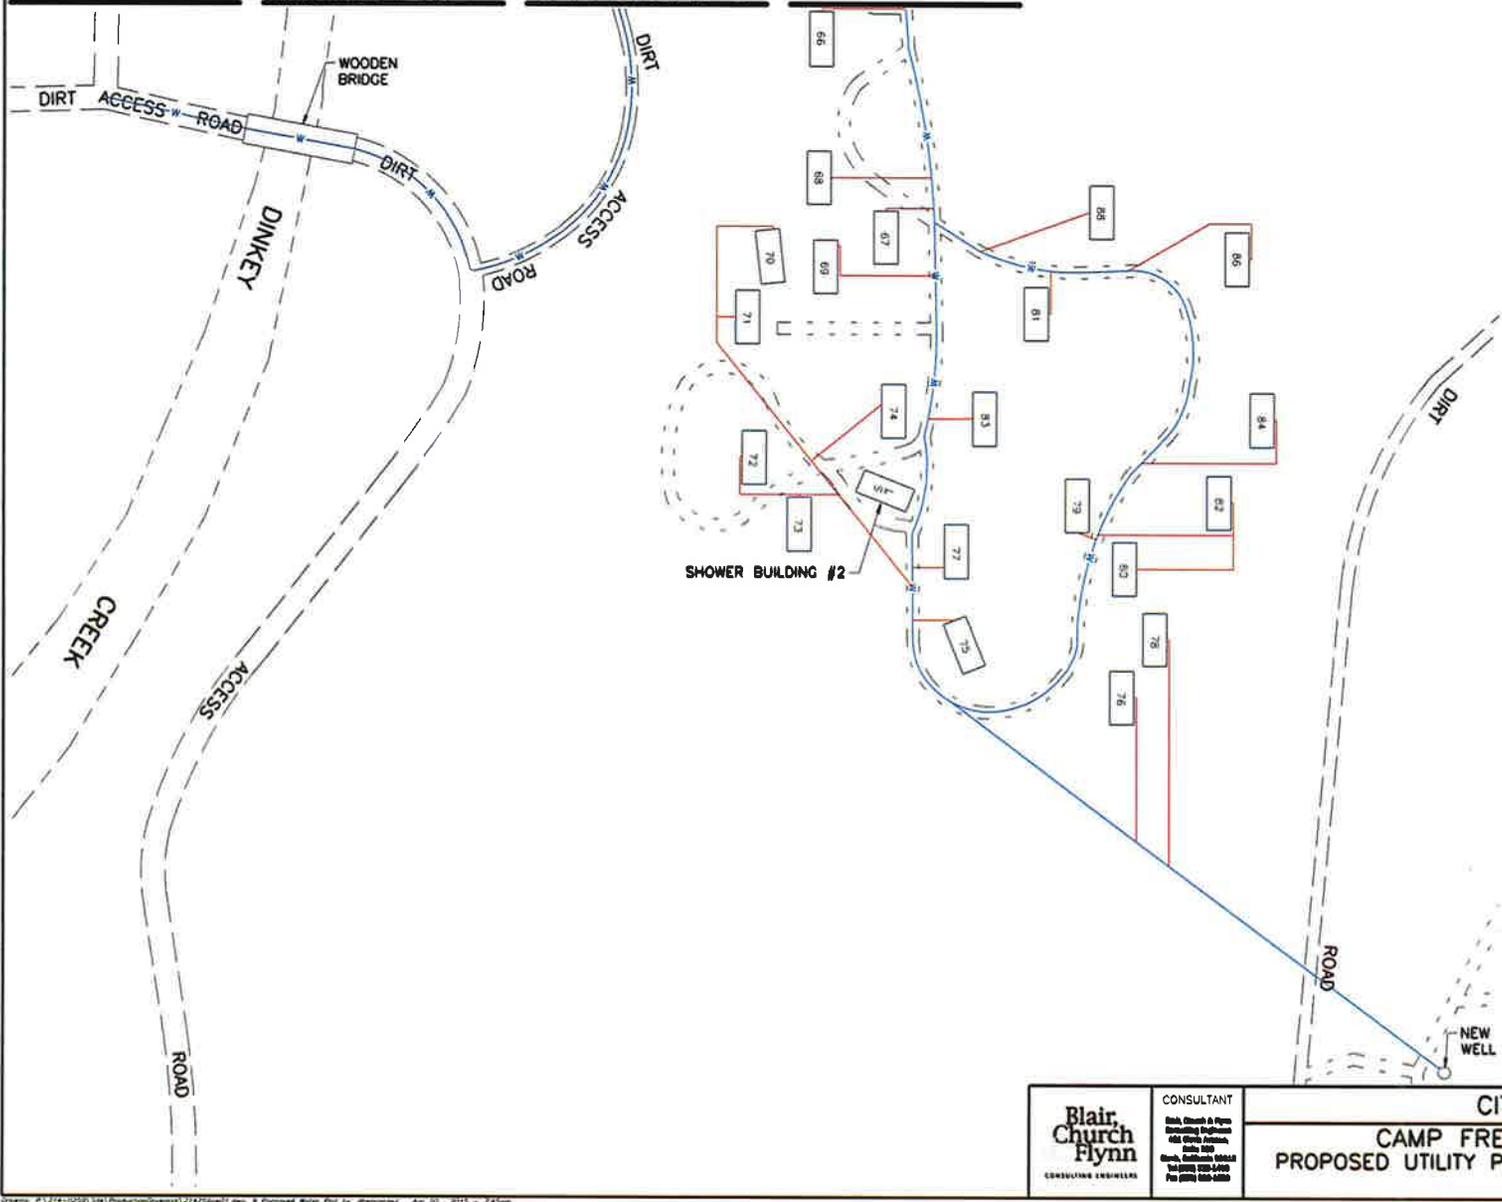
- LEGEND**
- HB PROPOSED HOSE BIB LOCATION
 - W — PROPOSED 4" MOP MAIN WATER LINE
 - PROPOSED 1 1/2" LATERAL LINES
 - PROPOSED 2" LINES TO RESTROOM
 - W — PROPOSED WATER LINE TO CAMP FRESNO JUNIOR
