## HISTORIC RESOURCES INVENTORY

## DESIGN NARRATIVE

PROJECT: **Sun Stereo Warehouse**  
736 Fulton Street, Fresno, CA 93721  
Local Historic Register Property #160

HISTORIC WAREHOUSE  
TENANT IMPROVEMENT  
MAY 2019

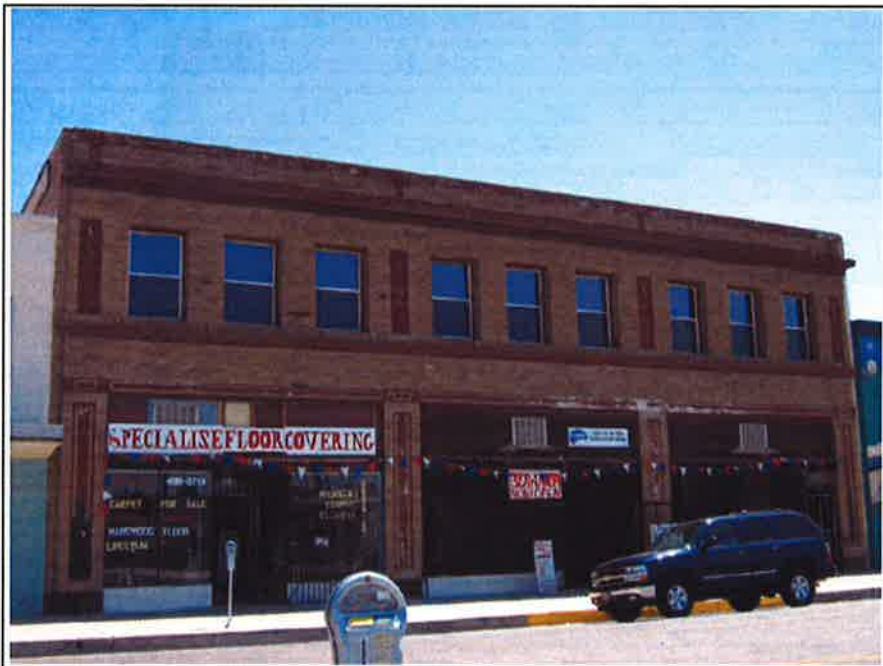
P5b. Photo: (view and date)

736-742 Fulton Street is located on the northeast side of Fulton Street, between Inyo and Mono streets. Built in 1920, 736-742 Fulton Street is a two-story, brick masonry commercial building, designed in the 20<sup>th</sup> Century Commercial style. The rectangular-plan building is capped by a flat roof. The foundation is not visible from the street. The southwest-facing, primary façade is clad in tan facing brick and is three bays wide. The first story of the façade features a storefront in the northwestern bay, which consists of aluminum framed plate glass windows over a stucco skirting. The windows are surmounted by a clerestory, which has been boarded up. The inset entry to this bay is located at the center of the storefront and consists of a glazed, wood door with a transom. The center and southeastern bays have been infilled with diagonal board siding, but have entrances consisting of non-historic flush wood doors. The clerestories over these bays have also been infilled. The bays are separated by brick piers with inset concrete panels. Above the clerestory level is a simple intermediate entablature formed by a concrete belt course, a plain brick frieze, and a molded concrete cornice. Above this, the second story features nine regularly spaced windows, three in each bay. These windows consist of one-over-one, double-hung, vinyl sashes. Inset concrete panels divide the bays at the second story level. The wall is capped by another entablature, consisting of a denticulated cornice and frieze with a plain (cont.)

View from southwest  
5/22/2007

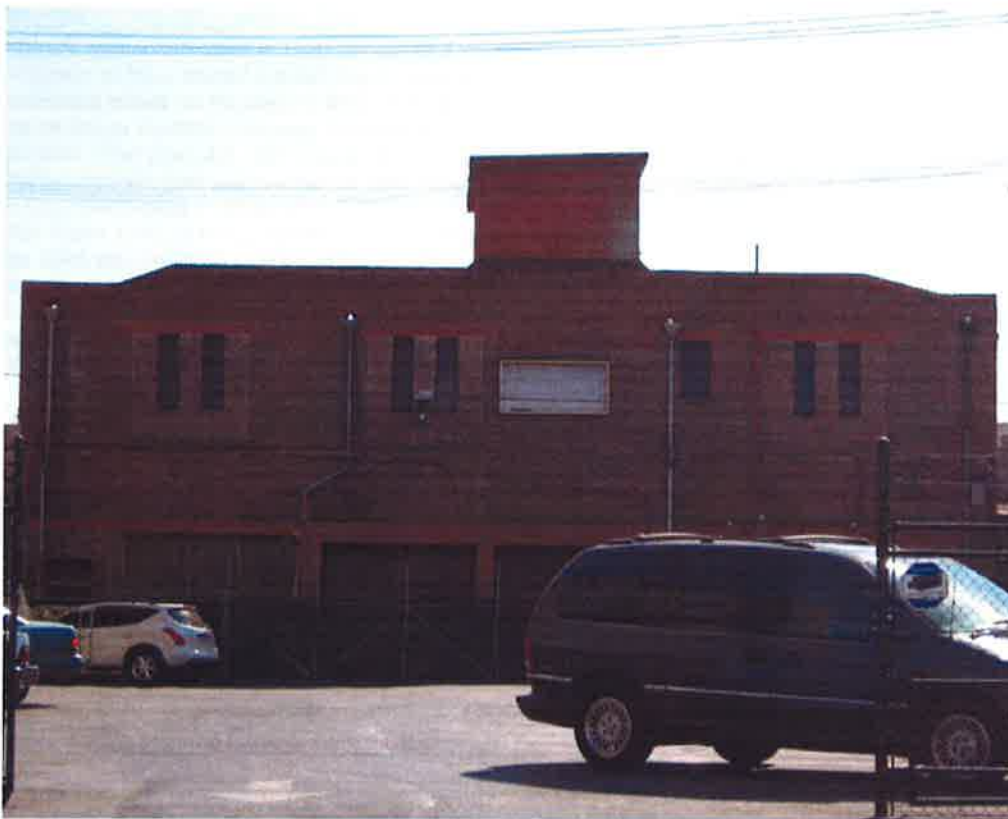
The secondary facades abut neighboring buildings and are not visible. However, on the northwest side, where the wall rises above the neighboring building, a historic sign has been affixed to the parapet. The rear of the building is constructed of common red brick. At the first story are two garage entrances with metal roll-up doors at the center of the façade. On either side of these garage entrances are large tripartite windows. At each end of the façade is a personnel door with a flush wood door and an infilled transom. A concrete bond beam is located over these openings and separates the first and second stories. At the second story, three large window openings appear to have been infilled and replaced with tall narrow, paired windows. A smaller single window also remains on the northwest side of the façade. All of these windows are surmounted by concrete header beams. A sign fixture is located near the center of the façade at the second story level. The façade terminates in a shaped parapet and a large elevator penthouse structure protrudes from the roof over the center of the façade. The building appears to be in good condition, and its physical integrity is fair.

Rear (northeast) façade, looking southwest.

Along the rear (alley) side, there are an assortment of small and large windows as well as rollup service type doors that have concrete headers above. We are planning on simplifying the rear façade to remove excess infill that has been added over the years, and plan on keeping the large steel windows where possible.

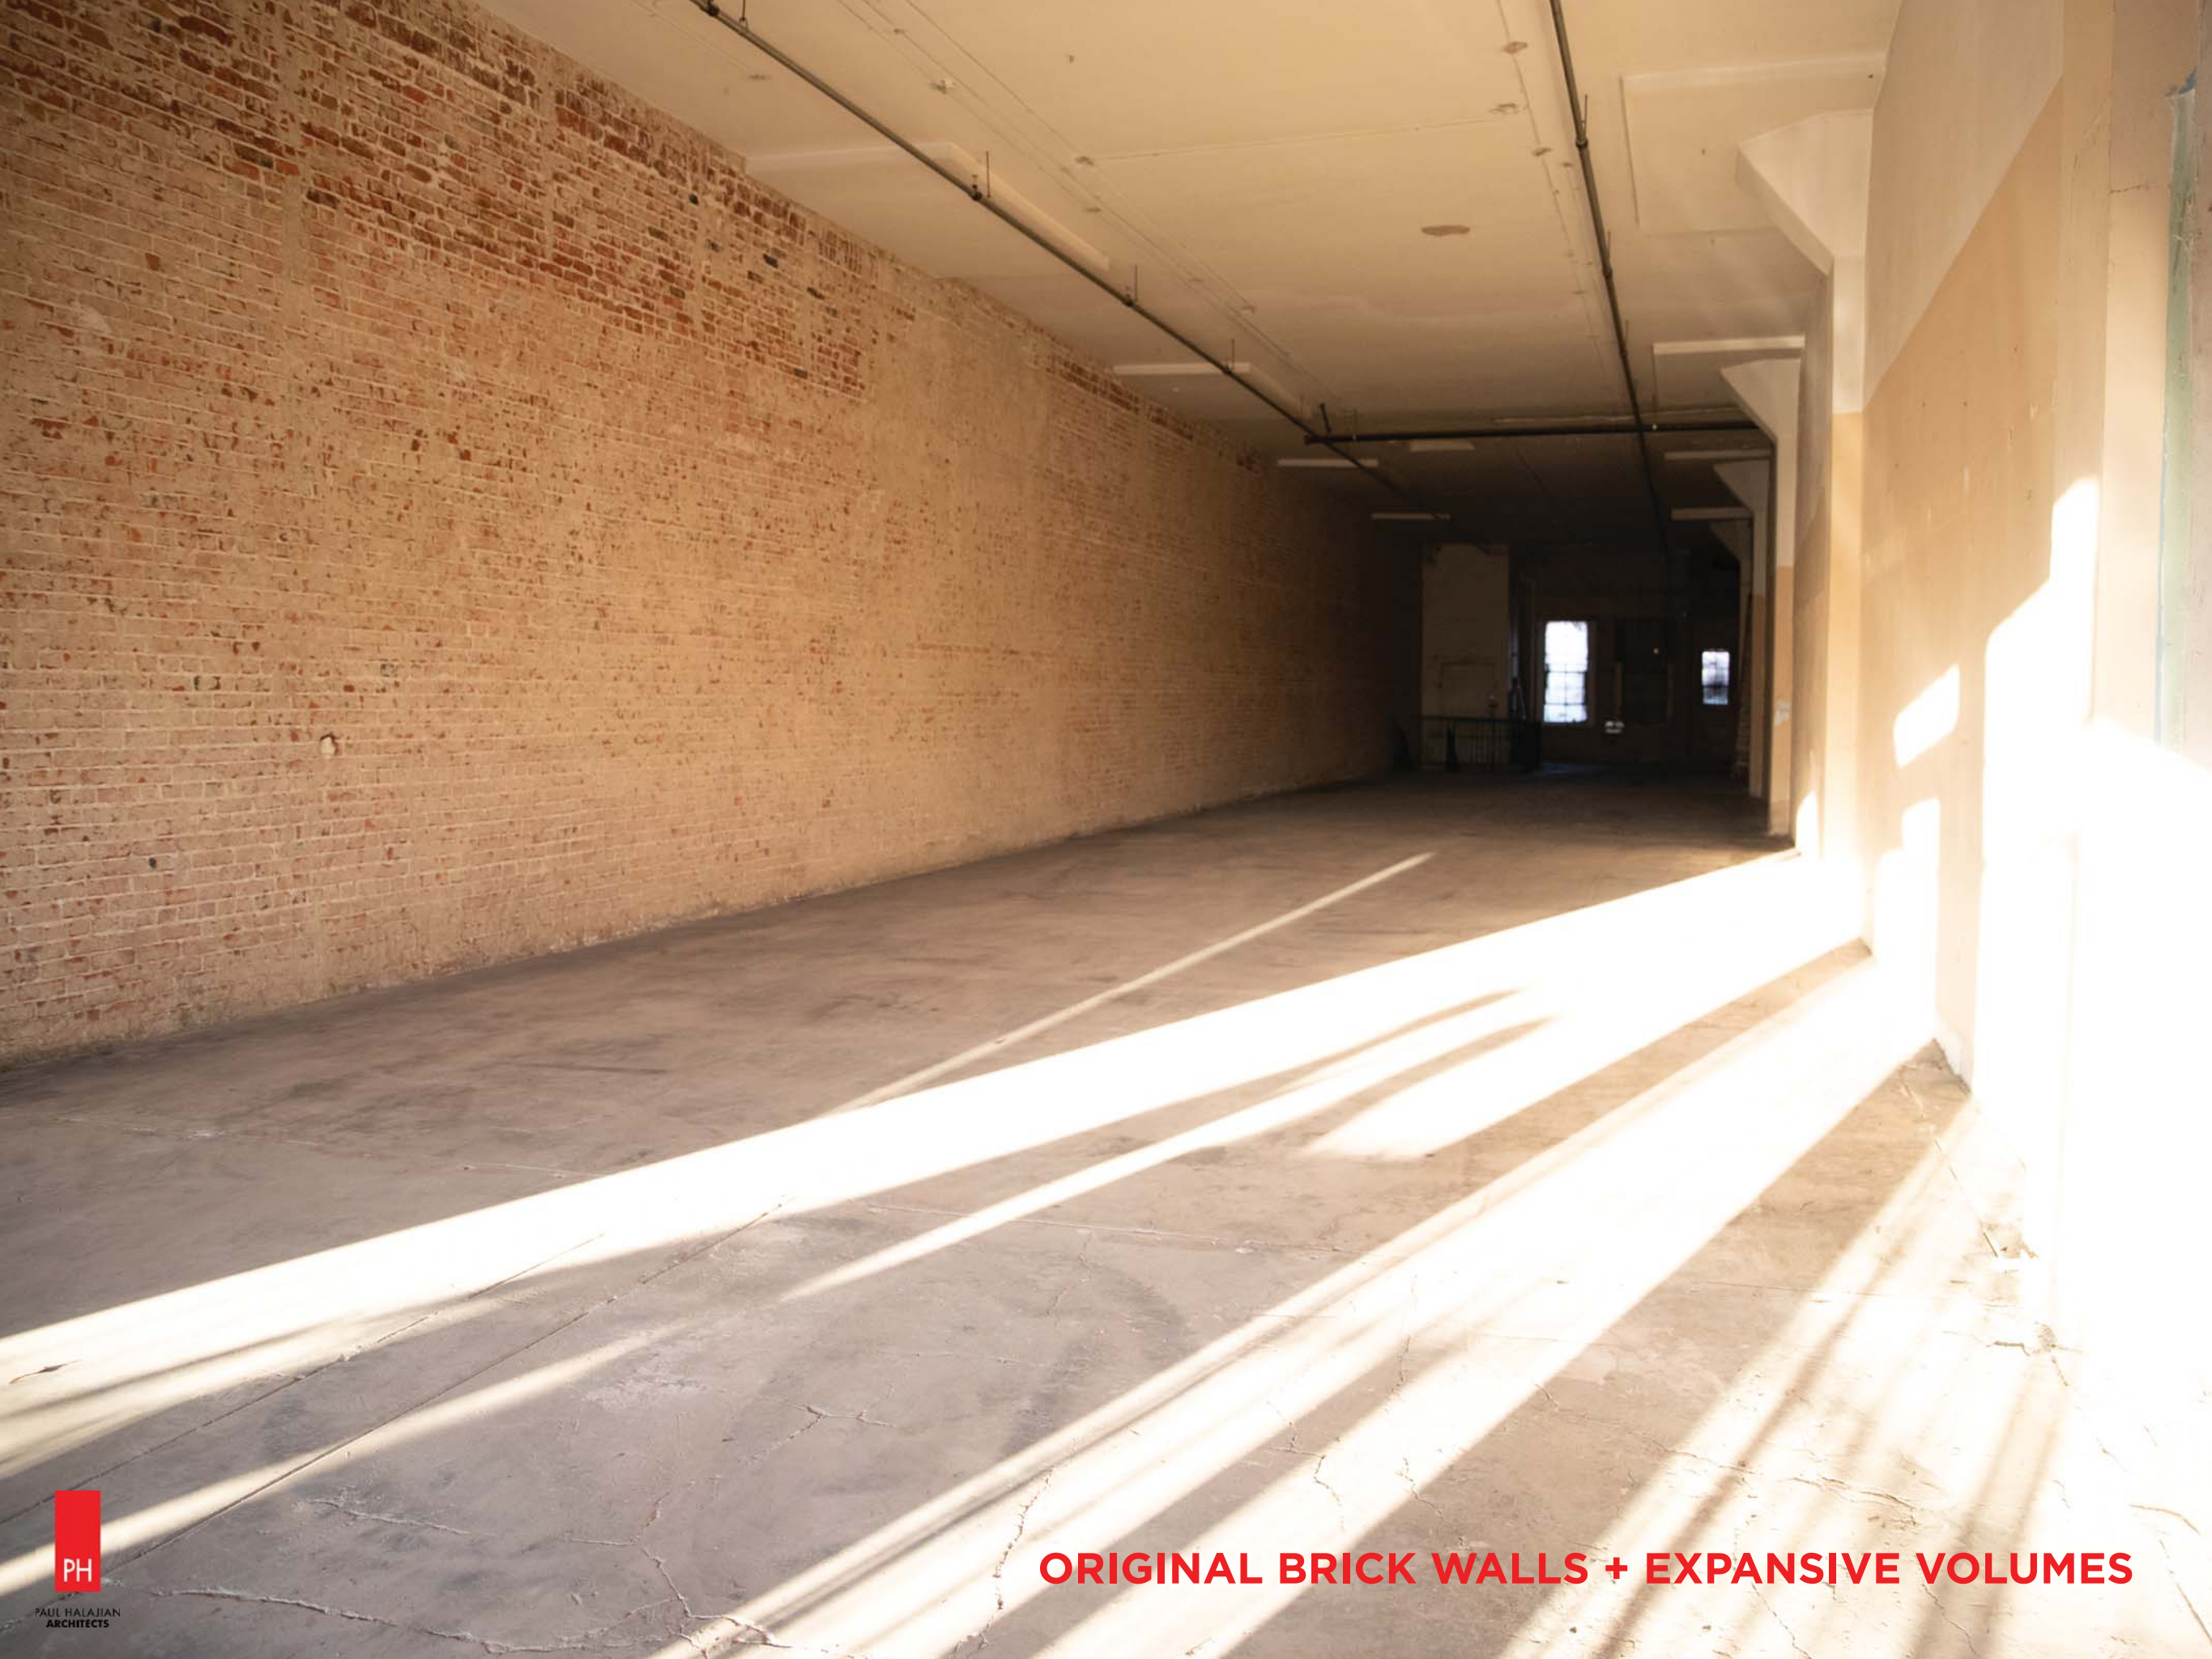
**ORIGINAL BRICK WALLS + EXPANSIVE VOLUMES**

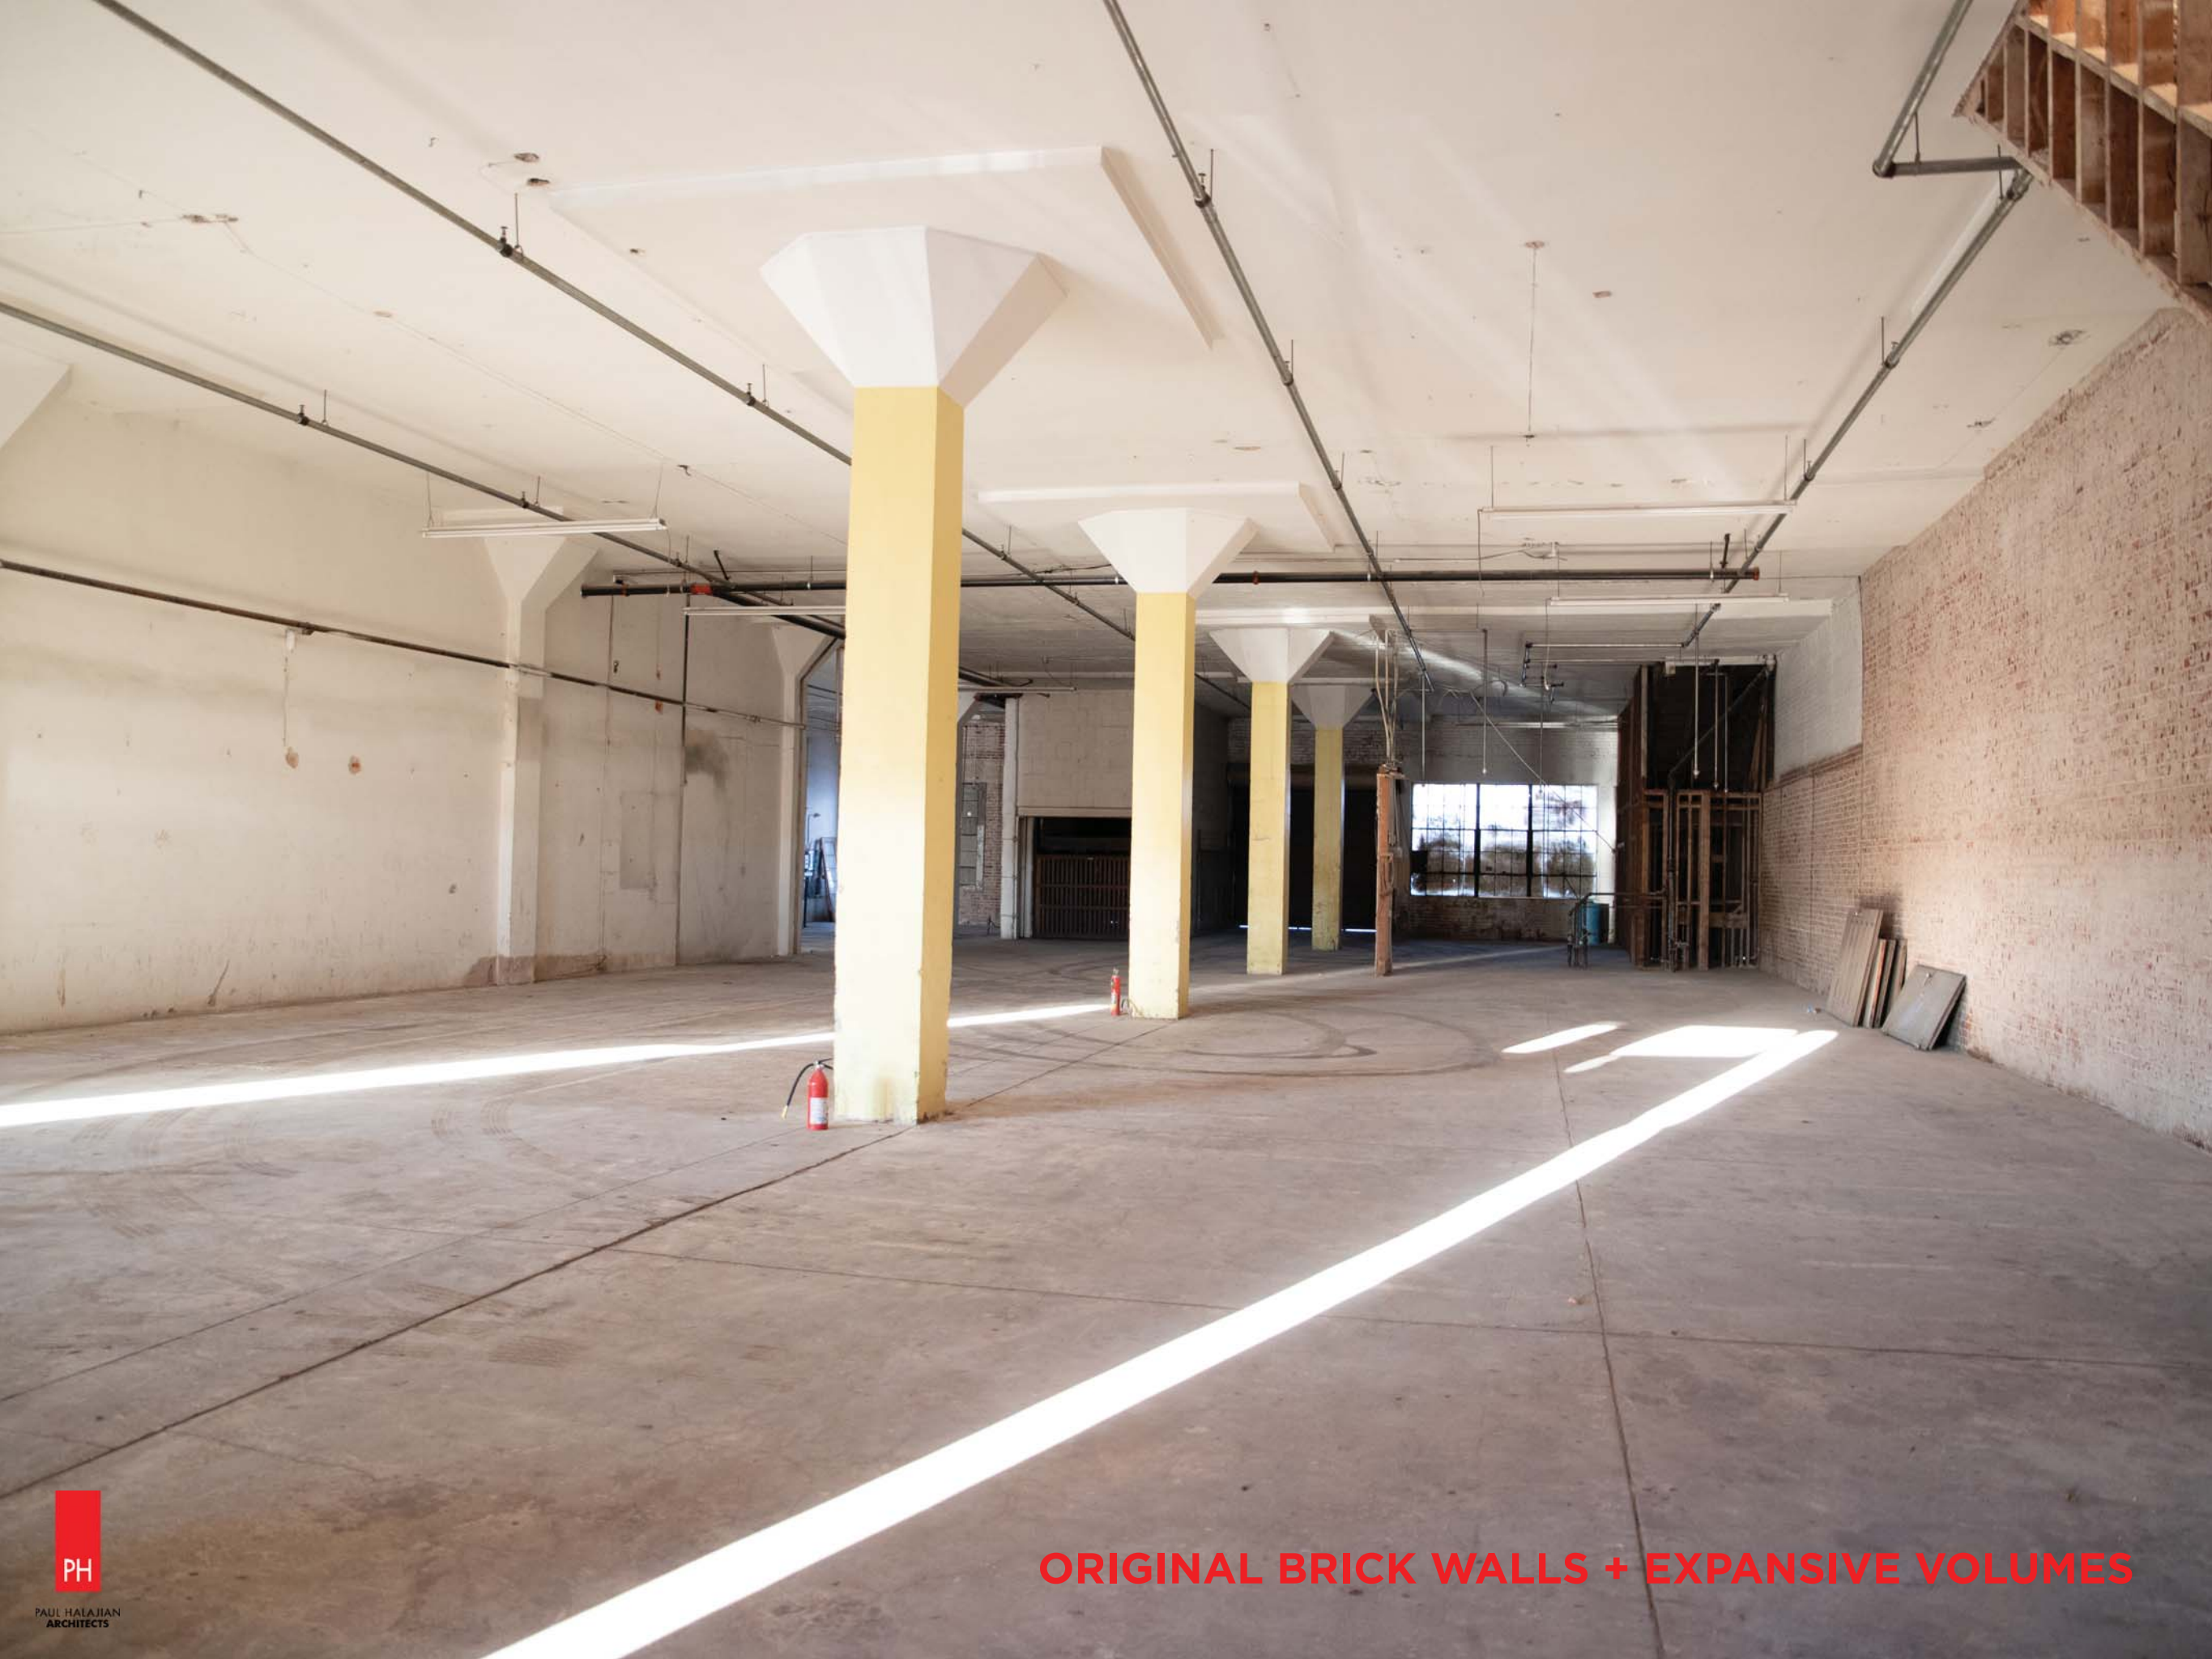
**WOOD ROOF TRUSSES 30" O.C.**

**WOOD-FRAMED SKYLIGHTS**

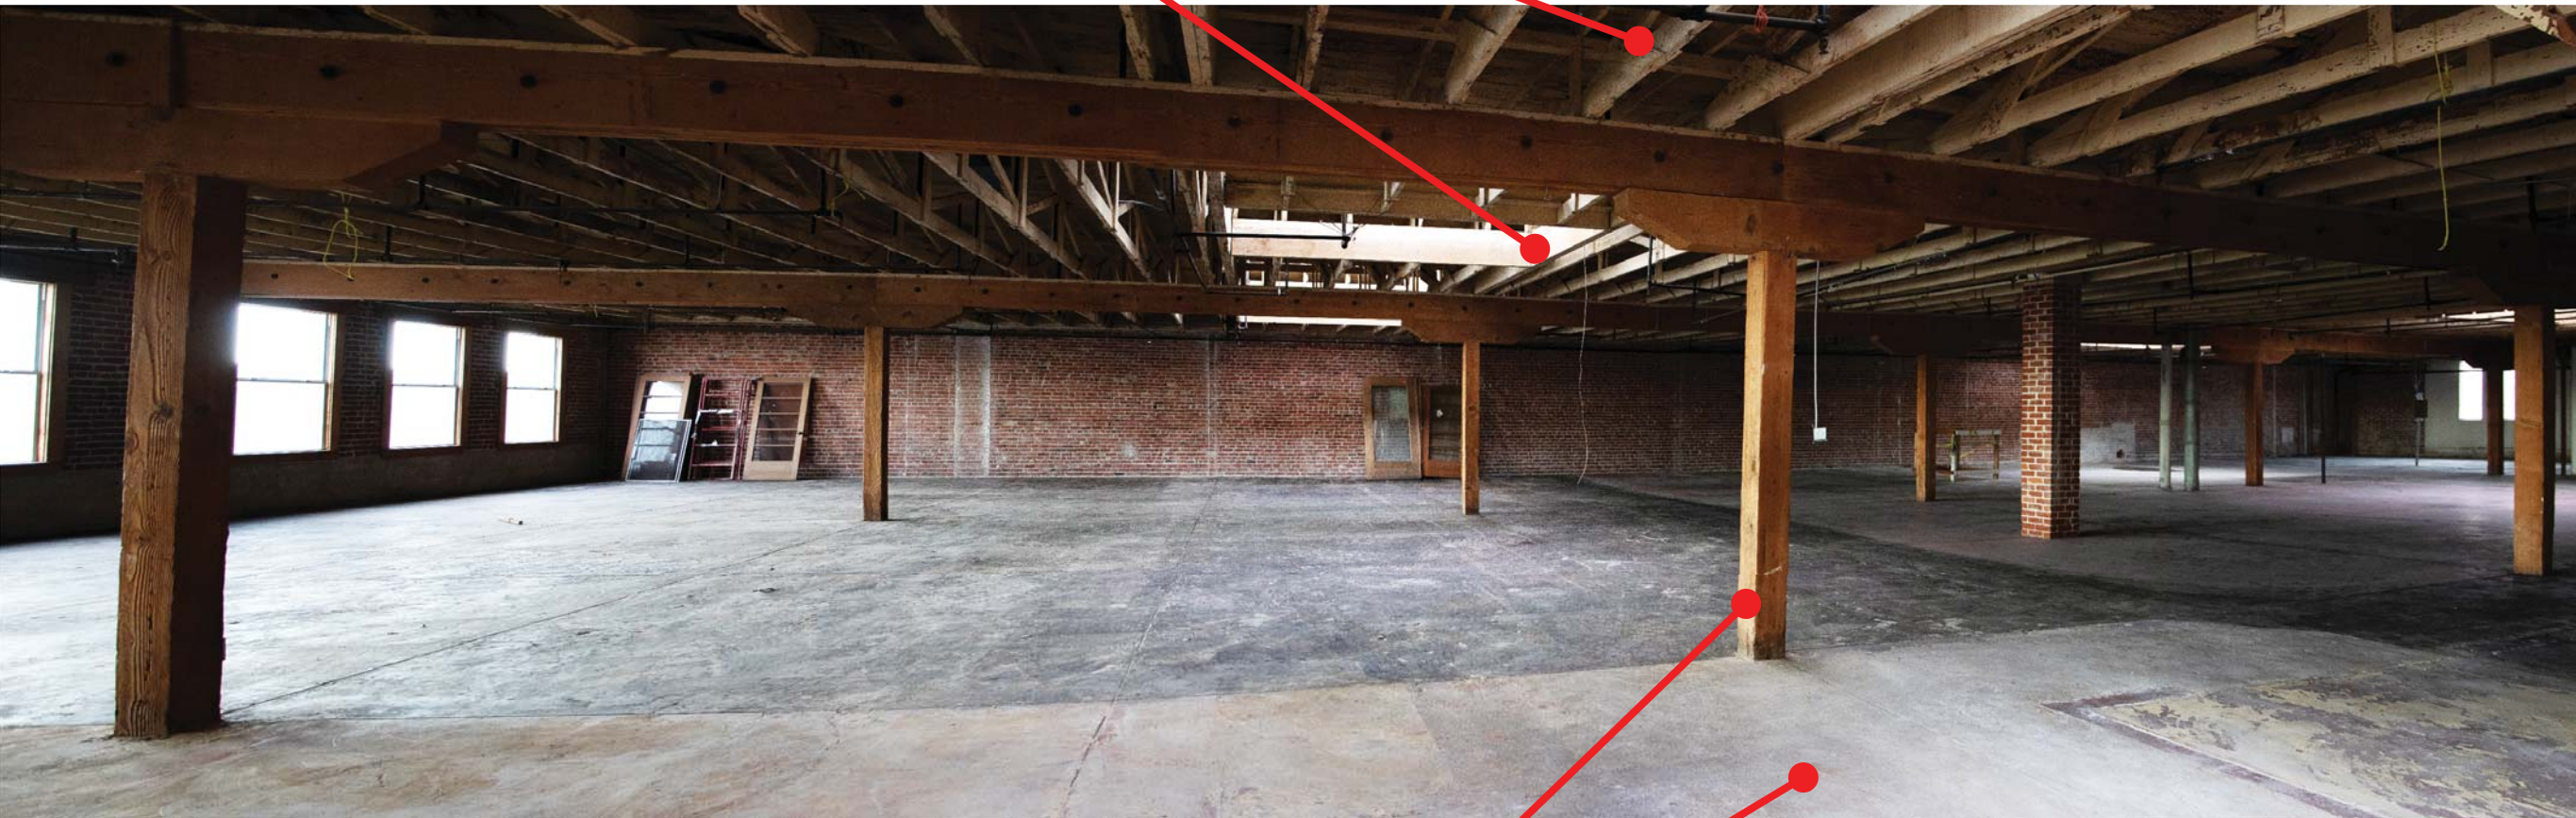
**HEAVY TIMBER COLUMNS + BEAMS**

**CONCRETE FLOOR SLAB**

**RECESSED UPPER WINDOWS**

On the level above, there are nine thin stile, single-hung, single pane aluminum windows, three in each bay. They are set back into the façade about 12” from the front, creating depth and shadow lines throughout the day. At one time, they were believed to have been a sturdier double-hung window, although original images were not included in the surveys or available in public records. The design team is proposing to replace these upper windows

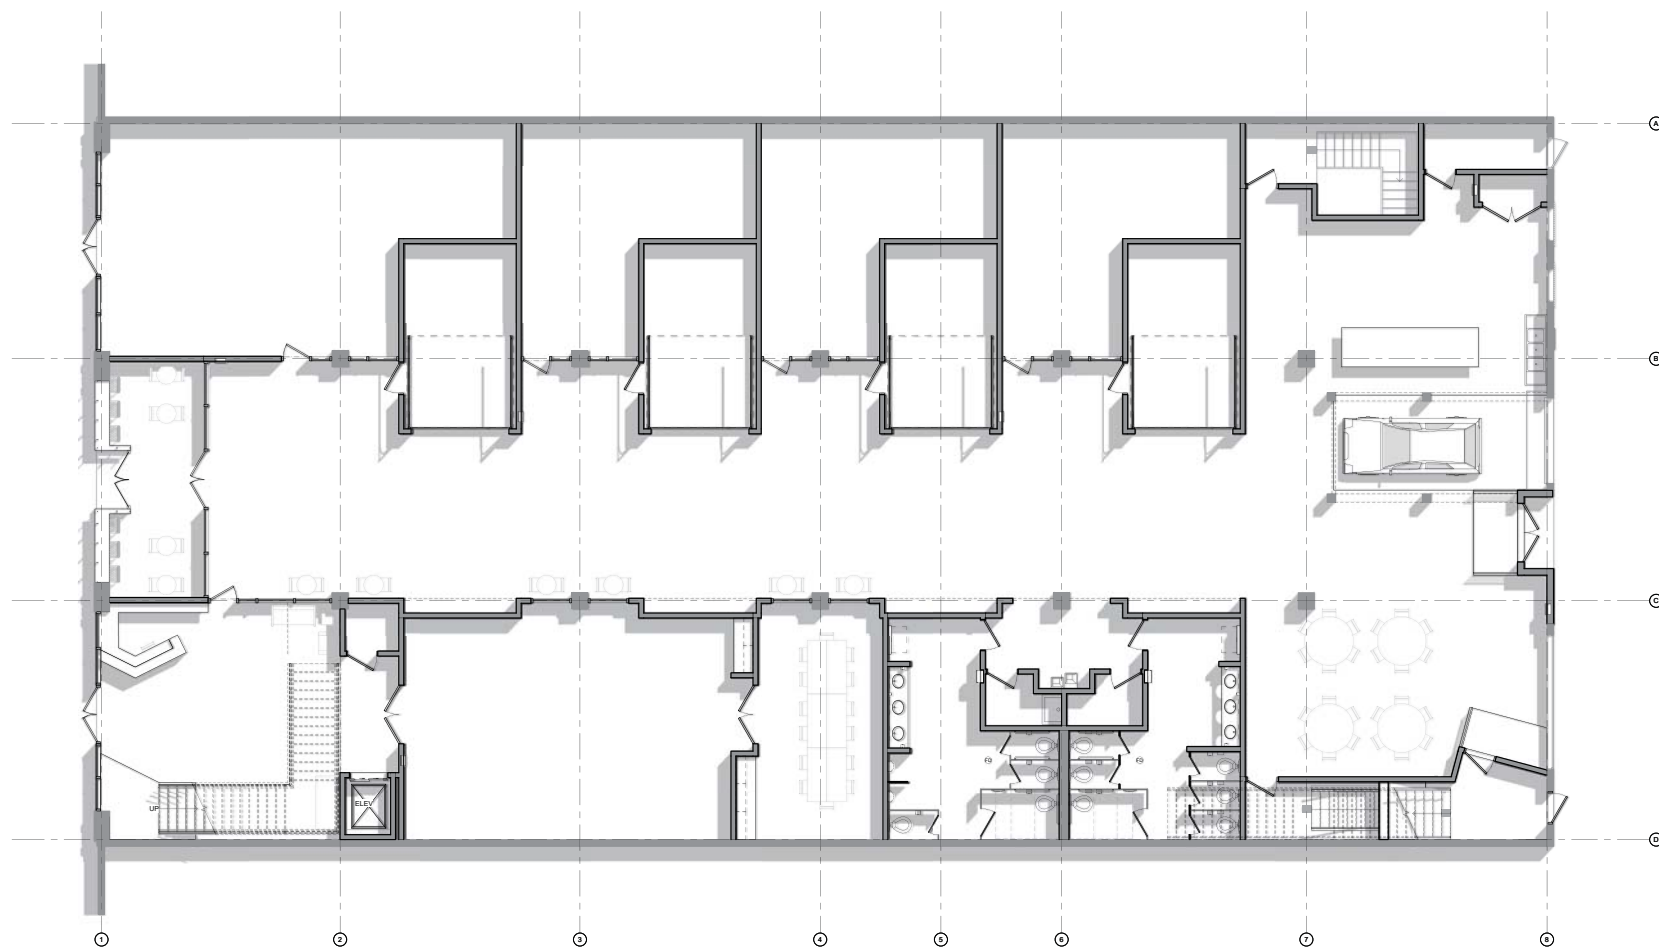
FIRST FLOOR PLAN

- 10,900 sf total
- 1,949 sf leasable B occupancy
- 4,632 sf leasable A occupancy
- 60% ratio

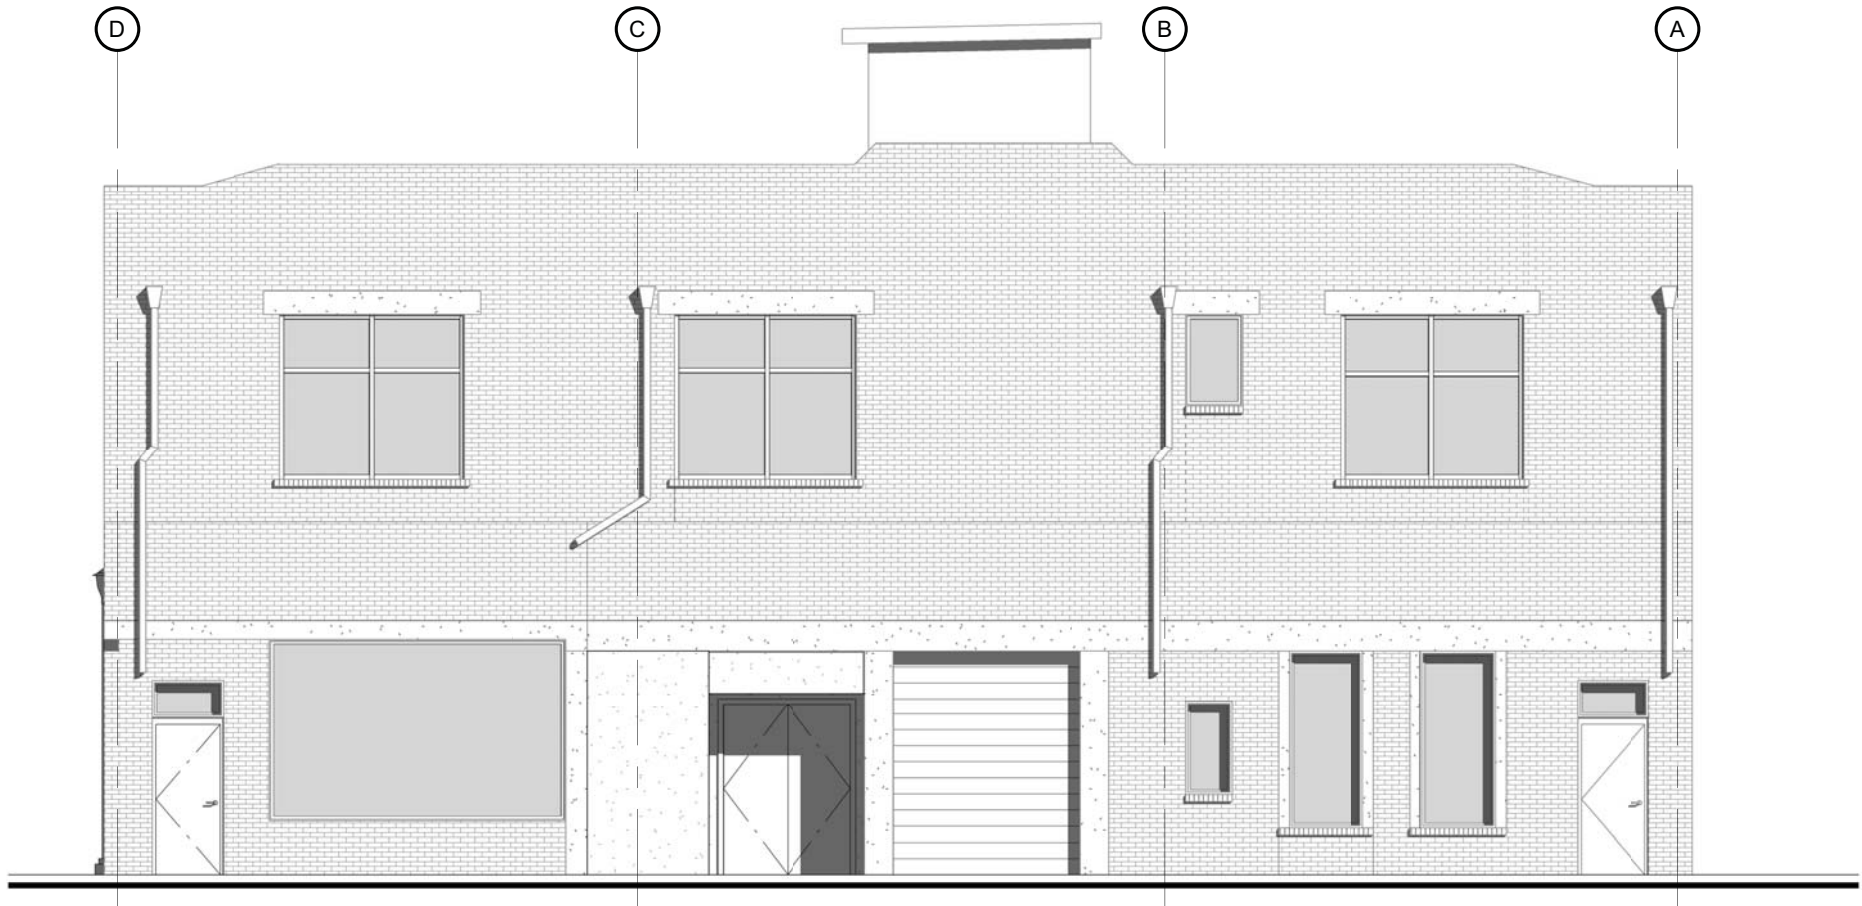
EXISTING TO REMAIN/ BE RESTORED:

BRICKWORK  
CONCRETE HEADERS  
SOME ORIGINAL STEEL WINDOWS  
TRANSOMS  
ROLLUP DOOR

REMOVE:

ROLLUP DOOR  
DIVIDED FIXED WINDOWS/BRICK INFILL  
BOX SIGN

REPLACE WITH:

EXIT DOORS  
FIXED HOLLOW METAL GLAZING
