City of Fresno

Request For Qualifications For U.S. Environmental Protection Agency
Brownfields Revolving Loan Fund Supplemental Grant Consulting Services

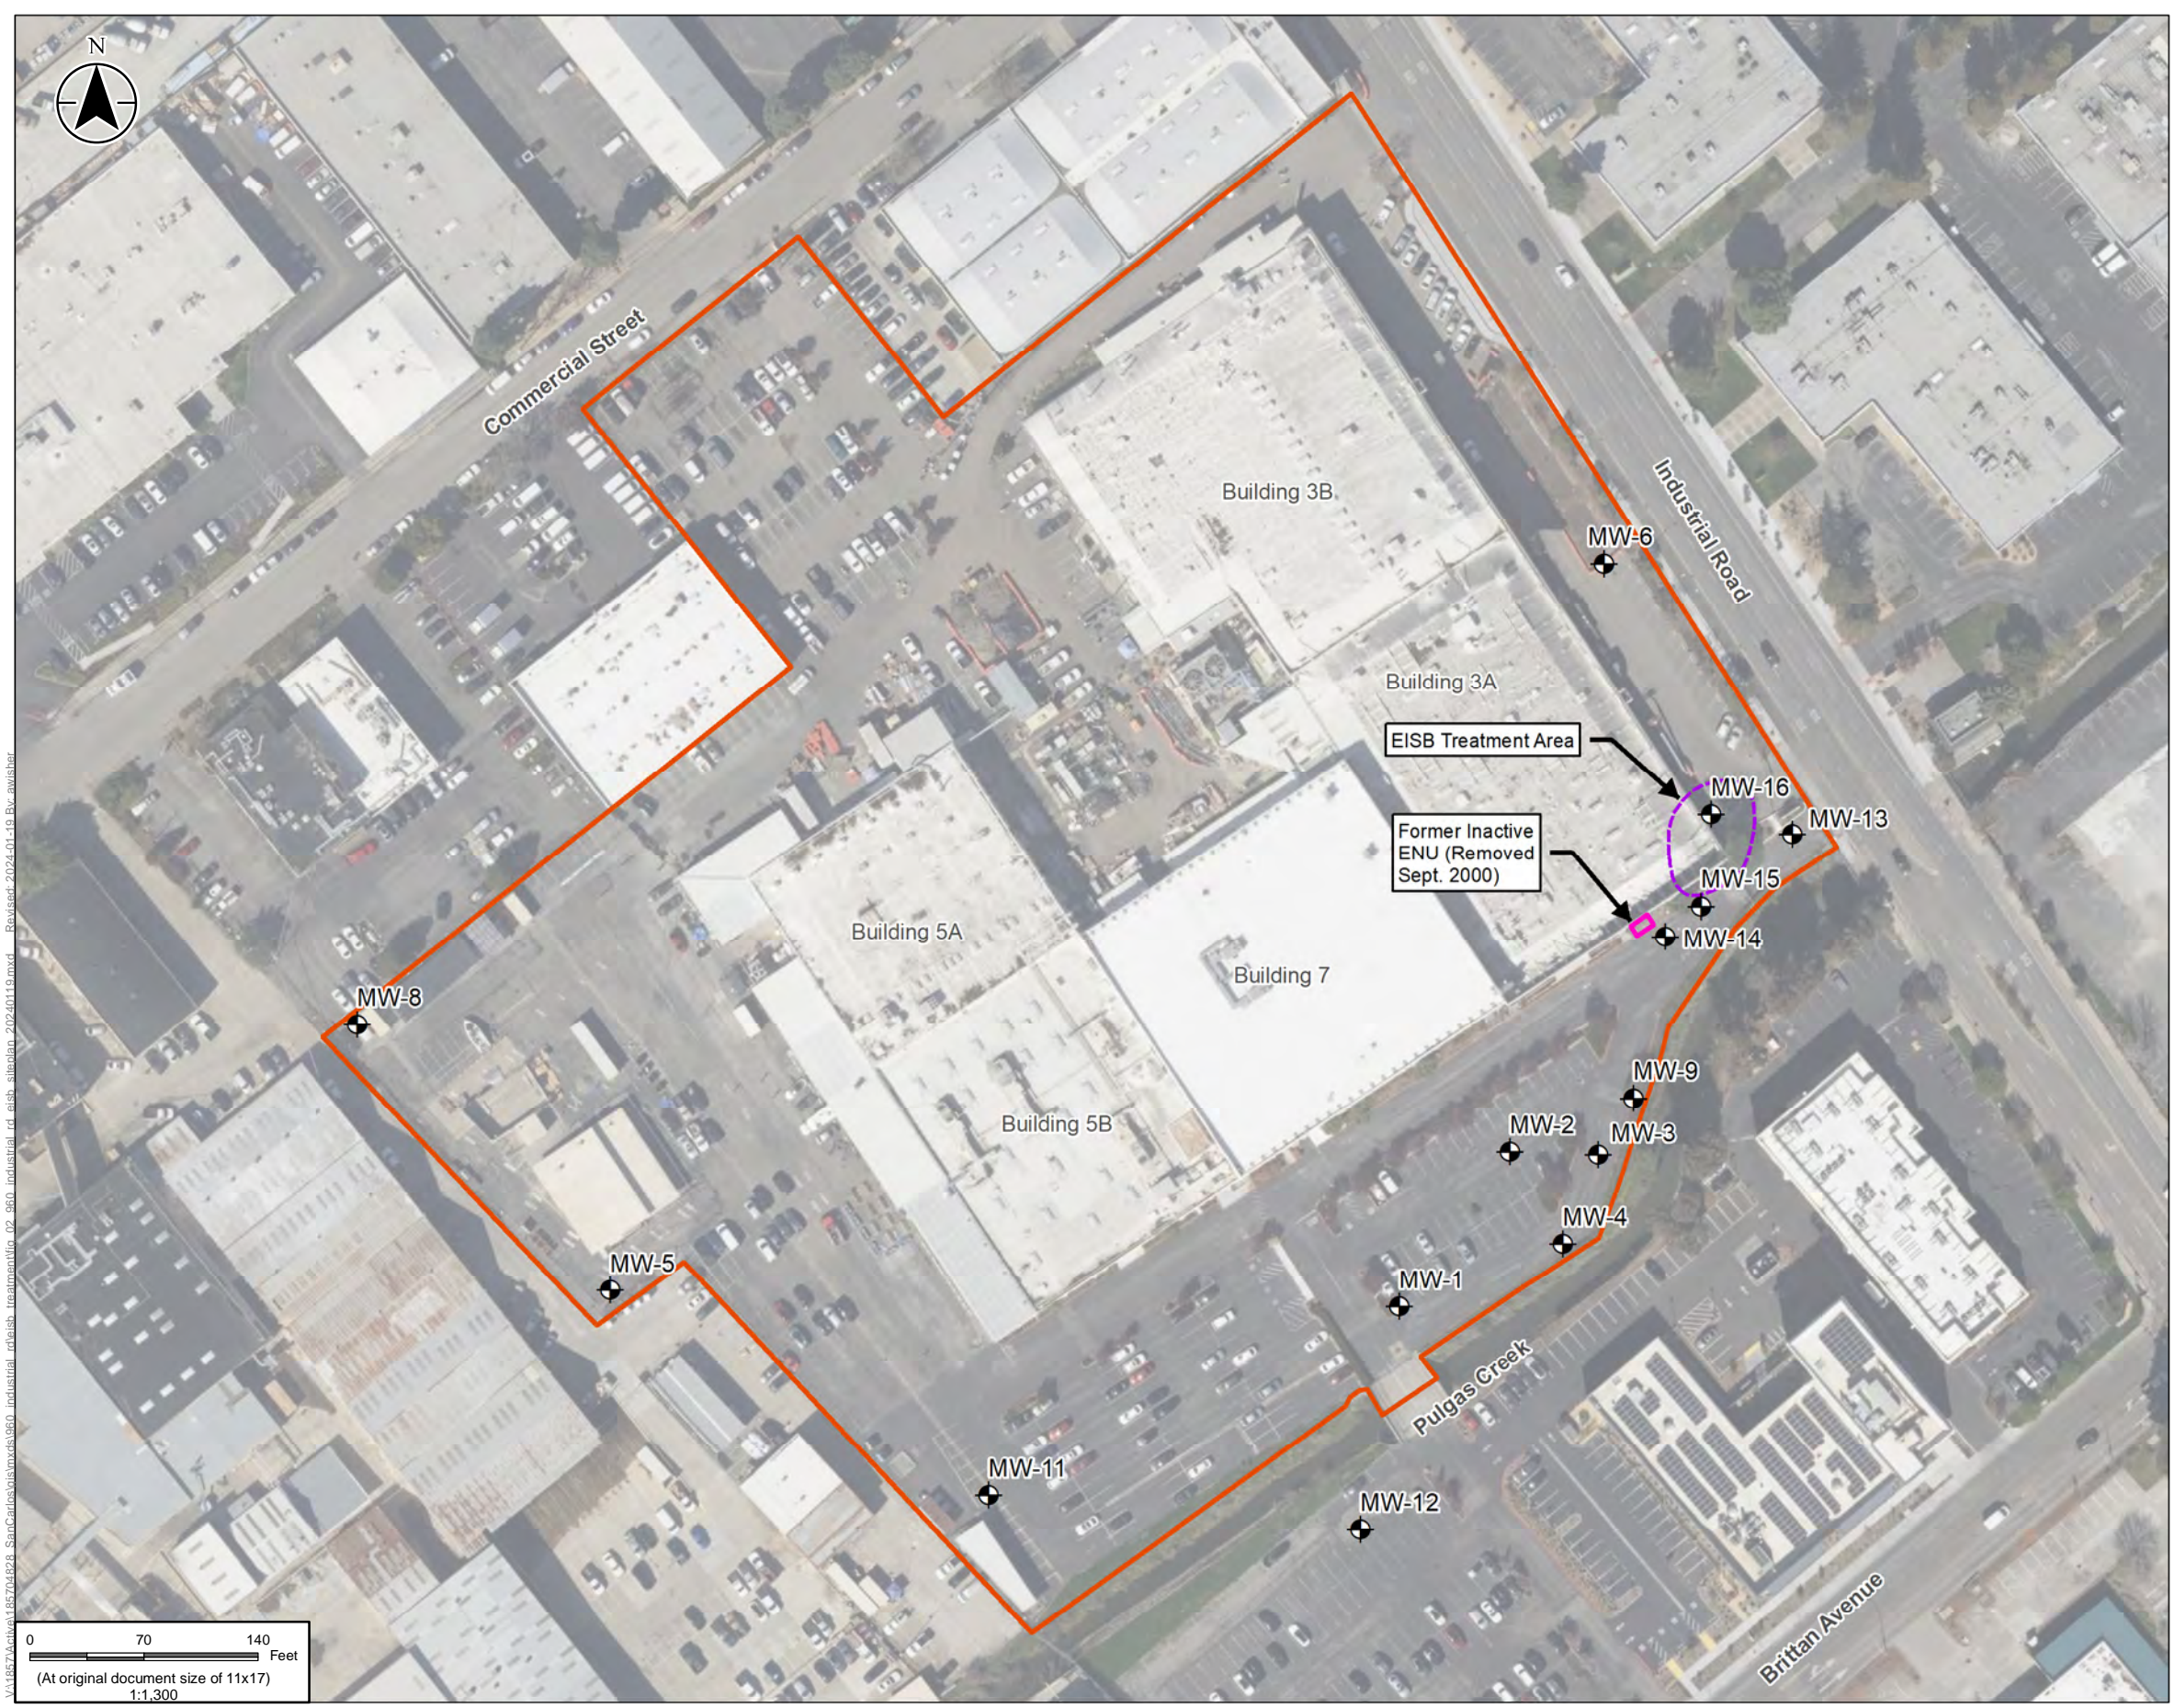
Figure No.
2

Title
Site Plan and EISB Treatment Area
