8 SUPERIOR COURT OF CALIFORNIA

Case No. 21CECG02816

**DECLARATION OF JOHN H. FROST  
IN SUPPORT OF RESPONDENTS'  
OPPOSITION TO CITY OF FRESNO'S  
PETITION FOR APPOINTMENT OF A  
RECEIVER**

**Re: Asbestos Survey**  
**Trails End Mobile Home Park – Space 22**  
**Burned Mobile Home**  
**104 E. Sierra Ave.**  
**Fresno, CA**  
**Job No. S103-21-01**

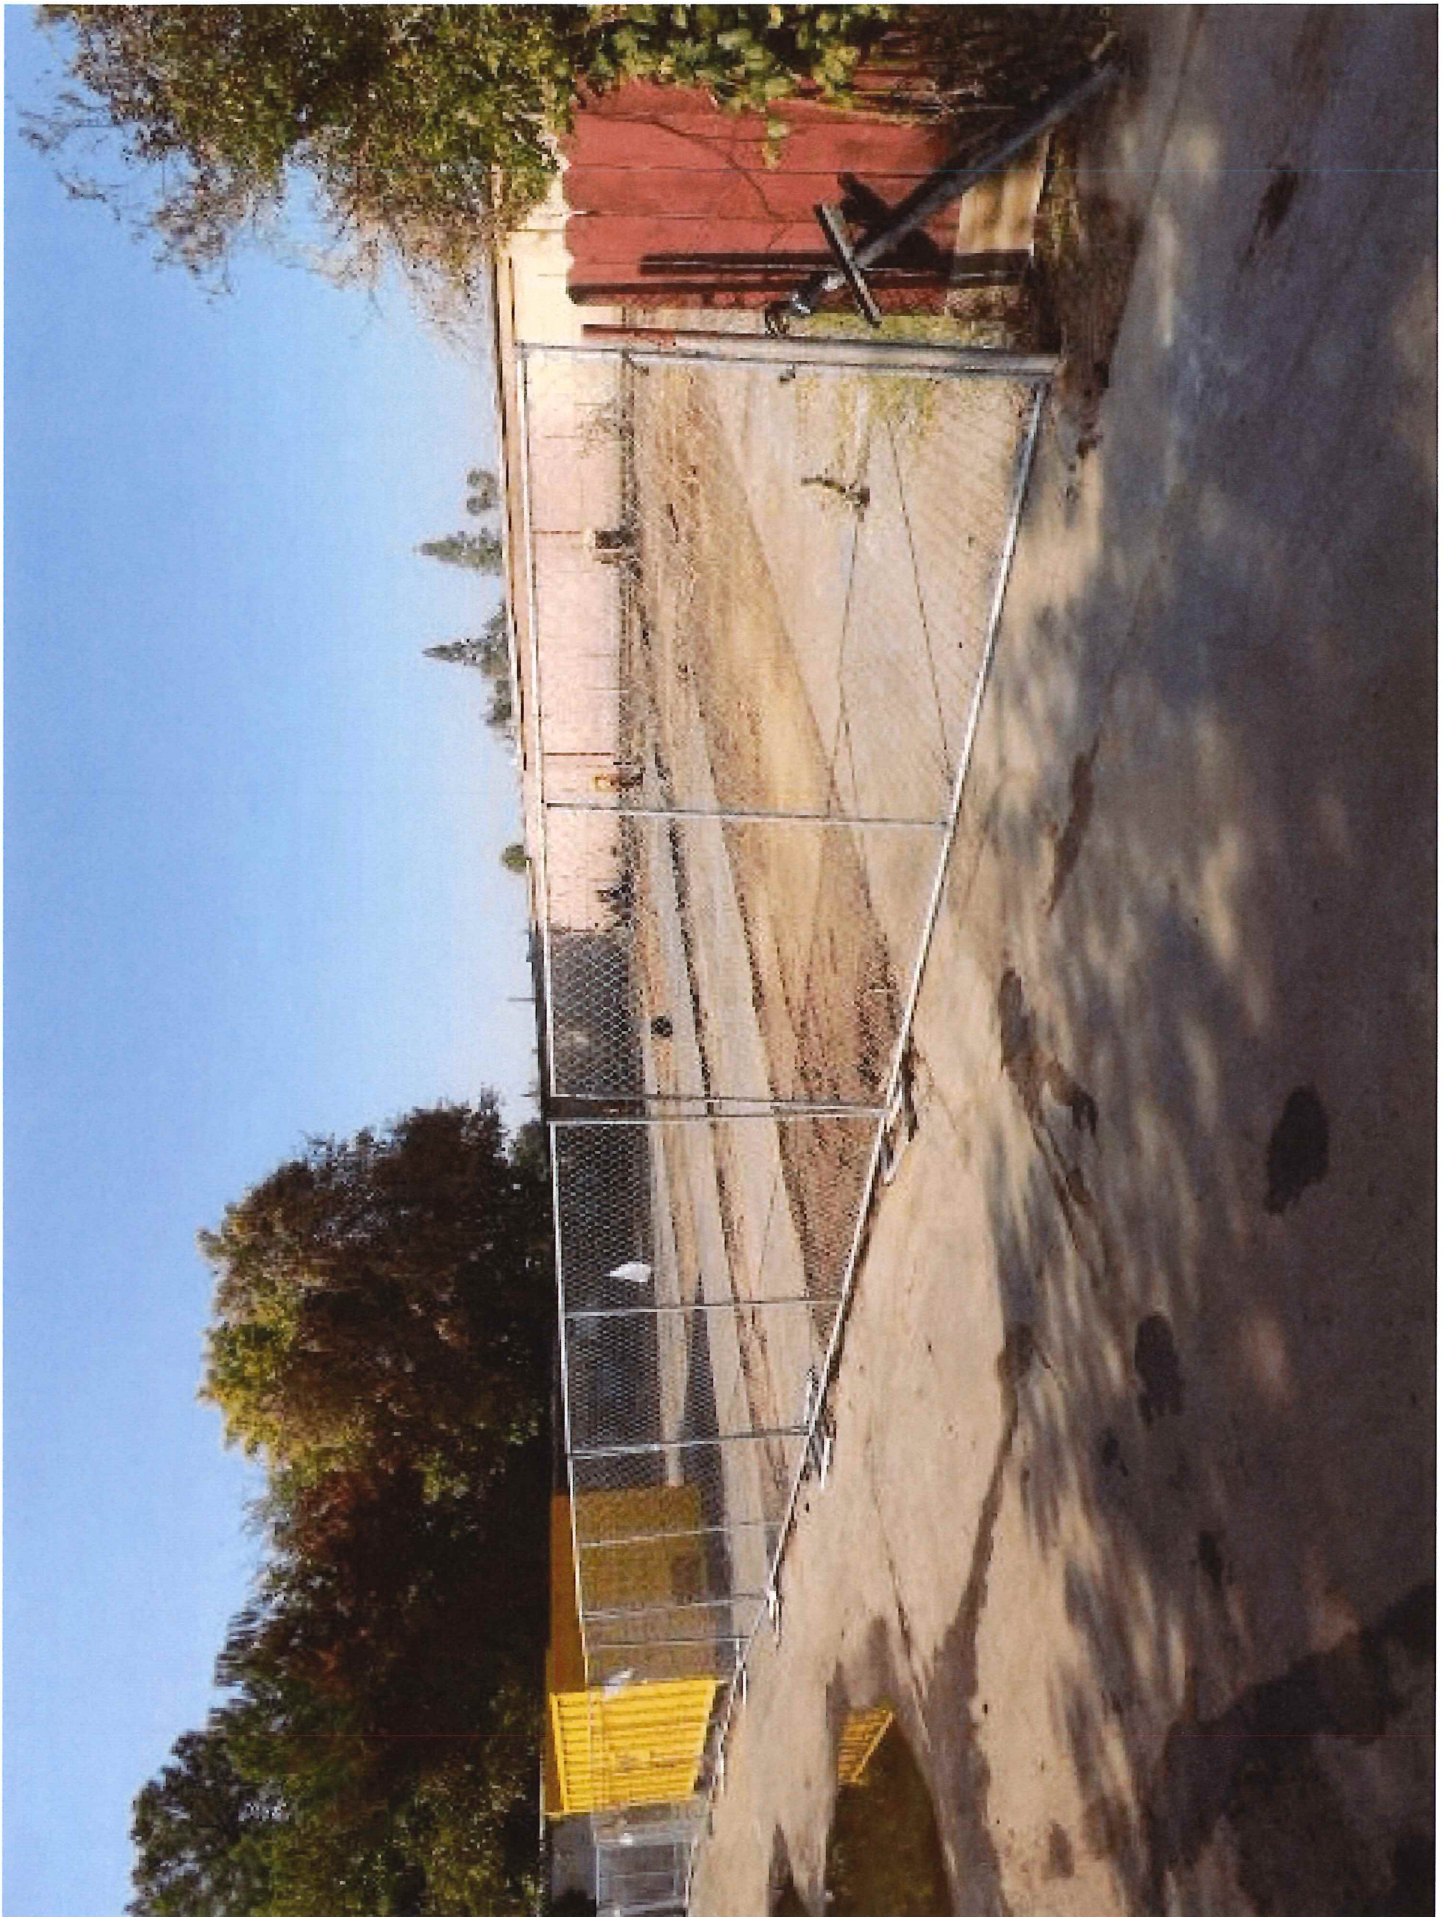
SPACES 22, 23, 24

21 13. Response to Abatement Notice Issue 6. Clear the five mobile homes from the five  
22 fire lots. I solicited cost proposal from Leon Environmental to take asbestos samples at the affected  
23 lots and coordinated the sampling and testing required for potential asbestos abatement of fire  
24 damaged units on lots 22, 23, 24, 27 and 28. The 'approvals' to take asbestos samples at the 1st Fire  
25 were delayed pending approvals from insurance investigators. I directed Leon Environmental to  
26 prepare reports to meet the requirements of the San Joaquin Valley Air Pollution Control District  
27 for permits. I solicited bids from two demolition companies to remove the debris piles, coordinated  
28 the bid award to Bowen Engineering & Environmental. Bowen was responsible for obtaining the

1 demolition permits from the City of Fresno, Air Pollution, and the chain-of-custody of the debris  
2 to the disposal/recycling yards. I coordinated and observed the removal of the five mobile homes  
3 from the affected lots. Copies of the asbestos test reports and photographs of the cleared spaces are  
4 attached hereto as Exhibit C.

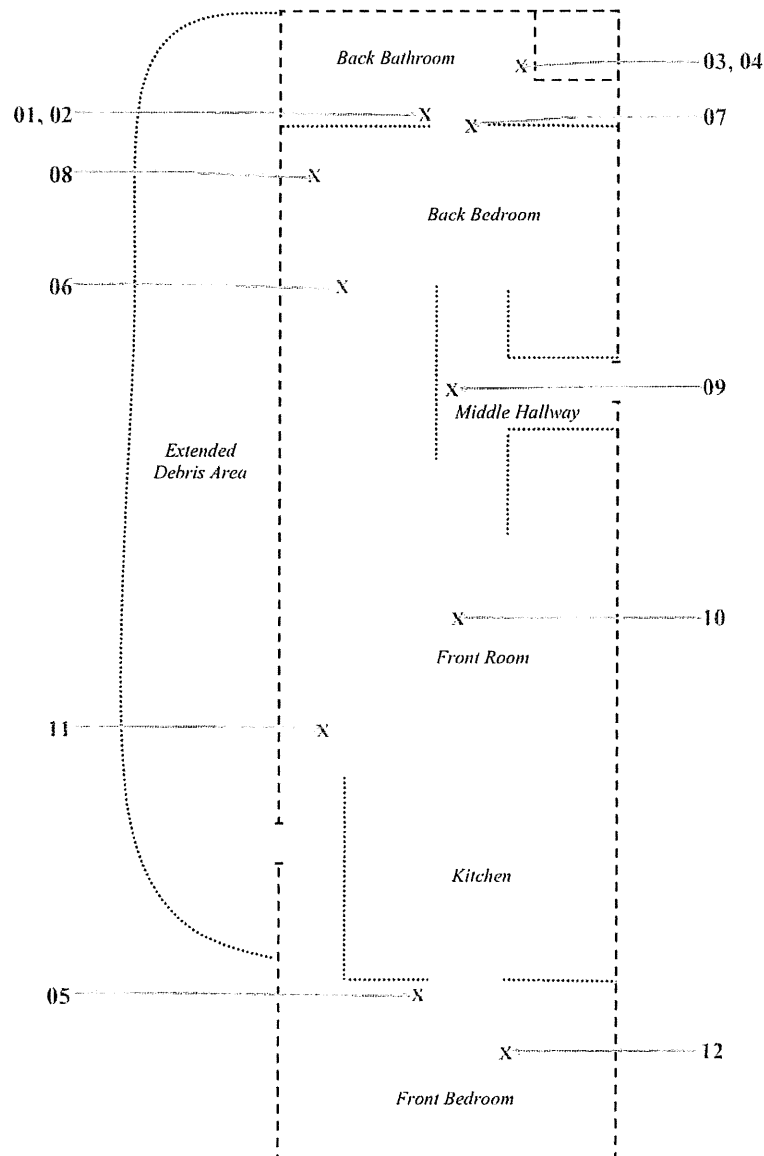
Trails End Mobile Home Park - Demo Burned Mobile Home / 104 E. Sierra Avenue, Space 22, Fresno, CA

An asbestos survey was performed on **September 21, 2021** at **104 E. Sierra Ave, Fresno, CA, Space #22, Fresno, CA**. The mobile home is approximately 40-50 years old and the debris area was approximately 800sqft. It was severely burned by a local fire. The original construction had a wood floor, metal exterior walls and a metal roof. The burned debris pile that is left at the site had few recognizable building materials. The building materials identified were flooring materials, sheetrock with associated joint compound and texture . At the time of the survey the site was accessible.

Sample	Location	Material	% Of ACM	Friable	Sq. Ft.
01	Back Bathroom Wall	Joint Compound	ND		
02	Back Bathroom Wall	Sheetrock	ND		
03	Back Bathroom Wall	Joint Compound	ND		
04	Back Bathroom Wall	Sheetrock	ND		
05	Front Bedroom Wall	Sheetrock	ND		
06	Back Bedroom Floor	12x12 Floor Tile	ND		
07	Back Bedroom Floor	Flooring Material	ND		
08	Back Bedroom Area	Burn Debris	ND		
09	Middle Hall Area	Burn Debris	ND		
10	Front Room Area	Burn Debris	ND

11	Entry Area	Burn Debris	ND		
12	Front Bedroom Area	Burn Debris	ND

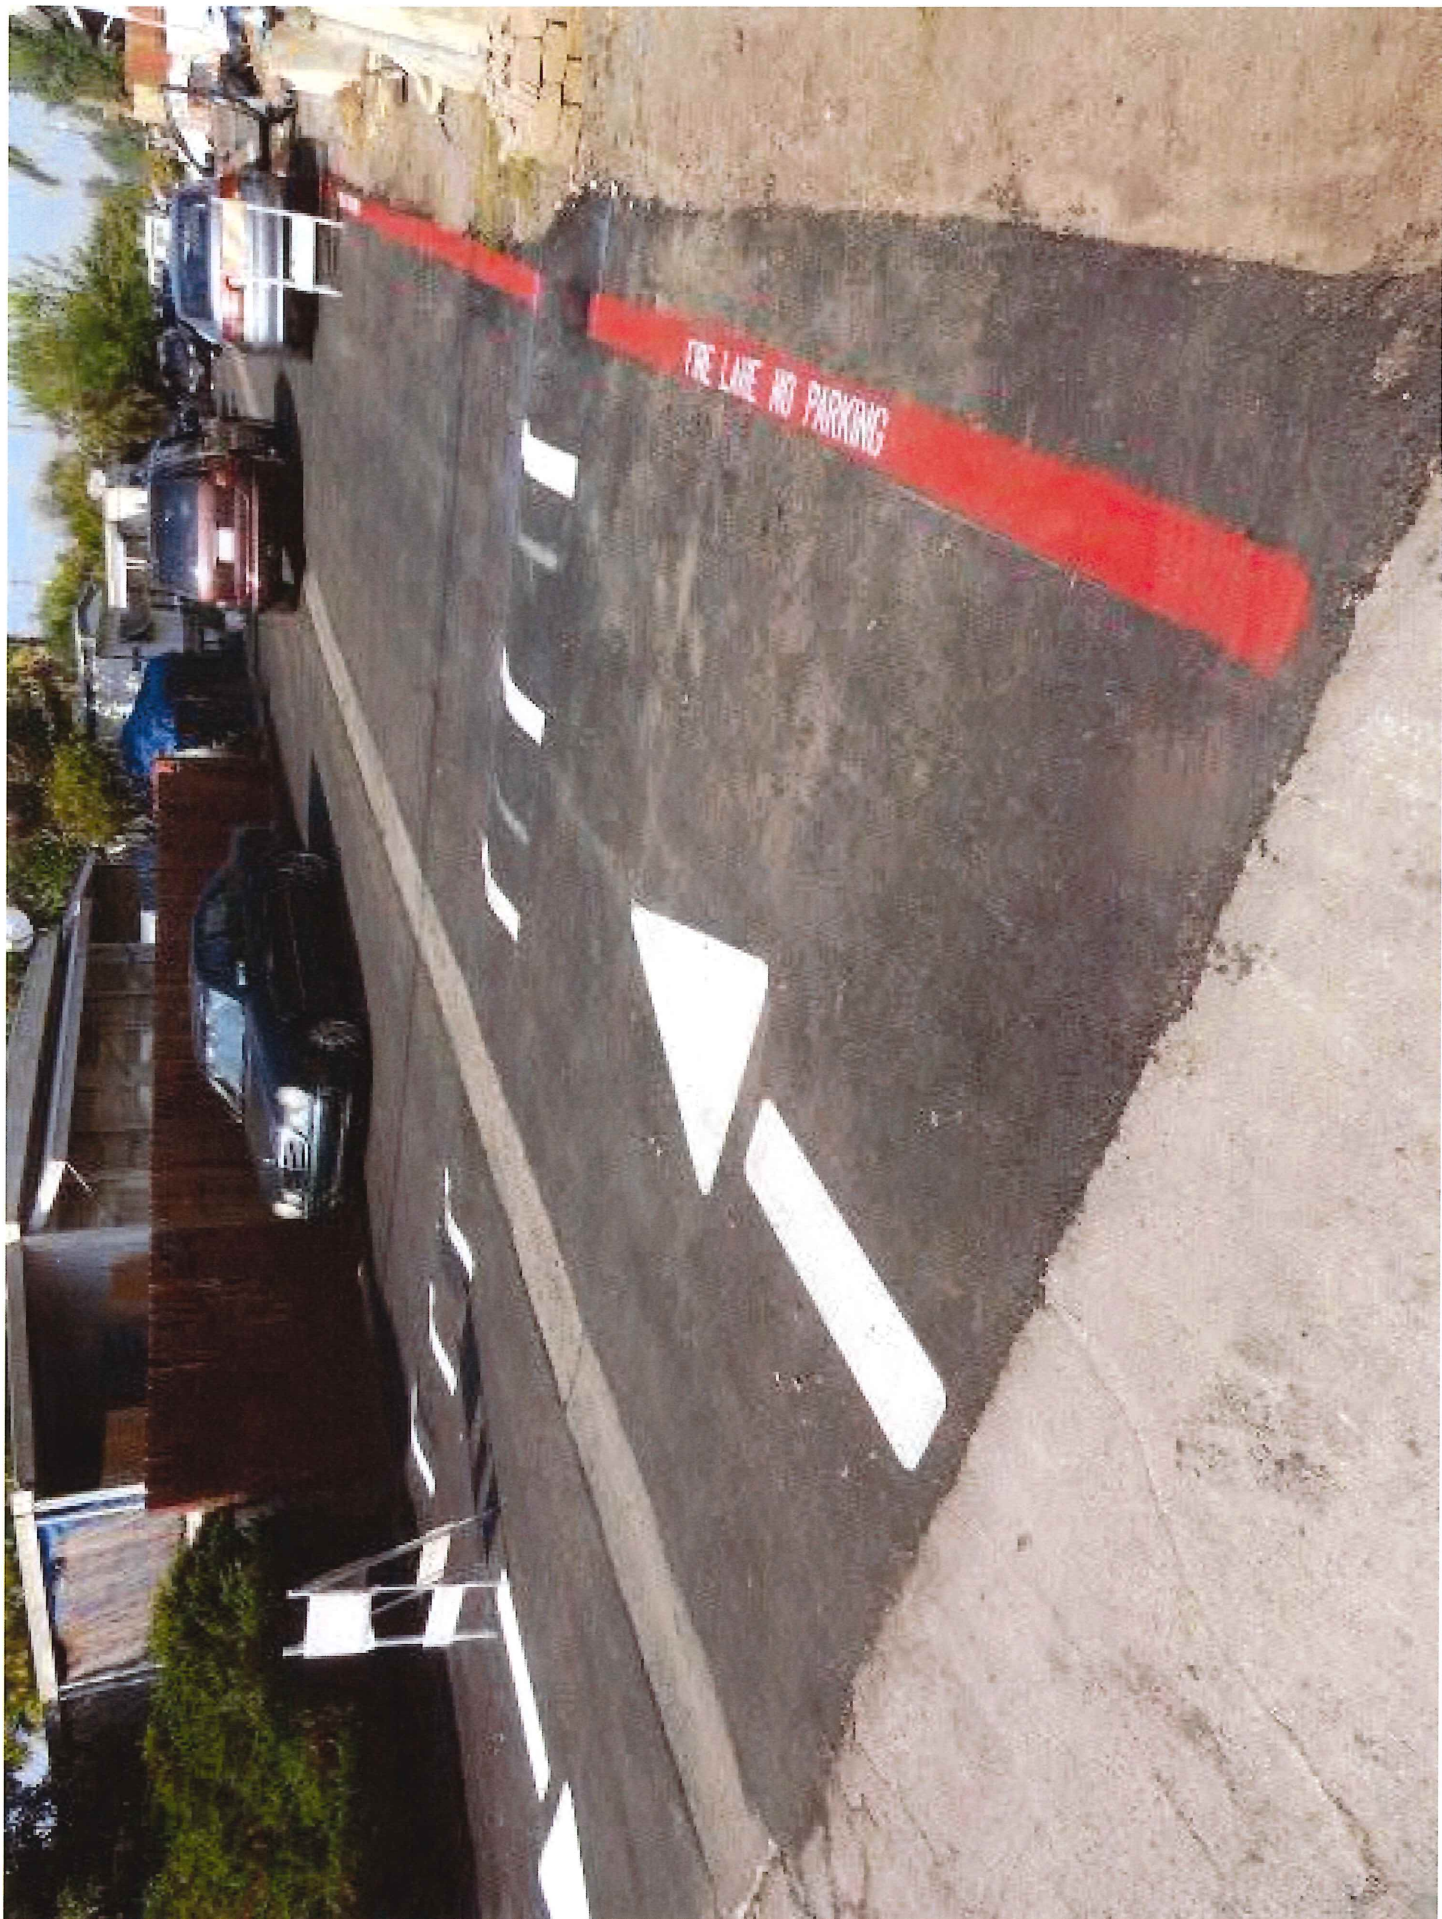
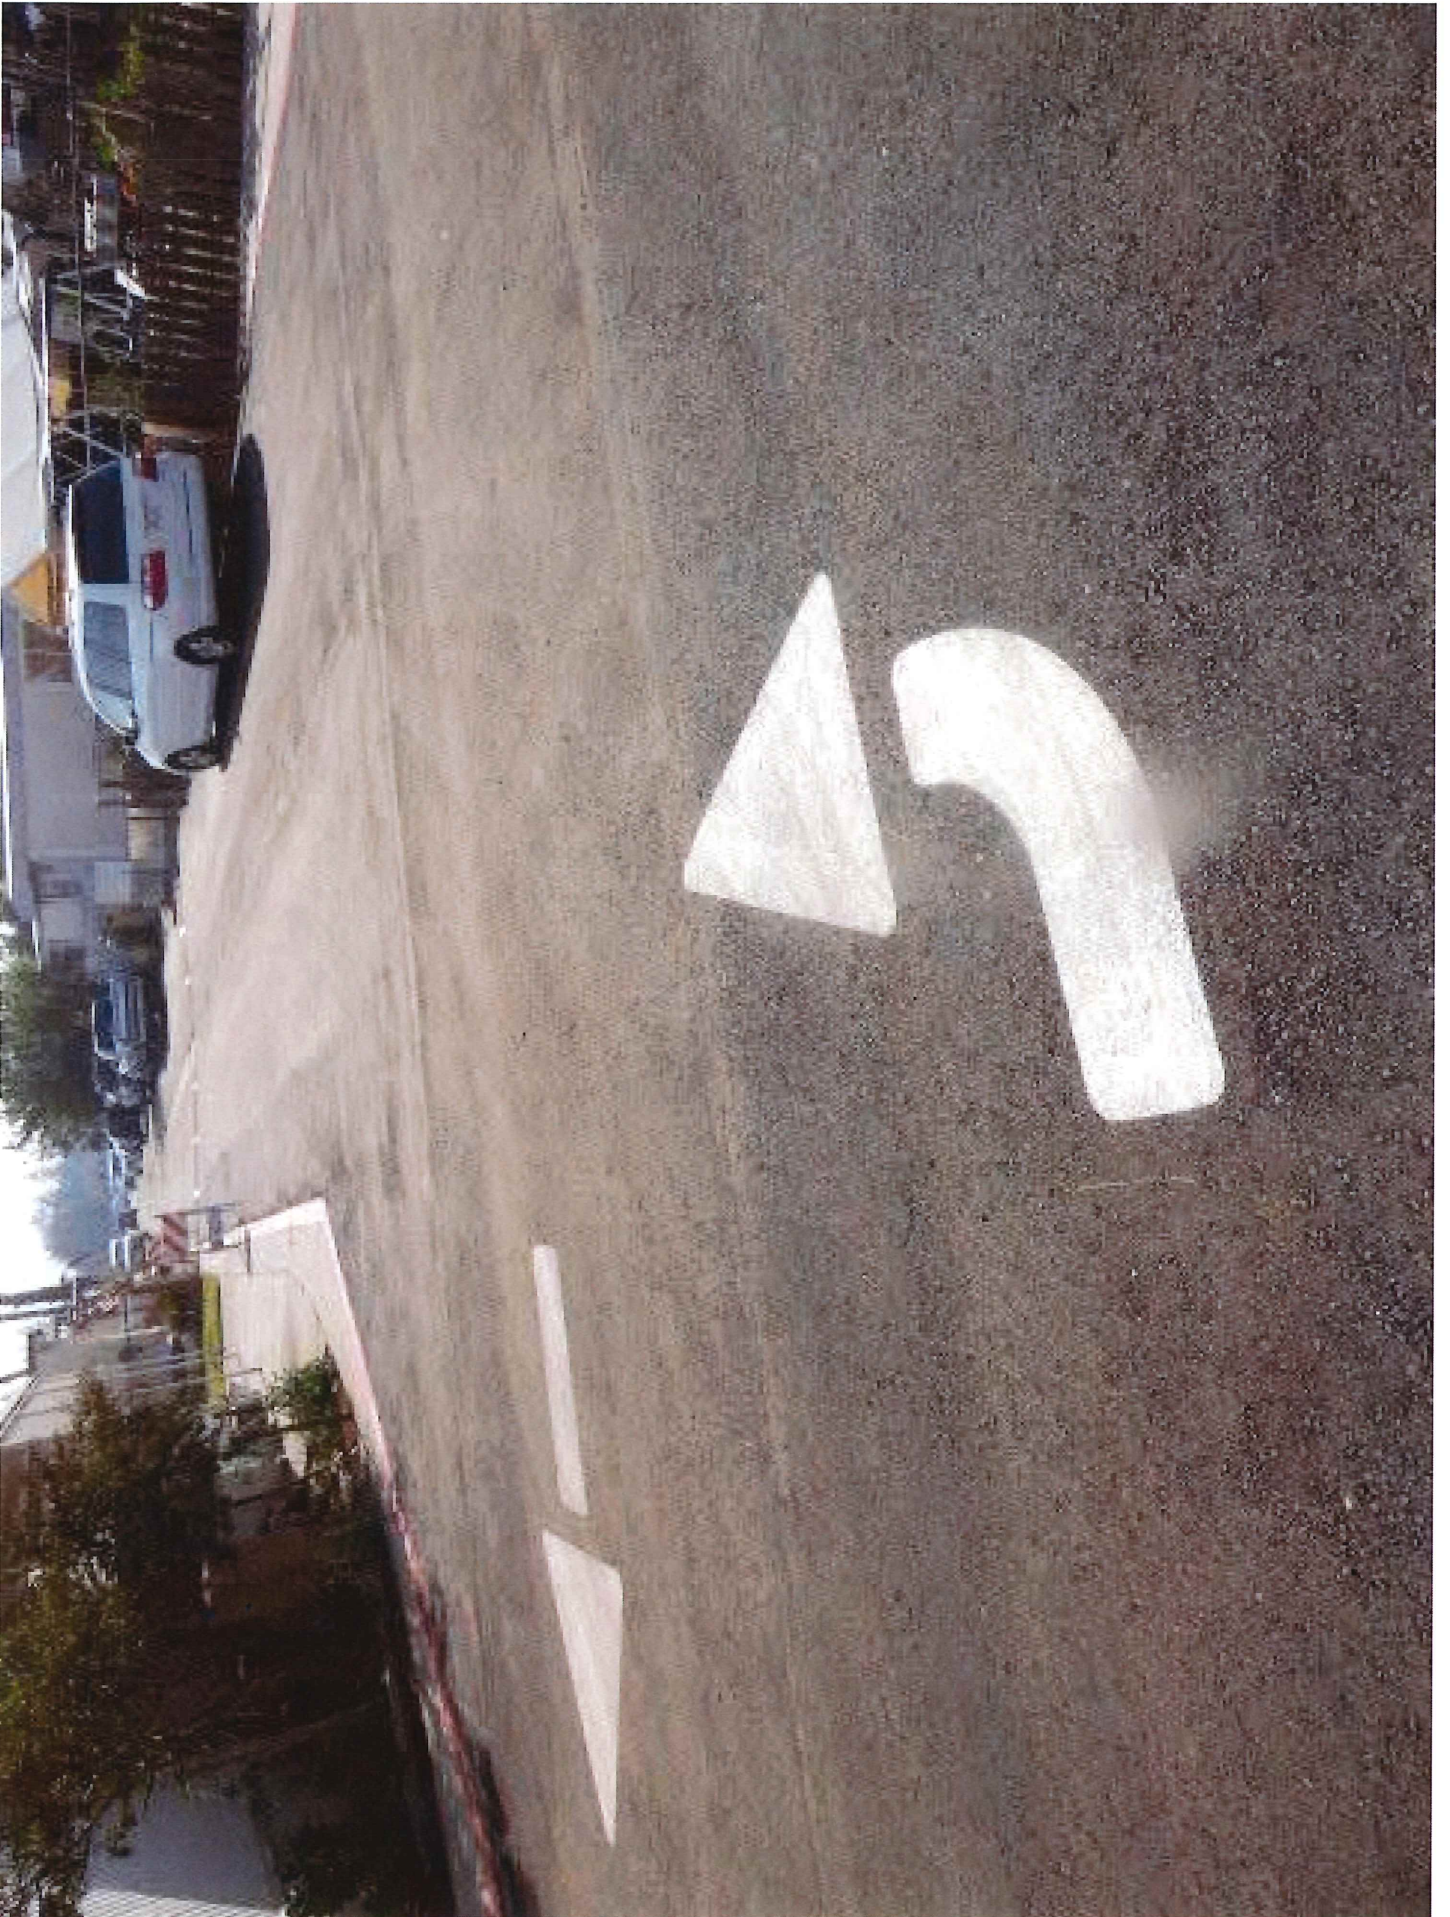
# **EXHIBIT D**

5 14. Response to Abatement Notice Issue 7. Roadways are damaged and deteriorated. I  
6 observed the various deteriorated conditions of the asphaltic pavement in the driveways throughout  
7 the Mobile Home Park, and advised the owners of the options to repair or replace the asphaltic  
8 concrete pavement. The park owner selected the repair option to help remedy the condition of the  
9 deteriorated asphaltic pavement (in part because replacement would have required engineered  
10 plans, plan check, back check, permits, inspections, As-graded plans, and a significant time delay).  
11 I negotiated the asphalt repair work with Asphalt Technology, Inc. The scope-of-work for the  
12 asphalt repairs was divided into four (4) Phases for the following reasons: 1) Trails End is occupied  
13 and repairing all the asphalt drives would significantly disrupt resident's daytime & overnight  
14 parking opportunities; 2) Much of the subgrade in the 4th Phase is remains saturated with water

15 from the leaking mobile home in Space 15B (which is plumbed with purportedly unrepairable  
16 polypropylene pressurized water lines); 3) Equipment used during the demolition process for lots  
17 22, 23, 24, 27 and 28 included several excavators (with caterpillar tracks) and roll-off bins that  
18 would have damaged new asphaltic pavement repairs. I directed the asphalt repairs in the 1st Phase  
19 (i.e. the west driveway and 25% of the north driveway). Photographs of the completed paving work  
20 are attached hereto as Exhibit D.

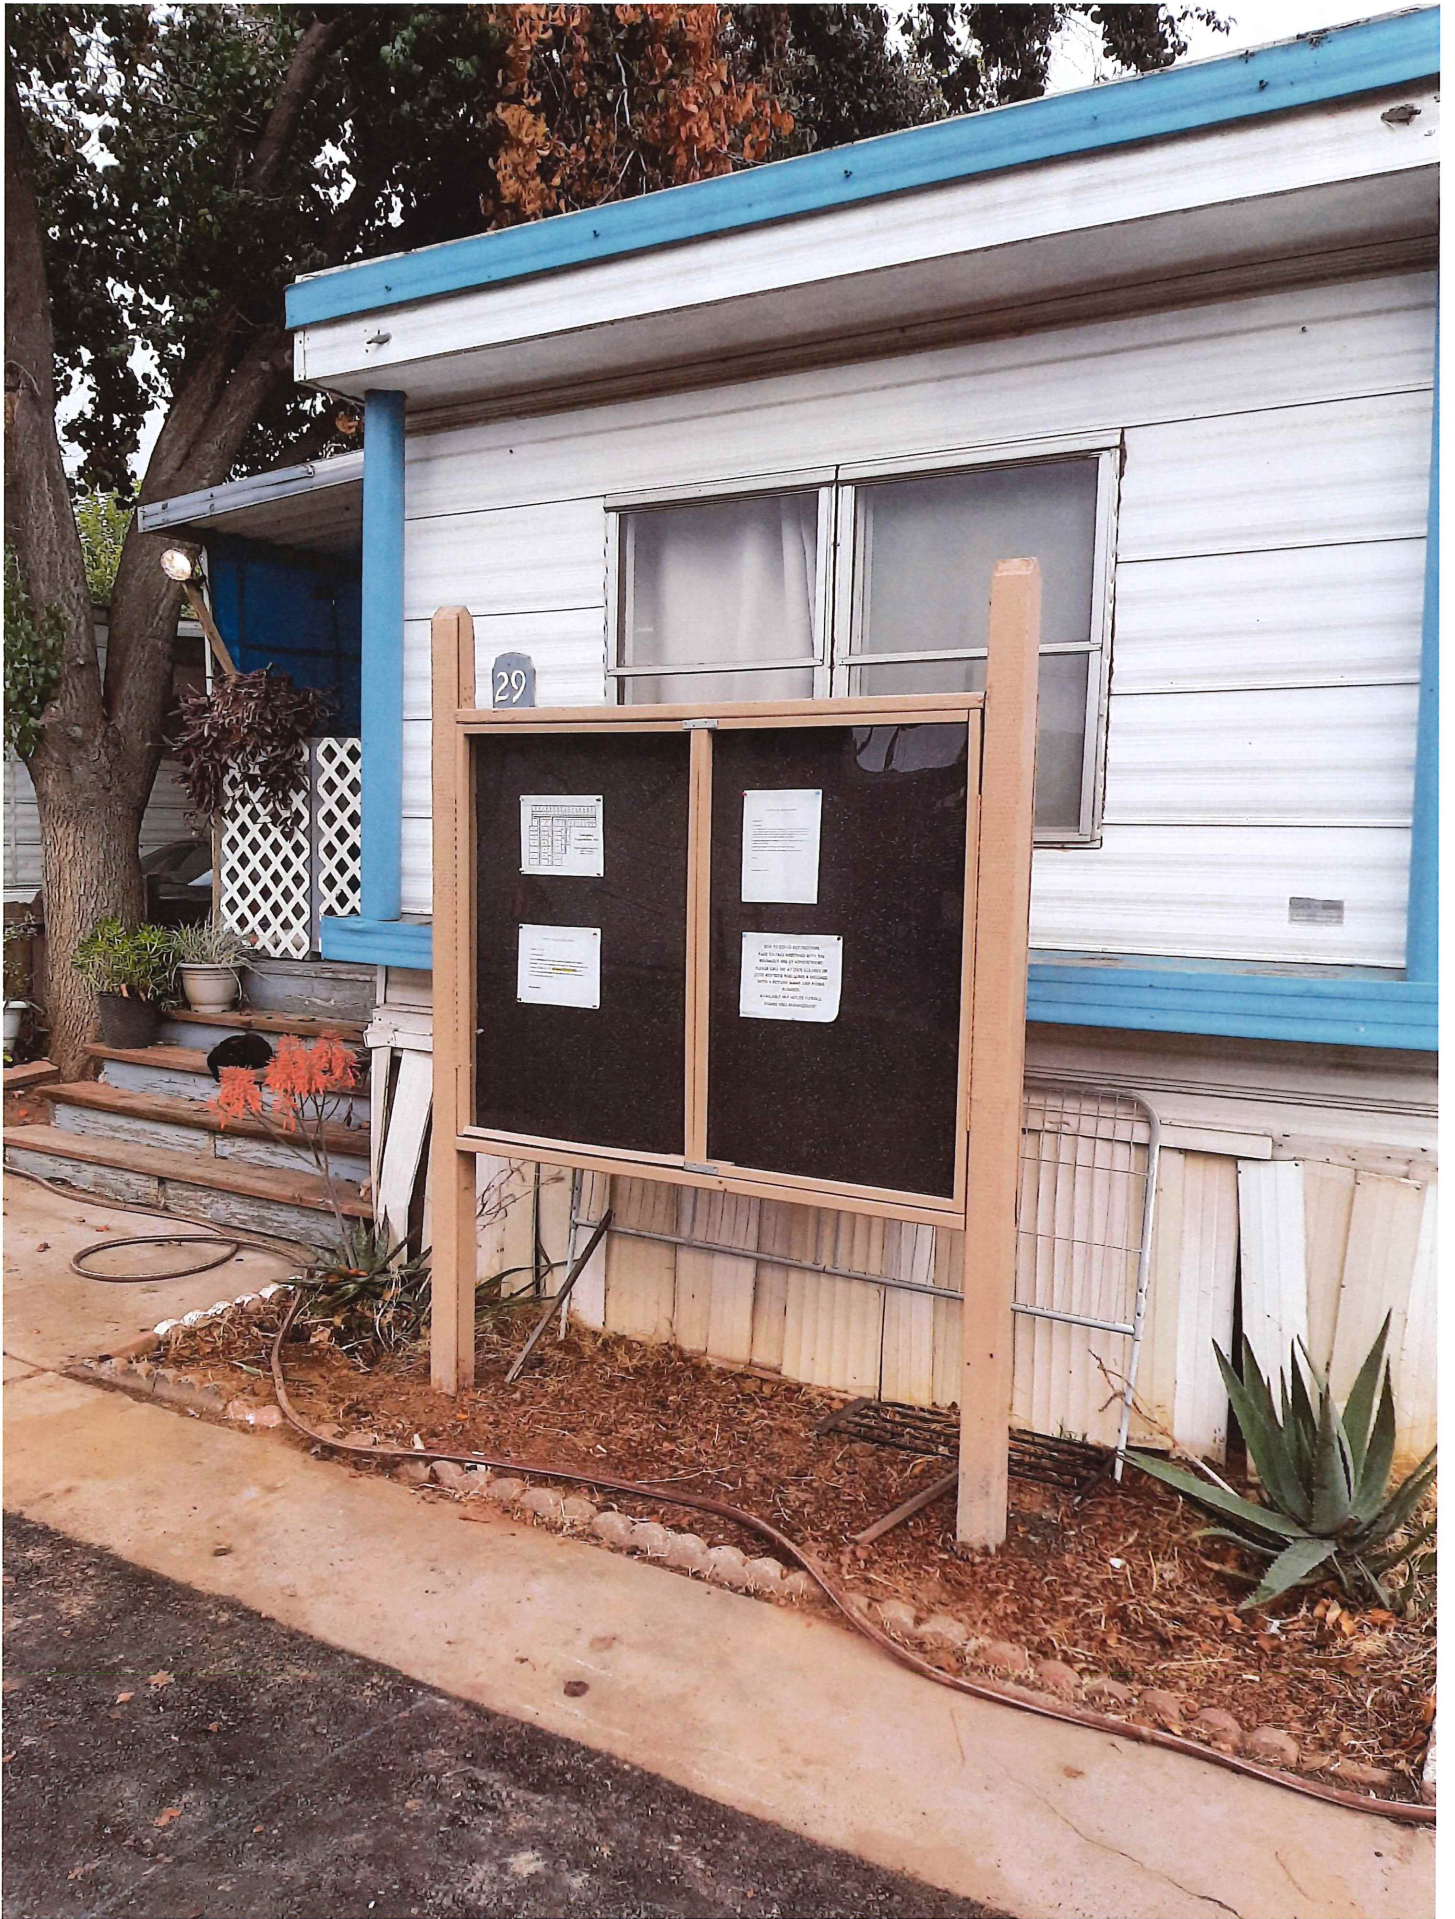
# **EXHIBIT E**

21 15. Response to Abatement Notice Issue 8. Post the Emergency Preparedness Plan  
22 and a notice of where one can obtain a copy of the plan. At the direction of the Respondents, I  
23 assisted Gilbert Delarosa, the Trails End Mobile Home Park Manager, and observed his completing  
24 that project. Photographs of the emergency plan and posting are attached hereto as Exhibit E.
