**REPORT TO THE HISTORIC  
PRESERVATION COMMISSION**

AGENDA ITEM NO. VIB  
HPC MEETING: 06/27/2016

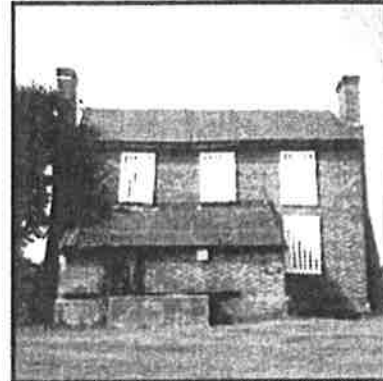
**A NOTE TO OUR USERS:** The web versions of the **Preservation Briefs** differ somewhat from the printed versions. Many illustrations are new, captions are simplified, illustrations are typically in color rather than black and white, and some complex charts have been omitted.

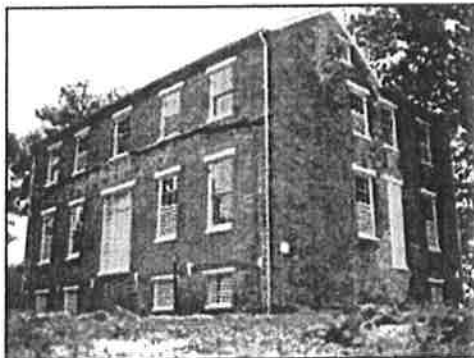
This building has been successfully mothballed for 10 years because the roof and walls were repaired and structurally stabilized, ventilation louvers added, and the property maintained. Photo: NPS files.

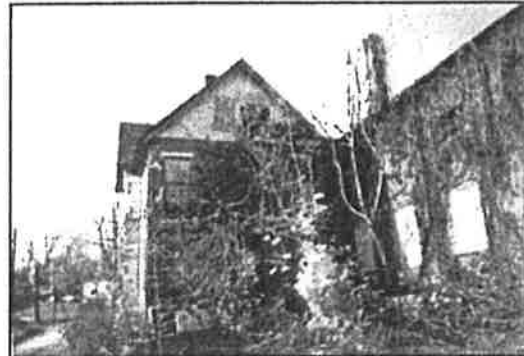
Boarding up without adequate ventilation and maintenance has accelerated deterioration of this property. Photo: NPS files.

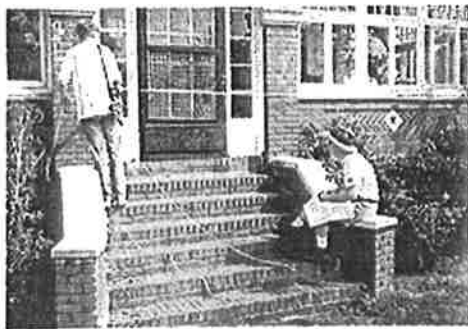
Documenting a building's history and assessing its condition provide information to set priorities for stabilization and repair, prior to mothballing. Photo: NPS files.

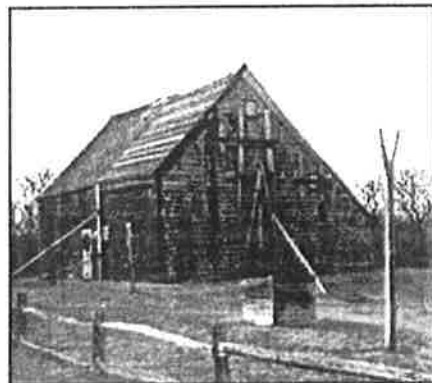
**Buildings seriously damaged by storms or deterioration may need to be braced before architectural evaluations can be made. Photo: John Milner Architects. Photo: NPS files**

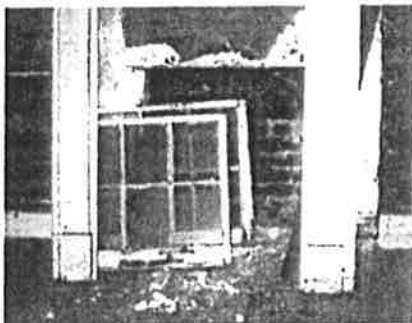
Loose or detached elements should be identified, tagged and stored, preferably on site. Photo: NPS files

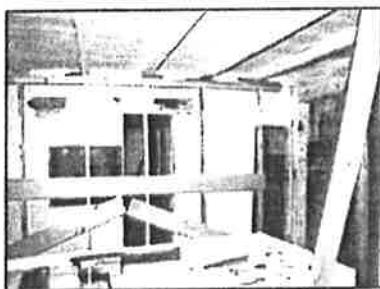
Interior bracing which will last the duration of the mothballing will protect weakened structural members. Photo: John Milner Architects.

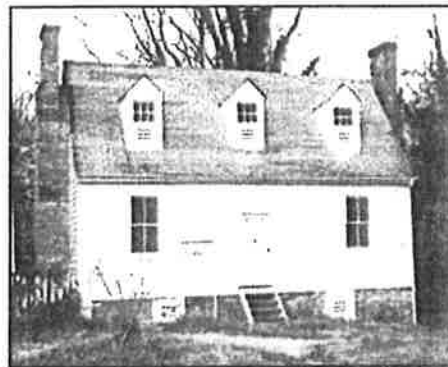
Regrading has protected this masonry foundation wall from excessive damp during its 10-year mothballing. Note the attic and basement vents, temporary stairs, and interpretive sign. Photo: NPS files.

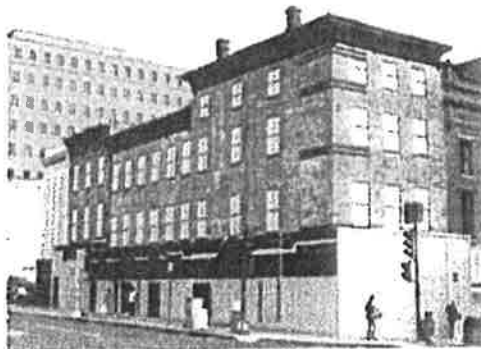
Urban buildings often need additional protection from unwanted entry and graffiti. This commercial building uses painted plywood panels to cover its glass storefronts. The upper windows on the street sides have been painted to resemble 19th century sash. Photo: NPS files.

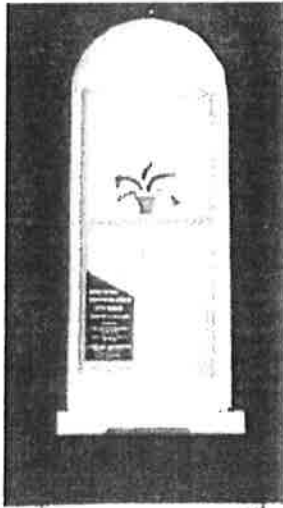
This painted trompe l'oeil scene on plywood panels is a neighborhood-friendly device. Photo: NPS files.

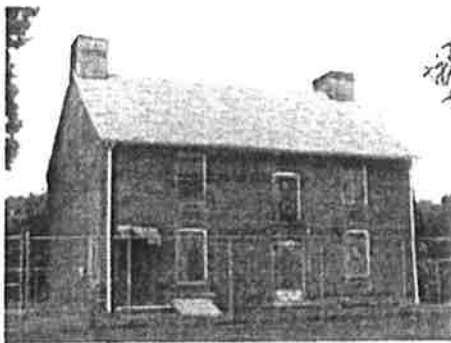
A view showing the exterior of the Brearley House, New Jersey, in its mothballed condition. Photo: Michael Mills, Ford Farewell Mills Gatsch, Architects.

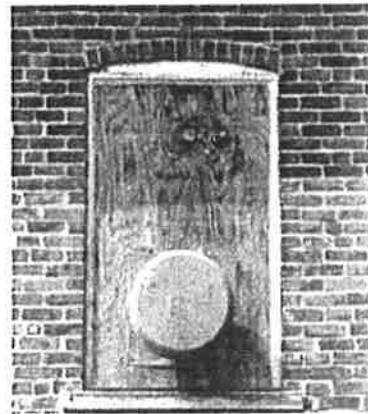
This exhaust fan has tamper-proof housing. Photo: Michael Mills, Ford Farewell Mills Gatsch, Architects.

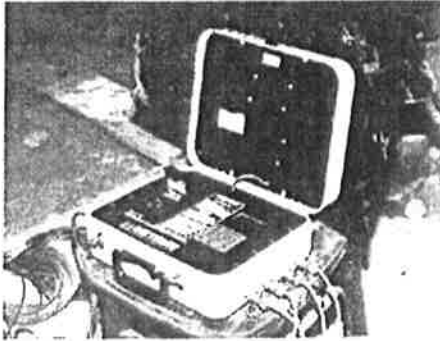
Portable monitors are used to record temperature and humidity conditions in historic buildings during mothballing. Photo: NPS files.
