## FRESNO STATION EARLY WORKS - HISTORIC DEPOT

CITY OF FRESNO - HISTORIC PRESERVATION COMMISSION PRESENTATION  
August 25, 2025

- Seismic Retrofit of Depot Building
- Accessibility Upgrades to exterior walks and interior path of travel - new elevator / lift
- Demolish non-historic interior work
- Rehabilitation at Main Waiting Room area, new public restrooms
- Life-safety and New Fire Protection System
- Provide Warm Shell Condition
- Exterior Envelope Repairs for weather-resistance - new roofing
- Tracking LEED Gold

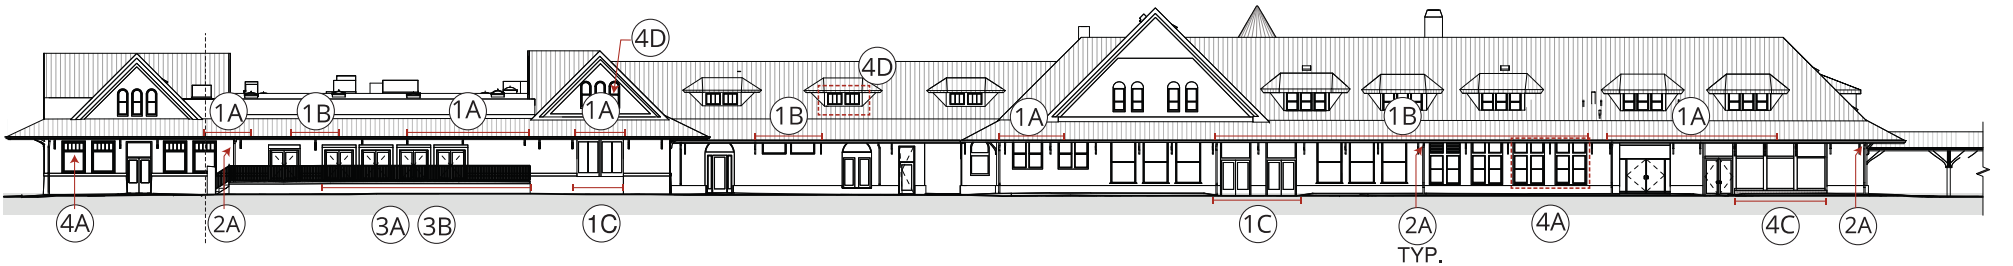
NORTH ELEVATION

- Wood: Repair, replace as needed, repaint
- Gutter: Replace
- Cement Plaster: Patch, repaint
- Wood Windows: Repair, reseal, repaint
- Roofing: Replace
- Chimneys: Rebuild

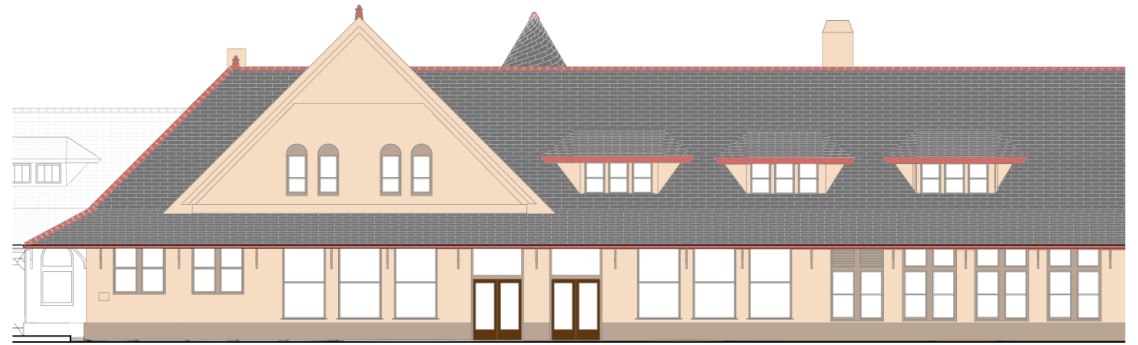
Existing elevation with dark gray roofing

- Existing roof is asphalt shingle. Original roof was slate.
- Replacement asphalt shingles with LEED compliant "cool roof" features
- Existing historic ridge tiles and finials to be maintained and replaced if damaged.
- Several styles of ridge tile and finial are present
  - Ridge tiles are primarily clay
  - Some ridge tiles appear to be painted concrete replicas

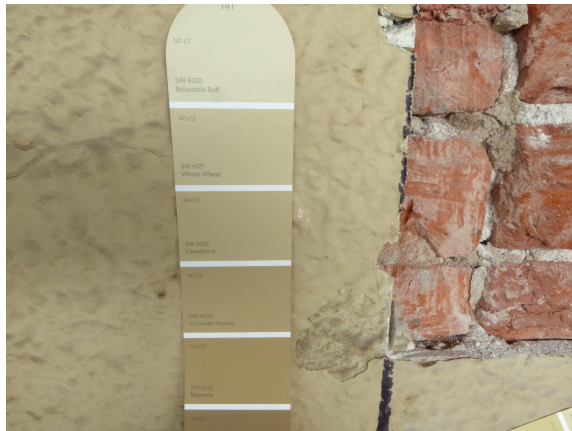
Painted cement plaster

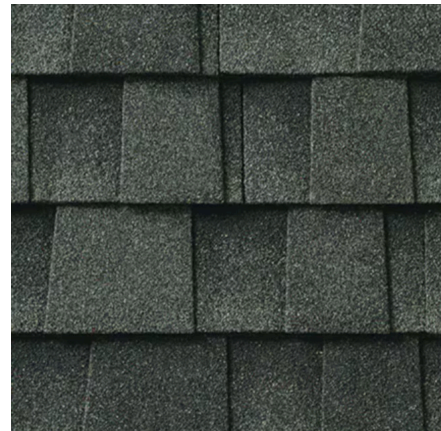
Charcoal colored asphalt shingle

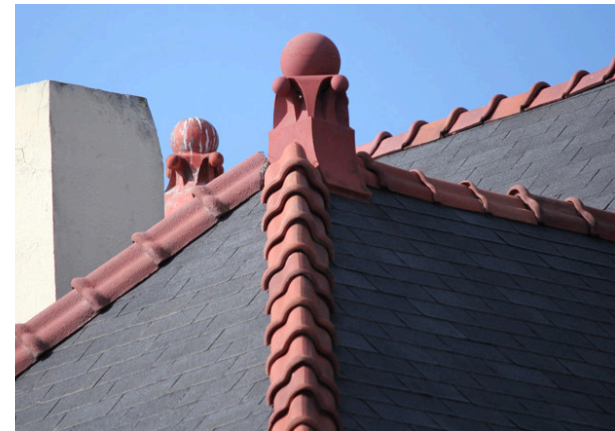
Existing ridge tiles and finials

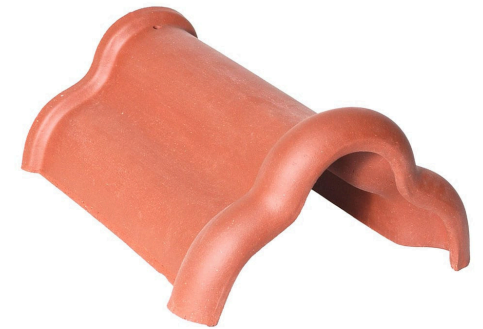
Replacement material:  
Ludowici Ridge Tile 206

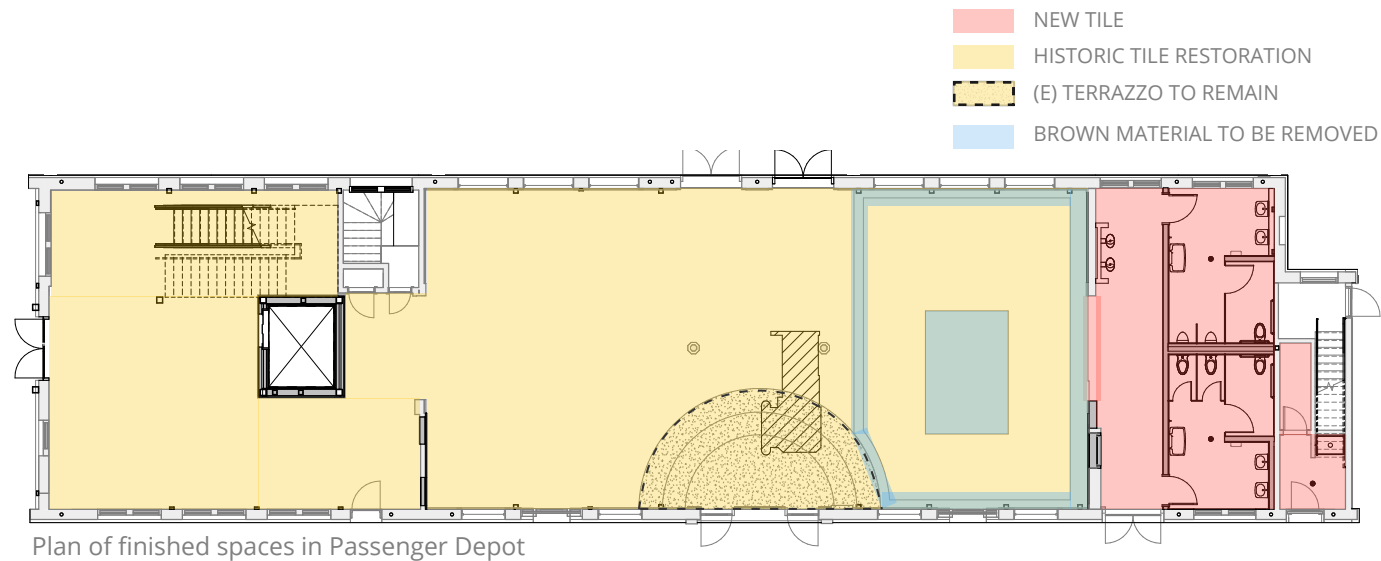
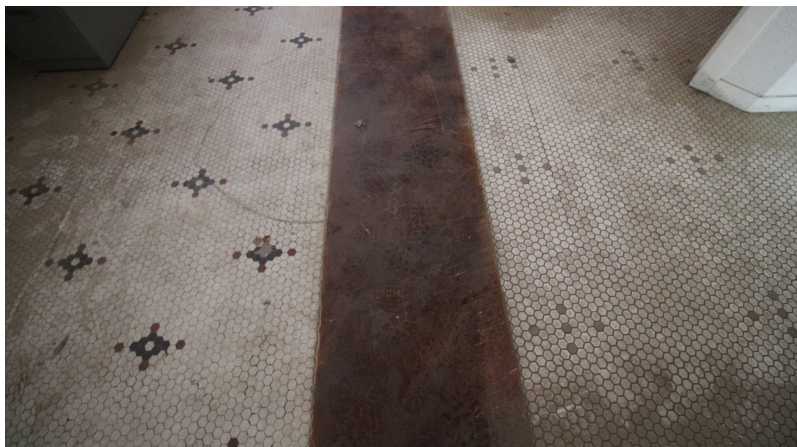
Passenger Waiting Room existing conditions

Left - Historic Tile, to be restored  
 Center - Brown Material. Remove and patch to match historic.  
 Right - Non-historic tile. Remove and replace with new tile.

- Historic hexagon porcelain tile believed to date ca. 1916
- Brown material to be removed and patched.
- Terrazzo floor area at south doors to remain.
- Existing non-historic tile, occurring at areas that will become the restrooms and corridor, to be removed and replaced with new tile.
- New tile at the corridor should be visually compatible with existing finishes at the Passenger Waiting Room.

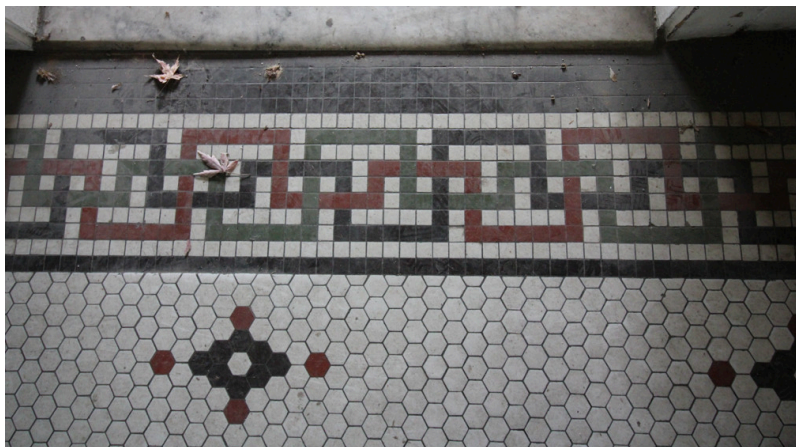
Historic mosaic pattern with border

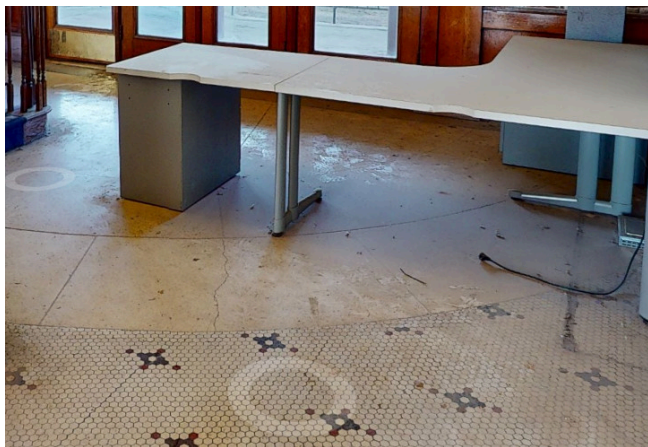
Existing Terrazzo floor (semicircle shape) at south doors

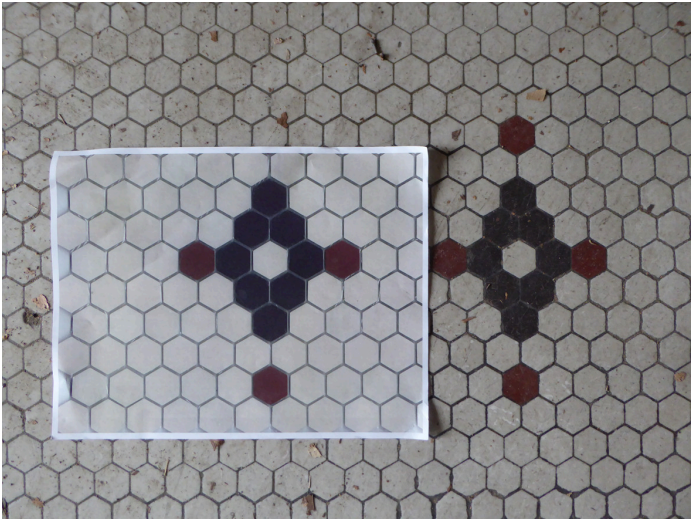
Full scale photocopy of tile sample overlaid on actual floor

- Damaged areas to be patched and repaired with matching porcelain tile to extent feasible

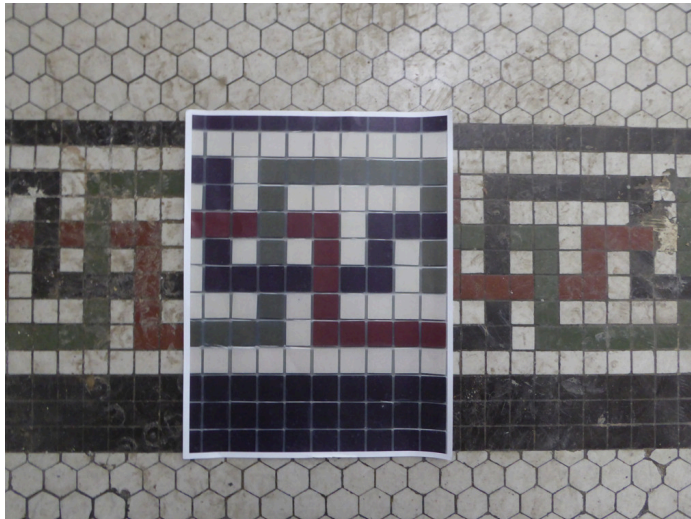
Full scale photocopy of tile sample overlaid on actual floor

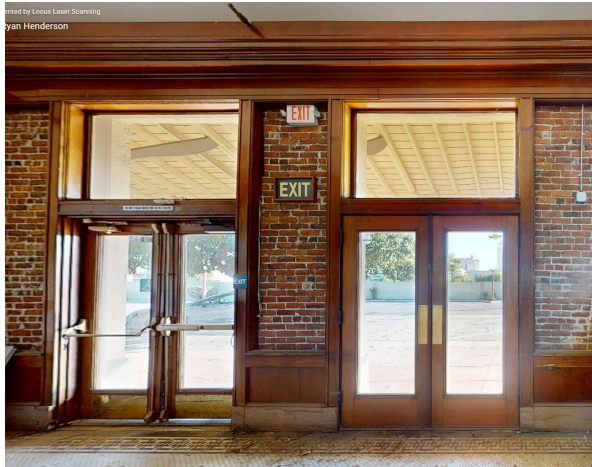
North wall with extensive existing wood trim

- Repair damage to existing crown trim, opening trim, wainscoting, and window trim
- Reproduce missing wainscoting at east and west walls
- Clean, repair and infill marble baseboard

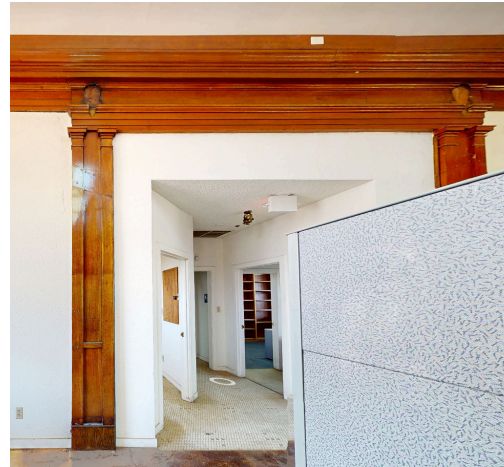
Opening trim at east wall

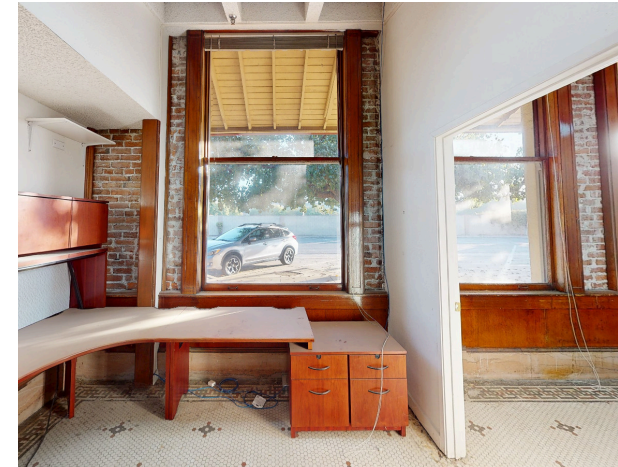
Example of area likely to require repairs after demo

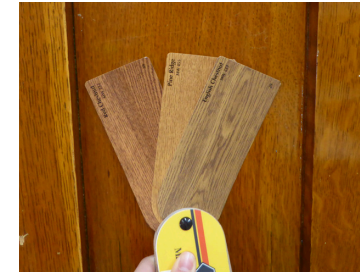
Wood stain color comparison

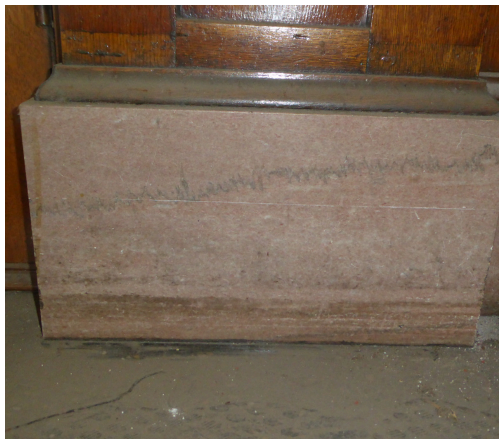
Tennessee Pink Marble Baseboard

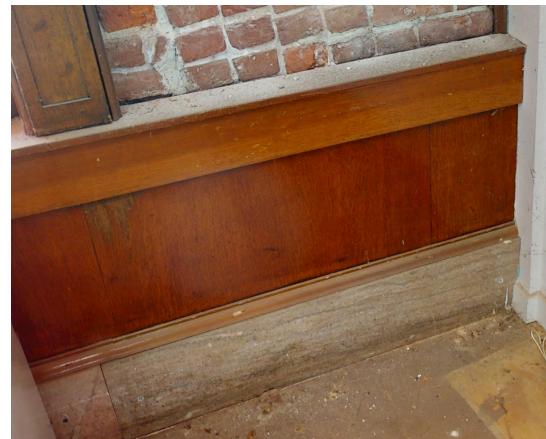
Wainscoting

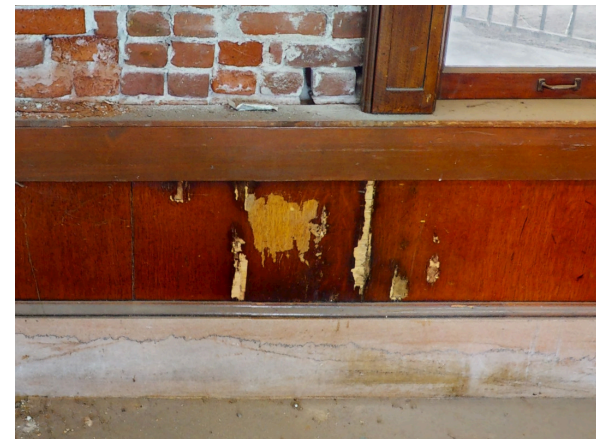
Example of existing damage at wainscoting

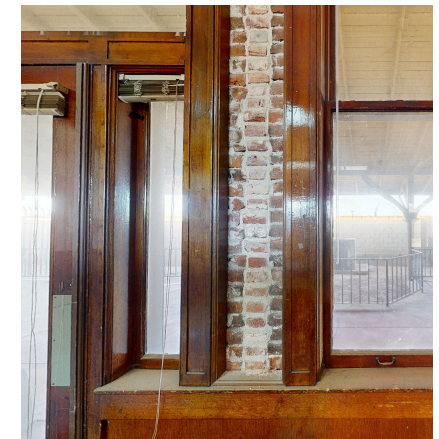
Trim at windows

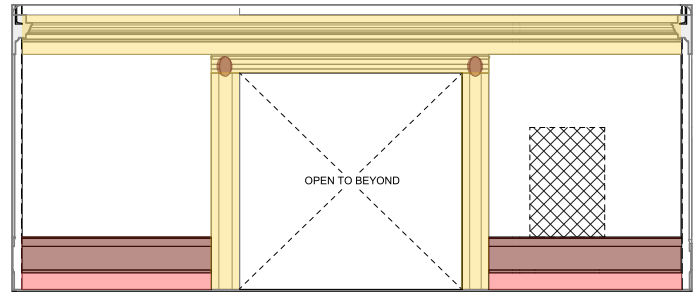
4 PASSENGER WAITING ROOM - EAST  
1/4" = 1'-0"

- MISSING MARBLE TO BE REPLACED
- EXISTING WOOD ELEMENTS TO BE REPAIRED
- MISSING WOOD ELEMENTS TO BE REPRODUCED

- Repair damage to existing crown trim, opening trim, wainscoting, and window trim
- Maintain existing wood stain, match stain color at repair material
- Reproduce missing wainscoting at east and west walls, approx. 30 linear ft
- Repair and replace missing sections of marble baseboard

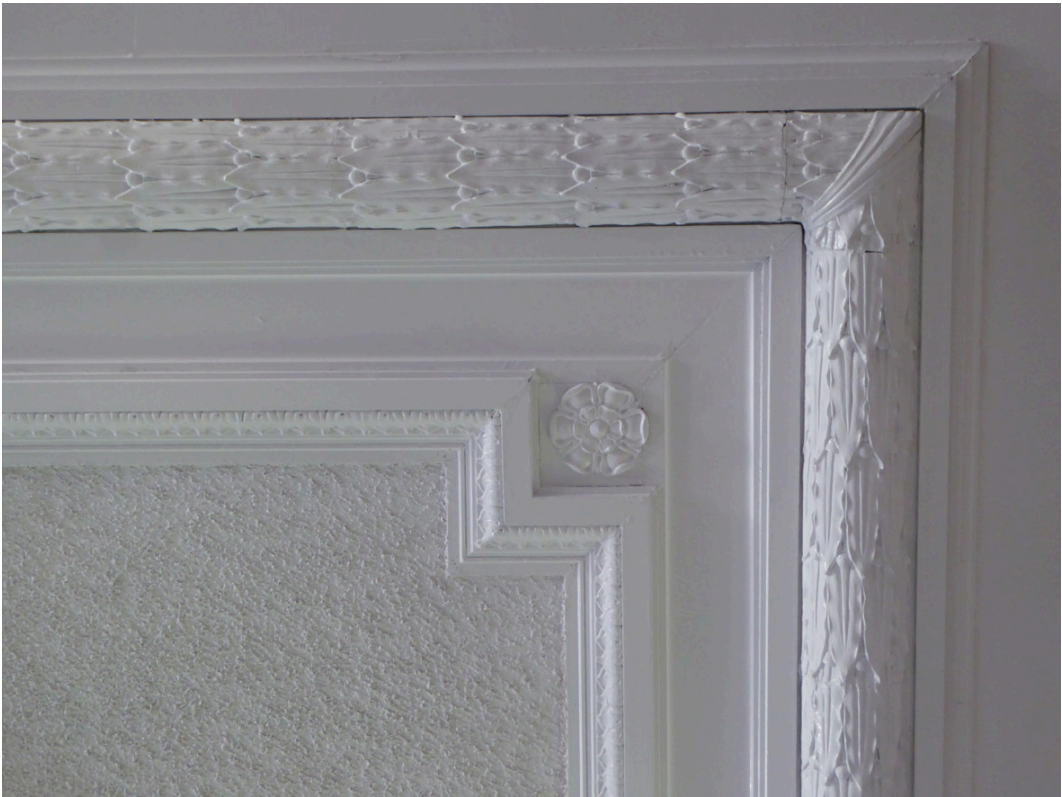
Existing plaster ceiling ornament with wood trim elements and non-historic acoustic texture

HISTORIC PLASTER & WOOD TO MAINTAIN
-

ACOUSTIC TEXTURE TO DEMOLISH

- Maintain historic plaster ornament, reconstruct if necessary for structural work
- Maintain historic ceiling cove, reconstruct if necessary for structural work
- Demolish acoustic texture and replace with smooth finish

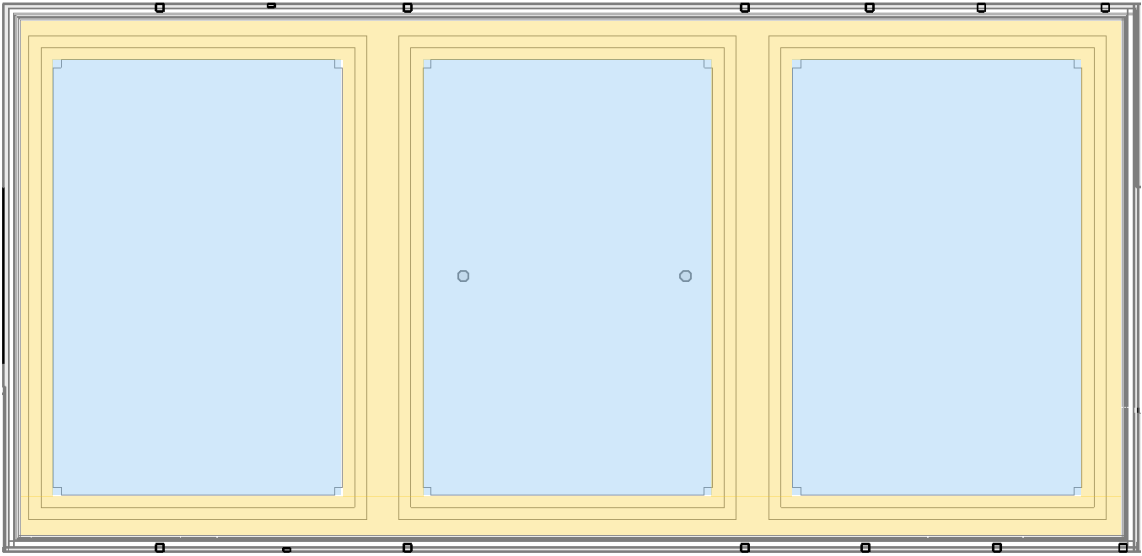
Passenger Waiting Room - Ceiling Plan with decorative plaster

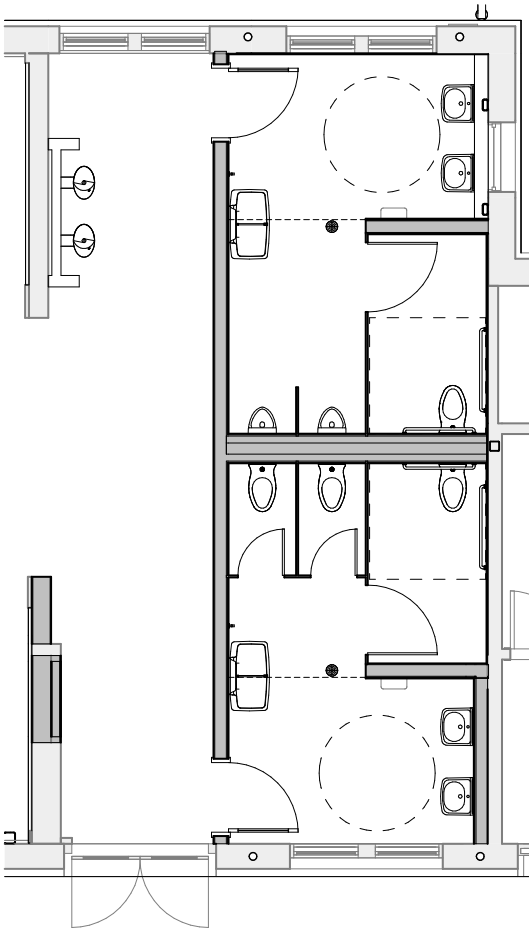
Enlarged Plan - entry and exit to south covered walkway

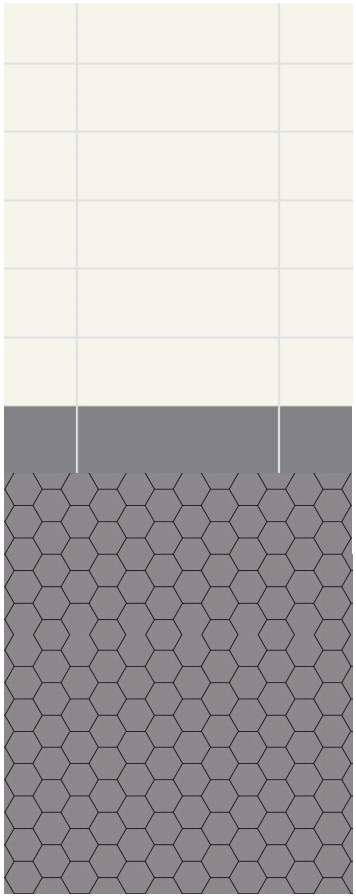
2" Hexagon Tile

Daltile Color Wheel Linear ceramic tile

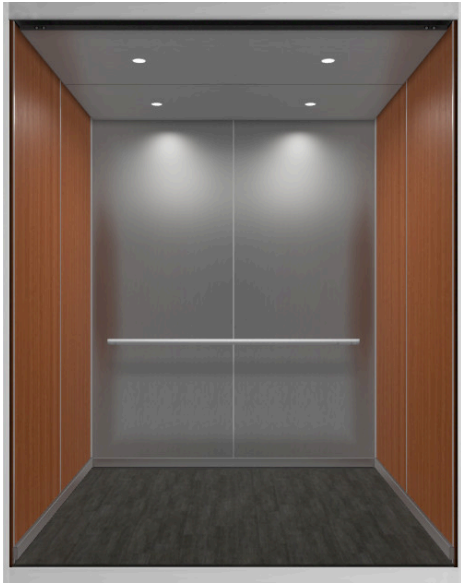
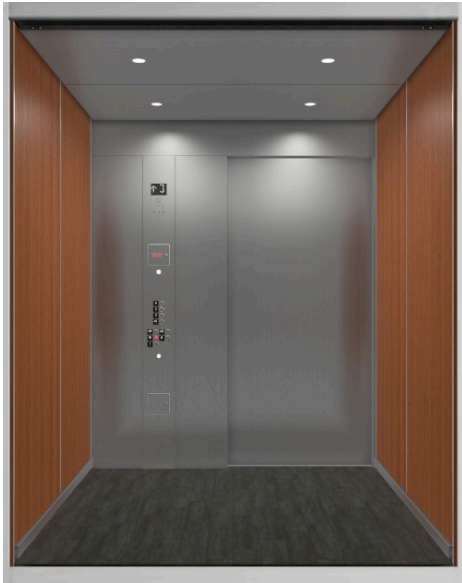
- Kone Monospace 300 DX
- Traction elevator with control room at level 2, side opening
- Brushed stainless and wood laminate panel interior

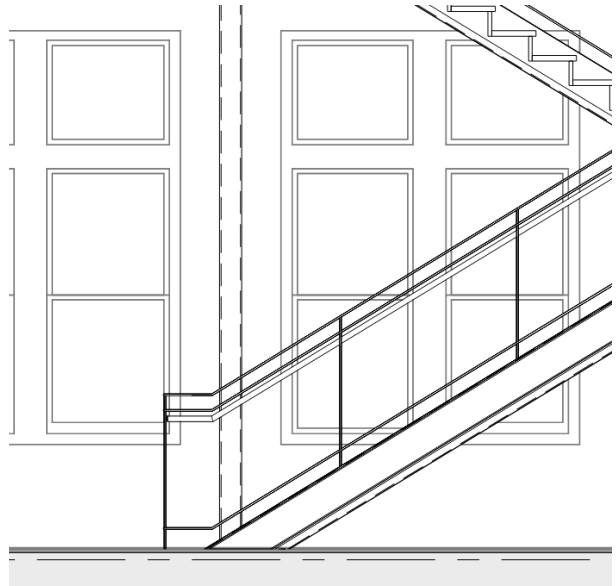
- Painted steel stringer with stained wood treads and plate steel risers
- Painted guard rail and hand rail
- Painted steel wire mesh infill panels
