## ROOFS

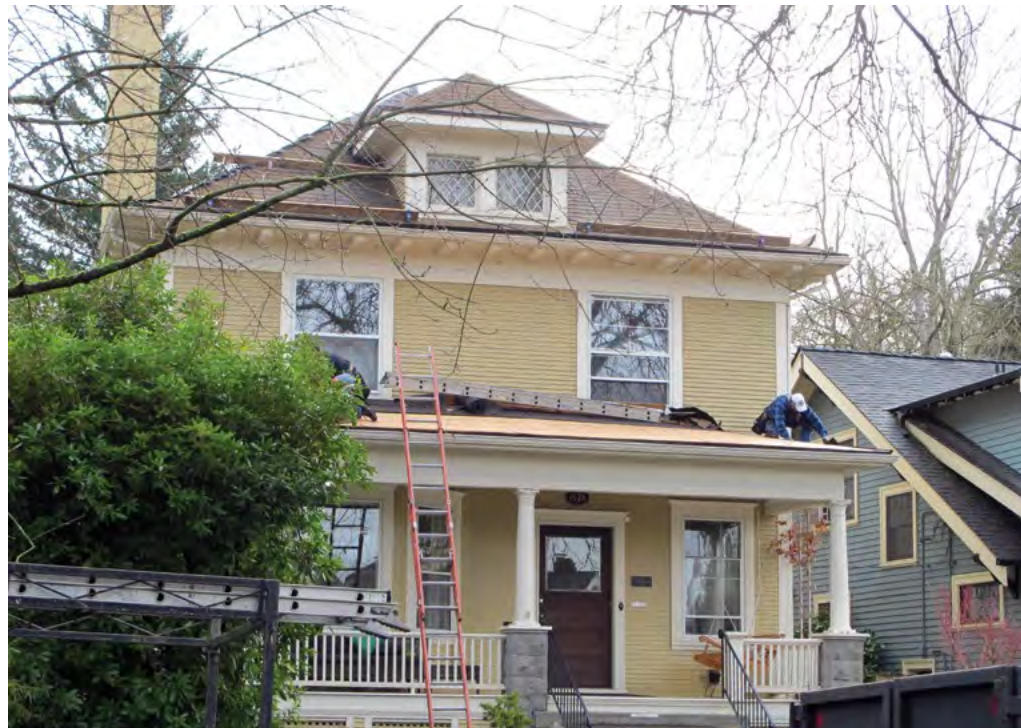
[16] The deteriorated asphalt shingles of this porch roof are being replaced in kind with matching shingles.

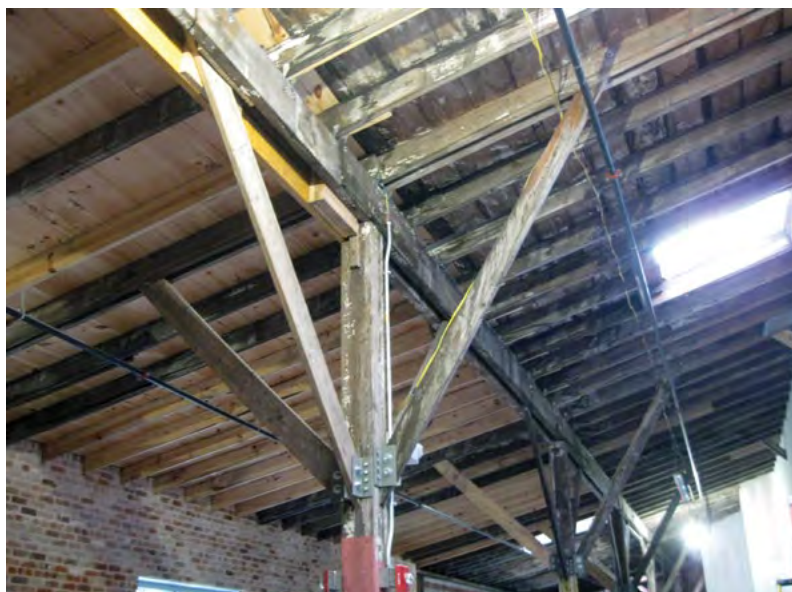
[17] New wood elements have been used selectively to replace rotted wood on the underside of the roof in this historic warehouse.
