THE SECRETARY  
OF THE INTERIOR'S  
**STANDARDS** FOR  
THE TREATMENT  
OF HISTORIC  
PROPERTIES

WITH  
**GUIDELINES** FOR  
PRESERVING,  
REHABILITATING,  
RESTORING &  
RECONSTRUCTING  
HISTORIC  
BUILDINGS

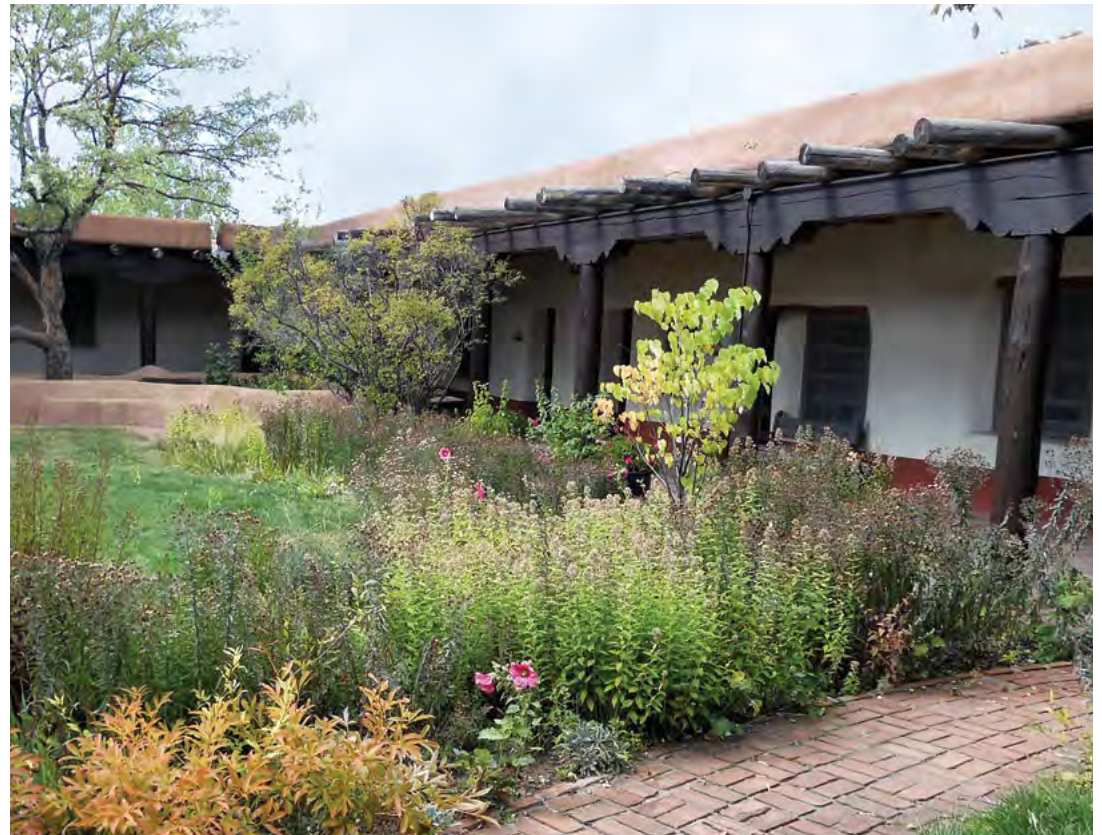
### Standards for Preservation

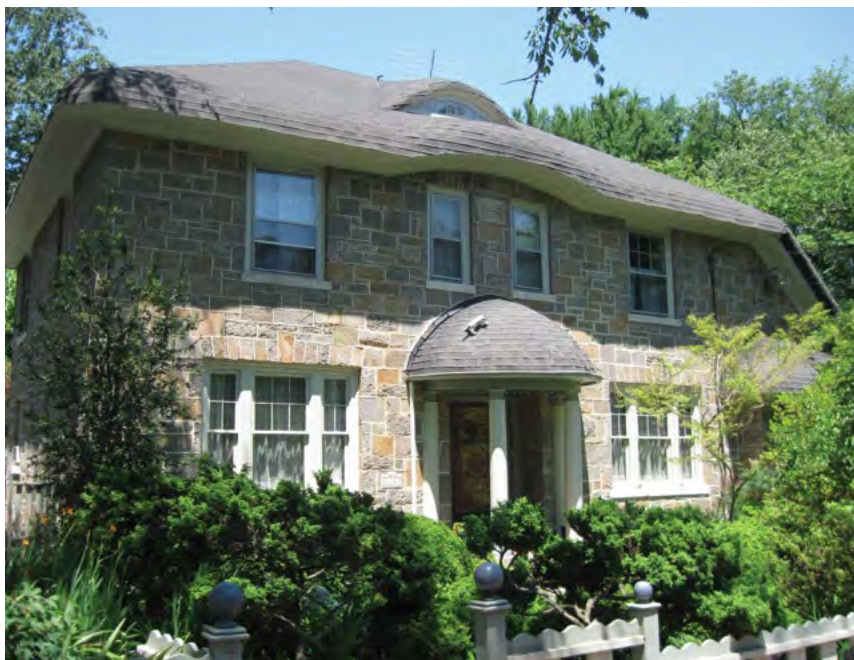
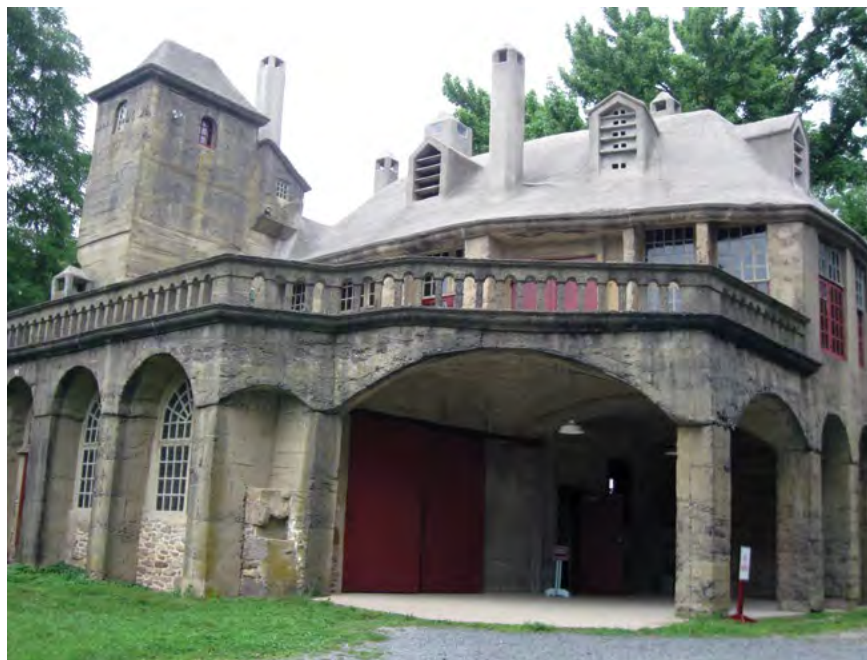
[9] Distinctively-shaped roofs are important in defining the historic character of these early 20<sup>th</sup>-century structures: (a) an asphalt shingle roof on a house; (b) and a concrete roof on Fonhill, Doylestown, PA (1908-1912), designed and built by Henry Chapman Mercer.

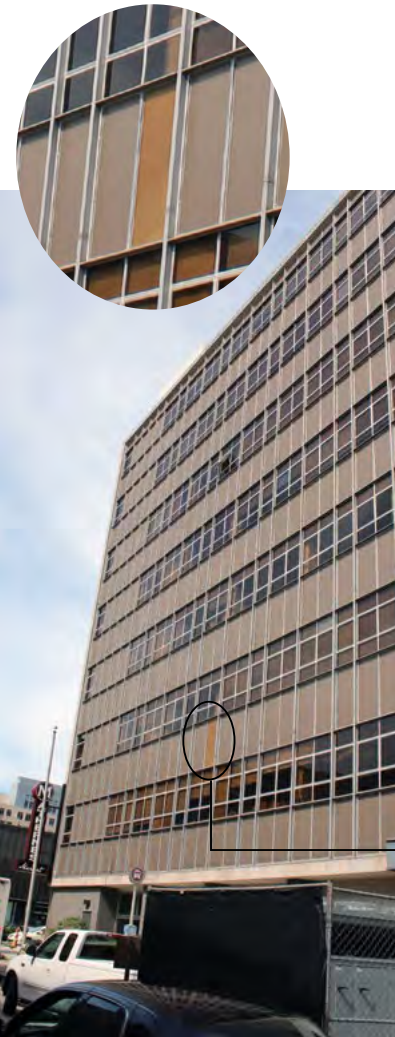
| CURTAIN WALLS | |

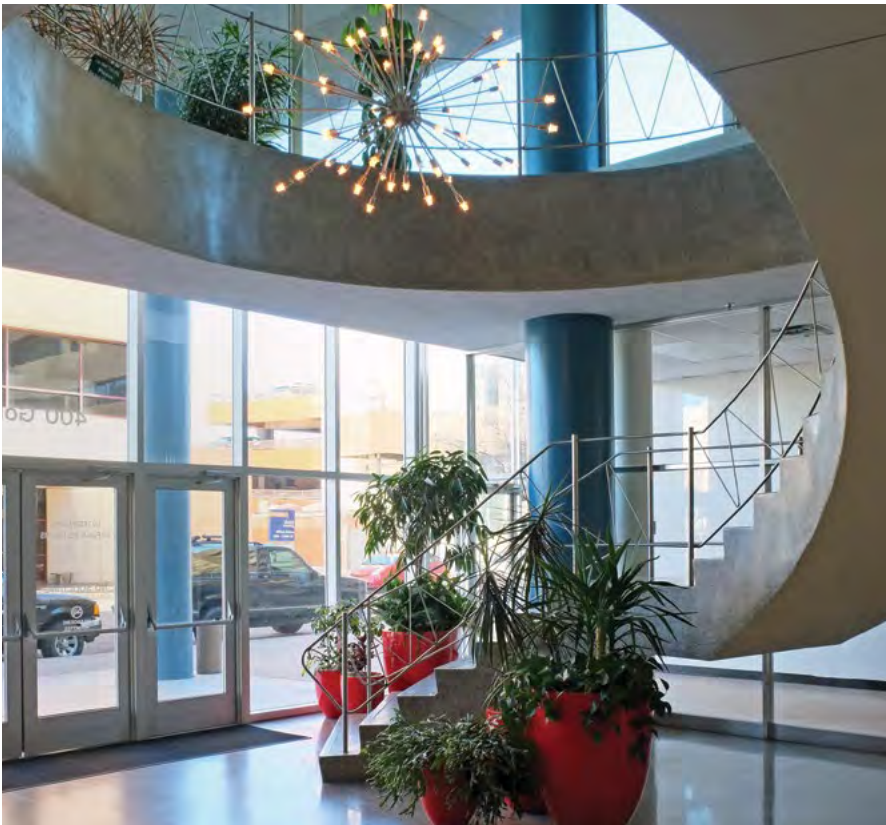
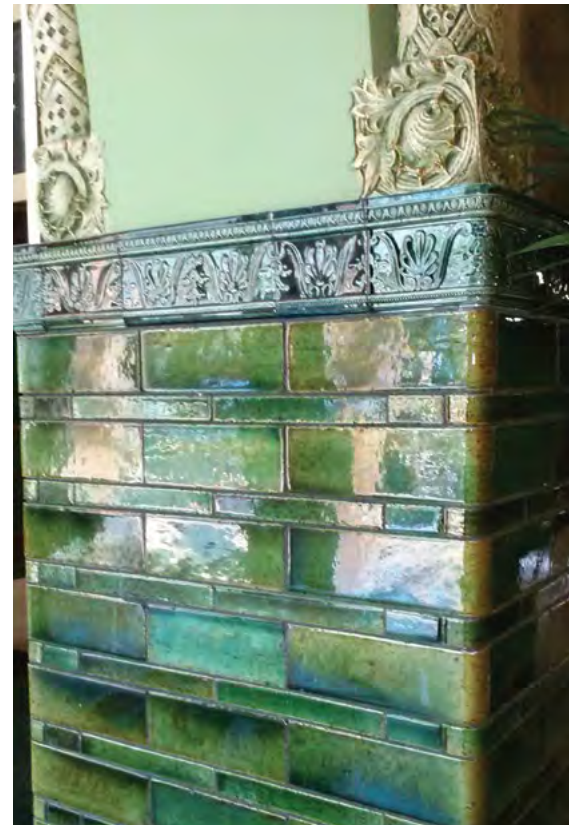
[19] The sweeping staircase with its metal railing, chandelier, and terrazzo floor in the lobby of the 1954 Simms Building, Albuquerque, NM, are character-defining features. *Photo: Harvey M. Kaplan.*

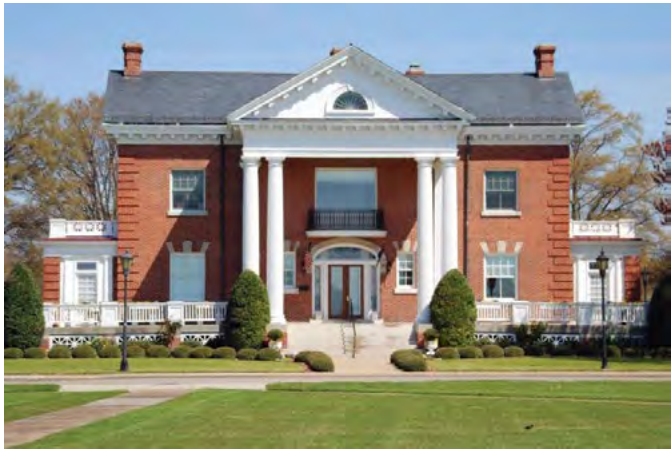
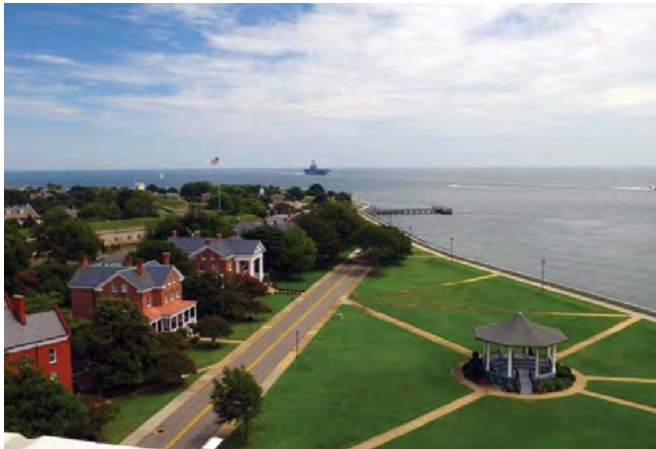
SETTING (DISTRICT / NEIGHBORHOOD)

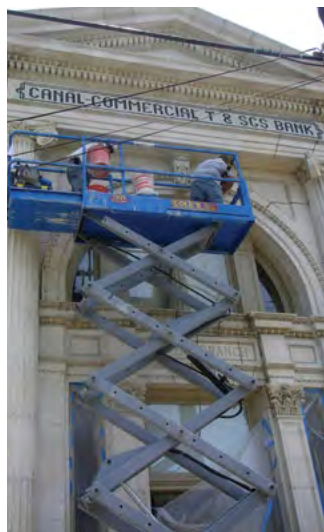
[1] An alkaline-based product is appropriate to use to clean historic marble because it will not damage the marble, which is acid sensitive.

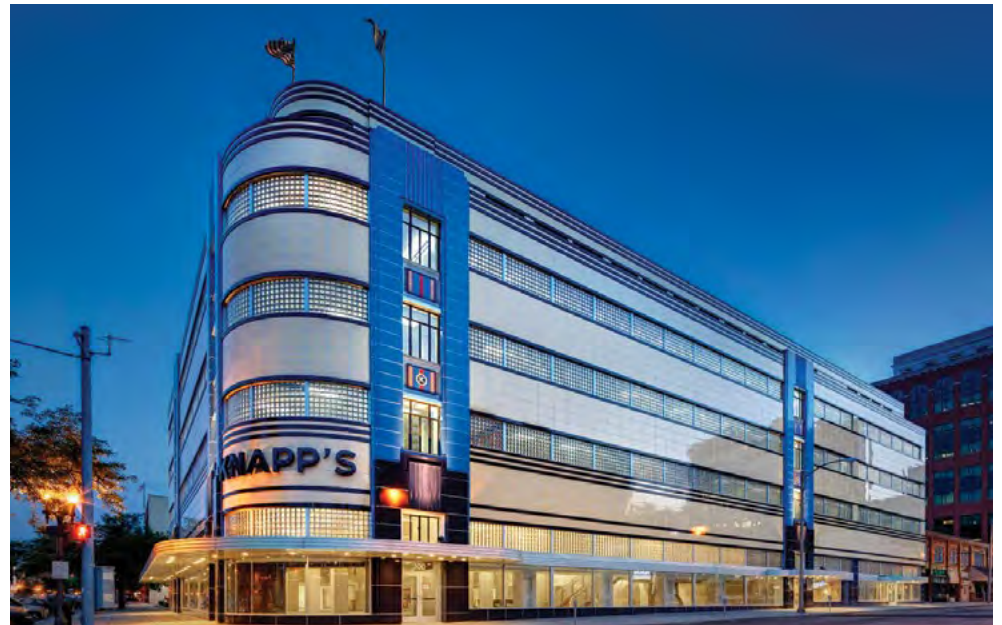
## MASONRY: STONE, BRICK, TERRA COTTA, CONCRETE, ADOBE, STUCCO, AND MORTAR

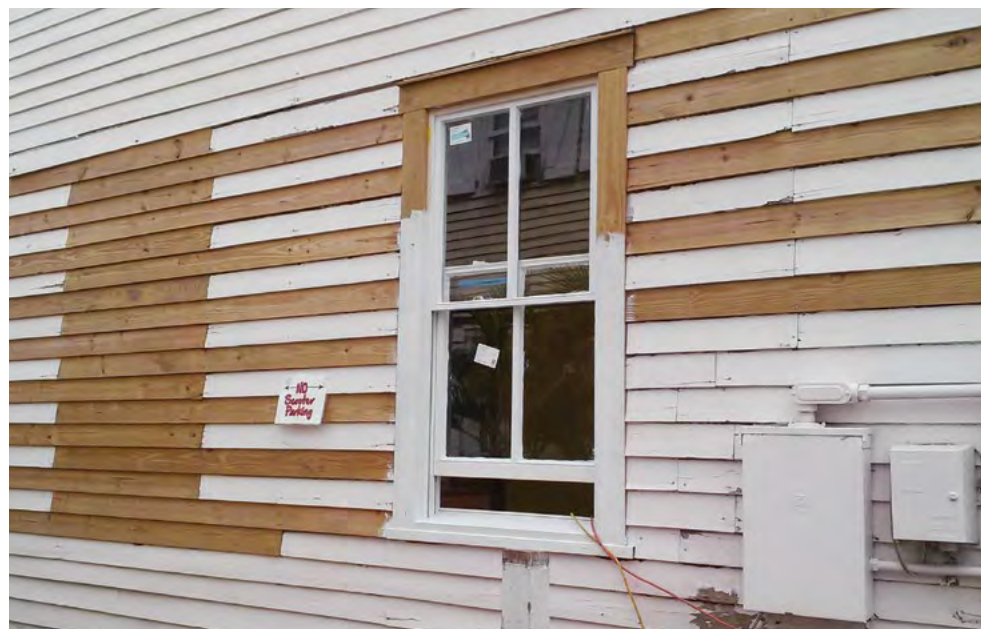
## WOOD: CLAPBOARD, WEATHERBOARD, SHINGLES, AND OTHER FUNCTIONAL AND DECORATIVE ELEMENTS

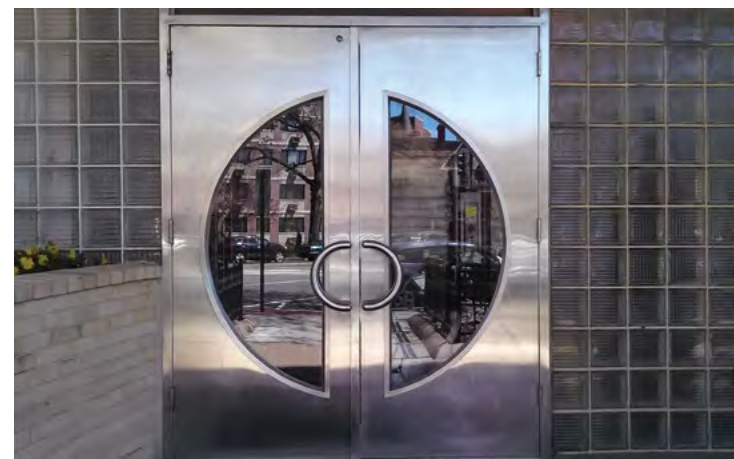
## METALS: WROUGHT AND CAST IRON, STEEL, PRESSED METAL, TERNEPLATE, COPPER, ALUMINUM, AND ZINC

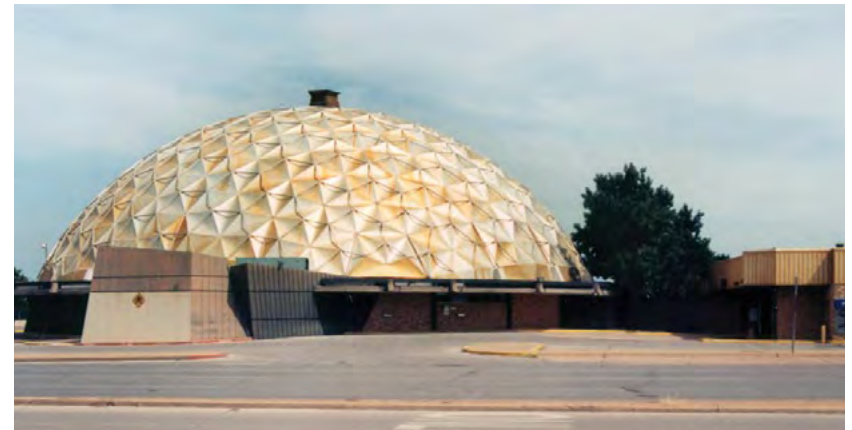
[13] The gold-colored, anodized aluminum geodesic dome of the former Citizen's State Bank in Oklahoma City, OK, built in 1958 and designed by Robert Roloff, makes this a distinctive mid-20th century building.

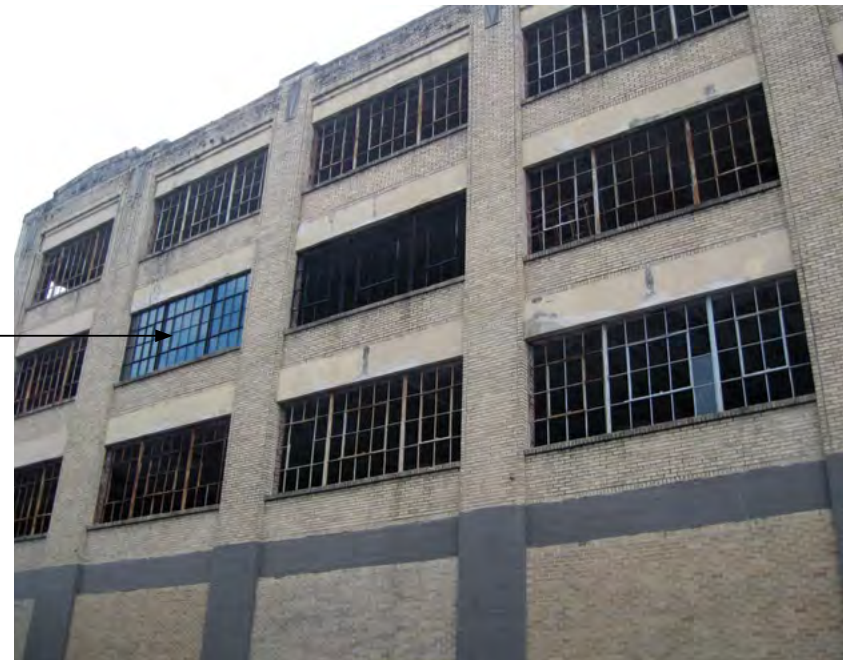
[19] Installing a mockup of a proposed replacement window can be helpful to evaluate how well the new windows will match the historic windows that are missing or too deteriorated to repair.

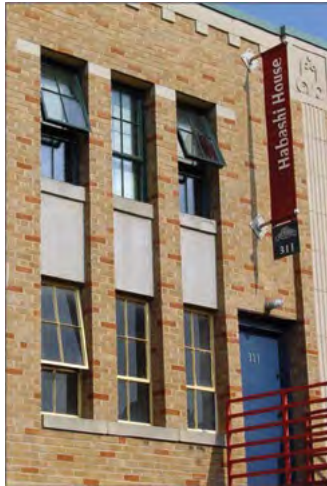
[21] The windows on the lower floor, which were too deteriorated to repair, were replaced with new steel windows matching the upper-floor historic windows that were retained.

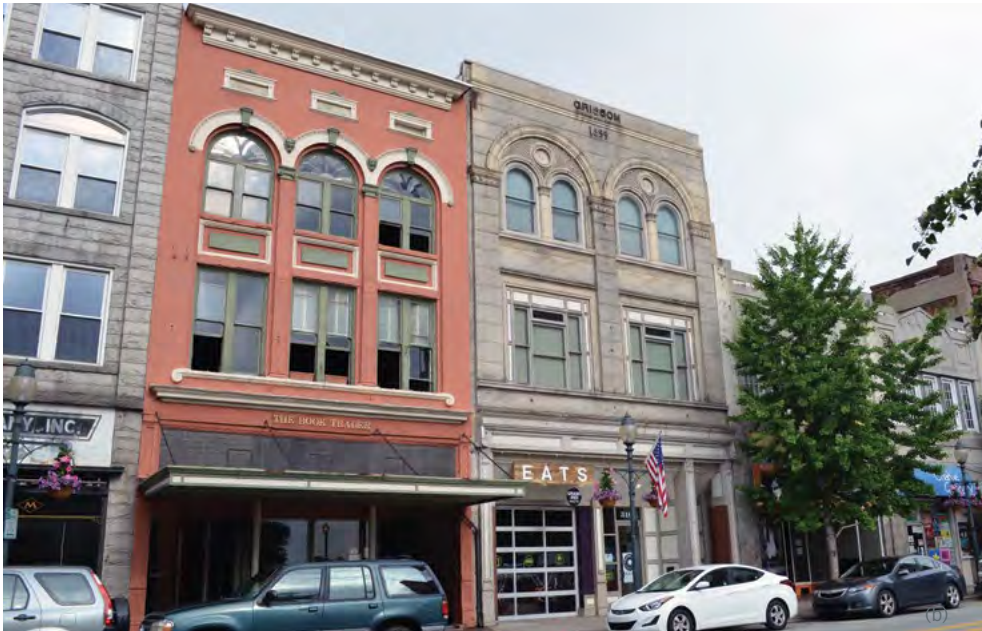
| | Installing replacement windows made from other materials that are not the same as the material of the original windows if they would have a noticeably different appearance from the remaining historic windows. |

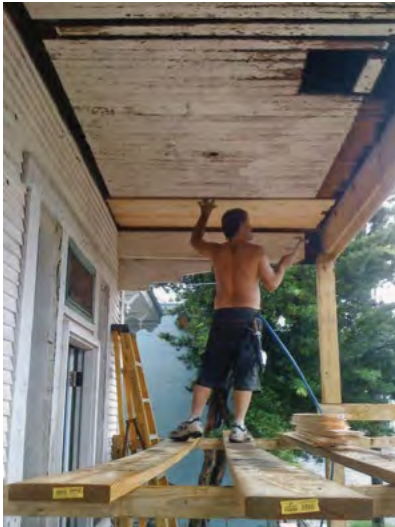
[24] Rotted boards in the beaded-board porch ceiling are being replaced with new matching beaded board.

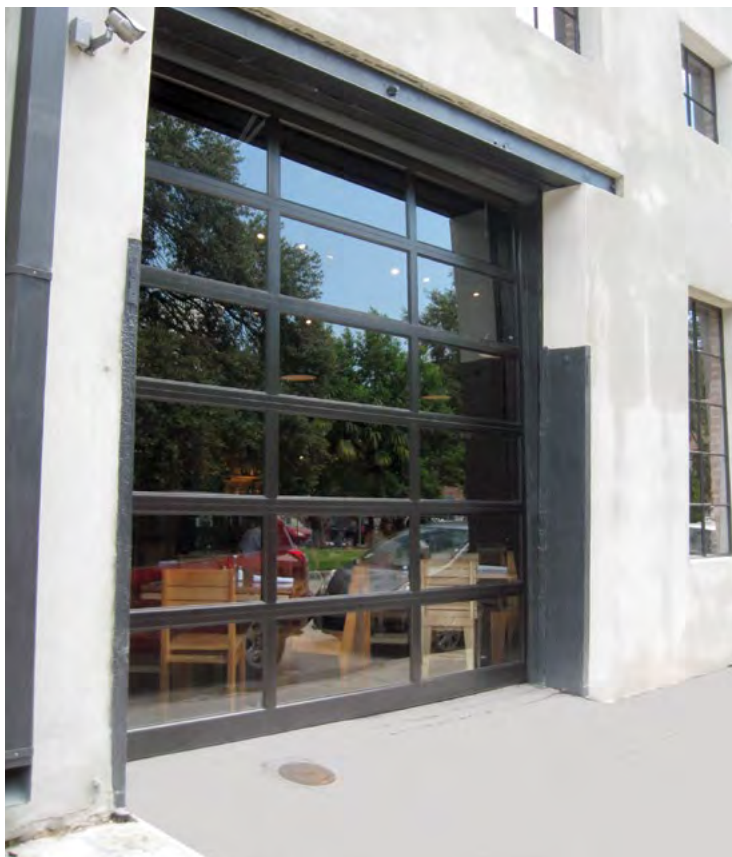
[25] The new infill designs for the garage door openings in this commercial building (a) converted for restaurant use and in this mill building (b) rehabilitated for residential use are compatible with the historic character of the buildings.

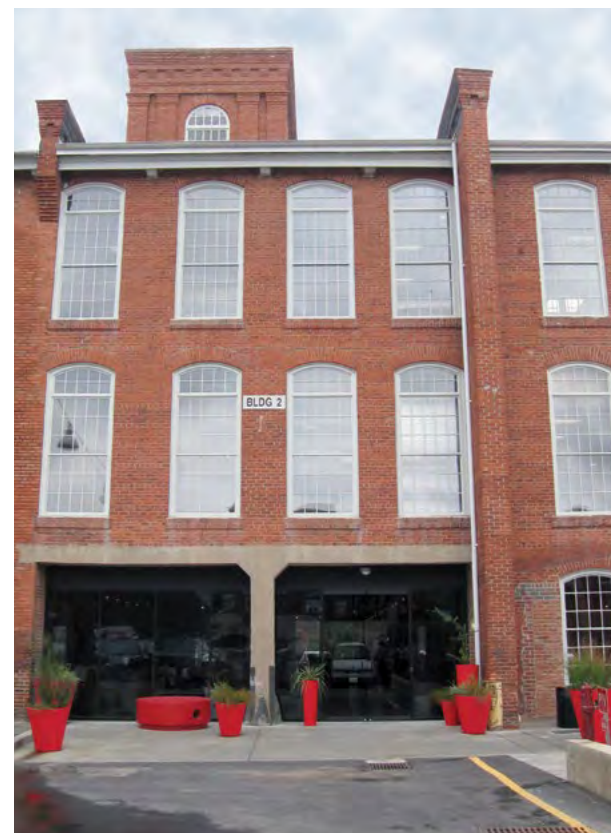
## ENTRANCES AND PORCHES

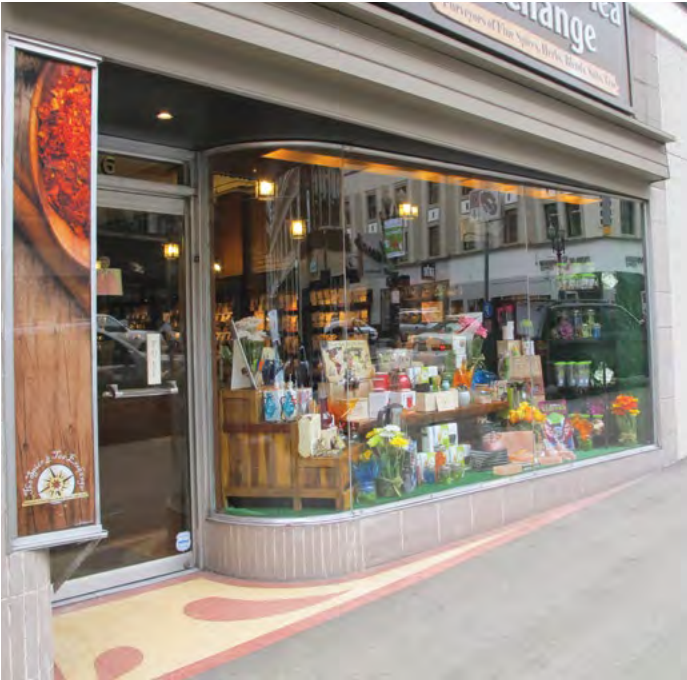
[27] This original c. 1940s storefront, with its character-defining angled and curved glass display window and recessed entrance with a decorative terrazzo paving, is in good condition and should be retained in a rehabilitation project.

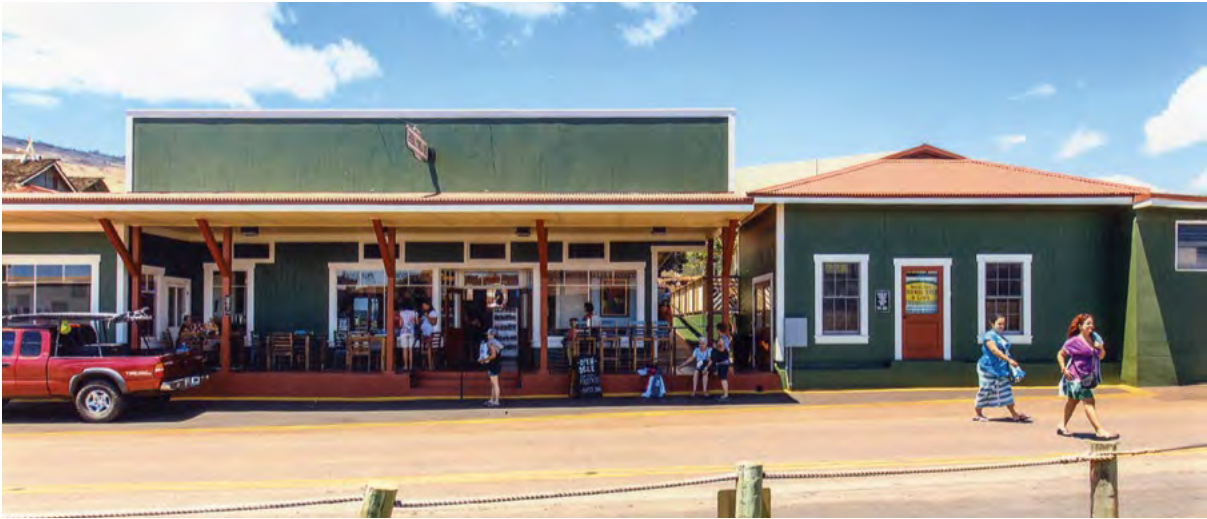
[29] The rehabilitation of the 1910 Māālaea General Store (a), which served the workers' camp at the Wailuku Sugar Company on the Hawaiian island of Maui, included the reconstruction of the original parapet (b).

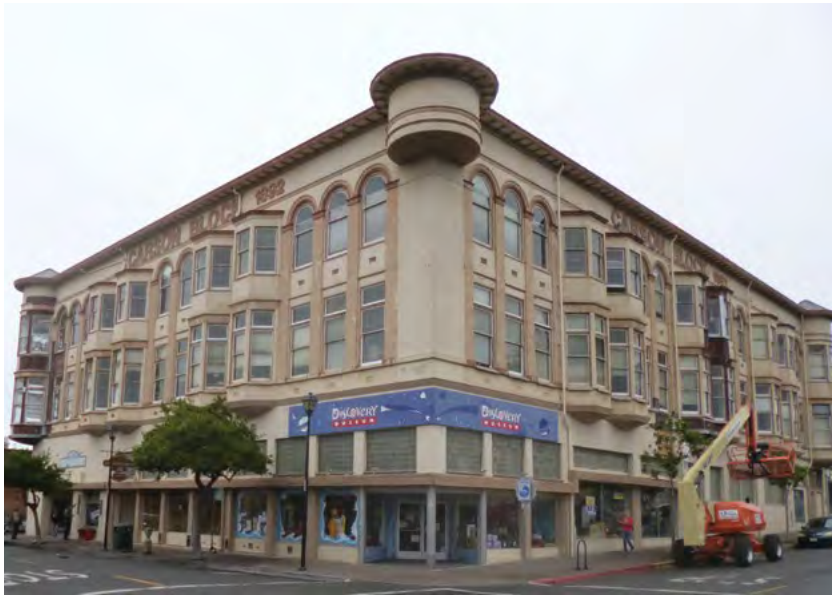
[32] (a-b) The rehabilitation of the 1892 Carson Block Building in Eureka, CA, for its owner, the Northern California Indian Development Council, included recreating the missing corner turret and sensitively introducing seismic reinforcement (c) shown here (opposite page) in a secondary upper floor office space. Photos: Page & Turnbull.

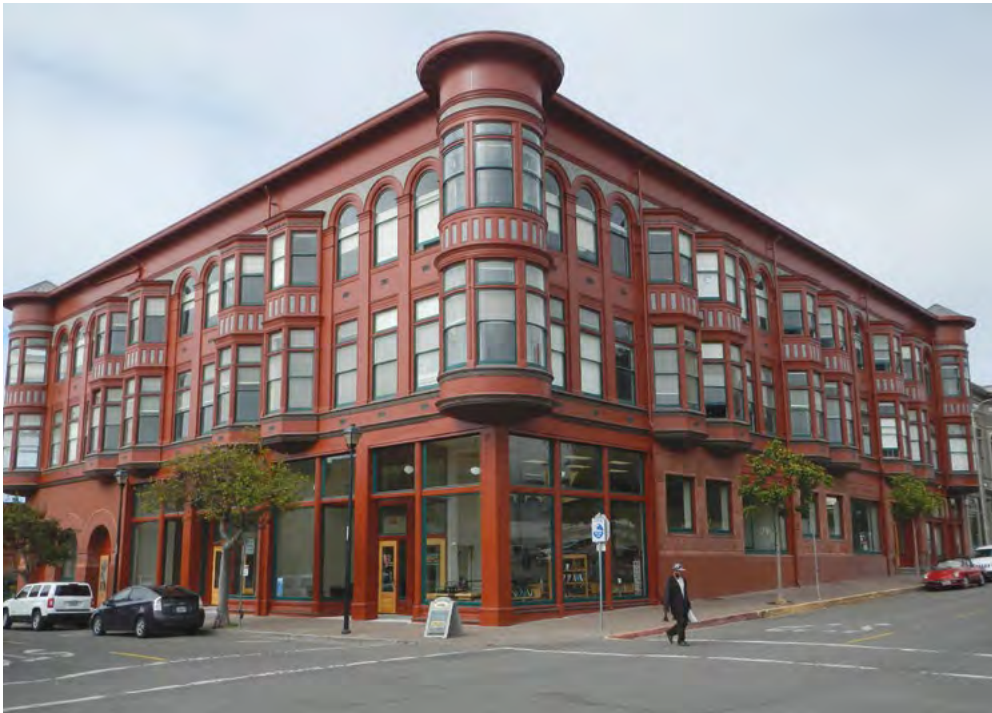
## STRUCTURAL SYSTEMS

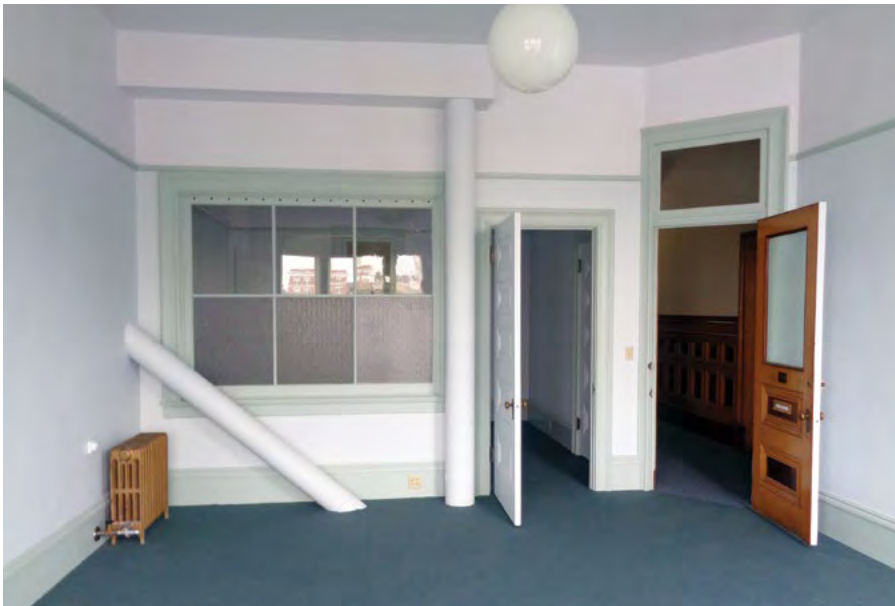
## STRUCTURAL SYSTEMS

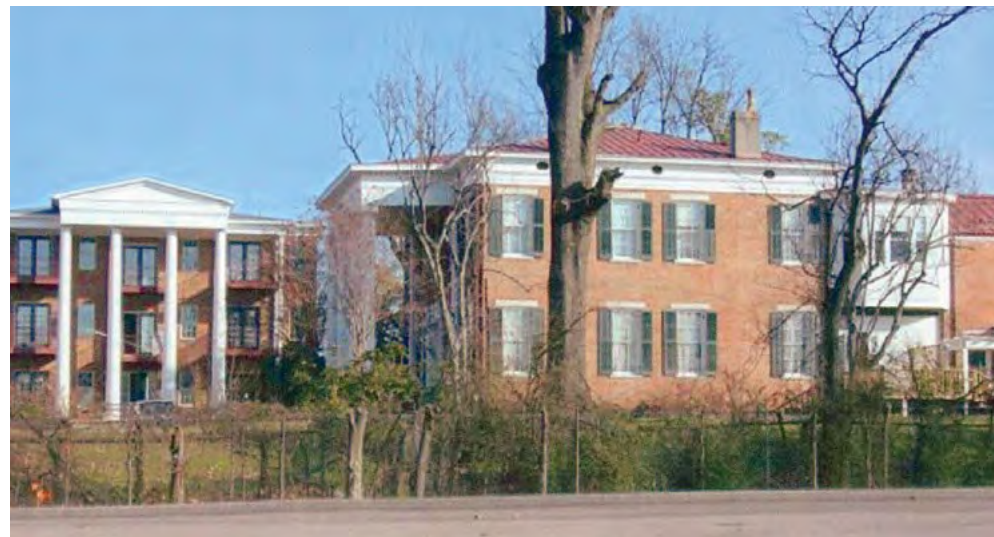
Adding conjectural landscape features to the site (such as period reproduction light fixtures, fences, fountains, or vegetation) that are historically inappropriate, thereby creating an inaccurate appearance of the site.

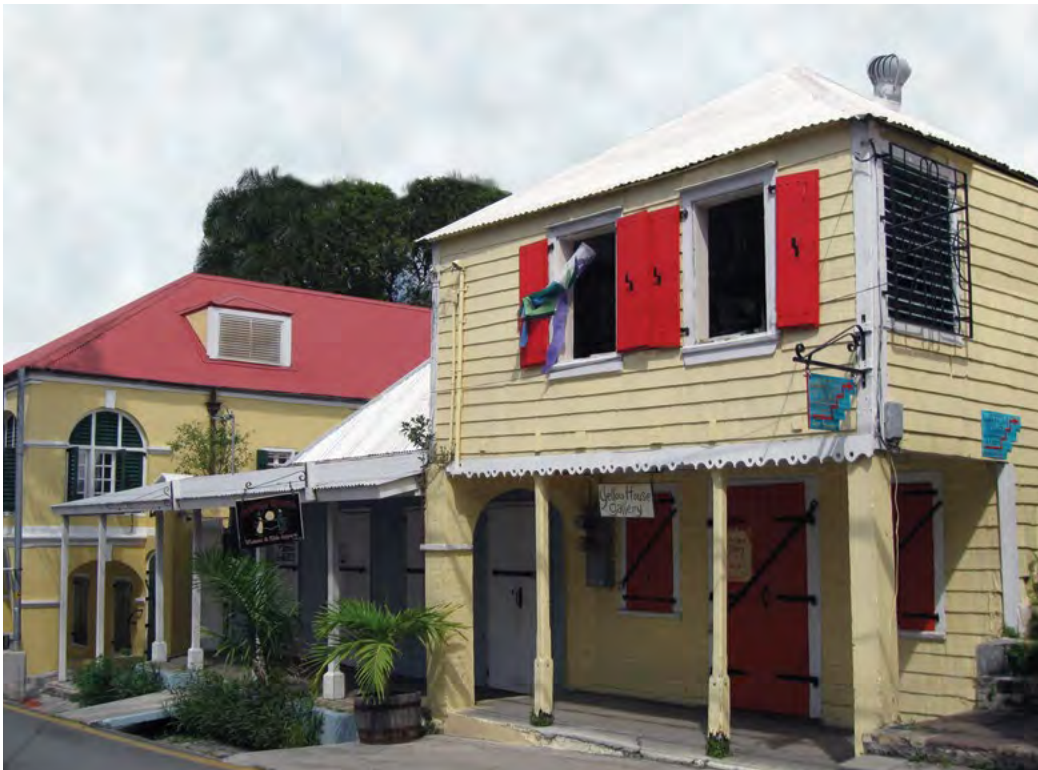
[46] The varied size, shapes, and architectural styles of these historic buildings are unique to this street in Christiansted, St. Croix, USVI, and should be retained in a rehabilitation project.

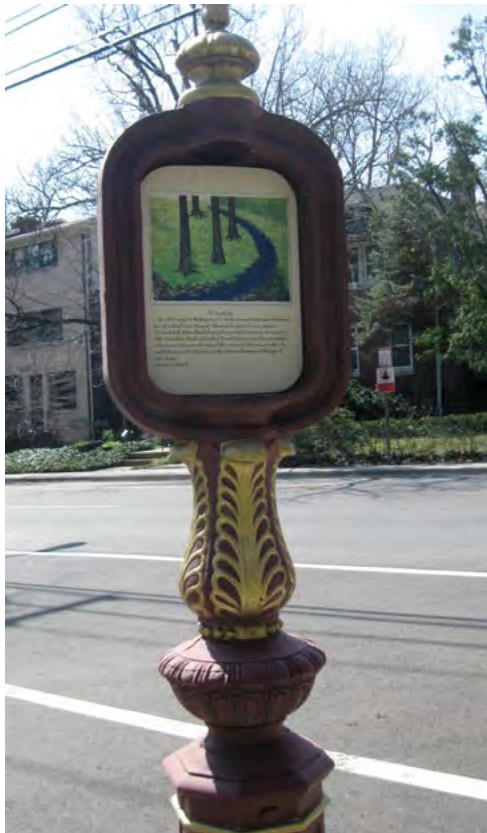
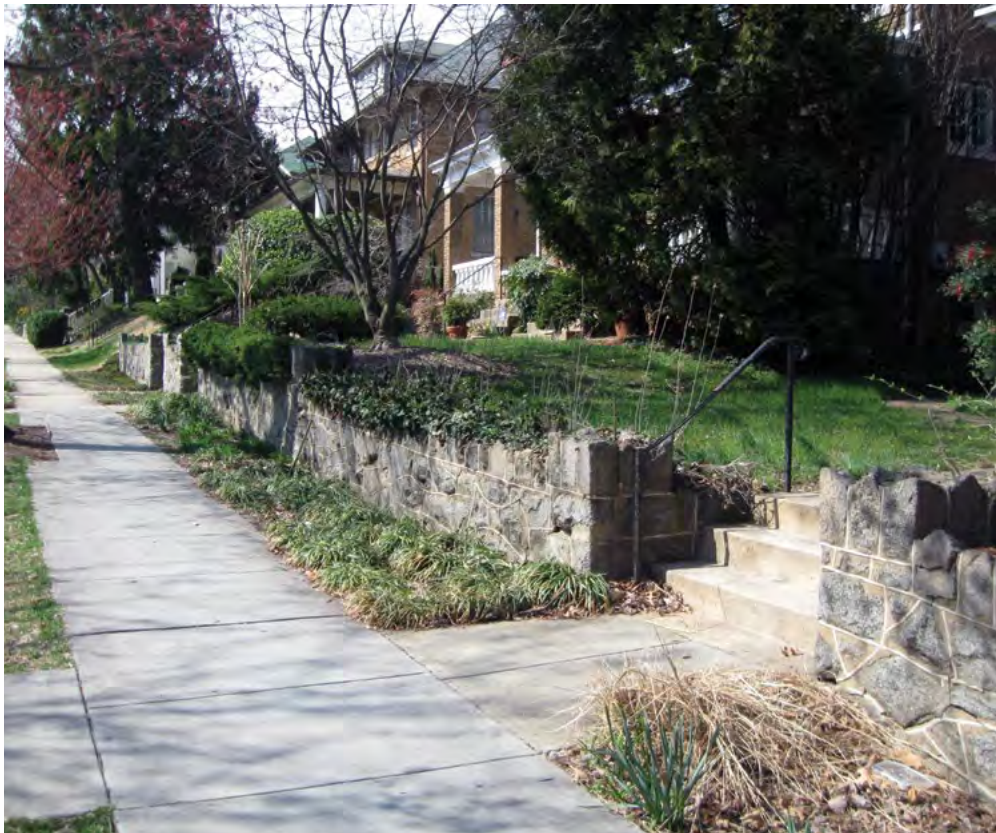
| SETTING (DISTRICT / NEIGHBORHOOD) | |
|---|---|
| | |

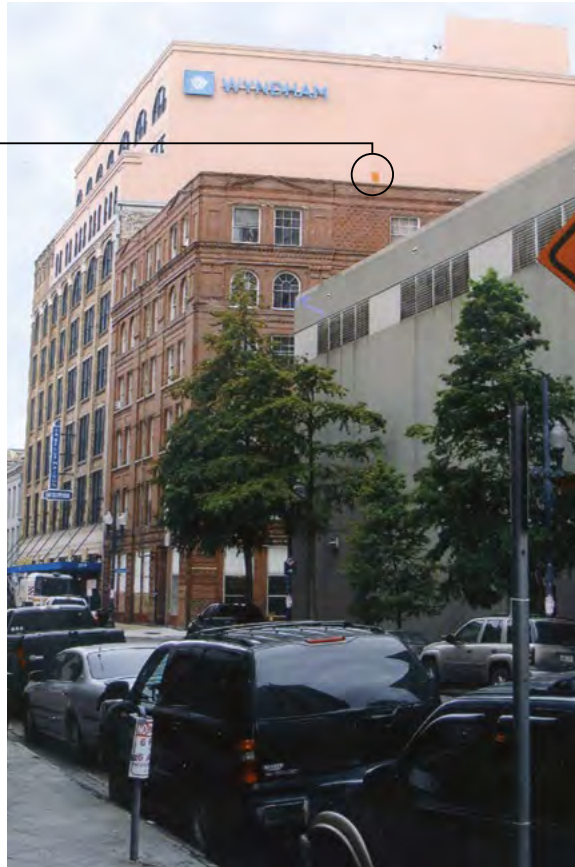
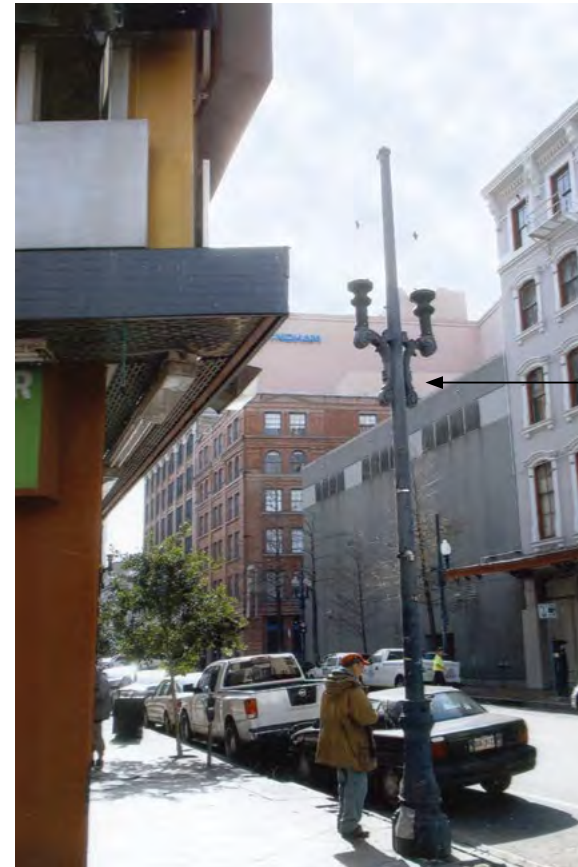
NEW EXTERIOR ADDITIONS TO HISTORIC BUILDINGS AND  
RELATED NEW CONSTRUCTION

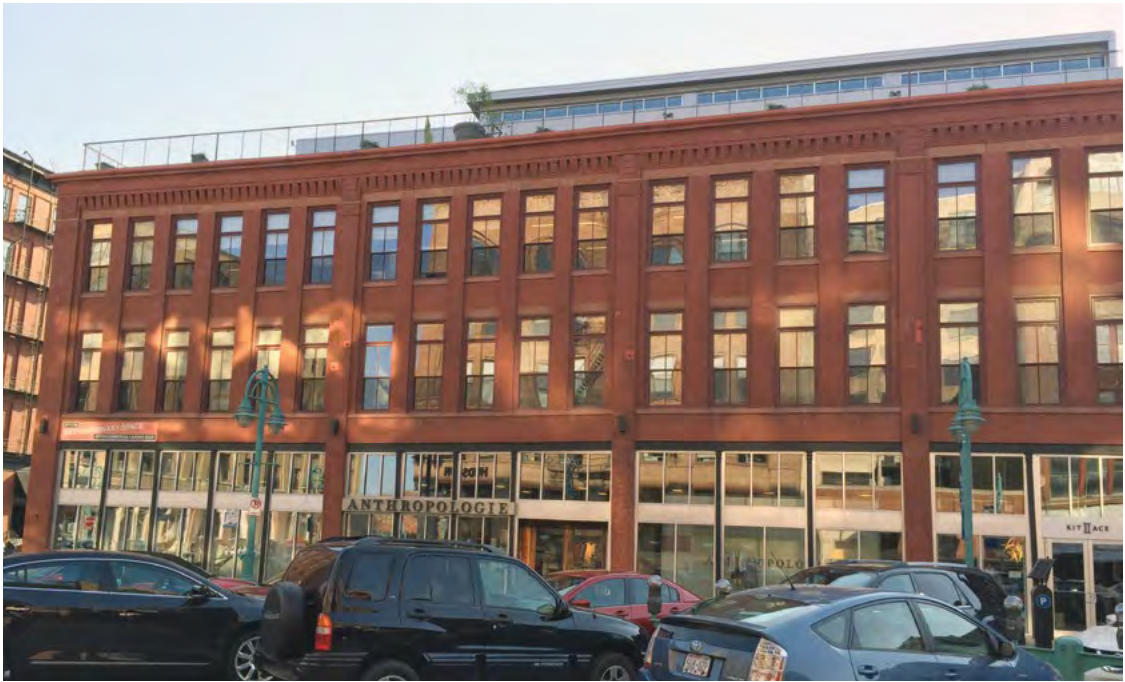
[64] **Not Recommended:**  
It is generally not appropriate to construct a rooftop addition on a low-rise, two- to three-story building such as this, because it negatively affects its historic character.
