Third Five-Year Review Report for

Fresno Municipal Sanitary Landfill Superfund Site

Fresno County, California

U.S. Army Corps of Engineers, Seattle District

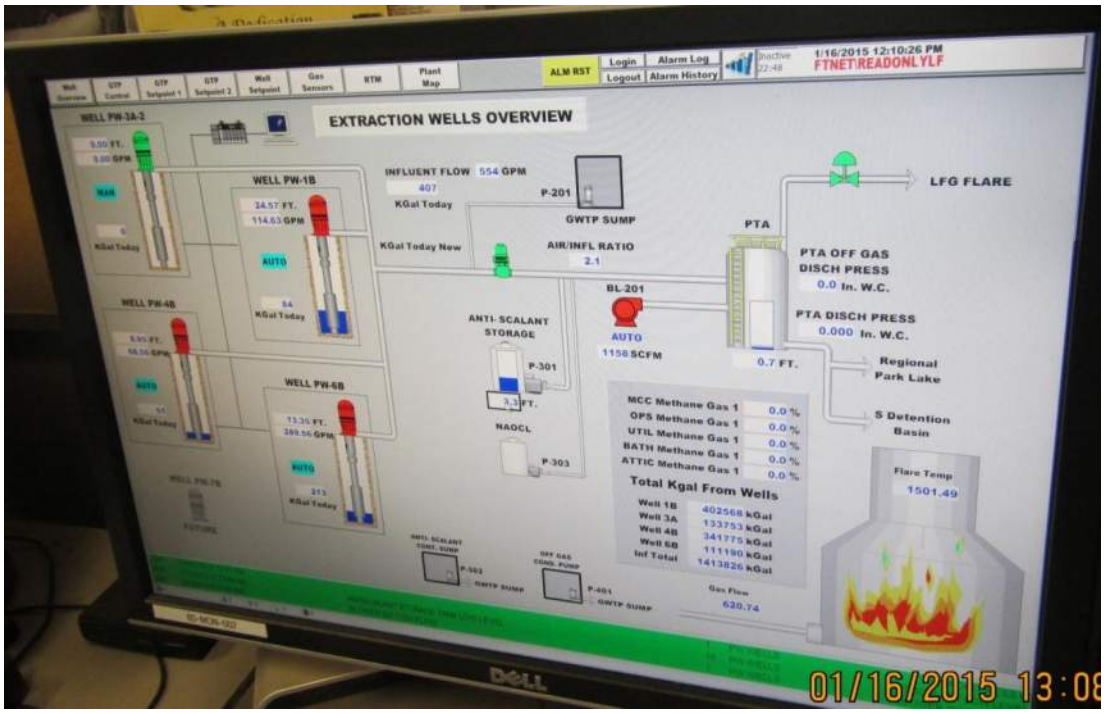
Photo 1: Treatment System Overview Screen

Photo 2: Gas Monitoring Device in Site Office
