1651 L STREET

CED CASE # E21-11874

FFD INCIDENT # 21-075838

Source of Fire

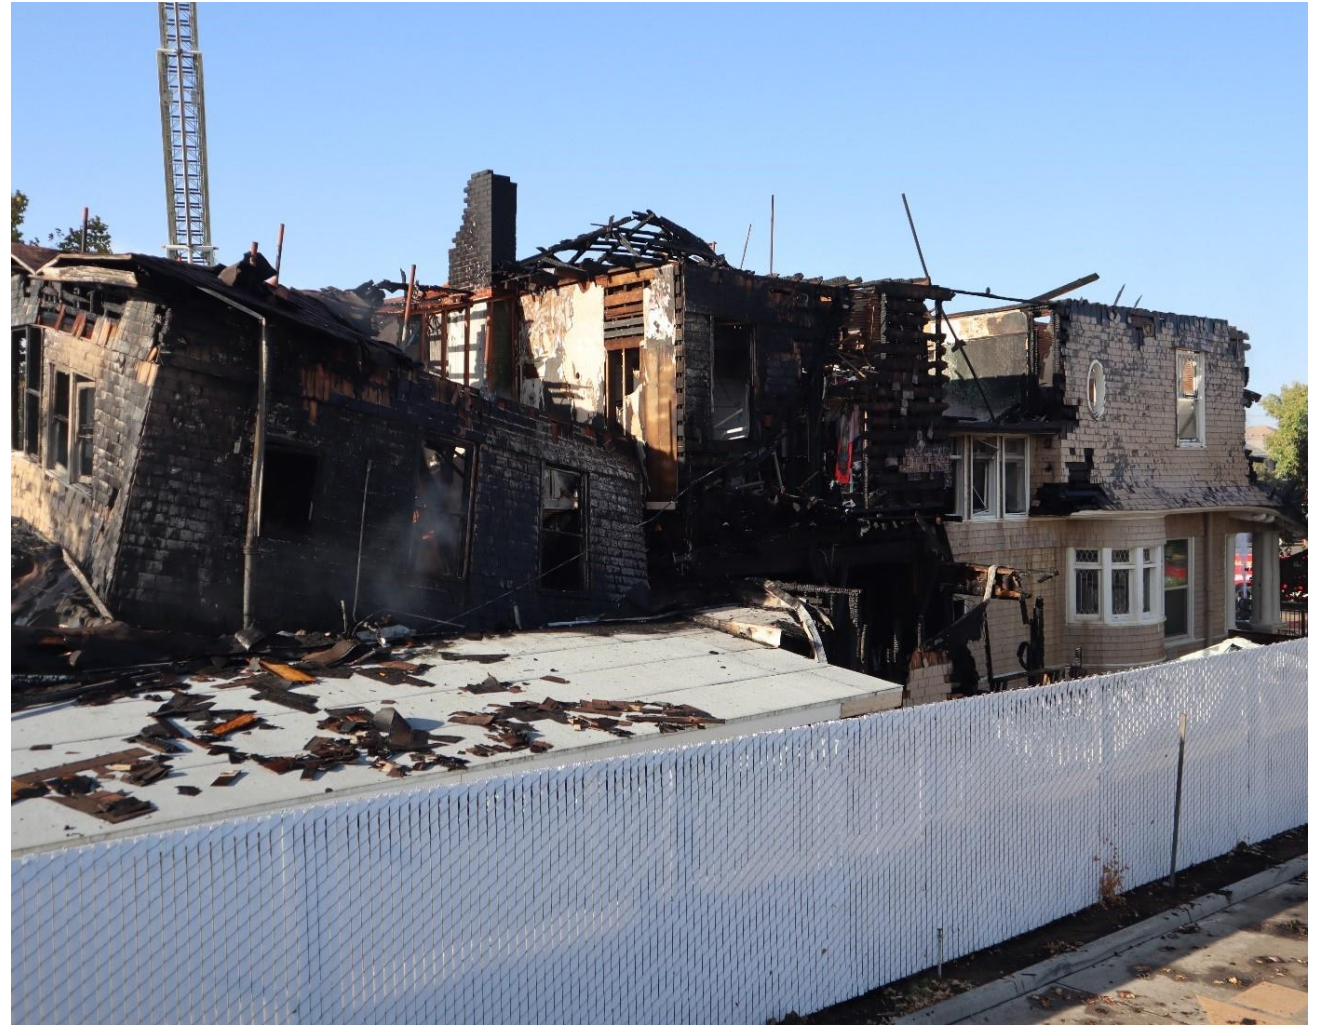
The accidental fire occurred on Sunday, October 17 at approximately 1:05 PM on the patio roof at the east elevation of the structure. The two-story structure consists of Type V wood-framed construction at the exterior and interior walls. Except for approximately 4-5 lineal feet of brick masonry construction at the west elevation of the first story, the exterior of the single-family structure is clad with wood shake shingles applied over 1x6 wood battens. It appears that approximately one-third (1/3) of the structure was an addition to the original structure and was of like-type construction as the original.
