SUBJECT: UNIQUE QUALIFICATIONS OF BROOKS RANSOM ASSOCIATES TO PROVIDE DESIGN AND CONSTRUCTION SUPPORT SERVICES FOR ROESSLER WINERY BUILDING PROJECT

Project No 23067

Subject: Roessler Winery Structural Report

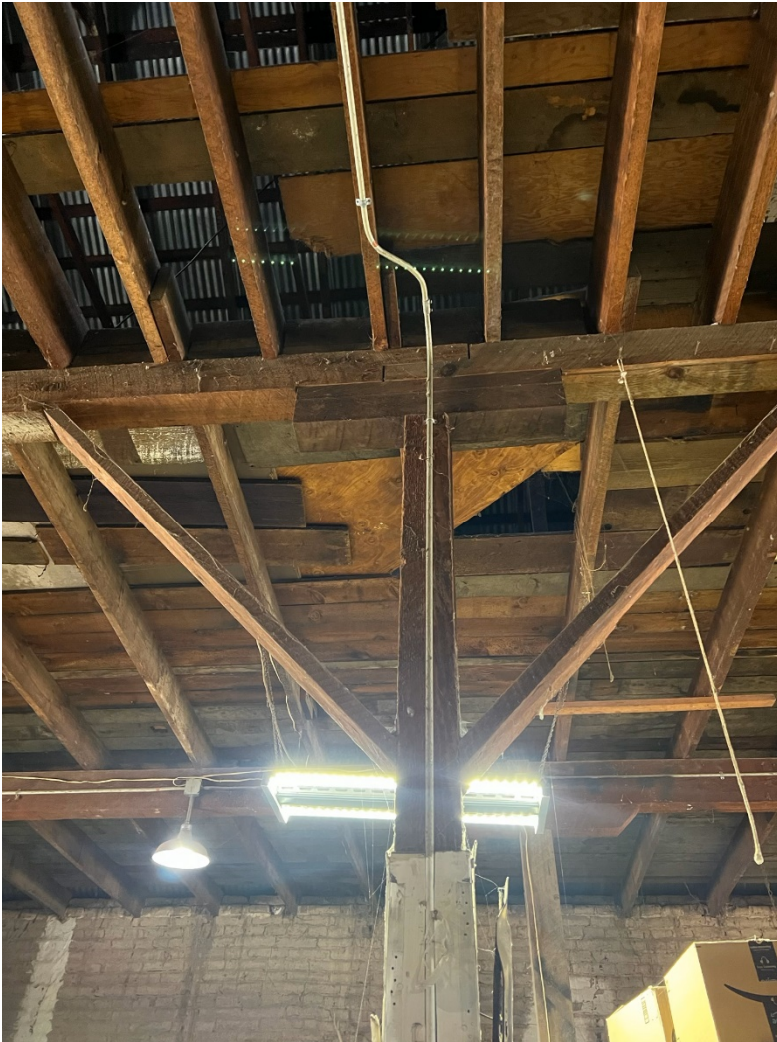
Photograph No. 3
Floor framing

The construction of the structure at the 1902 N. Winery is as follows: All four walls of the structure are unreinforced adobe brick (**See Photo No. 1**). The walls terminate at an approximate elevation of 14'-10" above finish floor and transition to a 1x8 finish to the roof elevation. The floor framing consists of 8x8 beams supported by 8x8 posts. In some instances, the beams appear to be 8x12 still supported by 8x8 posts. The floor framing consists of 2x12 joists at 16"o.c spacing (**See Photo No. 3 and Exhibit No. 1**). In some bays of the structure the floor framing switches to 32"o.c. spacing, but these areas would need to be infilled to have a consistent floor framing system at 16"o.c. The floor sheathing itself appears to be 1x8 straight sheathing. The roof framing is field built trusses at 48"o.c. consisting of 2x6 top chords, 2x4 bottom chords and 1x8 web members (**See Photo No. 2 and Exhibit No. 2**). There is a post and beam system helping to support the roof trusses at both the north and south lines of the
