MASTER PLAN REPORT

FAX Transit Operations & Maintenance Facility Fresno FAX Fresno, California

November 21, 2014

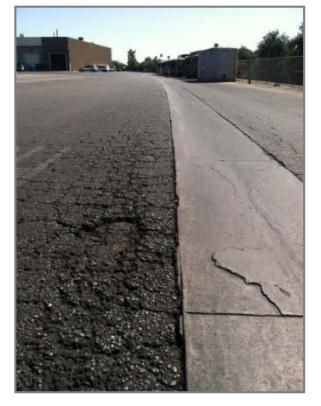
Drive aisle between northerly fence and uncovered bus parking

- Asphalt severely distressed with fatigue cracking extending the length of the concrete ribbon gutter
- Cracking is most severe near the gutter and reduces with distance. Width of cracking is approximately 6 feet to north and 10 feet to south of gutter
- Areas of pavement spalling observed

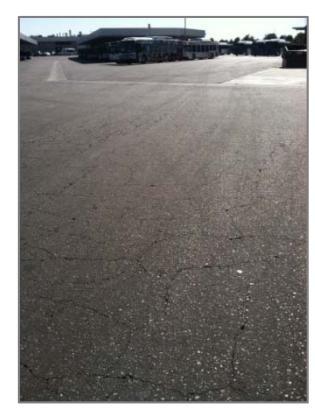
Drive aisle between parking bays and bus wash facility

• Asphalt surface displays moderate levels of fatigue cracking

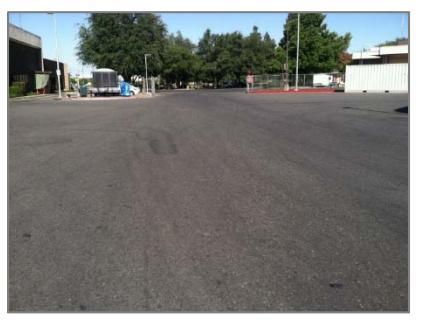
Drive aisle at primary bus exit

• Asphalt in generally good condition

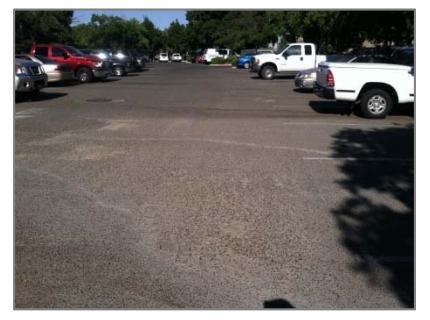
Main Employee Parking (northerly)

Asphalt is weathered and raveling with exposed aggregate

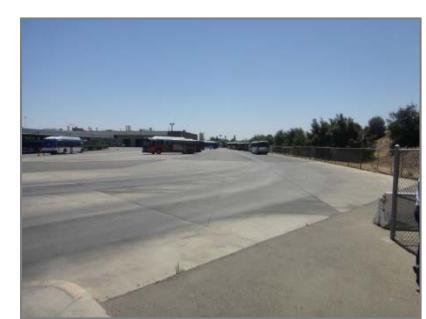
• Most of the PCC pavement on the facility is in good condition, including the bus parking bays

The photo to right is of the concrete pavement to the west of the bus wash facility

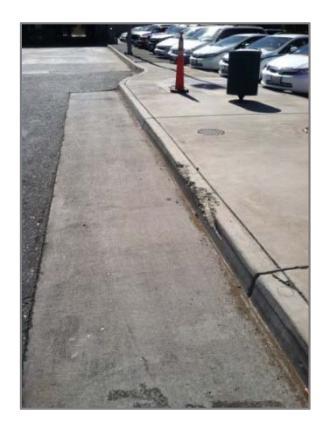
Concrete Curbs

- Most of the concrete curbs and/or gutters are in good condition
- One location near the exit of the bus wash has been significantly scarred, but this is a purely aesthetic issue

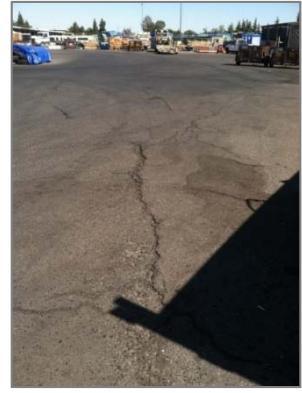
Pavement Behind Maintenance Building

- Weathered and poorly maintained
- Pavement distress ranges from thermal cracking to areas of fatigue cracking

Aggregate becoming exposed in some areas

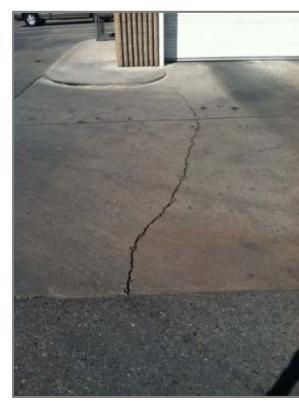
Portland Cement Concrete (PCC) Pavement adjacent to building

• Severe transverse cracking at areas of high stress

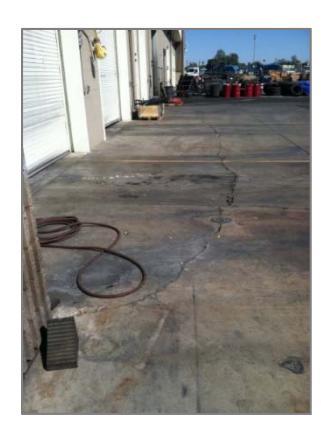
- Severe longitudinal cracking across length of roll-up doors
- Some pavement beginning to spall along the crack(s)

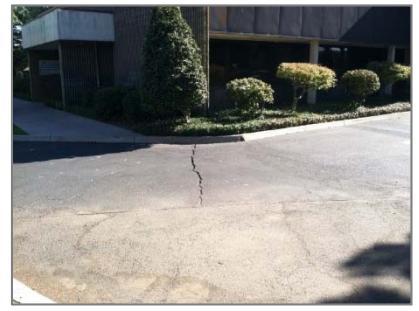
• Pavement in parking bays and straight drive aisles is generally in good condition, with more cracking at the northwest and

northeast corners of the building

Very long, deep, and wide cracks around northeast corner of building. This will lead to moisture intrusion and rapid decline of pavement strength

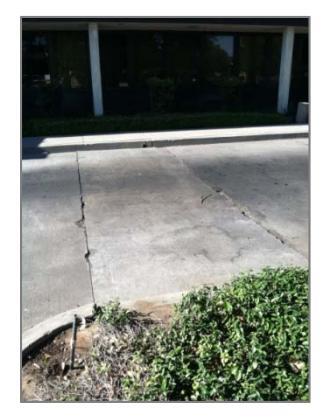
Portland Cement Concrete (PCC) Pavement

- Along the southerly side of the building.
- Pavement is worn with cracking and spalling occurring at joints

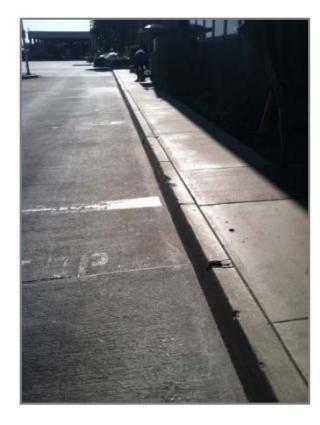
Concrete Curbs

- Most of the curbs are in good condition
- On the south side of the building, the curb is chipped in several locations; but this is a purely aesthetic issue

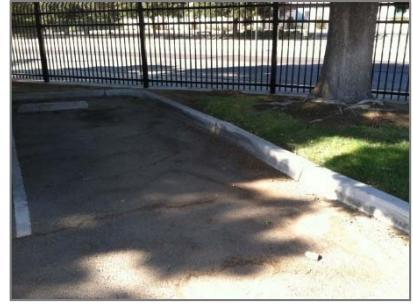
- One location adjacent to a tree at the northeast corner of the parking bay on the north side of the building is uplifting due to the tree roots
- Asphalt paving is lifted, but not yet cracking

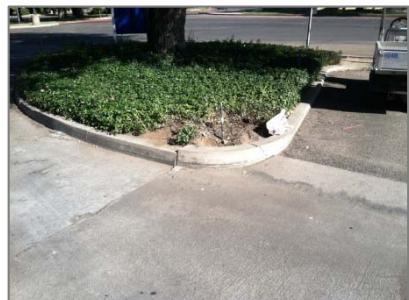
One location adjacent to a tree at the southeast corner of the parking bay on the south side of the building is uplifting due to the tree roots

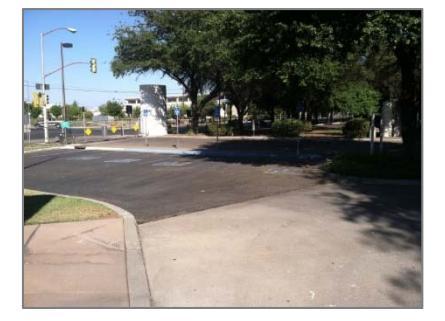
East Side of Administration Building

- Four stalls are marked with signage and the international symbol of accessibility on the pavement
- Stalls are non-compliant due to:
 - ✓ Lack of access aisle for two stalls at far left;
 - ✓ Lack of connection to accessible path of travel
 - Second space from right should be designated "van accessible"

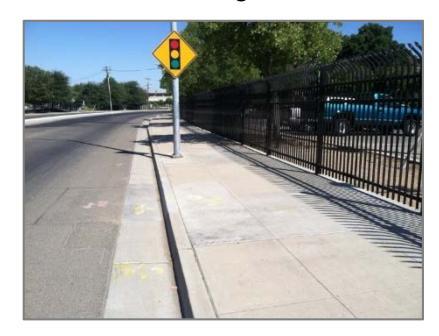
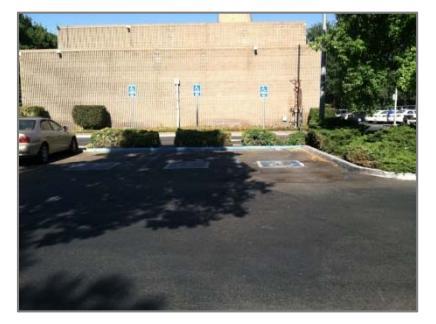
Perimeter Fence along G Street

- Black wrought iron fencing
- New and in great condition

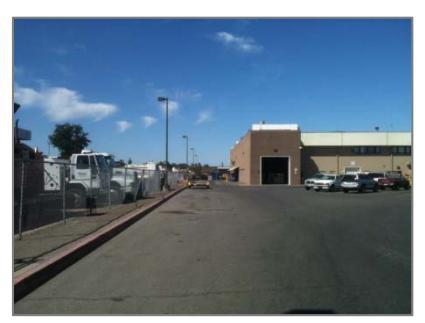
Fencing between FAX and City's Yard

- Chain link fencing without barbed wire
- Generally good condition
- One bent post observed, assumed to be the result of a City vehicle overhang

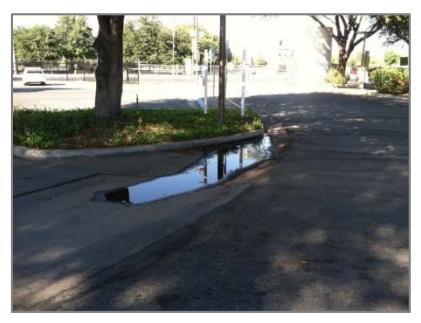
Ponding near exit to Divisadero Street

Regular, possibly daily, use of the fire hydrant to fill City vehicles was observed.
 Water spilling from this activity drains across the asphalt, damaging the pavement and creating a regular pond of standing water within a depression in the concrete gutter

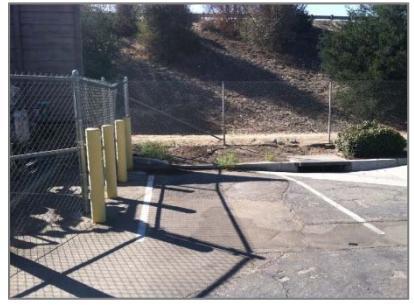
Drain Inlet near Main Employee Parking

Acceptable condition of gutter and inlet; adjacent asphalt shows signs of distress possibly due to water overwhelming drainage facilities

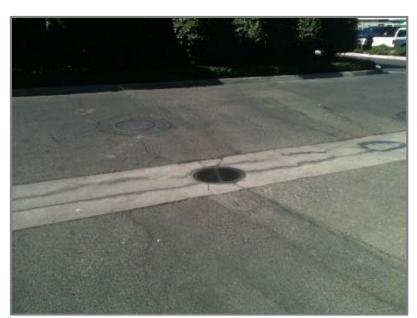
Concrete Ribbon Gutters and Grated Inlets

• Concrete gutters are in acceptable condition and inlets are free of debris; signs of failure of adjacent asphalt pavement is indication that drainage facilities are undersized or not functioning as desired; asphalt pavement failure near gutters was

observed in bus and employee parking areas

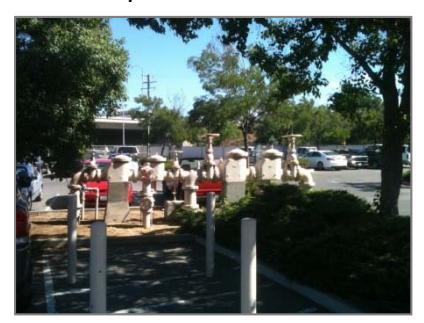
Potable Water/Backflow Preventer

Acceptable Condition

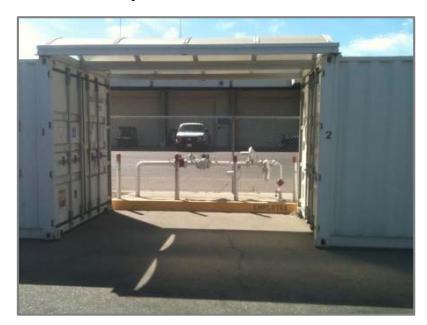
Natural Gas

• Acceptable condition

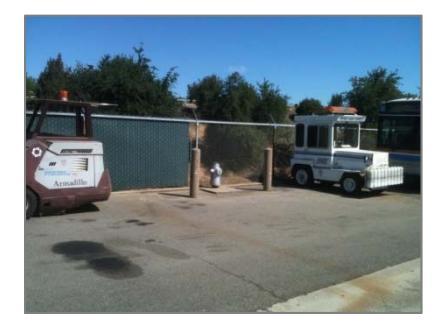
Fire Hydrants

- One hydrant is in the rear of the site behind the Maintenance Building; another is near the northwest corner of the Maintenance Building; both are older models, but appear to be in acceptable condition (hydrants untested)
- The hydrant used to fill the City vehicles near the Divisadero Street exit is not located on the FAX site

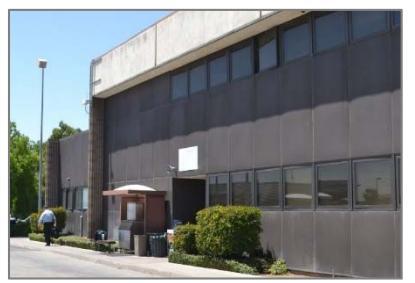
South Elevation

- Building exterior is generally in good condition and does not show any significant signs of deterioration.
- Exterior north/south walls are single-wythe; fluted

concrete masonry block (CMU) and east/west walls are embossed porcelain enamel panels with cement plaster clad fascia at the upper roof.

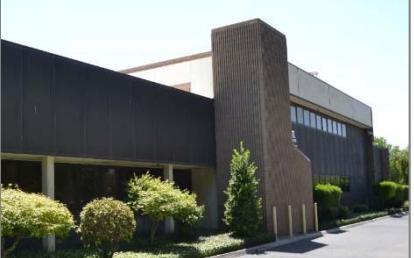
North Elevation

- Existing drawings indicate exterior walls have R-11 batt insulation within metal stud framing.
- ✓ E.P.E. panels may have cement asbestos board substrate. Further

investigation into panel composition will be required to determine if panels pose an environmental hazard.

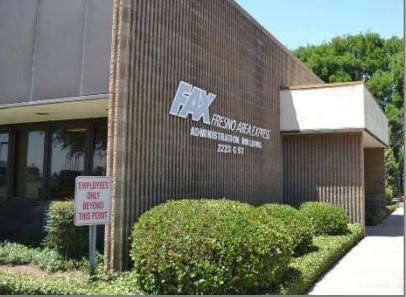
Main Entry (from South/East)

- Windows and storefronts consist of dual-pane glazing in aluminum frames. Openings are generally in good condition.
 - ✓ Operable windows appear to be in good condition, but functionality and hardware of each window was not assessed.
- Exterior envelope of the building may likely not meet current CAL-Green code required insulation values for exterior insulation.
- Exterior doors have push button door operators. Door operators were functioning at time of assessment, but do not meet current code requirements. New door operators are required to be at both high and low positions.

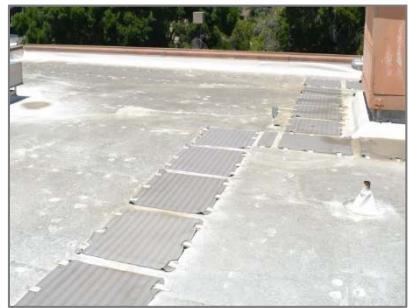
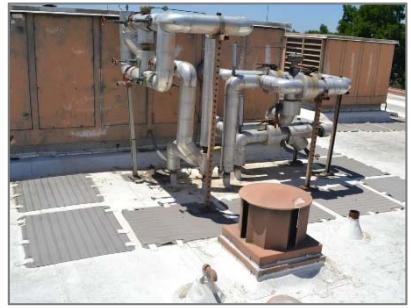
Roof Membrane & Walking Pads

- White membrane roofing does not appear to be original to the building. Roofing is generally in good condition with no apparent leaks.
 - ✓ Existing drawings indicate built-up roofing over lightweight insulating concrete. R-value of concrete is unknown.
 - ✓ Membrane roofing, textured walking pads are in fair condition and are causing debris accumulation in some areas.
- Roof drains have minor but typical debris accumulation around most drains.
- Mechanical equipment does not have screening around it.
- Roof is accessible from west stair.
- See Mechanical and Plumbing assessments for comments on rooftop equipment.

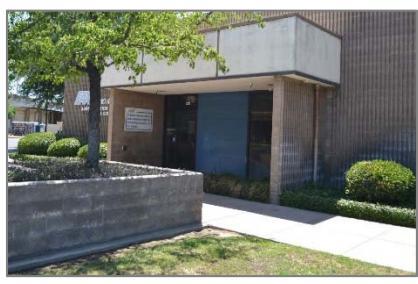
Main Entry (from northeast)

Entry space on east end of building is in fair condition.
 Significant weathering from landscape irrigation is visible on the face of the building adjacent to the entry way

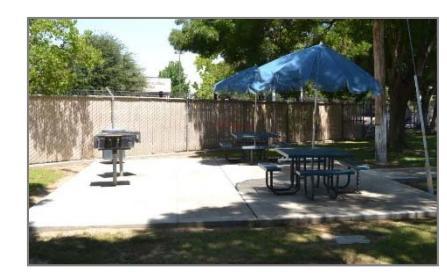
Admin Building Patio

• Barbeque grill and patio space north of the building is in fair condition but does not have direct access from Admin/Ops Building and therefore appears to not be in regular use.

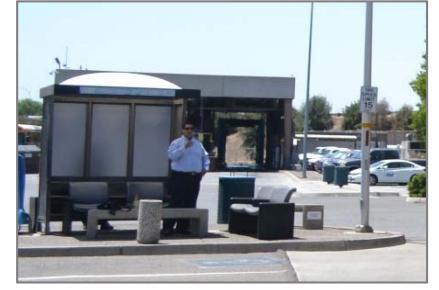
Smoking Patio

• Bus shelter and miscellaneous furniture located on the curb southwest of the building is used as a smoking area. Location of on traffic island does not appear to meet, or be appropriate for, the need for a designated smoking area for bus operators.

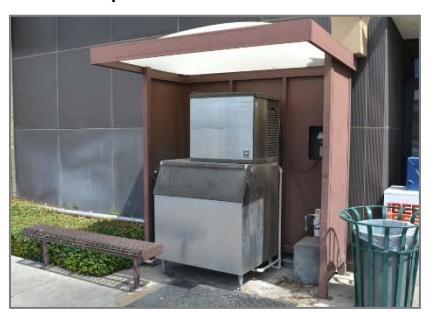
Exterior Ice Machine

Ice machine located adjacent to southwest entry door is located under bus shelter. Ice machine is not rated for exterior location and should be relocated inside or under more adequate cover.

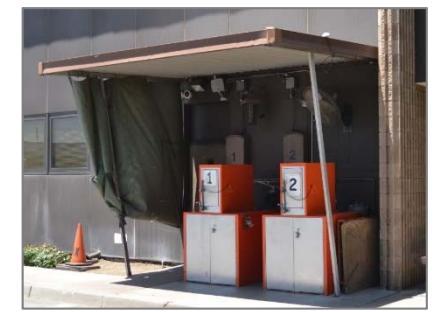
Fare Vaults

• Fare vaults are located under a canopy that is not original to the building. Date of canopy addition is unknown. Canopy does not appear to be providing sufficient cover for vaulting function and tarp has been hung on west side.

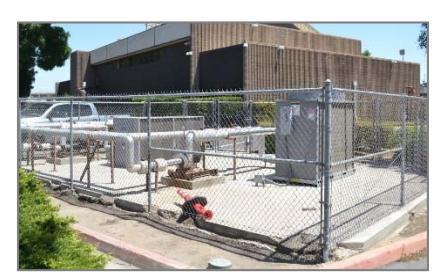
Chiller Plant for Admin

• Utility yard to the northwest only has chain-link fence around mechanical equipment. Screening should be provided around visible exterior equipment.

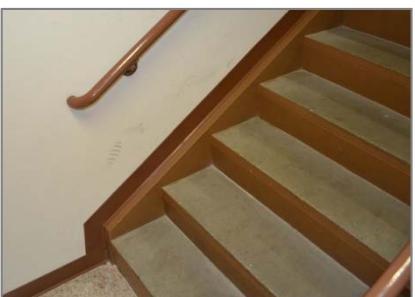
Typical Bottom of Stair & Handrail

- Interior stairs consist of concrete filled metal pan treads with bent metal risers. Rise of all interior stairs is approximately 7-1/4 inches. Current code maximum is seven inches for interior stairs.
- Handrails do not have code required handrail extensions at top
 - and bottom of stairs. Top of stair should have 12-inch handrail extension past top riser and bottom of stair should have extension of 11 inches plus tread depth.
- Stairs also do not have code required contrasting stripes at top and bottom treads of each stair run.

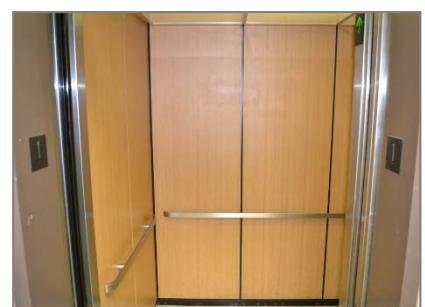
Elevator Cab

• Elevator is not original to the building; date of elevator addition is unknown.

- Elevator appears to meet current Code requirements for elevator access and usage.
- Location of elevator is not obvious and accessible path through second floor corridor/storage room is awkward.
- Elevator equipment room is accessed from the exterior and was not assessed.

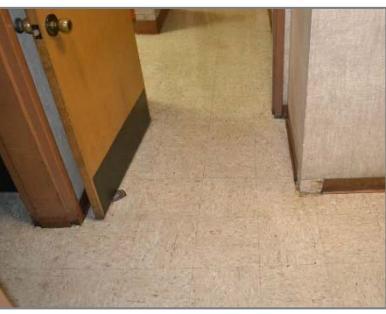
Typical Floor & Door Jambs

- Interior finishes are generally in good condition unless noted otherwise.
- Floor finishes are in fair condition and are generally worn and past typical lifespan. Rubber wall base is missing or damaged in various locations.
- Hollow metal, painted door jambs are worn and in need of repainting.
- Furniture is generally mismatched and inconsistent between spaces. Furniture systems also appear to provide insufficient storage in most areas.

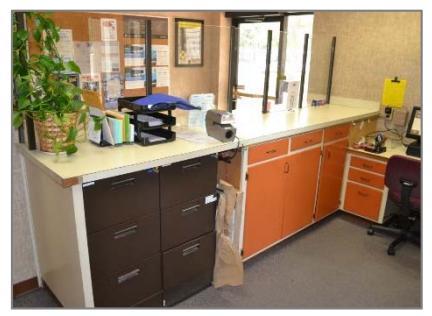
Reception Counter

- Transaction counter is 42 inches tall. Current code requires minimum of 36 inches of counter length to be maximum of 34 inches high. Millwork is otherwise in fair condition.
- Only one of the two offices appeared to be in use.

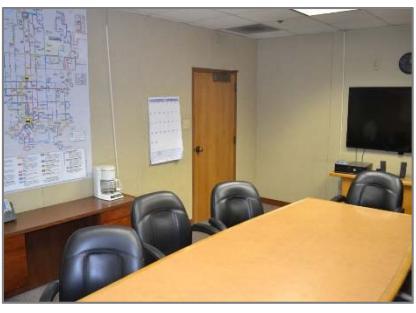
Conference Room

- Room has conference table and chairs for 12 persons.
- Room is generally in good condition, but has exposed data cable covers and miscellaneous furniture that appears unnecessary.
 Furniture is mismatched and

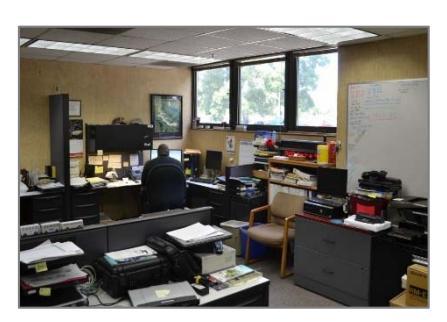
IT Office - 123

Rooms are in good condition. Floor finishes are in poor condition and IT Room is missing a threshold.

IT office has four workstations and other miscellaneous furniture. IT function appears to lack sufficient storage for IT equipment. Portion of storage issue could be solved with more efficient furniture, but additional storage room appears to be

necessary for IT.
Tele/Data equipment appears to be relatively new, but functionality of equipment was not assessed.

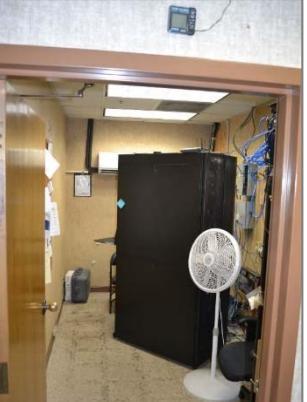
- IT Room has card reader access control.
- Electrical Room 210 also contains some IT equipment that may be in conflict with electrical equipment clearances.

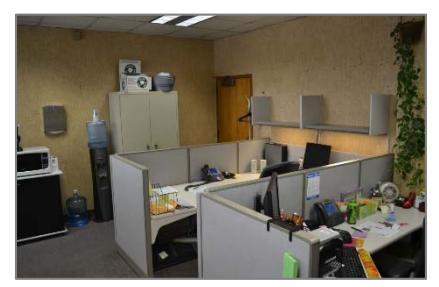
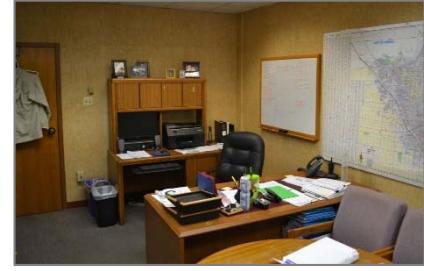
- Shared operations office has five workstations of various sizes. Furniture is mismatched and appears to be an inefficient use of space.
- Carpet is in poor condition and walls show numerous holes from prior furniture anchorage.
- Operations Manager Office is oversized compared to other administrative offices.
- Room contains excessive file storage and insufficient storage furniture.
- Room also has window in Fare Counting Room 131.

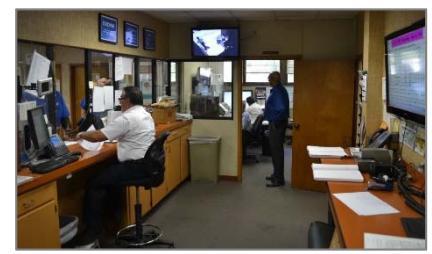
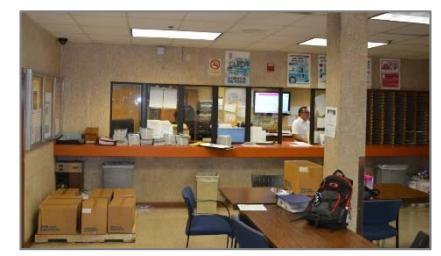
- Dispatch has poor visibility of main entry/exit for Operators.
- Dispatch counter and under-counter cabinets are original to building and are in poor condition.
- Transaction counter is 42 inches tall. Current Code requires minimum of 36 inches of counter length to be maximum of 34 inches high.
- Portion of dispatch counter and window has been replaced with mail slots (date unknown).
- Furniture, storage shelving, etc. is mismatched and inefficient use of space. Miscellaneous storage and cabinetry in space does not appear to be providing adequate functionality for dispatch operations.

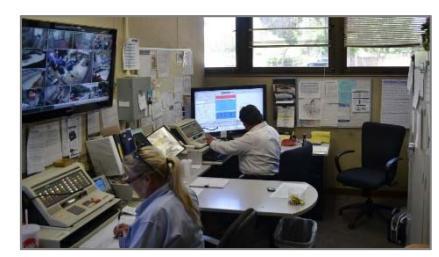
Radio Dispatch room appears to be too small for radio dispatch function. Workstations are too small for the size of monitors and hardware required for function.

- Radio Dispatch space is not original to the building and was originally a file storage room. Room was extended into Dispatch room, reducing the functional area of the room.
- Adjacent Copy and File area appears adequately sized, but furniture is outdated and mismatched.

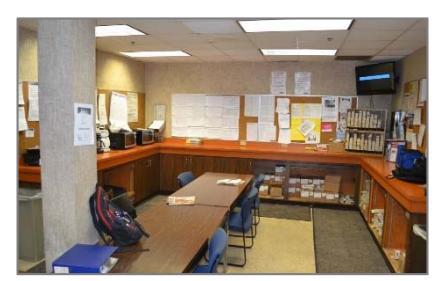
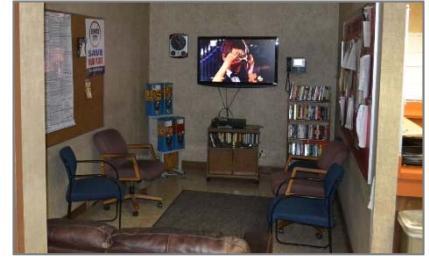
- Room is small for the number of Operators observed at the facility during peak times. Room was very loud which would pose a difficult space to do required paperwork.
- The orientation of the TV Alcove adds to noise in the Operators Room and at the Dispatch counter. Sound source

should generally be located such that the noise is directed away from Dispatch.

- Counter and cabinets are in fair condition. Counter is used • sufficiently, but half of the doors on lower cabinet storage have been removed which adds to visual clutter within the room.
- Operators do not have access to sink or kitchenette, but have • coffee makers and microwaves in the room.
- Bulletin boards are inconsistent and only two are lockable. •
- Space is also used for distribution and storage of route • schedules, pamphlets, etc. further reducing usable space.
- Furniture is in fair condition.

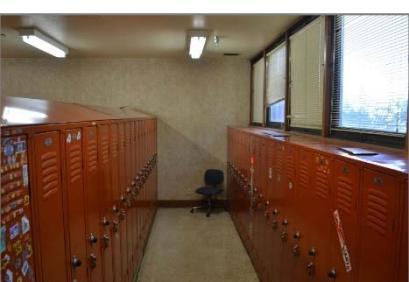
- Lockers are larger than • typically used for Operators. Half-size lockers are generally sufficient.
 - **Operator's Lockers**
- Lockers are generally in good condition with some minor • damage to a few lockers.

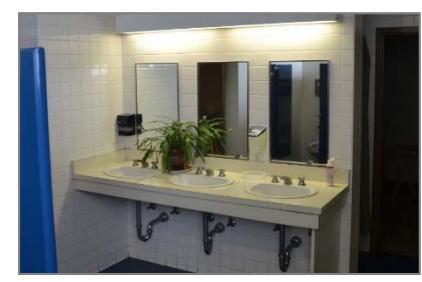
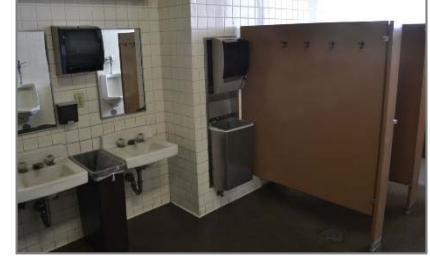
- Bottom of mirror height should be 40 inches maximum at all locations.
- Fixtures and showers appear to be in working condition, but in need of cleaning.

• Finishes are generally in good condition, but the ceramic tile is damaged in several locations and ceilings are showing excessive dust accumulation around ceiling diffusers.

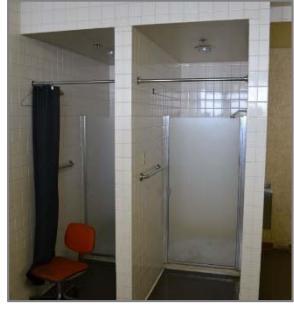
Men's Showers

Showers in both Toilet Rooms are too small to meet current accessibility standards. Where showers are located, minimum of one shower is to be accessible. Hand-held shower, folding bench, and grab bars are also required in accessible shower.

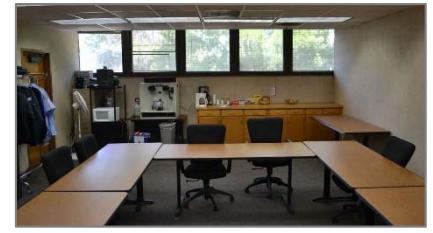
Training Room

- Room is adequate size for training and as secondary conference room.
- Room has a projection screen that appears to be in good condition, but room

does not have a built-in projector. Projection screen is small for the size of the room.

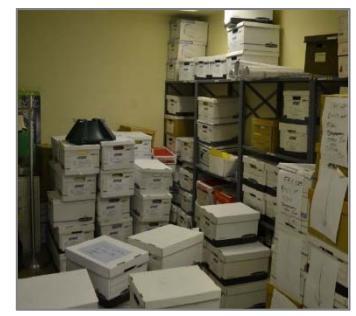
File Storage

- Room is not adequate size for the amount of file box storage.
- Shelving should be anchored to the walls per current seismic code requirements for tall shelving.
- Stacking of file boxes as observed may pose safety issues.

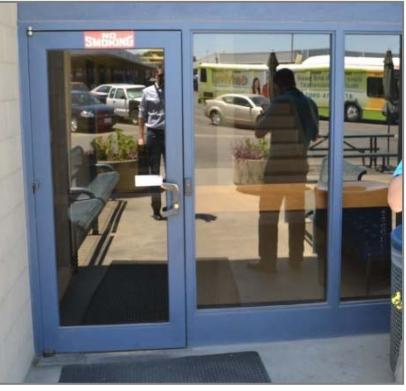
Main Entry Storefront Glazing

- Additional windows located in office area are not shown in the original drawings but windows are also in good condition.
- Main entry storefront consists of non-insulated glazing in hollow metal frame. All other doors are typical hollow style doors and frames and are in good condition.

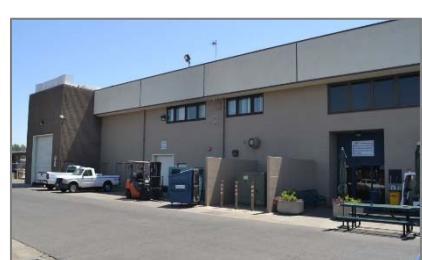
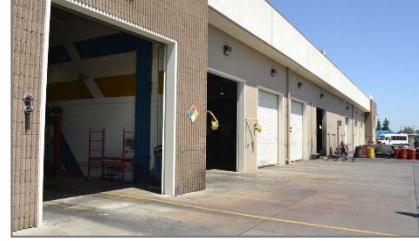
- ✓ Exterior envelope of the building may likely not meet current CAL-Green code required insulation values for exterior insulation.
- ✓ Exterior is generally in good condition and does not show any significant signs of deterioration.

- Exposed conduit for lighting, gas detection, etc. is visible in numerous locations on exterior walls, but exterior is generally free of extraneous utilities.

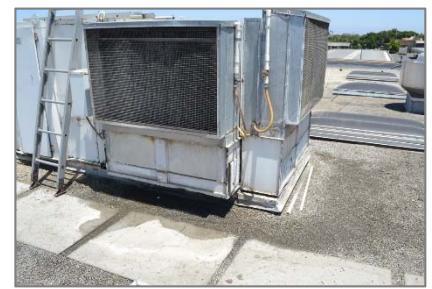
Roof Leak at HV-2

- At time of assessment roof was leaking under roof-top unit HV-2. Leak was located in the center of the second level parts storeroom.
- Roof is ponding in several locations around overflowing evaporative coolers.

- Storage Mezzanine 208 & 209
 - Rooms are in good condition with the exception of the leaking roof as noted above. Fireproofing may be damaged by significant leaks and further investigation may be required.
 - Rooms are separated by rated coiling doors with fusible links. Doors appear to be in good condition.

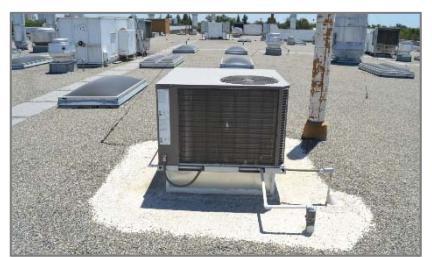
New White Membrane Roofing

- ✓ Existing drawings indicate built-up roofing over lightweight reinforced insulating concrete with three inches of insulation board. Total R-value of roof is unknown.
- At one location, roof has had fluid-applied, white membrane added over original built-up roofing around HVAC unit that is likely serving the Facilities Supervisor and Transit Police offices. Date of

spray-applied white roofing is unknown.

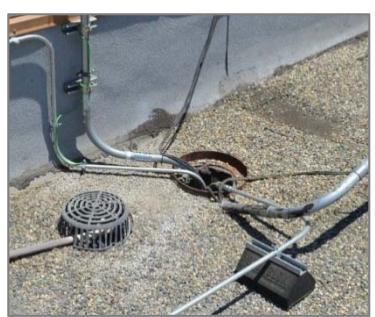
Conduit through Overflow Drain

- Roof drains have significant debris, dirt accumulation around most drains, with some drains having plant life growing within build-up around drains. Insufficient cricketing of roof edges appears to be causing ponding around drains and other locations.
- Various locations: Paint on parapet coping and various flashings is deteriorating. Parapet cap around entire perimeter is showing signification weathering and rust.
- Electrical conduit routed through overflow drain in one location. Integrity of conduit and overflow drain is unknown.
- Skylights throughout building appear to be in fair condition. Acrylic domes show significant weathering and are not transmitting as much light as possible.
 - About half of skylights are also operable smoke vents. The functionality of smoke vents was not assessed, but several were visibly leaking fluid from hydraulic mechanisms.

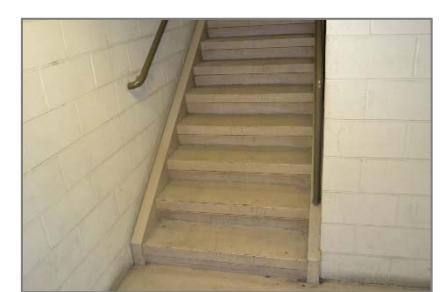
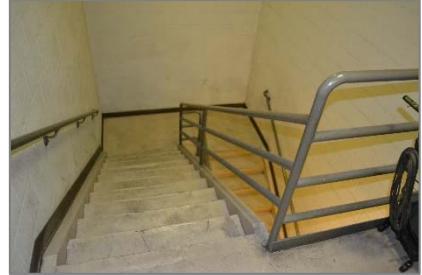
- Stairs are generally in good condition, but painted stairs are in need of repainting.
- Interior stairs consist of concrete filled metal pan treads with bent metal risers. Rise of all interior stairs is approximately 7.09 inches. Current Code maximum is seven inches for interior stairs.
- Handrails do not have Code required handrail extensions at top and bottom of stairs. Top of stair should have 12-inch handrail extension past top riser and bottom of stair should have extension of 11 inches plus tread depth.
- Stairs also do not have Code required contrasting stripes at top and bottom treads of each stair run.

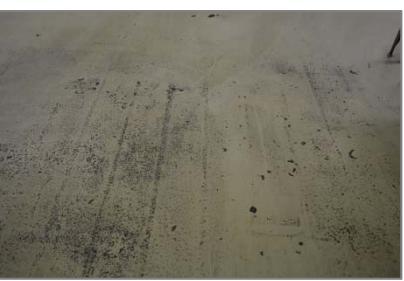
Typical Floor Finish

• Concrete floors are currently in poor condition. Light colored floor finish is worn and peeling in numerous locations. Multiple

locations have new concrete slabs that were not refinished to match the remainder of the building.

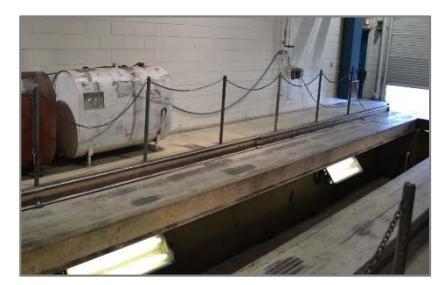
Pipe and Rail Guards at Pit

- Removable pipe and chain guards as shown on original drawings were removed from interior inspection position, but guards are still partially in place for position closest to north door.
- Rails were added to guide buses along inspection pits. •
- Inspection pit has cardboard on floor to absorb fluid spills and . leaks. Floor should have permanent solution to collect fluid spills.

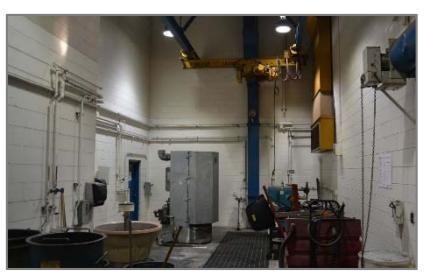
Component Clean Area

- Floor in component clean area is worn and in need of refinishing.
- Lighting in component clean is very good, but much higher foot candles than elsewhere in the Maintenance facility.

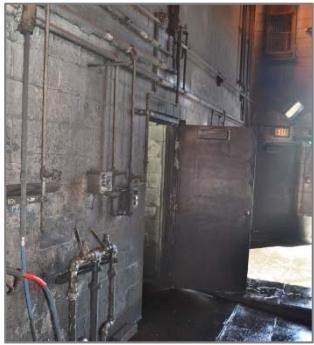
Chassis Wash Bay

The Chassis Wash bay has significant residue accumulation from chassis wash operations and wall paint is flaking off. Room is in need of significant

cleaning and refinishing.

- Pipe insulation on wall mounted plumbing is deteriorating and should be replaced.
- Light levels within chassis wash bay are low compared to other bays and shops. Lighting levels should be consistent between spaces.

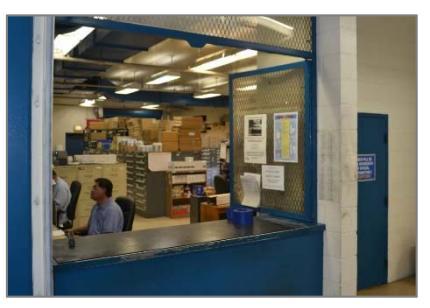
Parts Counter

- Painted parts counter is heavily worn. Re-painting of transaction counter is generally not recommended. Stainless steel surface is typically specified for a parts counter.
- Exit sign above door to Stair 6 corridor is missing and should be replaced.
- Four workstations adjacent to parts counter are in good condition and appear to be sufficiently sized.
- Parts Room Office 132
 - ✓ Room is sufficiently sized but has inefficient furniture.

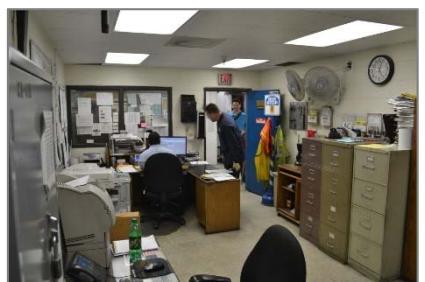
Supervisors Office

- Shared Supervisor office has two shared workstations in addition to other various furniture. Furniture is mismatched and inefficient use of the space.
- Space is adequate but more efficient furniture layout would provide space

adequate for at least three workstations.

- Windows into maintenance shop is in good condition but it covered with paperwork.
- Room is in good condition with the exception of the composite tile flooring which is in poor condition.

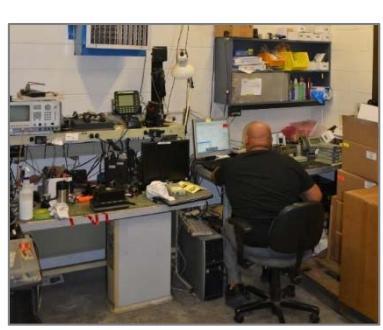
AC Unit

- Room was originally designated as the Battery Room.
- Room has insufficient storage and appears to be lacking proper work bench for amount of working being performed.
- Room has freestanding portable air conditioning unit that is vented through existing wall vent.

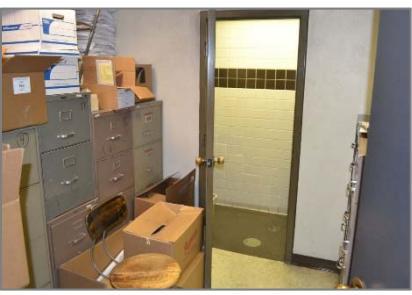
File Storage & Toilet Room Beyond

- Room was originally designated at the First Aid Room but is currently used for storage.
- Small toilet room at the rear of the room is not up to current accessibility standards, but would likely

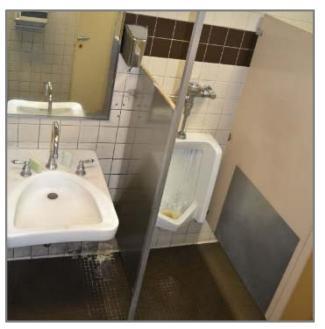
Men's Room Fixtures

- Both toilet rooms can be made accessible by removing the toilet partitions and converting to single occupancy toilet rooms.
- Toilet room stalls do not meet current accessibility clearance requirements. Stalls must be minimum five feet clear.
- Toilet paper dispensers and grab bars are not mounted at the correct heights.

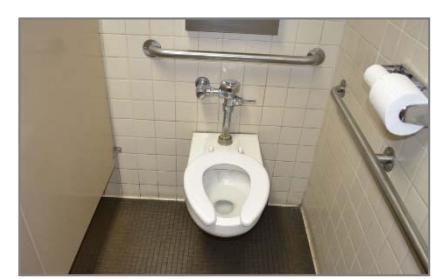
Men's Room Toilet

- Finishes in the Women's room are in good condition. Finishes in the Men's room are in poor condition.
- The sink in the Men's room does not meet accessibility clearances for sinks. The sink in the Women's room is compliant.
- Both sink drains are missing required pipe covers.

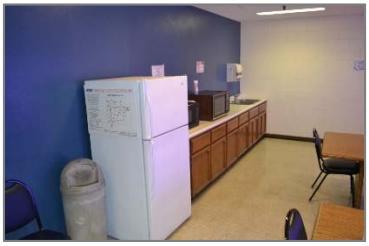
Kitchen Cabinets & Appliances

- Room and finishes are in good condition. Kitchen cabinetry is in fair condition. Appliances have not been assessed.
- Kitchen sink is not accessible and does not provide knee clearance under the sink.
- Evacuation sign is located on side of refrigerator. Signs should be located in conspicuous location adjacent to door.
- Furniture is in good condition.
- Maximum occupancy sign above door does not state occupancy and signage text is too small per current code.
- Room is also used for occasional training but does not have projector or projection screen typical of most training rooms.

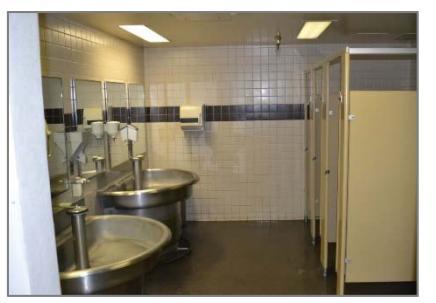
Toilet Room

Toilet and Locker Rooms do • not meet accessibility standards. Rooms would be required to be updated or provide reasonable accommodations elsewhere on the same floor in order to meet current Building Codes.

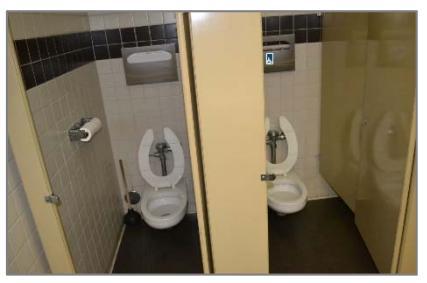
Non-Accessible Toilet Stalls

- Room has five showers, three urinals, three toilets, and two semi-circular hand wash basins. Minimum of one sink, toilet stall, urinal, etc. should be provided to make restrooms accessible.
- Hand wash basins do not quality as accessible sinks.
- Room was originally planned for 48, 12-inch wide by 15-inch • deep lockers. Original lockers have been replaced with 46, 18-inch wide by 20inch deep. Minimum of 5 percent of lockers and one bench should be made accessible.
- Bench has been added to • shower room.

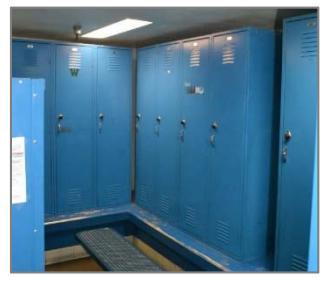
Large Lockers

- Lockers are generally in fair condition with some minor damage and wear to multiple lockers.
- Lockers do not have sloped tops, allowing for storage of miscellaneous items on top of lockers.
- Showers are not accessible size or configuration. Shower • does not have seat, proper hardware, and has large threshold.
- Fixtures all appear to be in working condition.
- Ceramic tile is generally in good condition with some minor damage and wear in various locations.

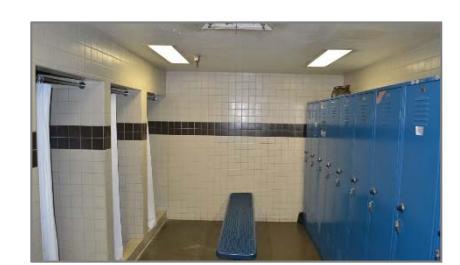
Shower Room w/ Large Lockers

Ceilings in shower room are in poor condition and exhaust • grilles have significant dust accumulation.

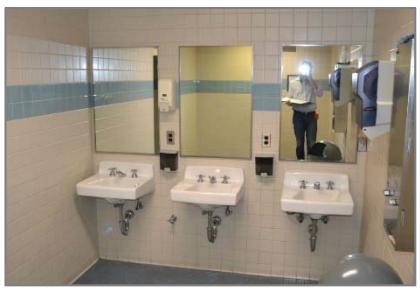
Sinks without Pipe Guards

Toilet and Locker Rooms do • not meet accessibility standards. Rooms would be required to be updated or provide reasonable accommodations elsewhere on the same floor in order to meet current building codes.

- Room has two showers, two toilets, and three sinks. Minimum of one sink, toilet stall, urinal, etc. should be provided to make restrooms accessible.
- Room was originally planned for 45, 12-inch wide by 15-inch • deep lockers. Portion of original lockers have been removed; only 24 remain and two, 18-inch wide by 20-inch deep lockers have been added. Minimum of 5 percent of lockers and one bench should be made accessible.
- Sinks are accessible, but drains do not have Code required • pipe guards.
- Fixtures appear to be in working condition.
- Finishes are all in very good condition.

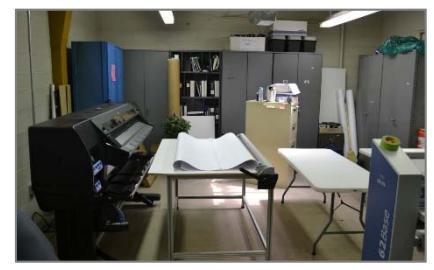
Print Shop Equipment

- Room is adequate size for • printing operations. Miscellaneous storage furniture appeared to not be utilized and could be relocated to provide more space for printing function.
- Smoke vent/skylight located within room appeared to be • dripping grease.
- Room access is controlled by card reader. •

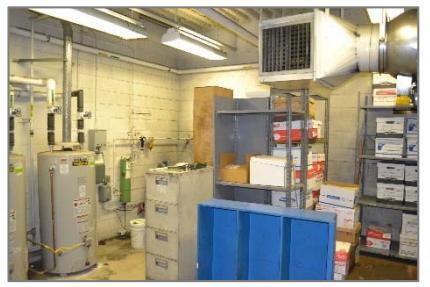
Mechanical Equipment & File Storage

- Room contains various • utilities (hot water heaters. air compressor, and electrical panels).
- Room is also used for file • storage and other miscellaneous storage. Paper storage should be separated from utilities to ensure files are not damaged and are secure.

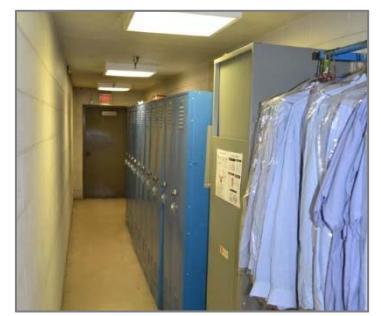
Lockers Located in Corridor

- Storage of lockers and uniforms • in eqress corridor as observed in first floor corridor from Stair 6, is prohibited by code. Lockers and uniforms should be relocated to appropriate areas.
- Doors at the ends of the Paint Bay and Inspection Bay do not have sufficient push clearance on latch side of doors. Doors

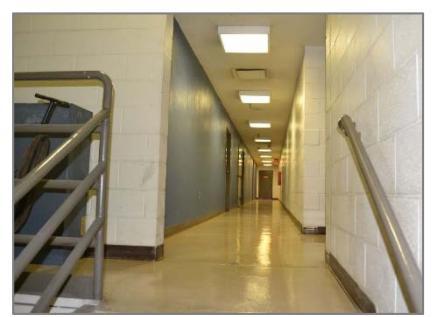
Stair-5 Open to Corridor

Pending detailed design • process, the use of Stair 5 for exiting from second floor may not be permitted since stair exits through an intermediate space (maintenance bays). Exiting will be determined by occupancy and existing analysis typically done

during the schematic design phase of the architectural process.

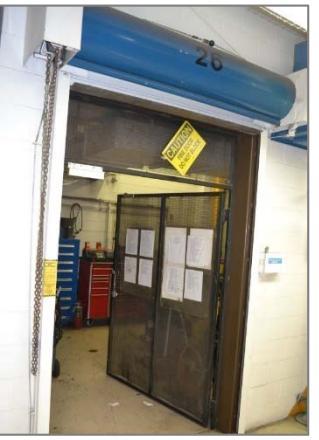
Fire Shutter on Room 135

Fire shutters on storage rooms 135 and 137 create egress issues for occupants. In the event of a fire the fire shutter will close, trapping those inside without an exit. Necessity of fire shutters on these rooms is likely not required by the current code and could be removed. Electronics Shop-138 has a similar issue with the fire shutter but has separate man door that would allow for egress.

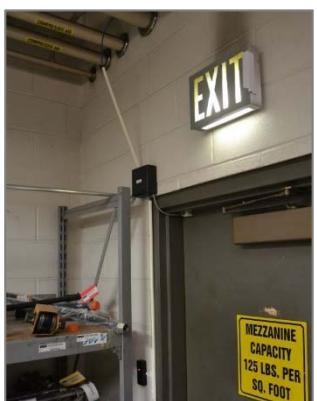
Typical Card Reader Wiring

- Card readers have been added to various doors throughout the facility. Cabling to card readers has been installed is plastic cable covers. Low-voltage equipment should be concealed within appropriate conduit.
- Maintenance Management and Supervisors functions do not have a separate break room or kitchenette. Numerous microwaves, refrigerators, and other appliances are located throughout the facility. Appliances and break spaces should be consolidated into specific areas.
- Finishes are generally in good condition, unless noted otherwise. Most areas have significant wear typical of maintenance facilities.

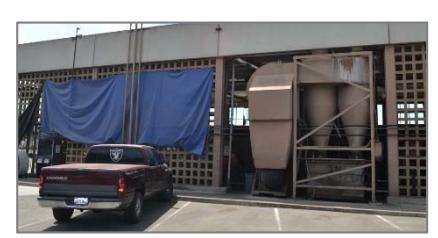
Removed CMU on N. Elevation

- Large portions of the north wall have been removed to make room for equipment (fuel dispenser and vacuum equipment).
- Tarps have also been hung on north face of the building along fuel lanes apparently to shade the interior.
- Exposed conduit for lighting, gas detection, security cameras, etc. is visible in numerous locations on all exterior walls.
- Canopy added over CNG fuel dispenser on south side of building. Date of canopy addition is unknown.

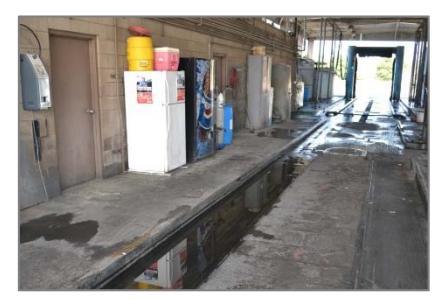
Service Lane

Drainage from bus wash cycle was observed overflowing beyond floor drainage between bus washer and vacuum position. Standing water in service lane is likely leaking into unused lower level. Drainage and floor slopes should be analyzed in more detail.

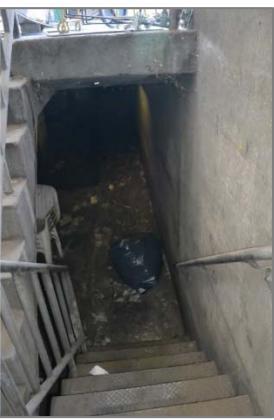
Stair to Lower Level

- Lower level has been abandoned and is no longer used for bus inspection, but stair access is still open.
- Floor openings have steel plates added to cover openings but plates are not sufficiently secured to prevent movement.
- Lower level space was not thoroughly assessed due to significant odor, but space was observed with standing water and trash. Environmental hazards of space have not been assessed but it is likely that local jurisdictions may require special precautions or remediation to be

addressed if space is to be repurposed or completely abandoned.

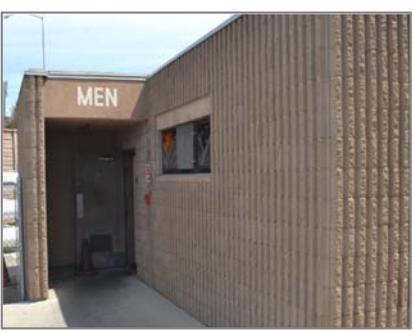
Building Exterior

The Toilet and Locker building is located at the northwest corner of the Fuel and Wash Building and is meant to serve as the locker and toilet rooms for the service attendants but the building is currently underutilized due to small size of lockers and lack of showers.

- Building consists of fluted, single-wythe CMU walls and metal deck roof. Building has no added insulation
- Mens room has 22 lockers and Womens room has 11 lockers. Lockers are all 60 inches tall by 15 inches deep by 12 inches wide. Lockers are small relative to the lockers available in the Maintenance Building locker rooms. Lockers are not being used.

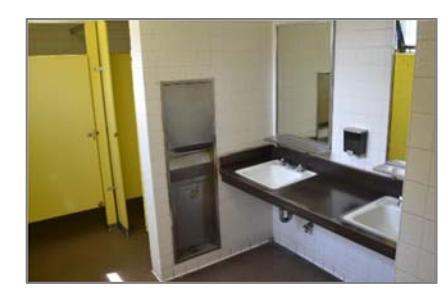
Womens Room Interior

- Sink vanities in both rooms are in very poor condition and sink drains do not have pipe guards.
- Toilet stalls do not meet current accessibility clearances.

- Men's room has two urinals. Minimum of one urinal should be at accessible height.
- Men's room toilet stall door has been partially painted black.
- Women's room paper towel dispenser and waste bin is missing waste bin and paper towel dispenser is not being used.

- Finishes are in fair condition with the exception of the ceilings which are in poor condition.

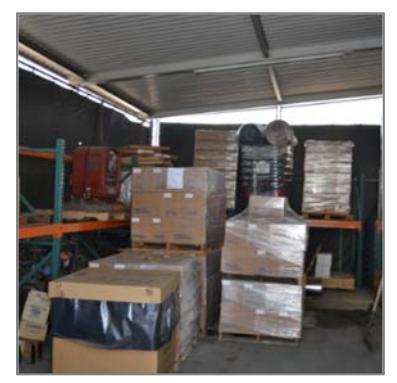
Covered Palette Storage

- Building does not have restroom or any other plumbing that was visible during assessment.
- Canopy structure off of building to the north is used for palletized storage.
 Canopy has fluorescent lighting but does not have fire sprinkler system.

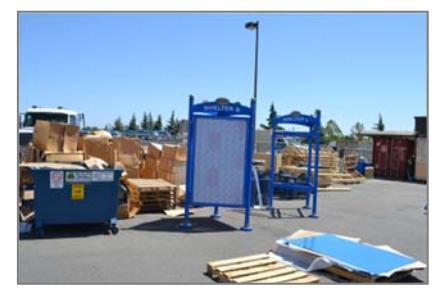
Exterior Uncovered Storage

• Function appears to be lacking sufficient exterior covered storage. Several portable containers are being utilized for storage needs and a large percentage of materials are stored in the yard.

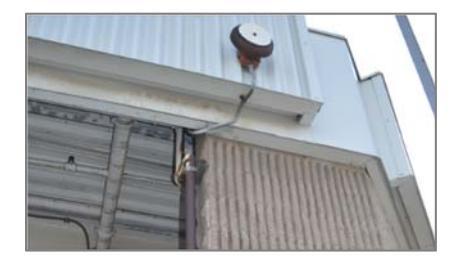
Fire Protection System

- Canopies are generally in good condition, but there is significant paint flaking and chipping on the underside of the canopies.
- Fire sprinkler system appears to have adequate coverage. Multiple pipes, particularly at ends of canopies have significant weathering and should be repainted to protect piping.
- Lighting systems appear to be adequate for canopies.
- Roofs were not accessible for assessment but no apparent leaks were observed.
- Photovoltaic system on roof of canopies has not been assessed. System was added in 2004 according to as-built drawings.

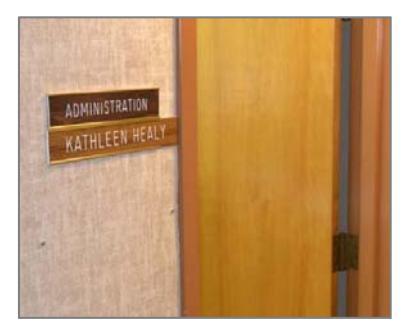
Typical Room ID Signage

- All buildings lack proper room identification signs and accessible way-finding signs with braille and raised text that is required by code. Room ID signage is sporadic and not consistent between all of the building. Room ID signage should be adjacent to doors and have minimum of raised room numbers and braille lettering.
- Restroom signage does not meet current Code for room identification.
- Evacuation maps also do not meet current Code requirements. For example, signs should indicate location of horns and strobes for fire alarm systems.
- Stairwells and exit paths lack tactile exiting and egress signage required by Code.

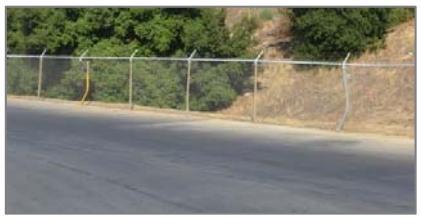
Damaged Perimeter Fencing

- Picket style, black security fence added to G Street frontage is in excellent condition. Fencing was in the process of being erected during assessment.
- Chain-link fencing with barbed wire around remainder of external perimeter is generally in fair condition, but several locations have apparently been damaged by bus collisions.

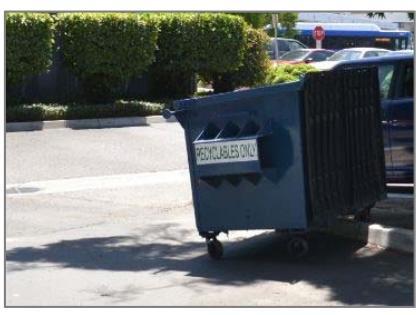
Recycling Dumpster in Admin/Ops Parking Lot

Buildings do not have trash or recycling dumpster enclosures. The CEQA (California Environmental Quality Act) or other local jurisdiction may require refuse containers to be located within a covered enclosure to prevent storm water from collecting in bins.

• Recycling dumpster at the Admin Building was observed propped up on curb in the employee parking lot.

Further analysis will be required to determine if necessary for FAX facility.

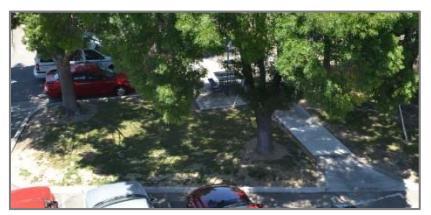
Landscaping Around Patio

- The landscaping at the facility exists only around the Admin/Ops Building and employee parking lot. No landscaping exists around the maintenance building or Fuel and Wash Buildings. Landscaping within in the MSC campus was not assessed.
- Plantings are generally in good condition, except as noted.
- Grass and vine ground cover is inconsistent and mulch is non-existent.
 Exposed soil and exposed sprinklers are typical of most areas.

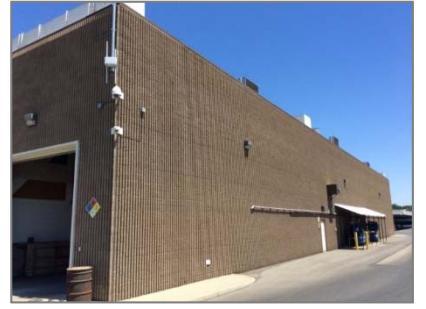
South Façade (North façade similar)

A significant item of note is a discrepancy that was observed between the structural drawings and the actual structure. The structural and architectural drawings provided to Arup both show a 12-inch concrete wall around the building perimeter, but these walls were found to be CMU upon inspection. This substitution may be sufficient to resist the required loading, however it raises questions about the construction quality control program. Such a change should never be made during construction without clear documentation and approval of the structural engineer of record. If this was done without the engineer's knowledge or without proper verification of the substitution, it is also possible that other deviations exist that could not be observed during this site visit.

Many penetrations exist in East and West facades, whereas North and South facades have few penetrations. Substantial equipment and penetrations exist on roof. Note perimeter walls are given as concrete in the structural drawings but were built as CMU.

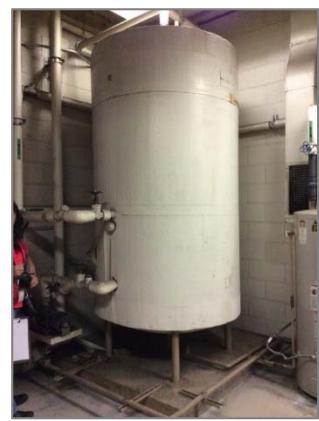
Large objects appear to be generally anchored, but falling hazards may still exist. Objects may slide off of shelving, a large water tank may not be sufficiently anchored, and an exhaust stack is anchored to a duct.

Tall water tank anchored to floor only

If the maintenance building is to be incorporated into the long-term functioning of this facility, it is recommended that a more rigorous structural evaluation be performed. A seismic analysis of the structure is recommended to confirm conformance with current code practice, as seismic codes have changed substantially since this building's construction; this will be required if the building's use, occupancy or geometry are changed as part of the master plan. Such an analysis should incorporate as-built information such as the substitution of masonry for concrete walls described above.

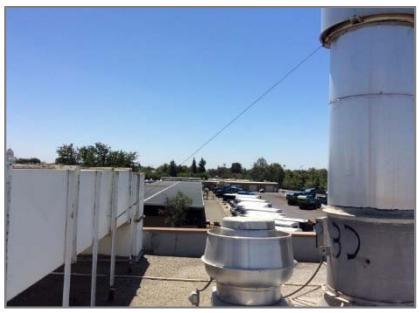
Another seismic consideration is the anchorage of non-structural components to minimize the risk of injury due to falling objects during a seismic event. In general, it appears that consideration has been given to this in this building, though some concerns exist. Tall storage shelves were observed to be bolted to the floor, though objects on these shelves could still slide off. A large water tank is bolted to the floor, but supported upon slender legs which may not be robust enough to prevent toppling. Rooftop equipment appears to be anchored, though in one instance it was observed that an exhaust stay cable was anchored to a duct.

Exhaust stack anchored to duct
