MASTER PLAN REPORT

FAX Transit Operations & Maintenance Facility Fresno FAX Fresno, California

November 21, 2014

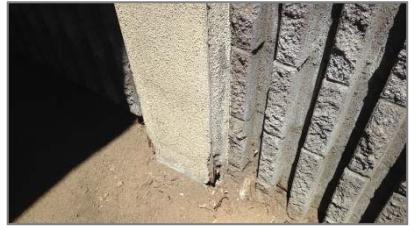
The structure is generally covered by architectural finishes, limiting the ability to observe its condition. Indirect observations, such as lack of water damage to finishes and lack of cracking due to excessive foundation settlement, suggest that the structure is generally in good condition. One exception is an exterior steel column at the South building face, which has suffered significant corrosion damage. The column does not appear to have been protected from the elements except for a thin plaster cladding, and soil is built up around this cladding. In this location the cladding was damaged and water could penetrate. The column could not be viewed closely enough to determine how much damage has occurred to its base plate or how much capacity has been lost. The same detail appears to exist at other exterior columns, but it was not evident that other columns have similar damage.

Damaged exterior structural column located at grid D/9

The following more detailed structural evaluations are recommended. The observed corroded column should be investigated by removing existing cladding and evaluating the extent of corrosion damage to the column and its base plate. Other similar columns should be closely observed and perhaps some finishes removed to confirm whether similar damage exists. Also, if this building is to be included in the long-range planning for this facility, a detailed seismic analysis should be conducted to determine if it meets current seismic design standards. Such an analysis will be required if significant changes in use, occupancy or geometry are anticipated.

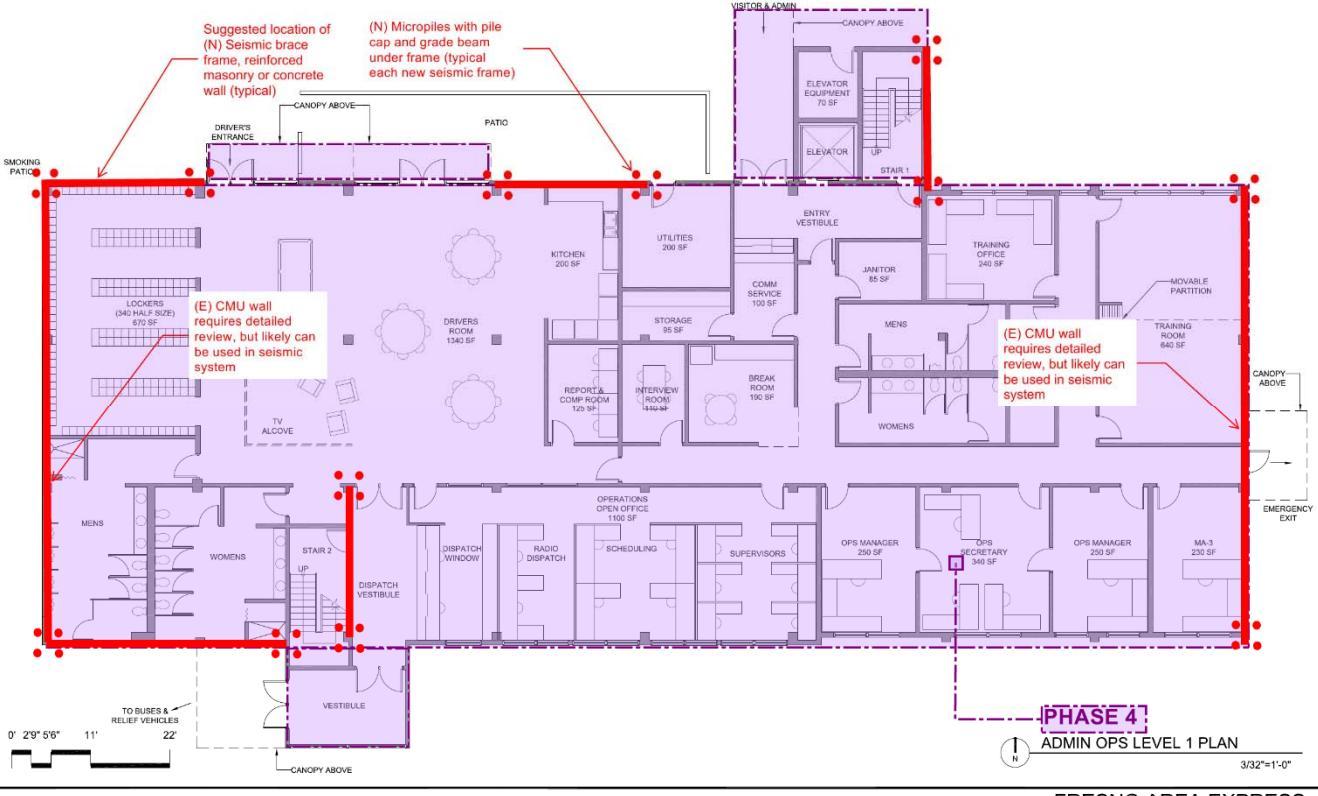
Figure 2.B - Seismic Upgrade Concept - Level 1

The first consideration is the vertical framing system. The eastwest steel brace frames, if they were to remain, would likely not be sufficient to resist current Code forces. A more robust system of concrete or reinforced masonry shear walls or steel brace frames is recommended. Figure 2.B shows some possible locations for such components. In the north-south direction, the proposed program may permit existing exterior CMU walls to remain intact. These walls can likely be incorporated into the new seismic system and extended to the new second floor level, though detailed structural evaluation is required to confirm this. Additional interior shear walls should be provided.

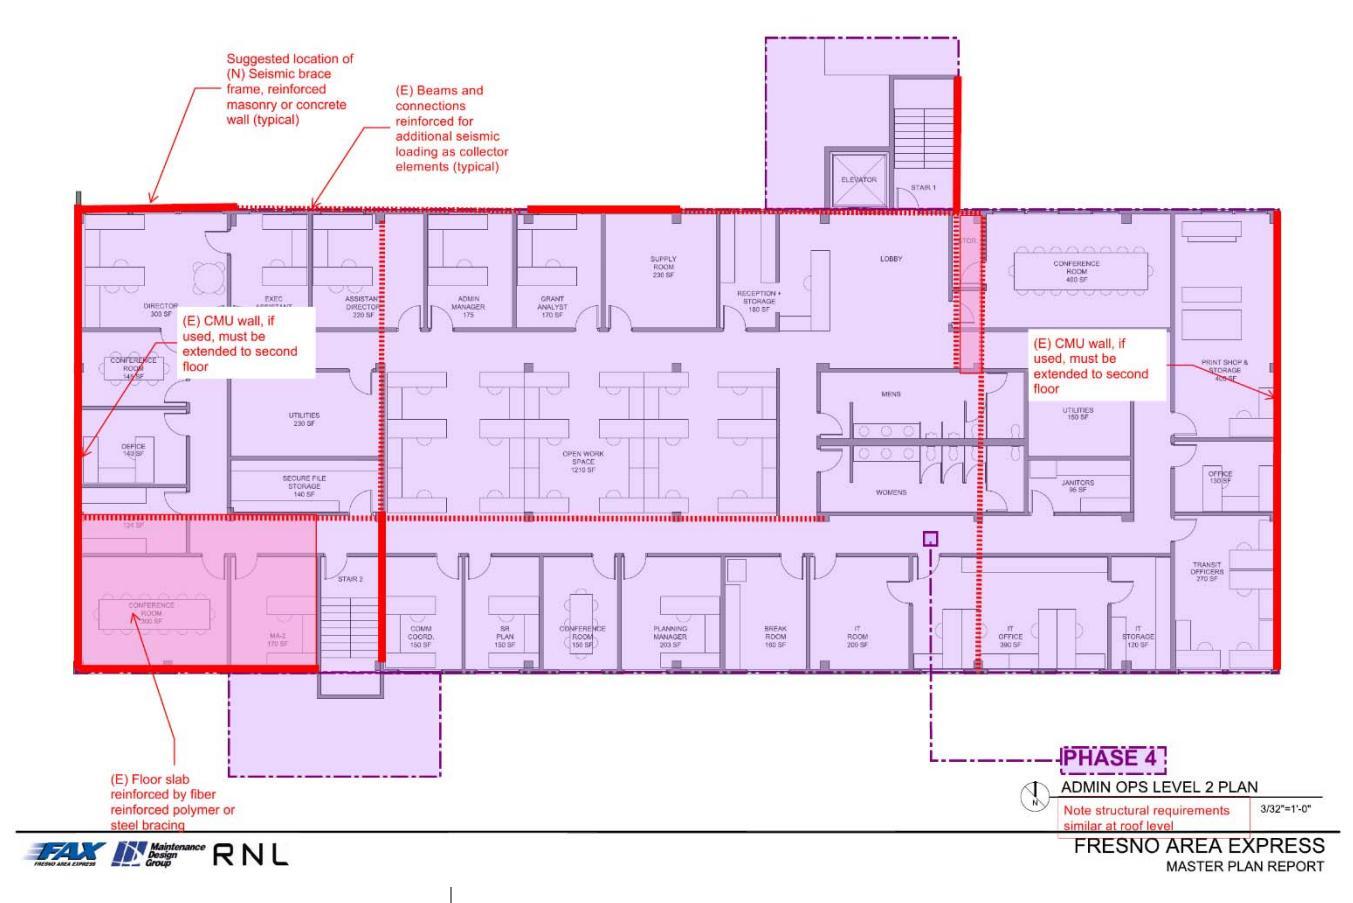
Figure 2.C - Seismic Upgrade Concept - Level 2 and Roof

Thirdly, to distribute seismic loads uniformly from the floor slabs to the vertical framing elements, a system of collector elements should be provided. These elements are shown as dashed lines in Figure 2.C. A typical collector line can consist of a line of steel beams with end connections specially designed for seismic loads generally welded or having a few more bolts than required for typical floor framing beams. Existing steel beams may serve as collector beams where their alignment matches the alignment of frames or walls. Existing beams and their connections may need to be strengthened to carry the additional seismic collector forces.

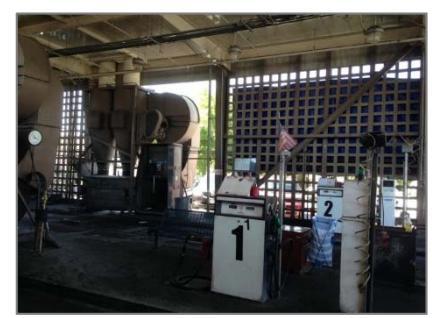
Exposed steel structure. Light weight framing. Note missing seismic brace.

Missing seismic brace

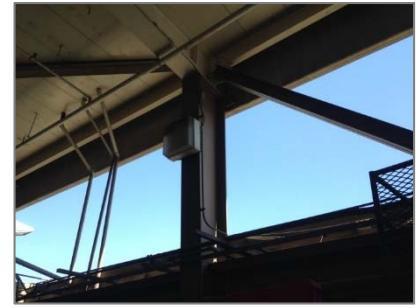
Top of brace connection

Ordinary concentric brace frame system used, with double channel braces. Braces are too slender to carry compression forces, so will behave as a tension-only system.

Masonry cladding is detailed for out of plane bracing to steel structure, but a gap is provided to allow steel structure to move inplane a limited amount without damaging cladding. Out-of-plane movements may be a concern, including buckling of braces.

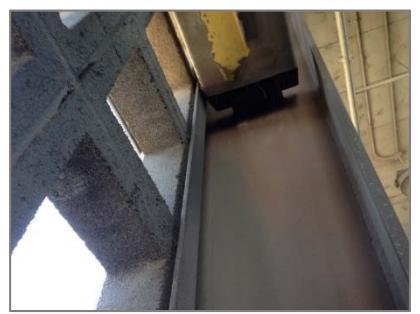
Masonry cladding bracing

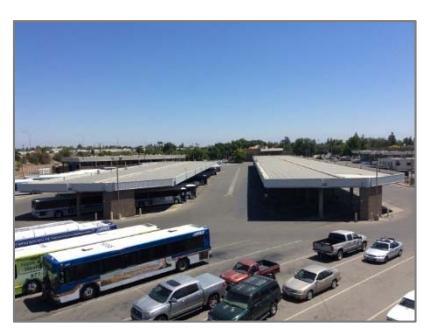
Light steel frame with concrete columns. Column alignment is skew relative to roof framing alignment.

View from maintenance building roof

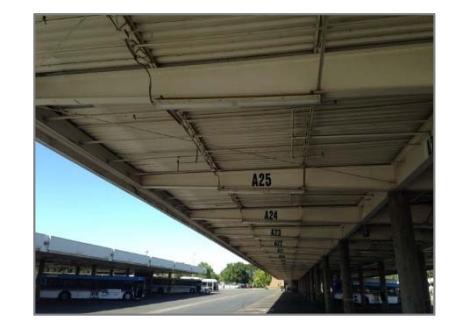
Typical framing

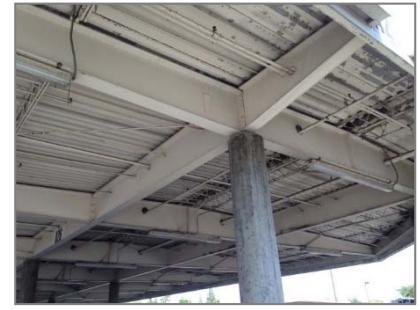
The structure appears to be in good physical condition, though flaking of paint may lead to corrosion in the future. No evidence of damage to steel or concrete was evident that could compromise the structure.

Typical top of column

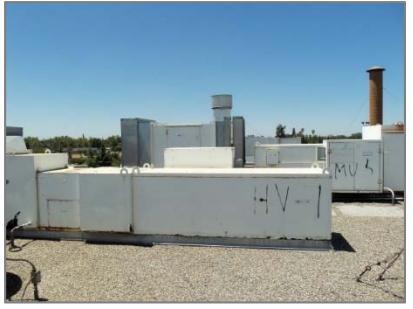
- HV-1: Rated for 5,400 CFM/8,100CFM; 5 horsepower (HP);460 Volt/3 Phase/60 Hz; Gas burner: 500 MBH; serving Inspection shop
 - ✓ Observation: Not running during site visit.

Typical Heat & Vent (H&V): HV-1 Shown

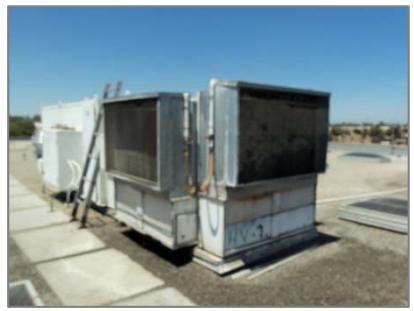
- HV-2: Rated for 13,000 CFM/26,000CFM; 15HP; 460 Volt/3 Phase/60 Hz; Gas burner: 750 MBH; serving chassis, brake, weld, and dynamometer
 - Observation: Evaporative coil leaking onto roof and has build-up. Fans were running at the time of site visit.

HV-2 Unit Leaking to Roof

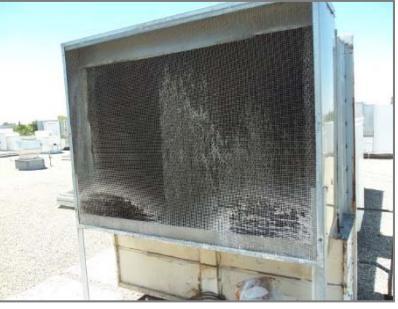
HV-4 Evaporative Coil Damage

Based on the reconfiguration of the paint booth and prep area, it is recommended that the equipment serving this area be removed and redesigned. The following equipment is to be demolished and replaced with a central system or a packaged paint booth unit including equipment with mechanical system:

- MU-3,4,5, and 6
- HV-3 and HV-4
- EF-10, 16, 17, 24, 25, 26, 27, 28, 29, 30, 31, 32, 33, and 34

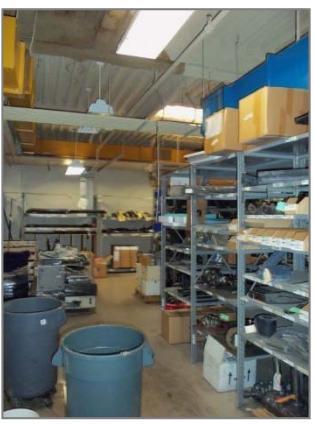
Leak from HV-5 to Floor below

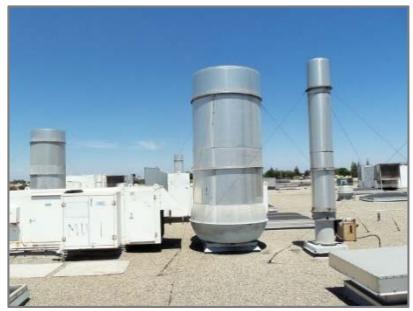
- MU-1: 9,700 CFM; 5HP;460/3/60; Gas burner: 500 MBH, serving steam cleaning make-up air
 - Observation: Intake shown on opposite side of design documents. Please see photo. FAX expressed concern about areas where re-

MU-1 Intake near EF-15 & EF-11 (serving parts cleaning rooms)

entrainment was potentially happening; especially when painting booth exhaust is on, other areas in building smell the fumes.

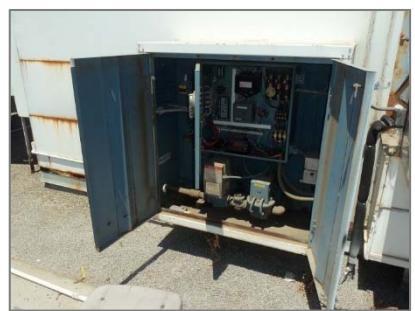
- \checkmark Observation: Not running on the day of the site visit.
- MU-3: 7,600 CFM; 5HP;460/3/60; Gas burner: 500 MBH; serving parts paint booth make-up air
- MU-4: 18,400 CFM; 15HP;460/3/60; Gas burner: 1250 MBH; serving paint preparation paint/cure operating make-up air
 - Observation: Not running on the day of the site visit. Panel open.
 Damaged evaporative coil seen.

MU-4 Unit Control Panel

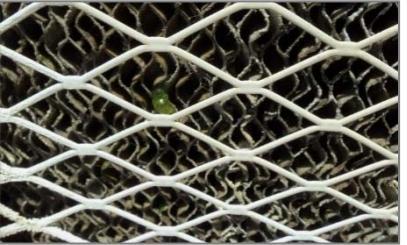
An evaporative cooler is located in lieu of EF-2 shown on original design documents. EF-2 was supposed to serve the inspection pit

and hoist pits. This unit appears to be in poor condition and evidence of algae was seen on the evaporative coil.

Evaporative Cooler (not on original drawings)

Recommend replacing this system and modifying to serve

the needs of the current space - PM Inspection. Currently only EF-

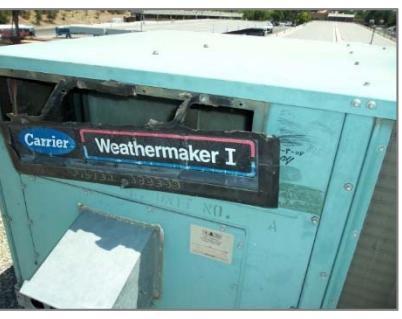
- AC-1 •
 - ✓ Carrier Weathermaker I DX Unit 3,000 CFM; 3HP;460/3/60; Gas burner: 150 MBH; serving offices, toilet/locker rooms. lunch room and first aid room
 - ✓ Observation: Rust on top of condenser section and damaged fins.
- AC-2
 - ✓ Two to three year old new DX (R-410A) heatpump. Model: BBUZ-F030AA; serving two offices.
 - ✓ Observation: Unit in good working condition and minor maintenance is required.

AC-1 DX Carrier Unit

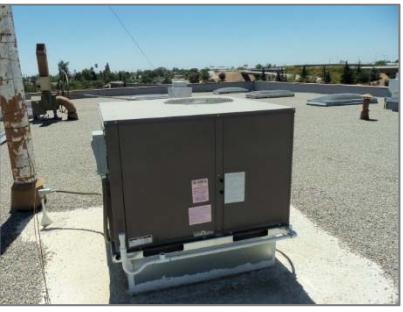
AC-2 New Heatpump Unit

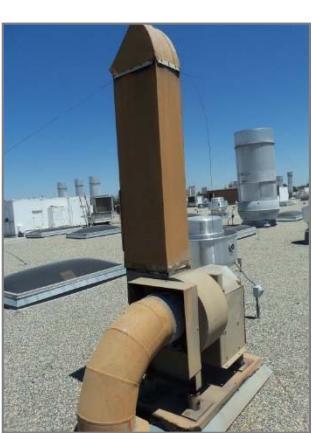
EF-9- Noisy Fan

Recommend that all EF's control be checked and documented. Depending on use and functionality, exhaust fan shall be evaluated to either be replaced with new high efficiency exhaust fans or motors replaced with high efficiency motors with variable frequency drives (VFDs).

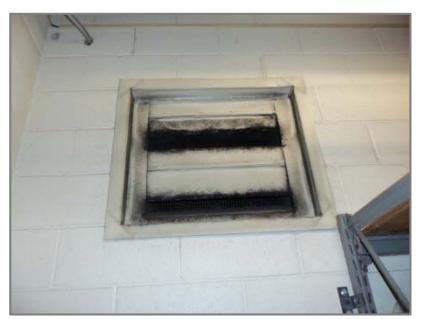
Grille in wall

We did not inspect the filters in HVs and MUs because they were not accessible but recommend to change based on dirt build-up on grille. See photo.

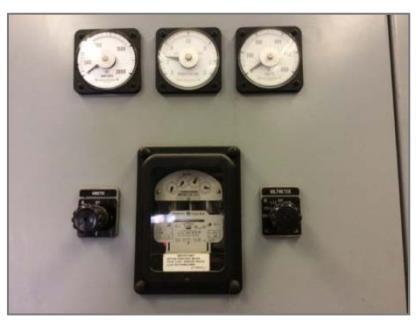
set of analog gauges measure voltage, current, energy, and power factor. At the time of the observation the power factor gauge read 0.76, lagging. This could be improved by replacing existing motor controls with more modern VFDs or adding power factor correction equipment.

A Set of Analog Gauges

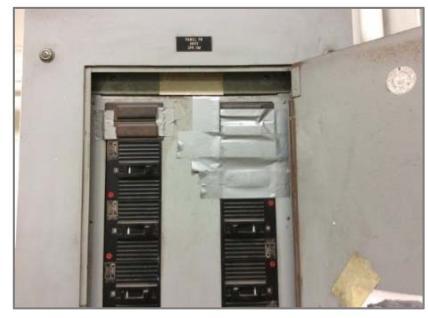
Panel 'PB' needs a proper cover plate instead of tape.

Panel 'PB'

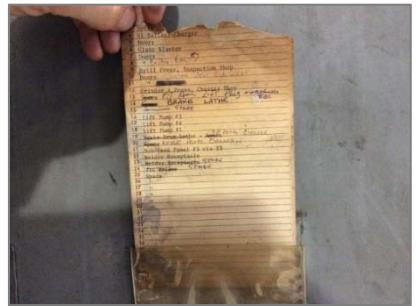
Panel schedules have handwritten corrections and some are falling apart. Updated printed schedules should be installed.

Proper schedules should be created

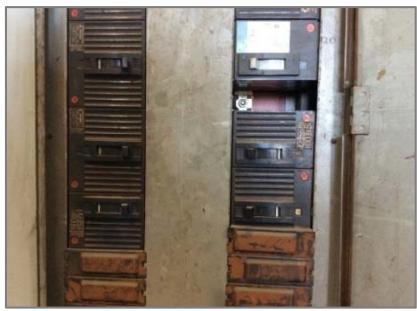
Panel 'PC' has exposed live conductors. A cover plate should be installed.

Panel 'PC'

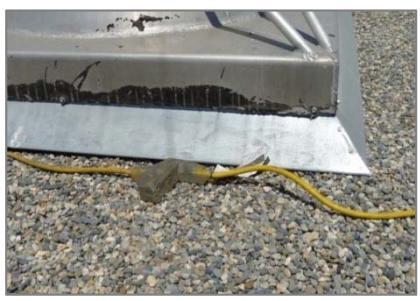
An extension cord on the roof provides temporary power to a small pump in a rooftop HVAC unit labeled '11V8'. The California Electric Code prevents this usage in Section 400.8.

Extension Cord on Roof

The receptacle inside the HVAC unit '11V8' should be inspected and repaired so it can power the pump.

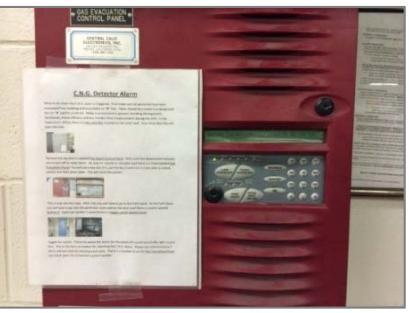
The 'Gas Evacuation Control Panel' produces regular alarms signals that force evacuations and a fire department visit. The

Gas Evacuation Control Panel

system should be inspected and serviced as needed.

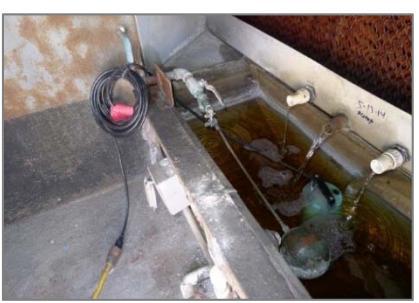
Extension cord power a small pump

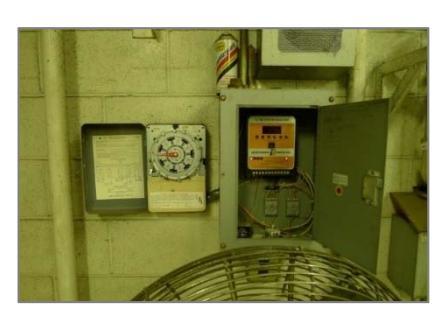
Controls equipment

Controls should be labeled as to which equipment it serves. Some controls equipment might be abandoned and should be removed.

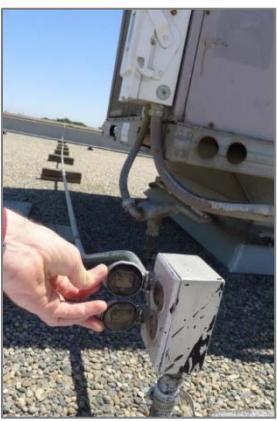
The rooftop receptacles covers are weathered and may allow water to enter. The receptacle face shows signs of water damage. This particular receptacle shared conduit with the exterior lighting mounted on the roof. New waterproof covers should be installed.

Rooftop Weatherproof Receptacle

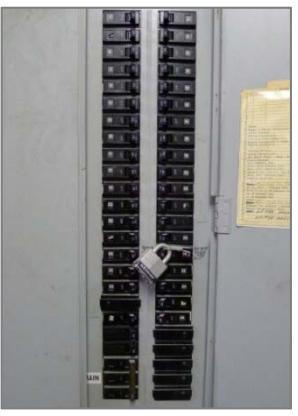
Panel 'P4'

Some breakers are fitted with trip locks to prevent an overcurrent event from tripping the breaker. These are to be used be used for fire alarm circuits only and should not be used to prevent nuisance trips. The circuit shown in this image is label as "New 2nd Floor Office Plugs" and should be investigated. Newer breakers can trip even if in held in the "ON" position per CEC 240.80. It is unknown if these breakers are up to that standard.

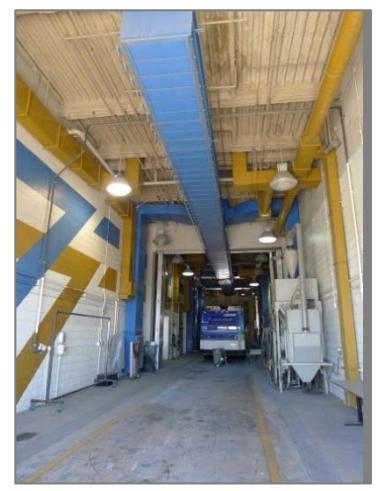
Lighting fixtures and controls throughout the building are outdated. We recommend replacing fixtures that need repair with modern equivalents. Many of the spaces are supplemented by day light though open garage doors or skylights. We believe that the existing lighting levels may cause issues at night or days when the weather prevents leaving garage doors open. Some area like the shop or paint booth should have higher levels of illumination

Paint Room With Garage Doors Open

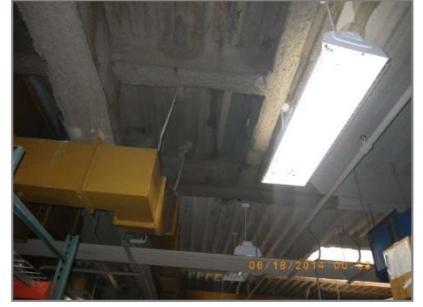
Leaky roof (under a roof Air handling unit which is leaking)

There is standing water on the roof from leaky Mech. system indicating insufficient roof slope or roof has not been installed properly.

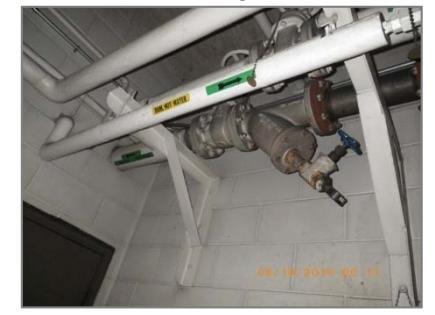
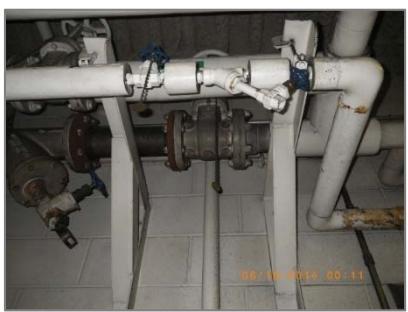
Domestic water does not have backflow preventer for each individual building.

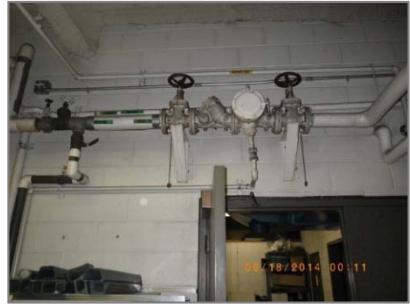
For industrial water they do have Reduced Zone Backflow preventers installed.

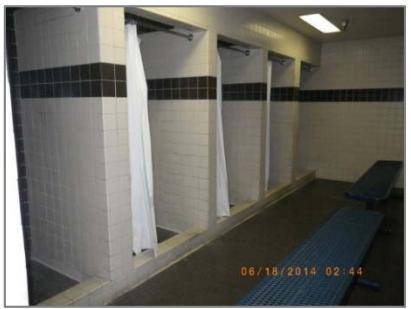
Restrooms seem to be not ADA compliant. Reconfiguration to address this issue.

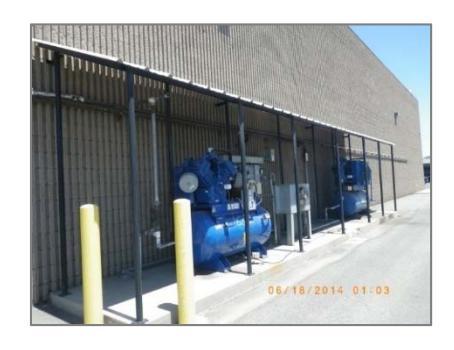
Newly installed compressors are located in exterior shed, are in working condition.

If the new Chassis bay addition is going to happen in this location, these air compressors will need to be relocated.

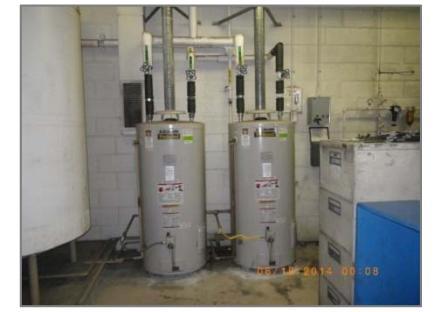
Two storage type gas fired water heaters are in working condition. Heaters to be A.O. Smith BT 80 112; 80-gallon, 75 MBH each.

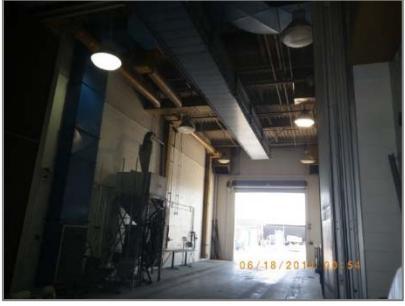
The Paint shop/booth will be re-configured. We recommend that the sprinkler layout to be re-evaluated and revised per the new layout. All MEP services penetrating new fire separations will need fire rated sleeves.

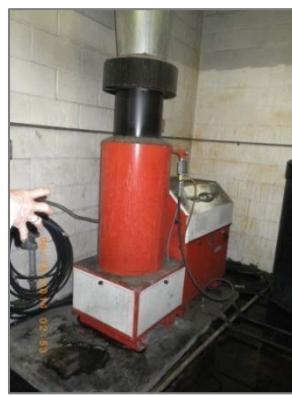
Steam/hot water cleaning system is in working condition

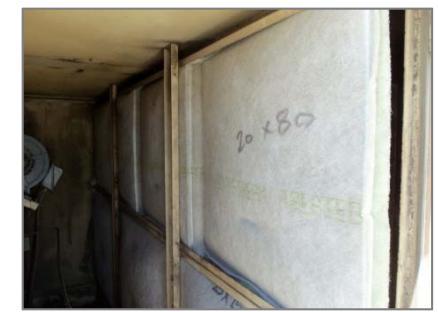
Filters do not appear to fit within the filter bank. Recommend upgrading the filter type used in the units.

Prefilters in the Units

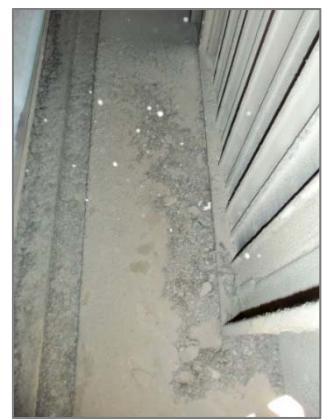
There is dirt within the units and recommend to clean, if units are to remain.

Before the filters: dirt in the units

Recommend that the existing air-handlers be properly sealed and cleaned immediately. These units shall be replaced with two new units for the remodeled and retrofitted space.

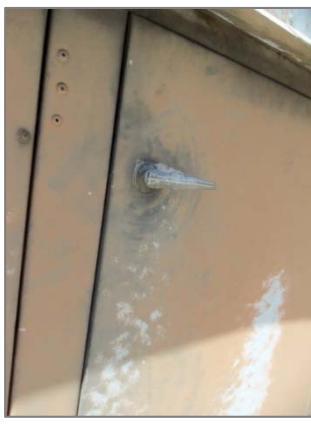
Currently there is a significant amount of air leaking from the access doors at the fan section of the unit. Recommend using a gasketed door to seal.

Leaky Access Doors

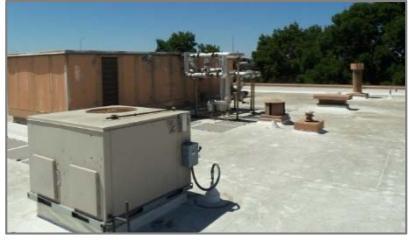
York Model D1NH024N03606C

There is one York packaged heating and cooling unit on the roof. Rated at two tons of cooling; Heating: input gas (45,000 BTU/hour) This unit is at least 10 years old based on equipment tag. Uses R-22, which is a refrigerant that has been phased out. We recommend replacing this equipment and disposing of properly.

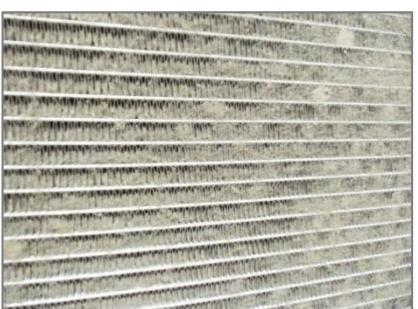
Chiller Yard is located adjacent to the building. There are two air cooled chiller. Both chillers have been having issues with tripping. Contractors have not been able to resolve issues with chillers. Potential issues: (a) communication between newer direct digital controls (DDC) and outdated pneumatic controls or (b) issues with part-load conditions causing tripping.

CH-1 Condenser Section blocked. Could lead to tripping if air path is blocked.

commissioned properly to diagnose issue of failure. Recommend to fix any damaged piping insulation in the immediate future and clean the condenser section of CH-1.

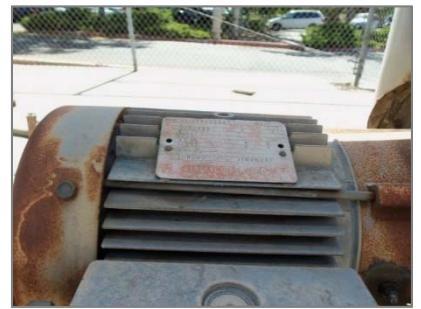
Exterior Chilled Water Pump Damage- CH-2

One pump motor recently replaced, other one has not been.

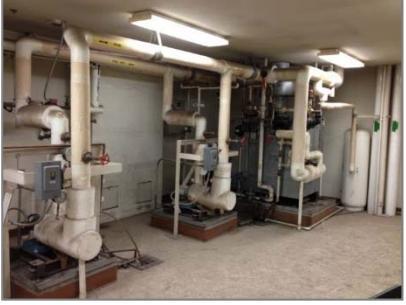
Heating Hotwater System

The 3/4 horsepower motor has been recently replaced a few months ago.

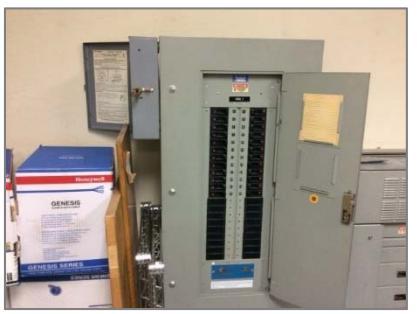
The room is a shared space and an effort should be made to mark off the required working clearances of the electrical equipment. User should remove combustible materials and prevent obstructions like the cable reel in the photo. The open wall shows that some minor electrical work has been done

Utilities - Room 210- Panel F

since the construction. Fire block may be required here and the hole in the wall should be patched.

We recommend reusing Panel "D" and replacing panels "H", "F", "L", "EB", and "E1". A single 480/277V panel can be used to supply all lighting loads in the building while a 120/208V panel for each floor will power plug loads. The elevator and HVAC system can be fed directly from Panel D by installing new breakers and utilizing the spaces feeding the existing HVAC system. The panels mentioned above could be reused if cost is an issue but an

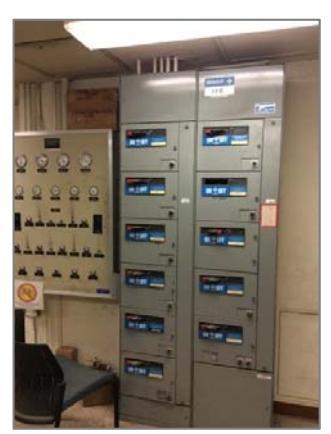
Utilities - Room 208

This Gould ITE Motor Control Center (MCC) powers the buildings HVAC equipment. If the HVAC system is replaced this MCC may be used to power the new equipment or removed. The MCC is rated at 277/480V and 225A. The 1981 drawings show that the chillers are powered from this MCC; our

observations were that the chillers have been connected to 'Panel D' in the utility room.

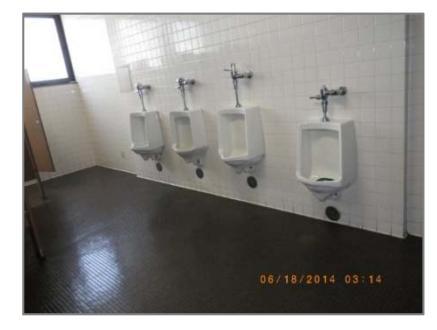
One of the water closets in one of the restrooms is leaking.

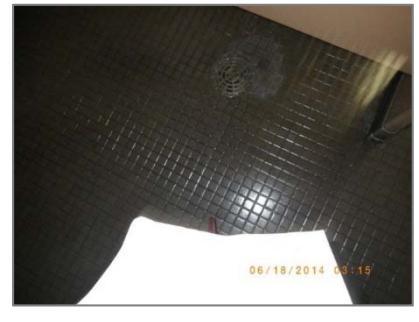
The faucet and drain are leaking in Women's restroom.

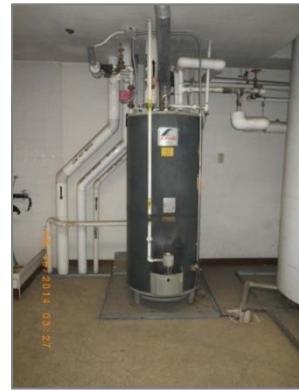
The Temperature and Pressure relief valve discharge pipe is piped up for steam vent and only a very small 1/4 inch) pipe extended to drain. This is a safety issue. We recommend replacing this small pipe to the same size of the relief valve discharge and piped to drain for safe Temperature and Pressure relief.

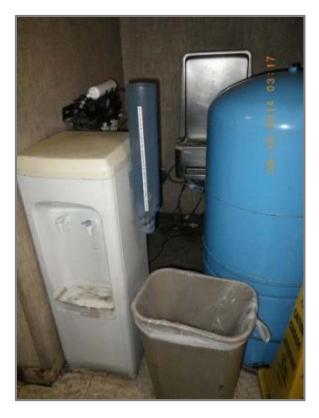
Additional filters and tanks are installed replacing drinking fountains, and these took additional space in the corridors. Further studies are required to decide if actions are required to improve water

quality/replacing existing domestic water system or just demo all filters, tanks and drinking fountains and replaced with bottled system.

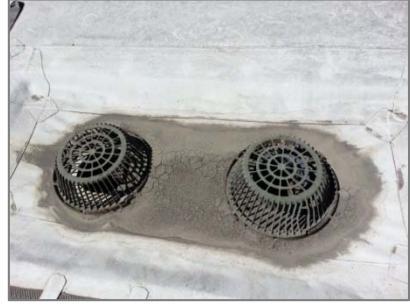
Overflow drain of the new addition are missing strainers. We recommend adding strainers.

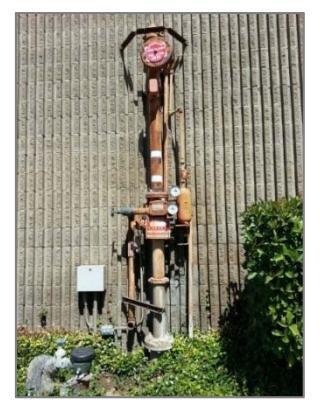
Building is fully sprinklered with no standpipe. Floor control valve is located at exterior - it shows signs of corrosion.

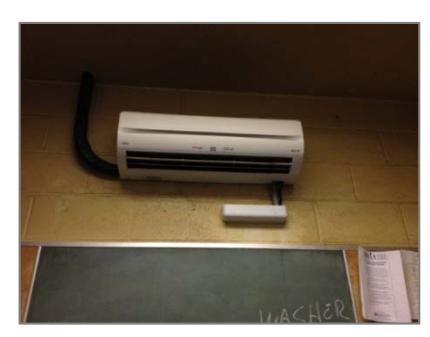
There is one DX split system serving the office in this building. Unit running at the time of visit. Requires confirmation that unit is on time clock but appears to be in good working condition and there are no known complaints in this office.

Recommend relocating this existing unit into the new office built out with the canopy extension.

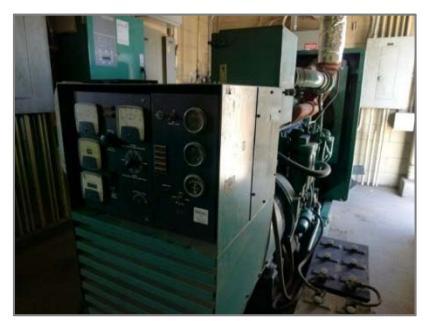
Bus Wash Generator

A generator installed in the electrical room in the bus wash island building. The last date of service was May, 20, 2014 when a voltage regulator was replaced. The service log suggests annual visits with load bank tests have been performed. No monthly testing logbook was found.

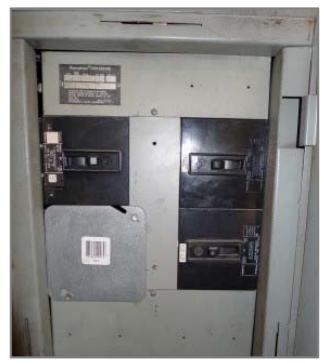
Makeshift cover plate

Panel 'A' contains an unlisted

part which is being used as a cover plate. Source and install proper cover plate.

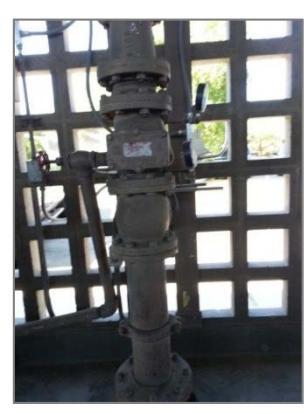
Storm water piping is not properly supported. We recommend fixing the supports.

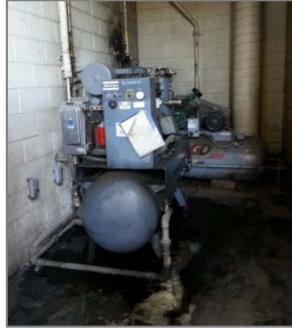
There is no floor drain/floor sink near the compressor for condensate. We suggest provide proper drainage for this area.

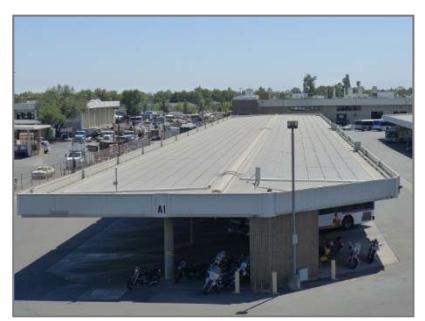
Canopy Solar Panels

The solar panel installation was not directly accessible at the time of the visit. The panels were observed from the roof of adjacent buildings and appeared to be dirty. Cleaning panels would produce more energy, which should be monitored before and after cleaning.

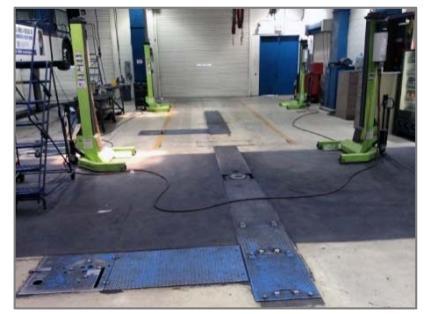
Non-Operating Lift - Repair Bay - 3

1980s buses were generally shorter and lighter than modern buses. 1980s buses ran on diesel fuel and had higher passenger decks than modern buses. Existing major maintenance equipment, such as vehicle in-ground drive-on and axle engaging lifts are currently operating at or near maximum weight capacity. Operating the equipment in this fashion leads to quicker deterioration and carries a potential safety risk. It is inefficient and not feasible to replace 30-year old in-ground lift components to

raise lift capacity to meet modern bus capacity and safety requirements. Existing lift controls offer independent although imprecise front and rear piston control. Those controls are either floor or wall mounted. Further, the existing lifts require a lift pump station that takes up considerable

- In-ground bus lifts are drive-on or axle-engaging.
- Lifts are original to building construction but work was done to them.
- Over time, lifts had had multiple repairs.
- Some lifts have broken and their controls removed; see Appendix A - Existing Maintenance & Service Equipment Photo Inventory & Assessment.
- Broken in-ground repair bays use portable lifts.
- Replace in-ground lifts with modern axle-engaging lifts. Remove old lift pump stations to free up floor space.

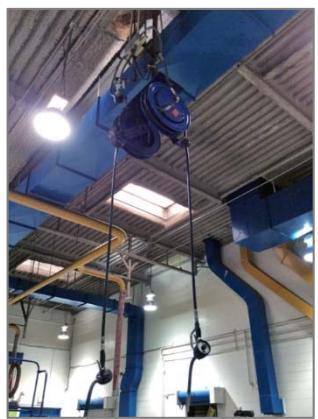
Hose Reels

Lubrication hose reels observed throughout the repair and inspection bays had visible wear on the reels, flexible hoses and connections between the hard tubing and reels. Fluid buildup observed on the majority of reel banks was consistent with the age of the system. Lubrication reels, hoses and dispensers within the Inspection Pits were either not working or in a considerable wear state.

- Fluid supply pumps in fair operating order however given the opportunity, replace with new and keep old as backups.
- Hose reels, dispensers and connections are worn or not working. Replace with new.
- Inspect the fluid management system for correct operation. Update software as necessary.

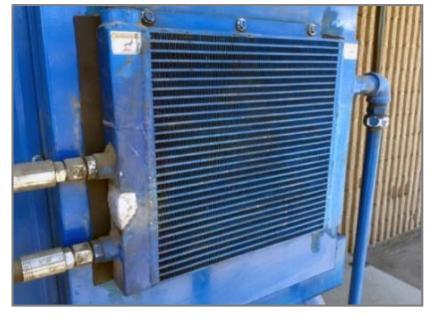
Radiator Repair

the repair and inspection bays are through wall mounted convenience outlets mentioned or through wall, column, or overhead mounted hose reels. A large number of wall/ column mounted convenience outlets were observed turned off or disconnected because they were either inaccessible (located behind portable equipment or shelving). Many were however observed in sufficient operating order. Many outlets contain components by different manufacturers. Further, compressed air hose reels were generally in good condition. There was no complaints heard and no deficiencies observed in the compressed air distribution piping, or air compressor equipment. Although, the east air compressor that is water-cooled, contained repaired damage to its radiator.

- Replacement equipment should consist of a filter/regulator and lubricator (where appropriate), blow-down "drip" leg, and quick coupler.
- Evaluate system air dryers. Potentially replace or add air dryers.
- Repair air compressor radiator.

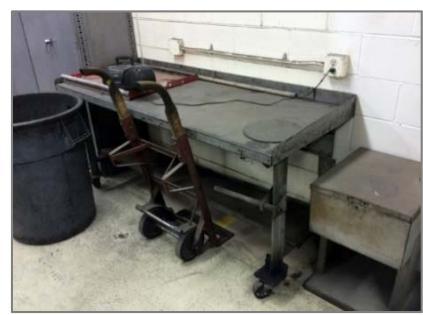
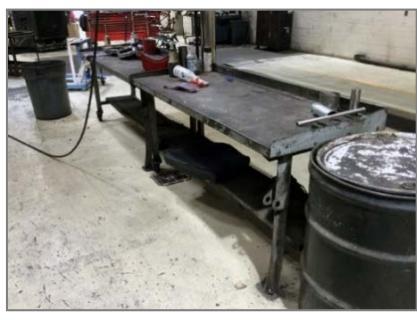
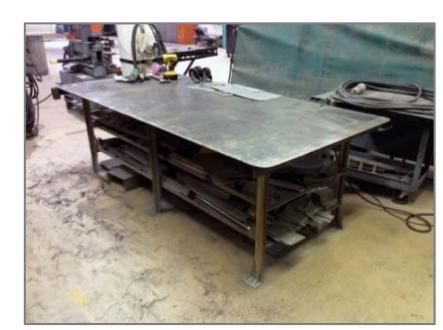
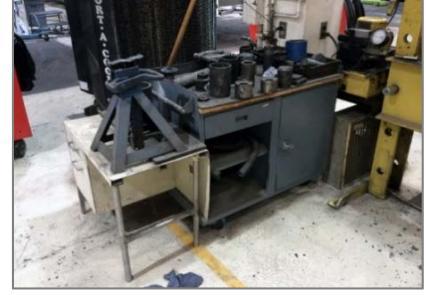
the facility, there are other smaller workbenches that are essentially base cabinets with working surface tops, some contain drawers. All workbenches look to be original to the building's construction; most are operational although some are damaged. Given the opportunity, replace the workbenches with new and reduce the amount of furniture to only those necessary, located where they will facilitate efficient use.

- Reduce quantity of workbenches and working surfaces cabinets
- Replace with new equipment.

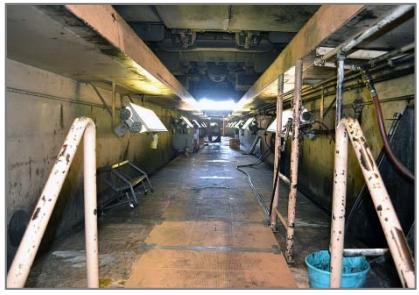
Inspection Pit

The Inspection Shop consists of the entire north end of the building, is one long bay containing a drive-on lift to the west and a long inspection pit to the east. The drive-on lift is broken and not being used. We were told that this bay was used for A/C repair in the past. A overhead fall-protection cable was observed in the bay. Consequentially, the west end of the inspection shop is currently underutilized. The inspection pit is heavily used. Its layout provides proper ingress and egress to and from the lower level. Opening protection is through guard post and chain and tire guides. The guard post and chain system was observed being used however, this type of system may pose an obstruction to mechanic's movement and is often removed, resulting in an unprotected opening. Further, the tire guides may be a tripping hazard to mechanics working above. The lower level passages are ventilated and lit and large enough for stand up desks for the mechanic's use. The pit area itself contains oil drip debris. A rolling waste oil drain pan and a rolling bridge jack were located within the inspection pit opening. The drain pan contains minor grating damage. Additionally, there is a stainless steel moveable pit bridge. The bridge contains visible welded repairs. Most vehicle lubrication fluid and compressed air hoses, outlets and dispensers within the Inspection Shop are damages, leaking or not in service.

- Clean and refinish the interior of the inspection pit.
- Provide updated lighting in the pit
- Fluid Reels need replacing.
- Rolling drain pan is damaged
- Consider replacing the pit opening post and chain protection and wheel guides with modern pit protection devices.
- Remove unused equipment.

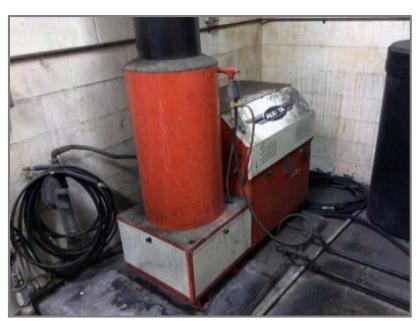
High Pressure Hot Water Washer - Not Performing

The current vehicle lift looks original to the building's construction. Lift equipment badges and control labels were not found. As previously discussed, the lift may be at load capacity. In addition to loading capacity, the use of the lift is also limited by its physical dimensions. Complaints were heard that the high-pressure hot water washer does not supply hot enough water and does not clean well. It is recommended to replace equipment in the future

build-out of the proposed chassis wash and component cleaning bay.

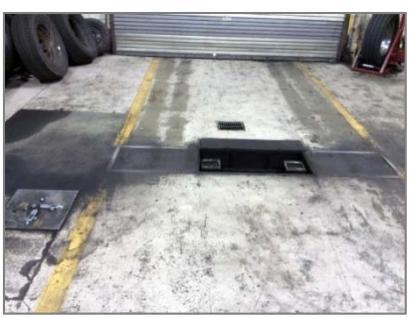
Tire Shop Lift

Buses are serviced with inground single-post axleengaging lifts. Of the two lifts within the Tire Shop, only one is accessible. Because of this, buses being services only pull into the bay part-way. The other half of the bus sticks out of the bay onto the apron. Repairing tires this way is inefficient as to

service both axles, either the technician has to pull the bus out of the bay, turn the bus around, then pull back in; or the technician has to use a portable jack to lift one of the axles. With both axles lifted at once within the bay, the technician can simply walk around the bus.

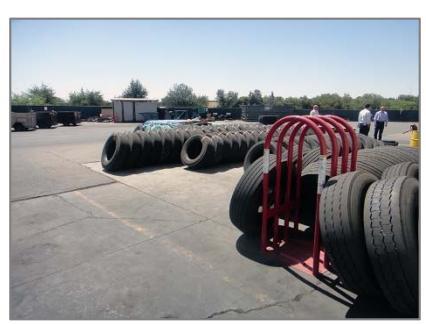
Tires stored on apron

New and used and both mounted and un-mounted tires are generally stored within the tire shop. FAX stated that the Contractor is storing more tires on-site than allowed. Tires were also observed stacked outside adjacent to the Tire Shop on the

bus apron. Tires are stacked at the interior of the bay blocking one of the single-post in-ground lifts. In addition to blocking one of the single-post lifts, stacked tires are prone to topple over when struck or during an earthquake. Along the south wall of the shop, a permanently fixed two-tiered tire rack is capable of holding up to 98 tires. The rack is custom built and anchored to the floor and block wall. Tires are accessed from the rack by overhead 500lbs. hoist that runs the length of the rack on a monorail track. The tire rack, overhead track and hoist are fairly new additions and are in good condition.

• Reduce the quantity of tires being stored on-site.

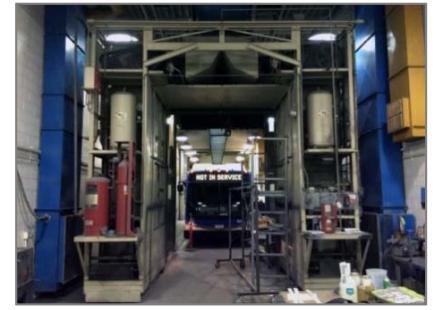
Rolling Paint Booth

While not being used, the rolling paint booth is currently permitted requiring a yearly renewal. FAX plans to decommission this booth. The bus drop table within this area is in use. While FAX desires to keep the drop table function, similar equipment is no longer manufactured. Therefore, in the

- Rolling paint booth not functional and inhibiting use of long painting bay.
- Paint prep being performed in frame-pulling bay is causing dust and fume migration into adjacent areas.
- Majority of Metal Shop equipment being utilized.
- Drop table lift being utilized but aging and not replaceable.
- Some parts painting booth components not operating.

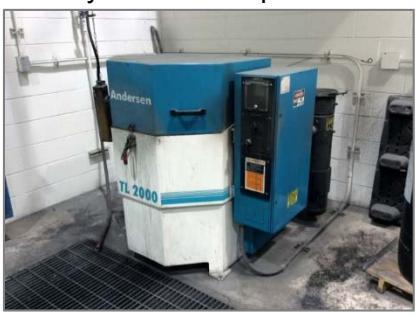
Parts Washer - Not Operational

- Areas are underutilized
- Cranes are operational. Leave operational and inplace if possible.
- Repurpose areas as expressed in the master plan.

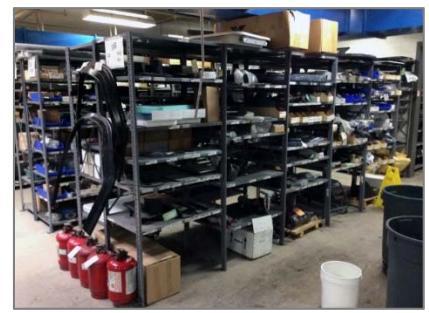
Parts Storeroom - Second Floor

corridor near the locker rooms and through the administrative offices. The Parts Storage Loft opens to the Body Repair Bays below through a gate. There is a disconnected jib crane and hoist once used to lift parts into the loft from below. This wall opening and hoist is no longer used and has issues allowing

dust and fume migration from the below Body Repair and Metal Shop.

- Existing storage equipment in good condition.
- Quantity of storage lacking.
- Parts office cramped and disconnected from customer interaction.
- Second floor area lacks efficiency.
- Second floor mezzanine opening problematic.

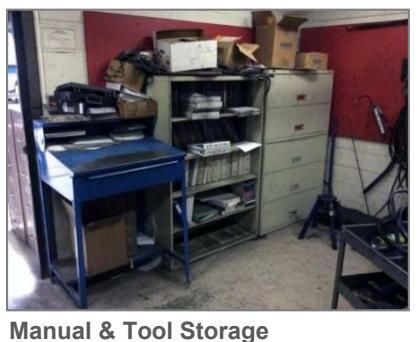
Manual & Tool Storage

FAX supplied tools are securely stored within the Tool Room (originally the Radiator Shop) and within the Tool and Manual Storage room. Both rooms are adjacent to the repair bays. Storage equipment within these rooms is in poor condition. Physical repair manual storage is no longer required as repair manuals are electronic and accessible through centrally located computer workstations and printers.

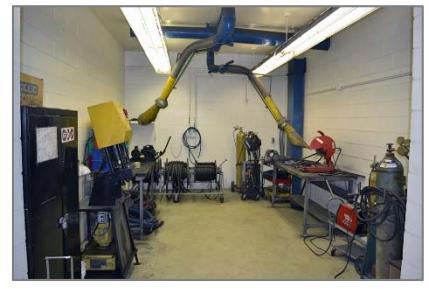
Hose Shop

plan relocates this room to another centrally located position. Hose storage and crimping is located adjacent to the stairwell to access the small offices on the north with of the central structural bay. The hose storage and crimping room contains rolls of hoses and crimping equipment that is in good working order. The room was previously the Weld Shop and still contains welding exhaust arms and welding tables.

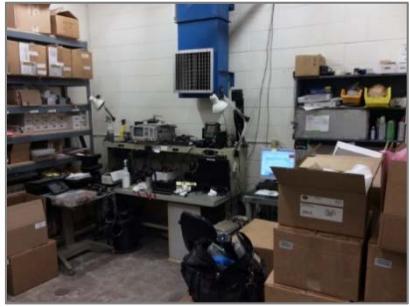
Electronics Repair Shop

The Electronics Shop is that room used to repair and store electrical and technology components used on the bus. The shop is secure and located at the southwest end of Repair Bay-3. Furniture and storage equipment within this shop is in poor condition.

As the Master Plan presents, it is desirable to have both of these

shops located adjacent to a repair bays that could be used for the repair of the specific components. Both shops and storage would also be housed in a shared but secure room.

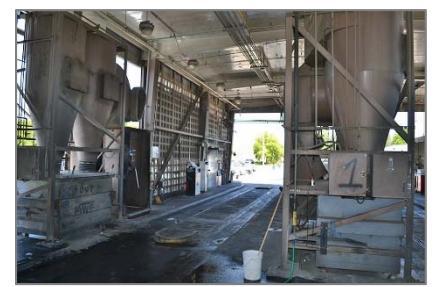
Fueling Lane Showing Plated Pit Opening & Cyclone Vacuum

Part of the original design involved lower level inspection pits. The pit openings were in each fueling lane. Personnel access to the pits was through stairway located on the southwest corner of the building. Since then, the pit openings have been plated over and the pit cavities house underground piping, exposed within the cavity. The stairway is still accessible and open. Standing rancid water was observed within the bottom of the pits.

- Underground inspection pits holding water.
- Hose reels worn.
- Cyclone vacuum systems worn and at end of life cycle.
- Personnel spaces lacking
- See Fueling Assessment section below for further fueling discussion

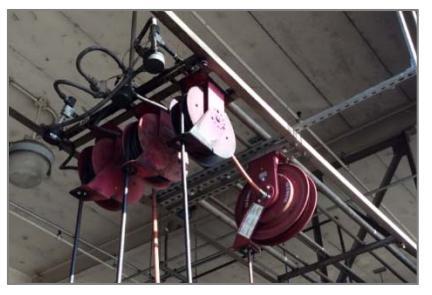
There are two fueling lanes accesses from the east. Both lanes contain CNG and diesel fuel dispensers, Engine Oil, Engine Coolant, Automatic Transmission Fluid, and Compressed Air Dispensers. There is an above ground storage tank with tank mounted pump and dispenser for Diesel Engine Oil accessible to both lanes. Current hose reels show wear and leakage similar to

Hose Reels

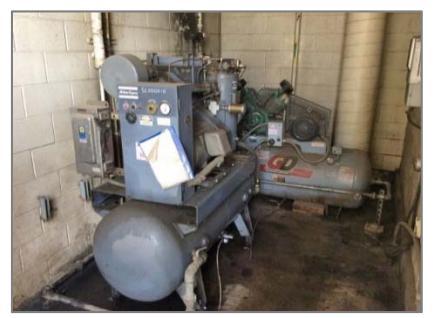
Air Compressors

those in the Maintenance Building. Originally, underground storage tanks were located south of the building storing the lubrication fluids, diesel, and leaded and unleaded gasoline. Lubrication fluids and petrol is now stored in newer underground storage tanks located east of the building. Compressed air is supplied from air compressors located within the Compressor Room. These compressors are aging and given the opportunity, should be replaced.

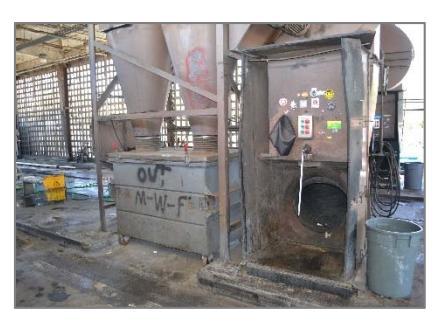
Door Blower

Parts of the original construction also included a central vacuum system with overhead distribution hoses and hose drops and the lanes. Over time, the central vacuum system was removed and replaced with two standalone cyclone type door blower systems. These systems require a person to walk through the bus with a broom or compressed air wand moving debris to the front door, that is then sucked up into the door blower system and deposited

into dumpsters located at the base of the machine. The cyclone systems are severely worn and aged. Using compressed air wands to move debris to the front of the bus commonly results in sand getting into the electronics and dash board of the bus. Those problems were mentioned as occurring here.

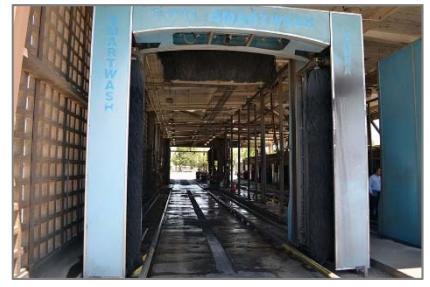
Bus Washers

There are two wash bays with rolling gantry bus washers. Original design shows these systems with a reclaimed water system located in the current wash equipment location. Approximately 15 years ago, the gantry washers were replaced with similar Whiting Supra Smart Wash Truck Washer systems. A Reverse Osmosis (RO) system was added. The (RO) console looks to be in good condition. Neither washer contains blowers for drying the buses. Minor shroud and rubber cracks were

observed on the washers. FAX personnel stated that not all buses are washed every day for water conservation. Additionally, less use of the equipment will prolong its calendar life. Buses were observed being washed in both lanes. The bus washer in Lane #1 was activated without a vehicle in it and continued to run until power was manually shut-off and reset to the equipment. During this time, spraying water was observed migrating towards the inspection pit openings although none was observed actually going down into the pit.

Rolling gantry washers have many moving parts requiring much maintenance. While the existing equipment are of good quality, based on its projected age at master plan implementation, and given the opportunity, a drive through bus washer with blowers and water reclamation is recommended.
