# MASTER PLAN REPORT

**FAX Transit Operations & Maintenance Facility**  
Fresno FAX  
Fresno, California

November 21, 2014

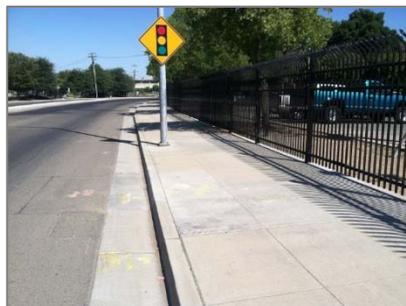
##### Sidewalk at G Street

- Good condition, even surface free of cracks or abrupt changes in level
- Black wrought iron fencing recently installed along the entirety of the FAX Operations and Maintenance Facility frontage at the back of walk

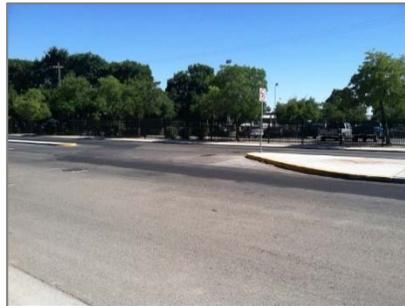
### **New Left Turn Pocket in G Street Median**

- Left turn pocket recently constructed within the median of G Street to allow for left turn off northbound G Street for future entrance into FAX employee parking lot
- Visual Observations and City records indicate that G Street is in good to very good condition

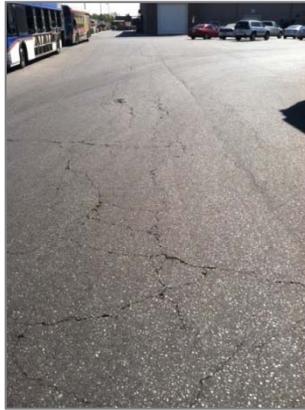
- Asphalt pavement displays evidence of thermal cracking, and early stages of fatigue cracking

- Some small localized areas of pavement spalling

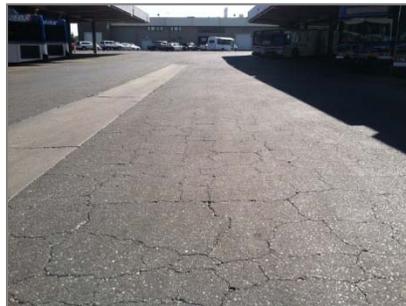
**Drive aisle between covered middle and southerly parking bays**

- Asphalt severely distressed with fatigue cracking extending the length of the concrete ribbon gutter
- Cracking is most severe near the gutter and reduces with distance. Width of cracking is approximately 13 feet to north and 10 feet to south of gutter

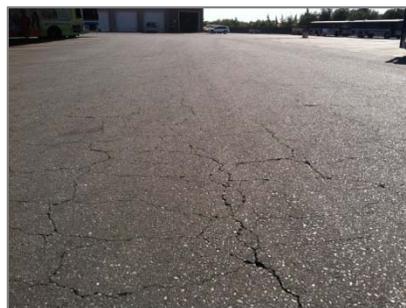
**Drive aisle between northerly (uncovered) and middle (covered) parking bays**

- Asphalt displaying signs of fatigue cracking and structural failure of pavement

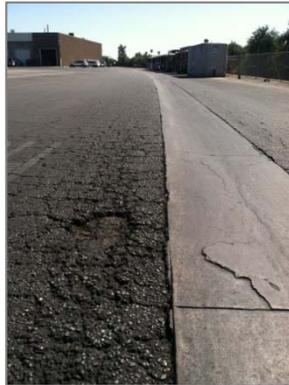
**Drive aisle between northerly fence and uncovered bus parking**

- Asphalt severely distressed with fatigue cracking extending the length of the concrete ribbon gutter
- Cracking is most severe near the gutter and reduces with distance. Width of cracking is approximately 6 feet to north and 10 feet to south of gutter
- Areas of pavement spalling observed

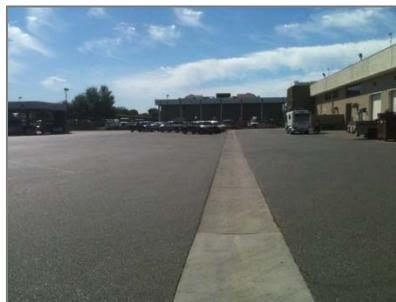
**Drive aisle south of parking bays and around Maintenance Building parking**

- Asphalt in generally good condition

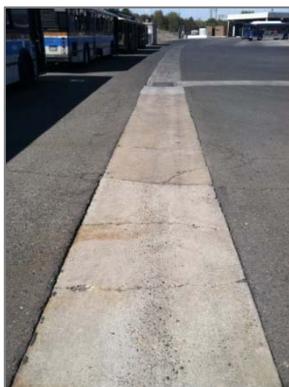
**Drive aisle to northwest of Maintenance Building**

- Asphalt is weathered with minor cracking
- Concrete ribbon gutter is severely cracked which may lead to water intrusion in the asphalt pavement, thus reducing the lifespan of the asphalt pavement

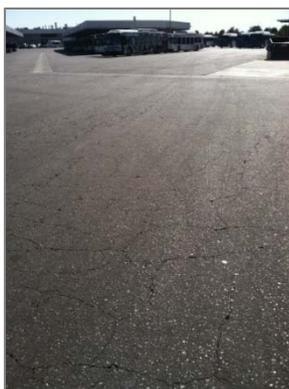
**Drive aisle between parking bays and bus wash facility**

- Asphalt surface displays moderate levels of fatigue cracking

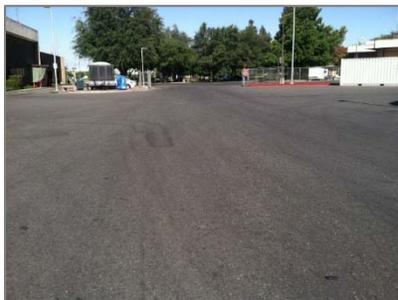
**Drive aisle at primary bus exit**

- Asphalt in generally good condition

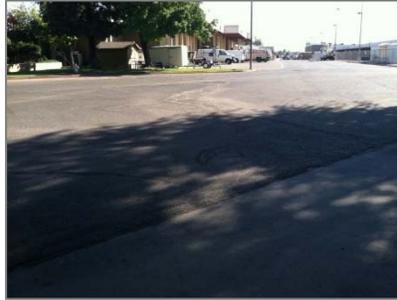
**Exit Lane at Divisadero Street**

- Use of the fire hydrant to fill City vehicles has led to water consistently running over the asphalt pavement which has damaged the integrity of the pavement

- Evidence of several attempts at crack sealing in the area

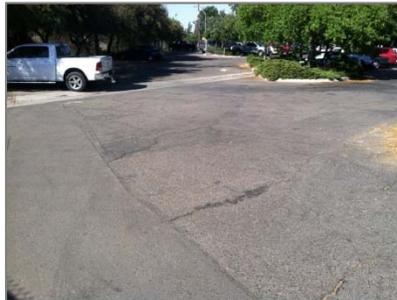
**Main Employee Parking (southerly)**

- Asphalt in generally good condition becoming progressively more distressed with increased proximity to drainage devices (ribbon gutters or inlets)

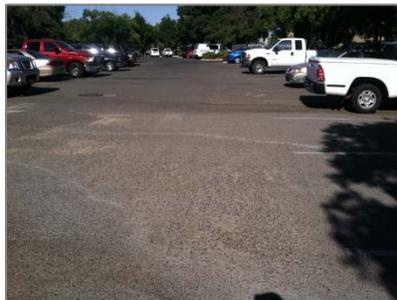
**Main Employee Parking (northerly)**

- Asphalt is weathered and raveling with exposed aggregate

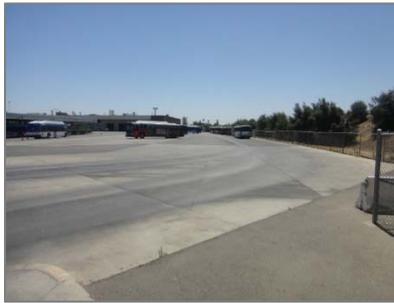
**Portland Cement Concrete (PCC) Pavement**

- Most of the PCC pavement on the facility is in good condition, including the bus parking bays

- The photo to right is of the concrete pavement to the west of the bus wash facility

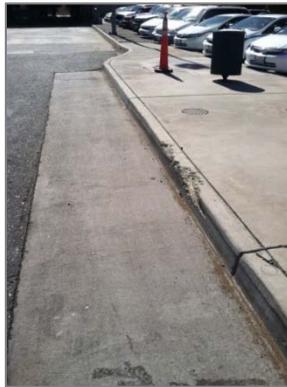
#### **Concrete Curbs**

- Most of the concrete curbs and/or gutters are in good condition
- One location near the exit of the bus wash has been significantly scarred, but this is a purely aesthetic issue

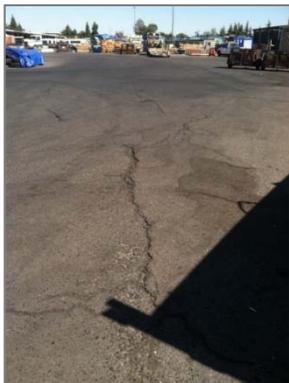
##### **Asphalt Pavement**

- Weathered and poorly maintained
- Pavement distress ranges from thermal cracking to areas of fatigue cracking

- Aggregate becoming exposed in some areas

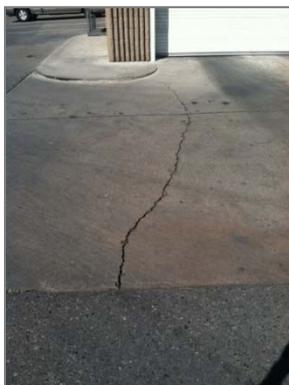
**Portland Cement Concrete (PCC) Pavement adjacent to building**

- Severe transverse cracking at areas of high stress

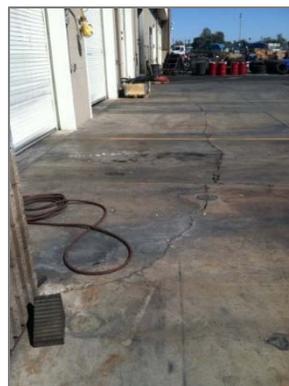
- Severe longitudinal cracking across length of roll-up doors
- Some pavement beginning to spall along the crack(s)

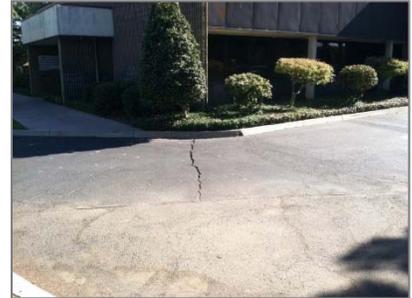
#### Asphalt Pavement

- Pavement in parking bays and straight drive aisles is generally in good condition, with more cracking at the northwest and northeast corners of the building
- Very long, deep, and wide cracks around northeast corner of building. This will lead to moisture intrusion and rapid decline of pavement strength

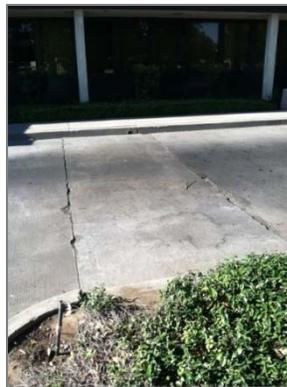
#### Portland Cement Concrete (PCC) Pavement

- Along the southerly side of the building.
- Pavement is worn with cracking and spalling occurring at joints

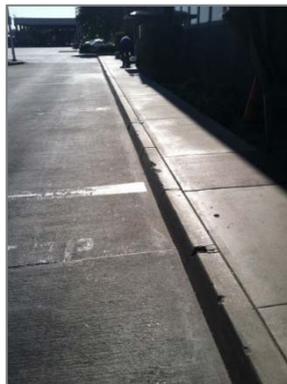
#### Concrete Curbs

- Most of the curbs are in good condition
- On the south side of the building, the curb is chipped in several locations; but this is a purely aesthetic issue

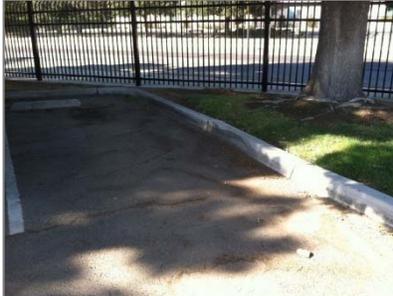
- One location adjacent to a tree at the northeast corner of the parking bay on the north side of the building is uplifting due to the tree roots
- Asphalt paving is lifted, but not yet cracking

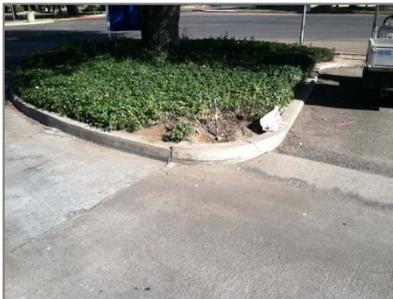
- One location adjacent to a tree at the southeast corner of the parking bay on the south side of the building is uplifting due to the tree roots

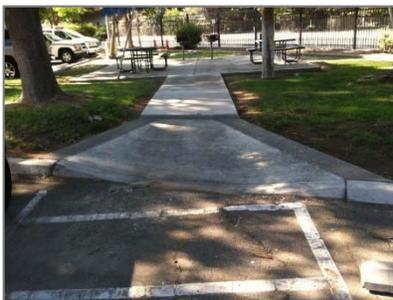
#### Concrete Picnic Area

- Good condition, surface is free of cracks or abrupt changes in level
- Ramp leading to picnic area is convenient, but it does not comply with current accessible codes for curb ramp as it lacks detectable warning surface and the slope of the wings exceeds 10 percent; additionally, there is no connection to a pedestrian path of travel

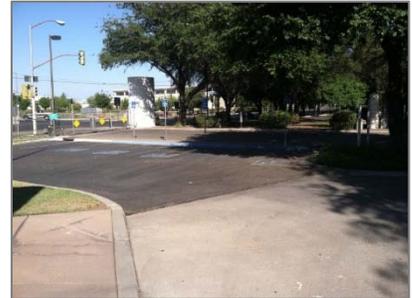
#### East Side of Administration Building

- Four stalls are marked with signage and the international symbol of accessibility on the pavement
- Stalls are non-compliant due to:
  - ✓ Lack of access aisle for two stalls at far left;
  - ✓ Lack of connection to accessible path of travel
  - ✓ Second space from right should be designated “van accessible”

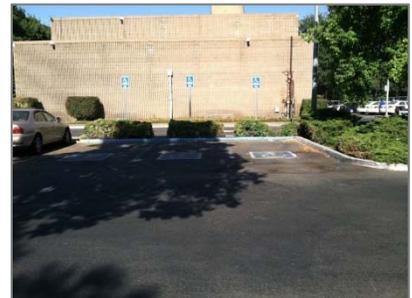
#### West Side of Administration Building

- Three stalls are marked with signage and the international symbol of accessibility on the pavement
- Stalls are non-compliant due to:
  - ✓ Lack of access aisle
  - ✓ Lack of connection to accessible path of travel
  - ✓ Less than required 18 foot length
  - ✓ Must have at least one van accessible space

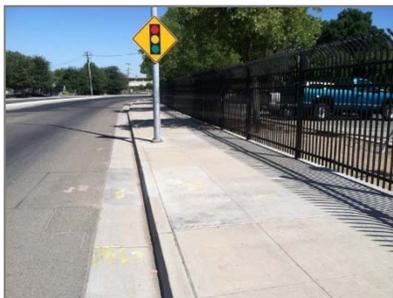
#### Perimeter Fence along G Street

- Black wrought iron fencing
- New and in great condition

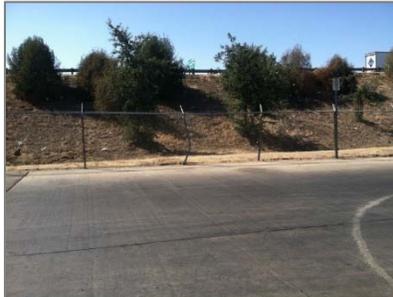
### Perimeter Fence along Highway 99 and 180

- Chain link fencing and barbed wire, with and without mesh screening
- Generally good condition
- One bent post observed near bus wash facility

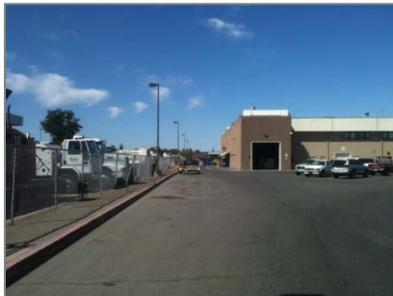
### Fencing between FAX and City's Yard

- Chain link fencing without barbed wire
- Generally good condition
- One bent post observed, assumed to be the result of a City vehicle overhang

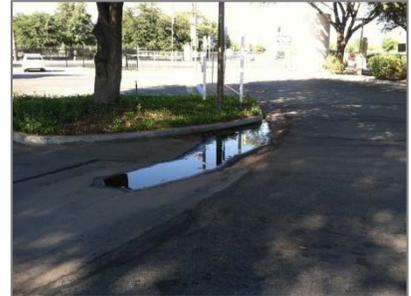
#### **Ponding near exit to Divisadero Street**

- Regular, possibly daily, use of the fire hydrant to fill City vehicles was observed. Water spilling from this activity drains across the asphalt, damaging the pavement and creating a regular pond of standing water within a depression in the concrete gutter

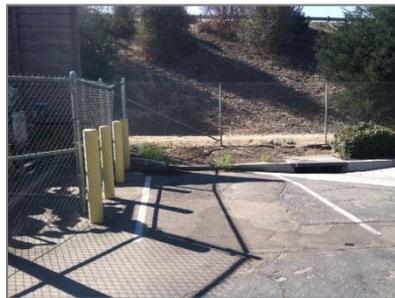
#### **Drain Inlet near Main Employee Parking**

- Acceptable condition of gutter and inlet; adjacent asphalt shows signs of distress possibly due to water overwhelming drainage facilities

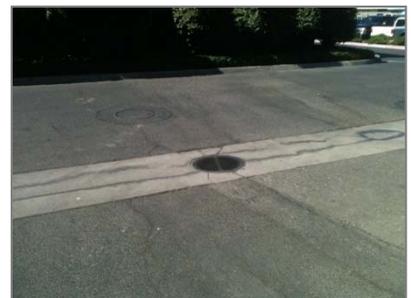
#### **Concrete Ribbon Gutters and Grated Inlets**

- Concrete gutters are in acceptable condition and inlets are free of debris; signs of failure of adjacent asphalt pavement is indication that drainage facilities are undersized or not functioning as desired; asphalt pavement failure near gutters was observed in bus and employee parking areas

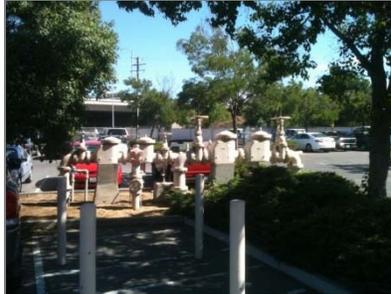
#### Potable Water/Backflow Preventer

- Acceptable Condition

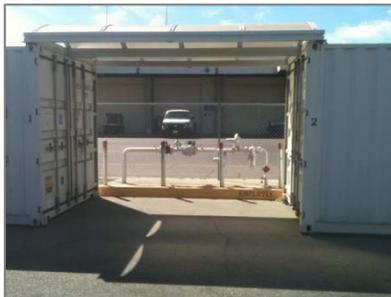
#### Natural Gas

- Acceptable condition

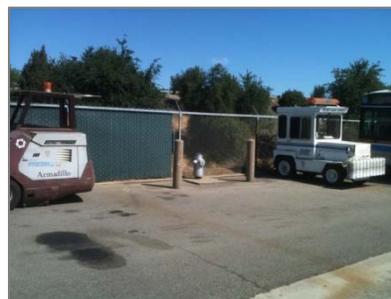
#### Fire Hydrants

- One hydrant is in the rear of the site behind the Maintenance Building; another is near the northwest corner of the Maintenance Building; both are older models, but appear to be in acceptable condition (hydrants untested)
- The hydrant used to fill the City vehicles near the Divisadero Street exit is not located on the FAX site

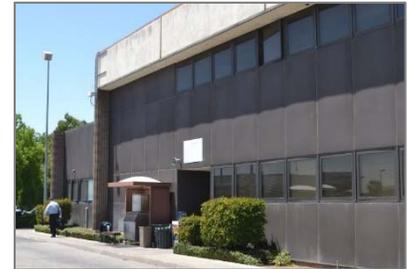
South Elevation

- Building exterior is generally in good condition and does not show any significant signs of deterioration.
- Exterior north/south walls are single-wythe; fluted concrete masonry block (CMU) and east/west walls are embossed porcelain enamel panels with cement plaster clad fascia at the upper roof.

- Exterior envelope of the building may likely not meet current CAL-Green code required insulation values for exterior insulation.
- Exterior doors have push button door operators. Door operators were functioning at time of assessment, but do not meet current code requirements. New door operators are required to be at both high and low positions.

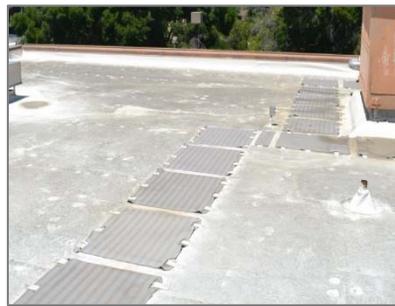
Roof Membrane & Walking Pads

- White membrane roofing does not appear to be original to the building. Roofing is generally in good condition with no apparent leaks.
  - ✓ Existing drawings indicate built-up roofing over lightweight insulating concrete. R-value of concrete is unknown.
  - ✓ Membrane roofing, textured walking pads are in fair condition and are causing debris accumulation in some areas.
- Roof drains have minor but typical debris accumulation around most drains.
- Mechanical equipment does not have screening around it.
- Roof is accessible from west stair.
- See Mechanical and Plumbing assessments for comments on rooftop equipment.

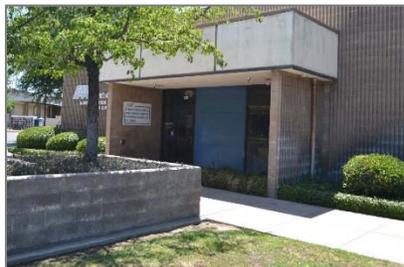
Main Entry (from northeast)

- Entry space on east end of building is in fair condition. Significant weathering from landscape irrigation is visible on the face of the building adjacent to the entry way

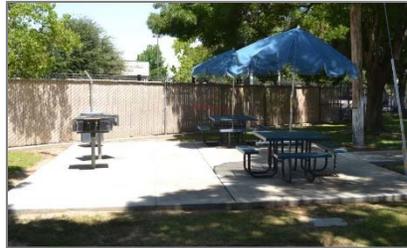
Admin Building Patio

- Barbeque grill and patio space north of the building is in fair condition but does not have direct access from Admin/Ops Building and therefore appears to not be in regular use.

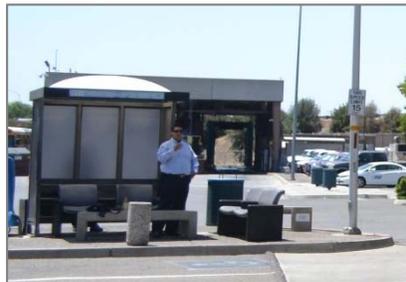
Smoking Patio

- Bus shelter and miscellaneous furniture located on the curb southwest of the building is used as a smoking area. Location of on traffic island does not appear to meet, or be appropriate for, the need for a designated smoking area for bus operators.

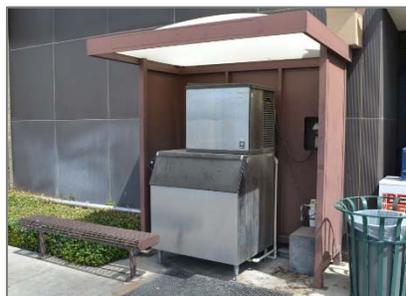
Exterior Ice Machine

- Ice machine located adjacent to southwest entry door is located under bus shelter. Ice machine is not rated for exterior location and should be relocated inside or under more adequate cover.

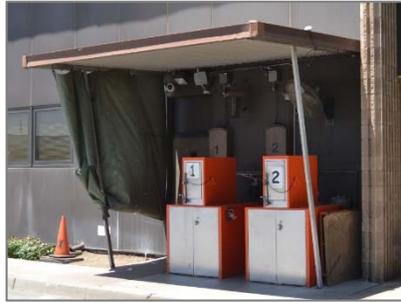
Fare Vaults

- Fare vaults are located under a canopy that is not original to the building. Date of canopy addition is unknown. Canopy does not appear to be providing sufficient cover for vaulting function and tarp has been hung on west side.

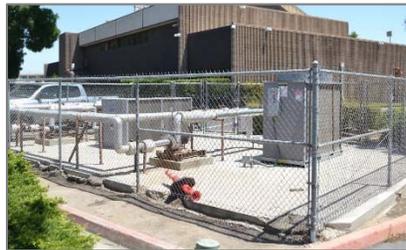
Chiller Plant for Admin

- Utility yard to the northwest only has chain-link fence around mechanical equipment. Screening should be provided around visible exterior equipment.

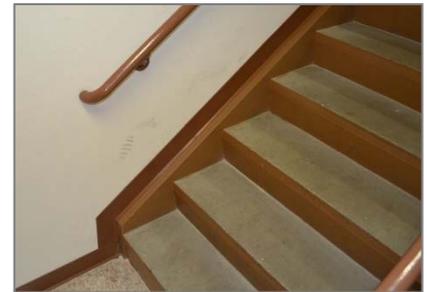
Typical Bottom of Stair & Handrail

- Interior stairs consist of concrete filled metal pan treads with bent metal risers. Rise of all interior stairs is approximately 7-1/4 inches. Current code maximum is seven inches for interior stairs.
- Handrails do not have code required handrail extensions at top and bottom of stairs. Top of stair should have 12-inch handrail extension past top riser and bottom of stair should have extension of 11 inches plus tread depth.
- Stairs also do not have code required contrasting stripes at top and bottom treads of each stair run.

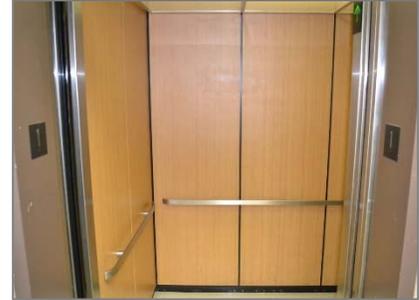
Elevator Cab

- Elevator is not original to the building; date of elevator addition is unknown.

- Elevator appears to meet current Code requirements for elevator access and usage.
- Location of elevator is not obvious and accessible path through second floor corridor/storage room is awkward.
- Elevator equipment room is accessed from the exterior and was not assessed.

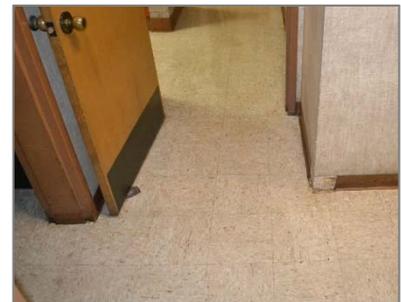
Typical Floor & Door Jambs

- Interior finishes are generally in good condition unless noted otherwise.
- Floor finishes are in fair condition and are generally worn and past typical lifespan. Rubber wall base is missing or damaged in various locations.
- Hollow metal, painted door jambs are worn and in need of repainting.
- Furniture is generally mismatched and inconsistent between spaces. Furniture systems also appear to provide insufficient storage in most areas.

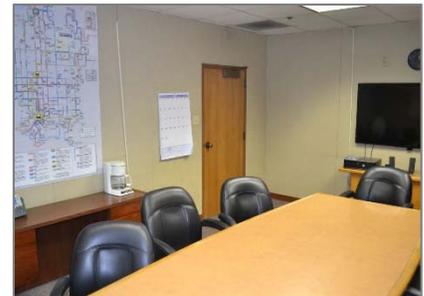
Conference Room

- Room has conference table and chairs for 12 persons.
- Room is generally in good condition, but has exposed data cable covers and miscellaneous furniture that appears unnecessary. Furniture is mismatched and not typical commercial grade.
- Room also does not have projector or projection screen, but has large screen monitor on west wall.

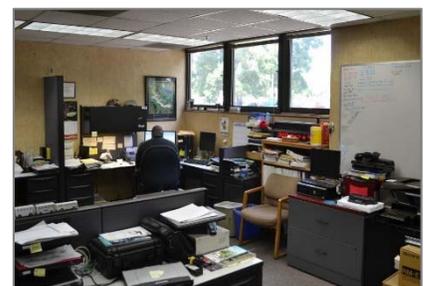
IT Office - 123

- Rooms are in good condition. Floor finishes are in poor condition and IT Room is missing a threshold.

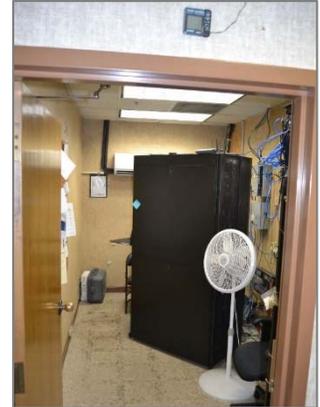
- IT office has four workstations and other miscellaneous furniture. IT function appears to lack sufficient storage for IT equipment. Portion of storage issue could be solved with more efficient furniture, but additional storage room appears to be necessary for IT.
- Tele/Data equipment appears to be relatively new, but functionality of equipment was not assessed.
- IT Room has card reader access control.
- Electrical Room - 210 also contains some IT equipment that may be in conflict with electrical equipment clearances.

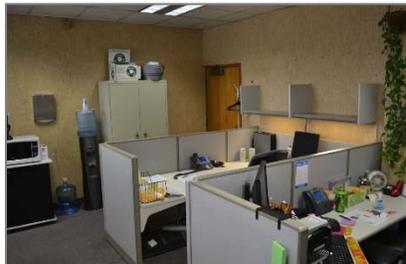
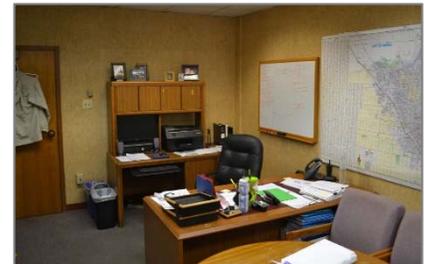
- Shared operations office has five workstations of various sizes. Furniture is mismatched and appears to be an inefficient use of space.
- Carpet is in poor condition and walls show numerous holes from prior furniture anchorage.
- Operations Manager Office is oversized compared to other administrative offices.
- Room contains excessive file storage and insufficient storage furniture.
- Room also has window in Fare Counting Room - 131.

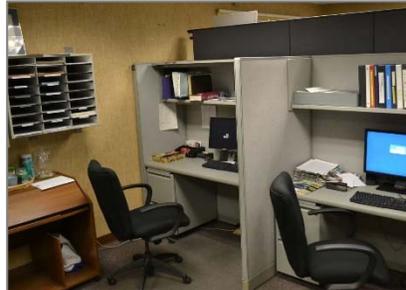
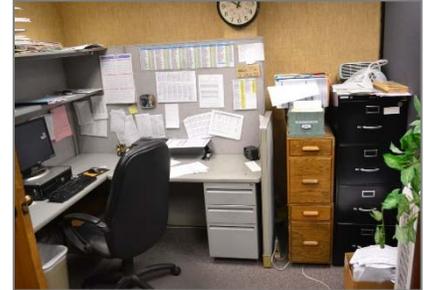
- Furniture is in fair condition but is mismatched.
- Carpet is in poor condition. Other finishes are in good condition.

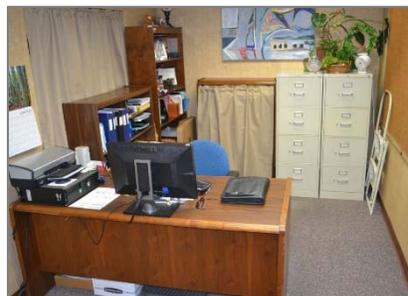
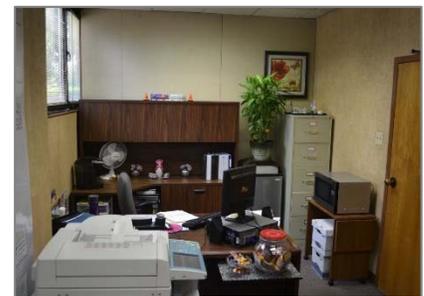
- Room was originally built as two separate offices (Instructor Office - 114 and Handi-Ride Office - 117), but demising wall was removed. Date unknown.
- Window from Operators Room into Room 114 has been covered by bulletin board in Operators Room and curtain in 114.
- In various location, the wall covering was removed and patched with cork material.

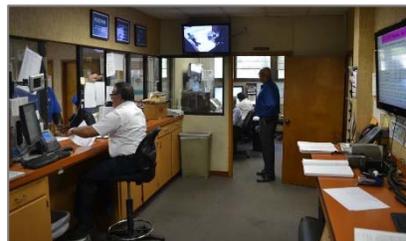
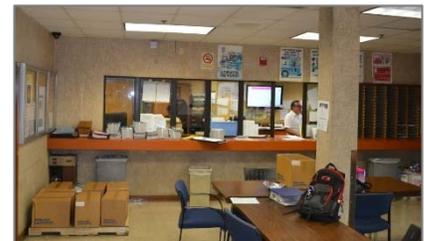
- Dispatch has poor visibility of main entry/exit for Operators.
- Dispatch counter and under-counter cabinets are original to building and are in poor condition.
- Transaction counter is 42 inches tall. Current Code requires minimum of 36 inches of counter length to be maximum of 34 inches high.
- Portion of dispatch counter and window has been replaced with mail slots (date unknown).
- Furniture, storage shelving, etc. is mismatched and inefficient use of space. Miscellaneous storage and cabinetry in space does not appear to be providing adequate functionality for dispatch operations.

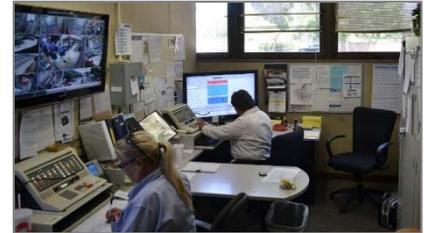
- Radio Dispatch room appears to be too small for radio dispatch function. Workstations are too small for the size of monitors and hardware required for function.

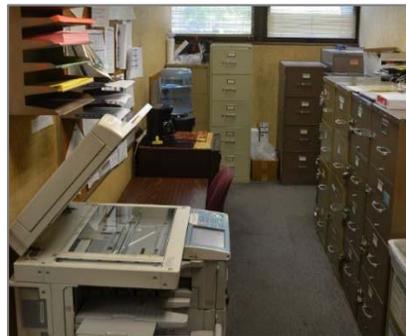
Copy & File Area

- Radio Dispatch space is not original to the building and was originally a file storage room. Room was extended into Dispatch room, reducing the functional area of the room.
- Adjacent Copy and File area appears adequately sized, but furniture is outdated and mismatched.

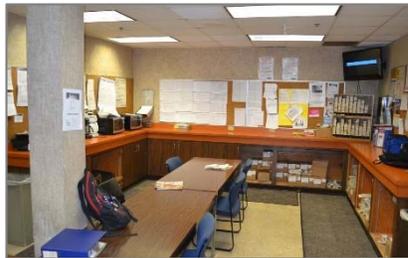
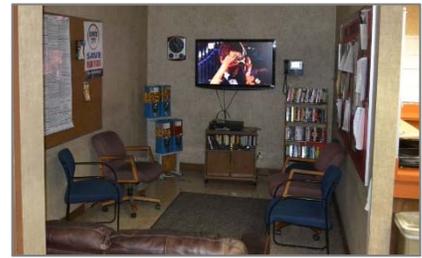
- Room is small for the number of Operators observed at the facility during peak times. Room was very loud which would pose a difficult space to do required paperwork.
- The orientation of the TV Alcove adds to noise in the Operators Room and at the Dispatch counter. Sound source

should generally be located such that the noise is directed away from Dispatch.

- Counter and cabinets are in fair condition. Counter is used sufficiently, but half of the doors on lower cabinet storage have been removed which adds to visual clutter within the room.
- Operators do not have access to sink or kitchenette, but have coffee makers and microwaves in the room.
- Bulletin boards are inconsistent and only two are lockable.
- Space is also used for distribution and storage of route schedules, pamphlets, etc. further reducing usable space.
- Furniture is in fair condition.

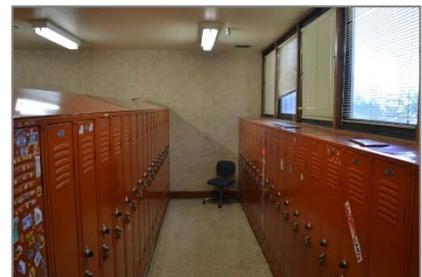
Operator's Lockers

- Locker room shared between men and women. Room has a total of 190 full size lockers (60 inches tall by 15 inches deep by 12 inches wide) . Lockers have sloped tops with the exception of the row of lockers under the north windows.
- Lockers are larger than typically used for Operators. Half-size lockers are generally sufficient.
- Lockers are generally in good condition with some minor damage to a few lockers.

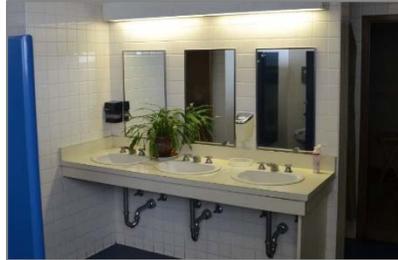
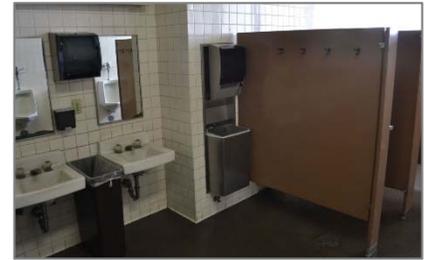
- Finishes are generally in good condition, but the ceramic tile is damaged in several locations and ceilings are showing excessive dust accumulation around ceiling diffusers.

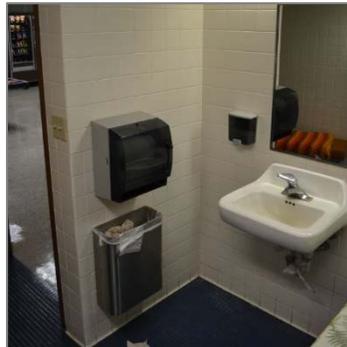
- Finishes are generally in good condition with the exception of the tile floor in Women's - 201 has lost its bond with the sub-floor in one observed location.

- Sink drains in rooms 201 and 202 do not have proper pipe guards and should be replaced.
- Fixtures appear to be in working condition.
- Drinking fountain outside second floor restrooms does not have proper accessibility clearances, should be minimum of 18 inches from adjacent wall.

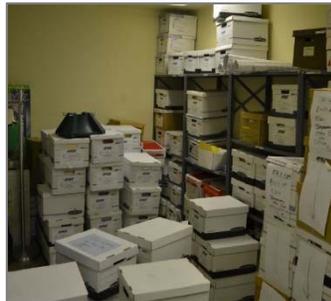
File Storage

- Room is not adequate size for the amount of file box storage.
- Shelving should be anchored to the walls per current seismic code requirements for tall shelving.
- Stacking of file boxes as observed may pose safety issues.

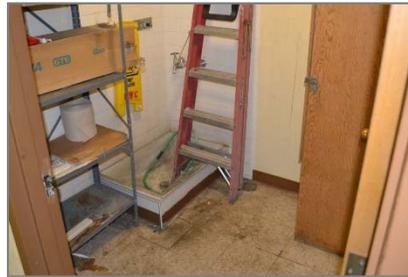
Janitors Room - 145

- Rooms are generally in good condition, but floor finishes are in poor condition. Janitor rooms should have tile finish on floor.
- Sinks appear to be in working condition.

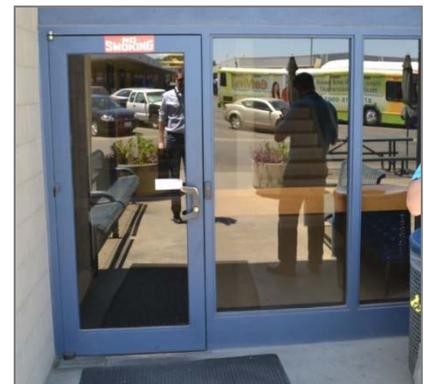
- ✓ Additional windows located in office area are not shown in the original drawings but windows are also in good condition.
- Main entry storefront consists of non-insulated glazing in hollow metal frame. All other doors are typical hollow style doors and frames and are in good condition.

Main Entry Storefront Glazing

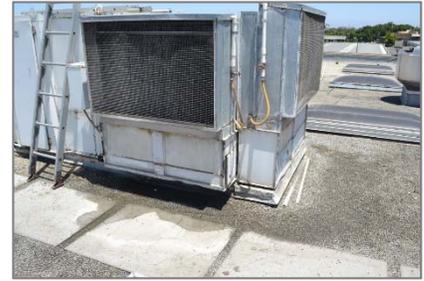
- ✓ At time of assessment roof was leaking under roof-top unit HV-2. Leak was located in the center of the second level parts storeroom.

Roof Leak at HV-2

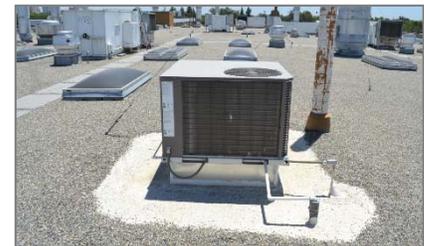
- At one location, roof has had fluid-applied, white membrane added over original built-up roofing around HVAC unit that is likely serving the Facilities Supervisor and Transit Police offices. Date of spray-applied white roofing is unknown.

New White Membrane Roofing

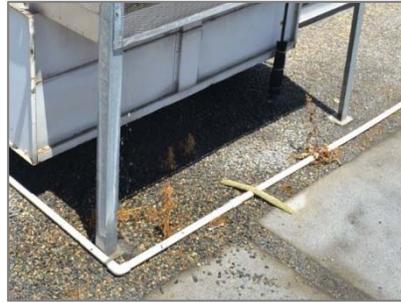
- ✓ Roof is ponding in several locations around overflowing evaporative coolers.

Overflow from Evap Cooler

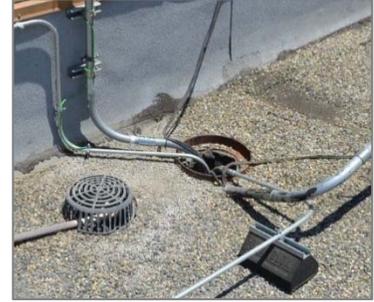
- Roof drains have significant debris, dirt accumulation around most drains, with some drains having plant life growing within build-up around drains. Insufficient crickets of roof edges appears to be causing ponding around drains and other locations.
- Various locations: Paint on parapet coping and various flashings is deteriorating. Parapet cap around entire perimeter is showing significant weathering and rust.
- Electrical conduit routed through overflow drain in one location. Integrity of conduit and overflow drain is unknown.
- Skylights throughout building appear to be in fair condition. Acrylic domes show significant weathering and are not transmitting as much light as possible.
- ✓ About half of skylights are also operable smoke vents. The functionality of smoke vents was not assessed, but several were visibly leaking fluid from hydraulic mechanisms.

Conduit through Overflow Drain

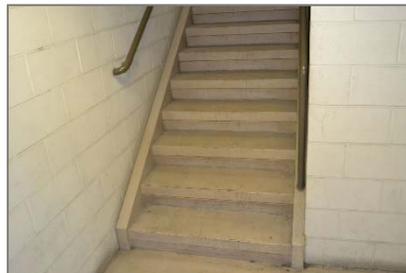
- Stairs are generally in good condition, but painted stairs are in need of repainting.
- Interior stairs consist of concrete filled metal pan treads with bent metal risers. Rise of all interior stairs is approximately 7.09 inches. Current Code maximum is seven inches for interior stairs.
- Handrails do not have Code required handrail extensions at top and bottom of stairs. Top of stair should have 12-inch handrail extension past top riser and bottom of stair should have extension of 11 inches plus tread depth.
- Stairs also do not have Code required contrasting stripes at top and bottom treads of each stair run.

Typical Bottom of Stairs

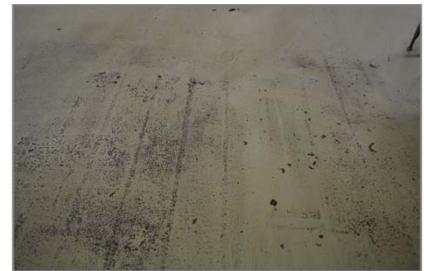
- Concrete floors are currently in poor condition. Light colored floor finish is worn and peeling in numerous locations. Multiple

locations have new concrete slabs that were not refinished to match the remainder of the building.

Typical Floor Finish

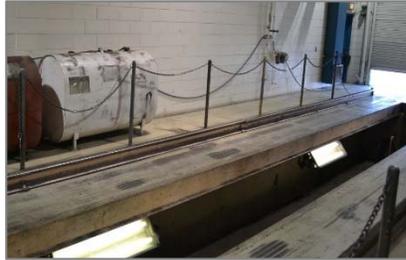
- Removable pipe and chain guards as shown on original drawings were removed from interior inspection position, but guards are still partially in place for position closest to north door.
- Rails were added to guide buses along inspection pits.
- Inspection pit has cardboard on floor to absorb fluid spills and leaks. Floor should have permanent solution to collect fluid spills.

Pipe and Rail Guards at Pit

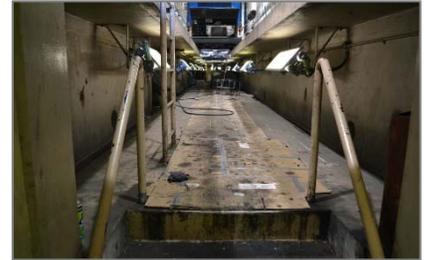
Inspection Pit

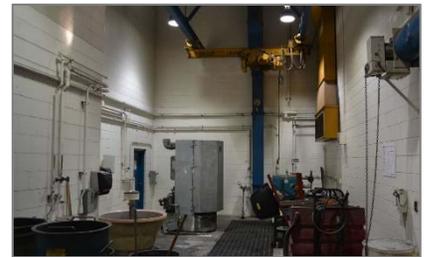
- Floor in component clean area is worn and in need of refinishing.
- Lighting in component clean is very good, but much higher foot candles than elsewhere in the Maintenance facility.
- The Chassis Wash bay has significant residue accumulation from chassis wash operations and wall paint is flaking off. Room is in need of significant cleaning and refinishing.
- Pipe insulation on wall mounted plumbing is deteriorating and should be replaced.
- Light levels within chassis wash bay are low compared to other bays and shops. Lighting levels should be consistent between spaces.

Component Clean Area

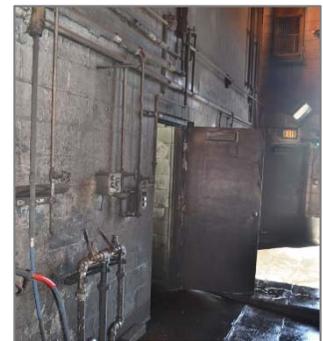
Chassis Wash Bay

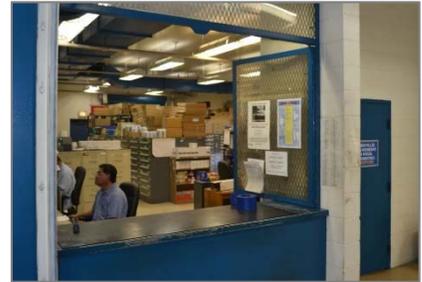
- Painted parts counter is heavily worn. Re-painting of transaction counter is generally not recommended. Stainless steel surface is typically specified for a parts counter.
- Exit sign above door to Stair 6 corridor is missing and should be replaced.
- Four workstations adjacent to parts counter are in good condition and appear to be sufficiently sized.
- Parts Room Office - 132
  - ✓ Room is sufficiently sized but has inefficient furniture.
  - ✓ Finishes are in good condition except the floor which has damaged composite tiles.
- Storage Mezzanine - 208 & 209
  - ✓ Rooms are in good condition with the exception of the leaking roof as noted above. Fireproofing may be damaged by significant leaks and further investigation may be required.
  - ✓ Rooms are separated by rated coiling doors with fusible links. Doors appear to be in good condition.

Parts Counter

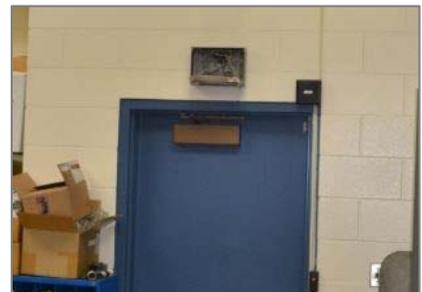
Missing Exit Sign

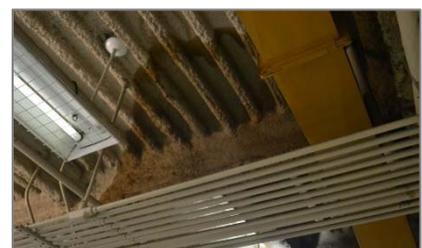
Roof Leak

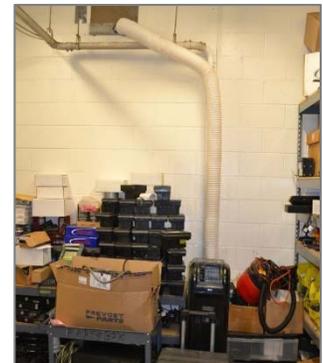
- Room was originally designated as the Battery Room.
- Room has insufficient storage and appears to be lacking proper work bench for amount of working being performed.
- Room has freestanding portable air conditioning unit that is vented through existing wall vent.

AC Unit

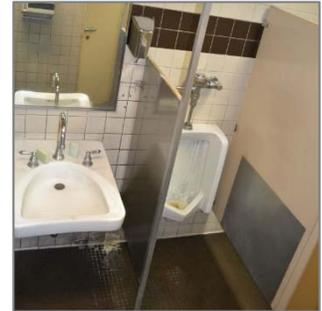
Men's Room Fixtures

- Toilet room stalls do not meet current accessibility clearance requirements. Stalls must be minimum five feet clear.
- Toilet paper dispensers and grab bars are not mounted at the correct heights.
- Finishes in the Women's room are in good condition. Finishes in the Men's room are in poor condition.
- The sink in the Men's room does not meet accessibility clearances for sinks. The sink in the Women's room is compliant.
- Both sink drains are missing required pipe covers.

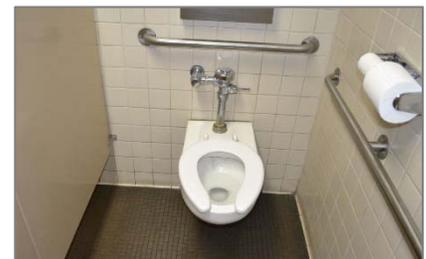
Men's Room Toilet

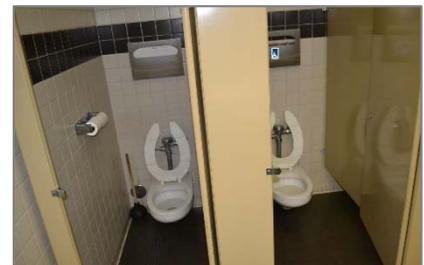
- Room has five showers, three urinals, three toilets, and two semi-circular hand wash basins. Minimum of one sink, toilet stall, urinal, etc. should be provided to make restrooms accessible.

Non-Accessible Toilet Stalls

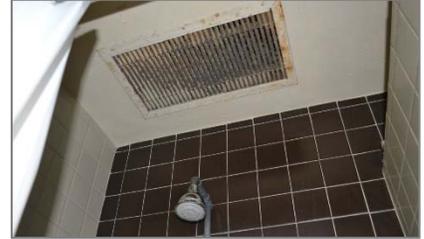
- Ceilings in shower room are in poor condition and exhaust grilles have significant dust accumulation.

Shower exhaust

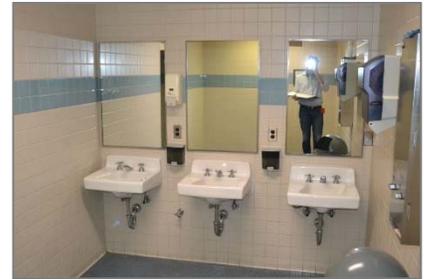
Sinks without Pipe Guards

- Room has two showers, two toilets, and three sinks. Minimum of one sink, toilet stall, urinal, etc. should be provided to make restrooms accessible.
- Room was originally planned for 45, 12-inch wide by 15-inch deep lockers. Portion of original lockers have been removed; only 24 remain and two, 18-inch wide by 20-inch deep lockers have been added. Minimum of 5 percent of lockers and one bench should be made accessible.
- Sinks are accessible, but drains do not have Code required pipe guards.
- Fixtures appear to be in working condition.
- Finishes are all in very good condition.

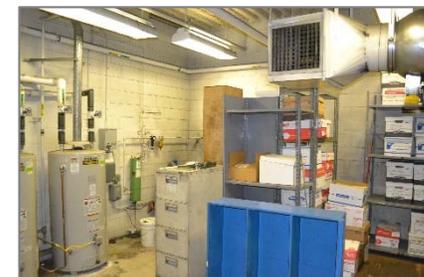
- Room contains various utilities (hot water heaters, air compressor, and electrical panels).
- Room is also used for file storage and other miscellaneous storage. Paper storage should be separated from utilities to ensure files are not damaged and are secure.

Mechanical Equipment & File Storage

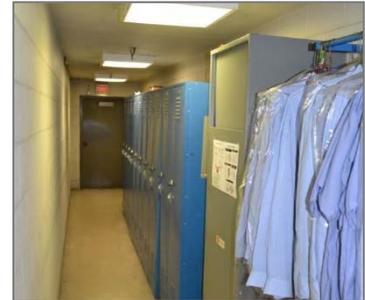
- Storage of lockers and uniforms in egress corridor as observed in first floor corridor from Stair 6, is prohibited by code. Lockers and uniforms should be relocated to appropriate areas.

Lockers Located in Corridor

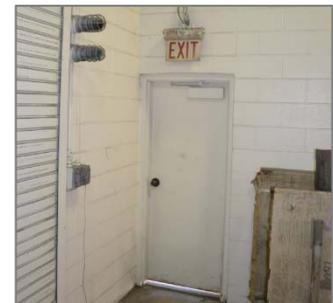
- Doors at the ends of the Paint Bay and Inspection Bay do not have sufficient push clearance on latch side of doors. Doors could be re-hung to opposite hand within current door frames to meet current code clearances.

Door with No Push Clearance

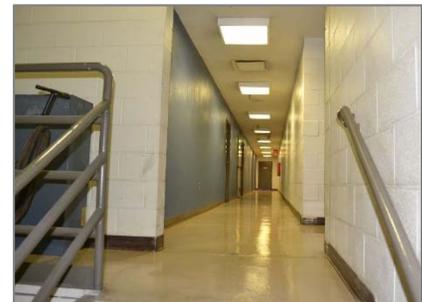
- Pending detailed design process, the use of Stair 5 for exiting from second floor may not be permitted since stair exits through an intermediate space (maintenance bays). Exiting will be determined by occupancy and existing analysis typically done during the schematic design phase of the architectural process.

Stair-5 Open to Corridor

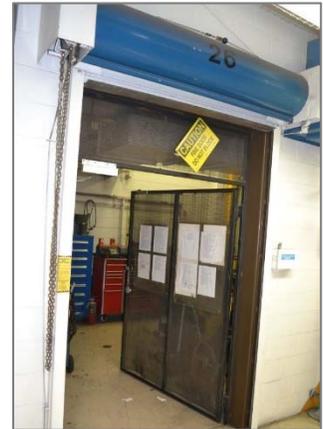
- Fire shutters on storage rooms 135 and 137 create egress issues for occupants. In the event of a fire the fire shutter will close, trapping those inside without an exit. Necessity of fire shutters on these rooms is likely not required by the current code and could be removed. Electronics Shop-138 has a similar issue with the fire shutter but has separate man door that would allow for egress.

Fire Shutter on Room 135

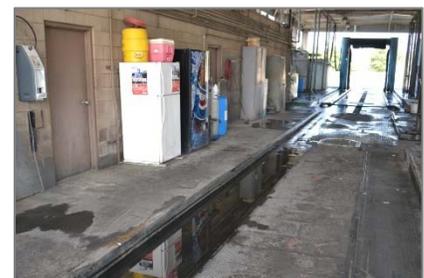
- Drainage from bus wash cycle was observed overflowing beyond floor drainage between bus washer and vacuum position. Standing water in service lane is likely leaking into unused lower level. Drainage and floor slopes should be analyzed in more detail.

Service Lane

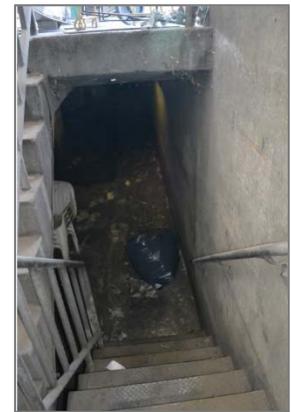
- Lower level has been abandoned and is no longer used for bus inspection, but stair access is still open.
- Floor openings have steel plates added to cover openings but plates are not sufficiently secured to prevent movement.
- Lower level space was not thoroughly assessed due to significant odor, but space was observed with standing water and trash. Environmental hazards of space have not been assessed but it is likely that local jurisdictions may require special precautions or remediation to be addressed if space is to be repurposed or completely abandoned.
- Guardrail and handrail on stair to lower level do not meet current code requirements.

Stair to Lower Level

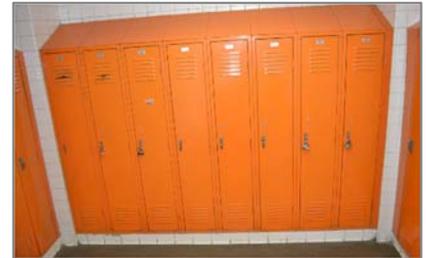
- Building consists of fluted, single-wythe CMU walls and metal deck roof. Building has no added insulation
- Mens room has 22 lockers and Womens room has 11 lockers. Lockers are all 60 inches tall by 15 inches deep by 12 inches wide. Lockers are small relative to the lockers available in the Maintenance Building locker rooms. Lockers are not being used.

Mens Room Lockers

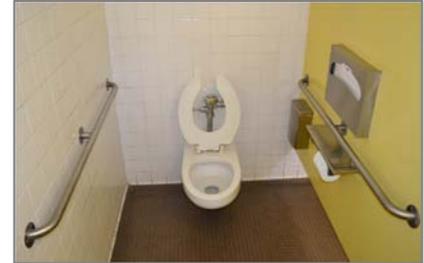
- Sink vanities in both rooms are in very poor condition and sink drains do not have pipe guards.
- Toilet stalls do not meet current accessibility clearances.

Womens Toilet Stall

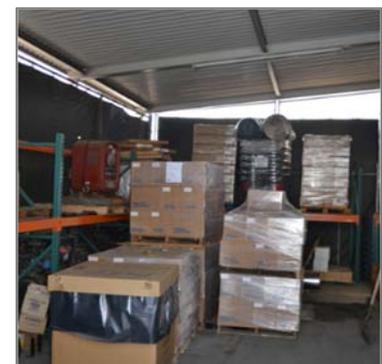
Covered Palette Storage

- Building does not have restroom or any other plumbing that was visible during assessment.
- Canopy structure off of building to the north is used for palletized storage. Canopy has fluorescent lighting but does not have fire sprinkler system.
- Function appears to be lacking sufficient exterior covered storage. Several portable containers are being utilized for storage needs and a large percentage of materials are stored in the yard.

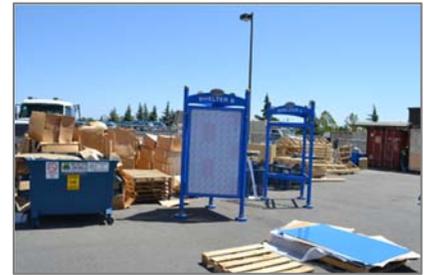
Exterior Uncovered Storage

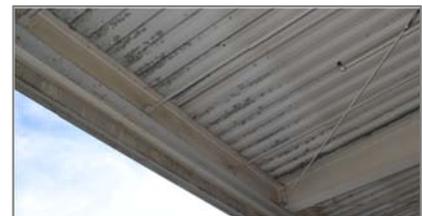
- Canopies are generally in good condition, but there is significant paint flaking and chipping on the underside of the canopies.
- Fire sprinkler system appears to have adequate coverage. Multiple pipes, particularly at ends of canopies have significant weathering and should be repainted to protect piping.
- Lighting systems appear to be adequate for canopies.
- Roofs were not accessible for assessment but no apparent leaks were observed.
- Photovoltaic system on roof of canopies has not been assessed. System was added in 2004 according to as-built drawings.

Typical Underside of Canopy

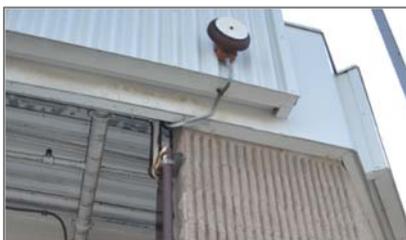
Fire Protection System

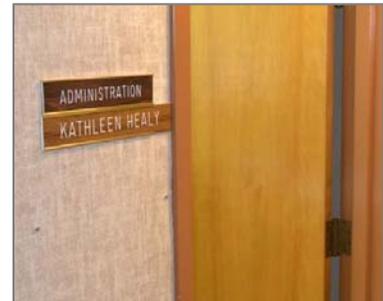
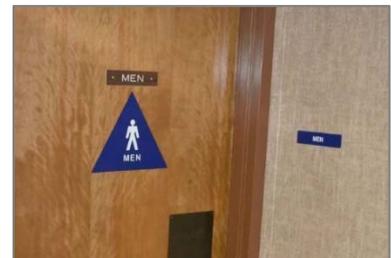
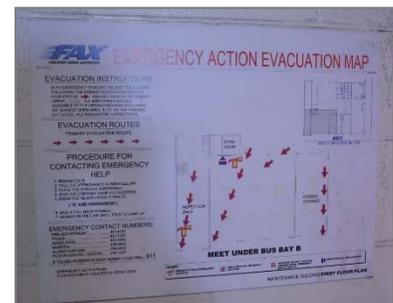
- All buildings lack proper room identification signs and accessible way-finding signs with braille and raised text that is required by code. Room ID signage is sporadic and not consistent between all of the building. Room ID signage should be adjacent to doors and have minimum of raised room numbers and braille lettering.
- Restroom signage does not meet current Code for room identification.
- Evacuation maps also do not meet current Code requirements. For example, signs should indicate location of horns and strobes for fire alarm systems.
- Stairwells and exit paths lack tactile exiting and egress signage required by Code.

Typical Room ID Signage

Restroom Signage

Typical Evacuation Signage

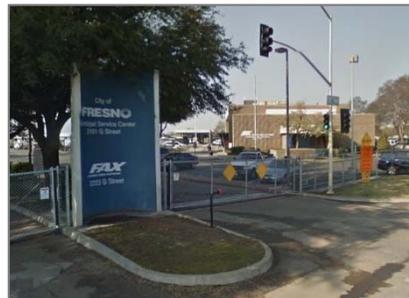
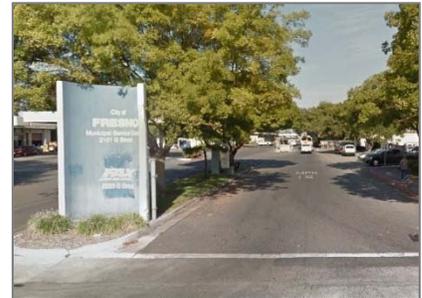
- Facility identification signage is located on the Admin-Ops Building main entry facing and visible from G Street. Signage contains building address and is in good condition.
- Additional FAX signage is included on semi-circular monument signage at campus entries on G Street and East El Dorado Street. Signage is difficult to see from the street due to shape of signage.
- Way-finding 'City of Fresno' signage within campus that provides directions to FAX buildings is difficult to see due to small text size. Text size may not be sufficient per City Fire Department standards.

FAX Signage on G Street

FAX Signage on El Dorado Street

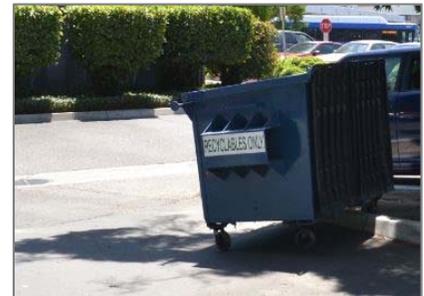
- Buildings do not have trash or recycling dumpster enclosures. The CEQA (California Environmental Quality Act) or other local jurisdiction may require refuse containers to be located within a covered enclosure to prevent storm water from collecting in bins. Further analysis will be required to determine if necessary for FAX facility.

Recycling Dumpster in Admin/Ops Parking Lot

- Recycling dumpster at the Admin Building was observed propped up on curb in the employee parking lot.

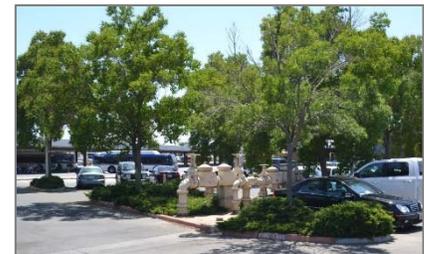
- The landscaping at the facility exists only around the Admin/Ops Building and employee parking lot. No landscaping exists around the maintenance building or Fuel and Wash Buildings. Landscaping within in the MSC campus was not assessed.
- Plantings are generally in good condition, except as noted.
- Grass and vine ground cover is inconsistent and mulch is non-existent. Exposed soil and exposed sprinklers are typical of most areas.

Landscaping in Parking Lot

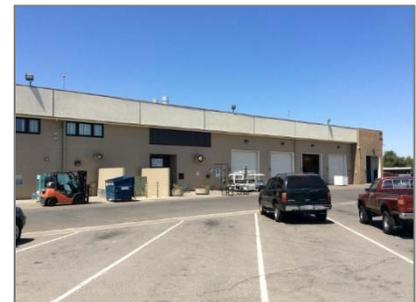
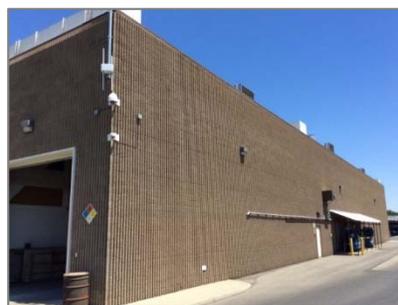
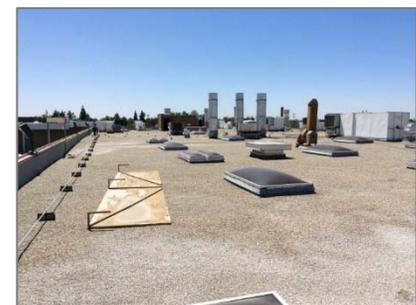
A significant item of note is a discrepancy that was observed between the structural drawings and the actual structure. The structural and architectural drawings provided to Arup both show a 12-inch concrete wall around the building perimeter, but these walls were found to be CMU upon inspection. This substitution may be sufficient to resist the required loading, however it raises questions about the construction quality control program. Such a change should never be made during construction without clear documentation and approval of the structural engineer of record. If this was done without the engineer's knowledge or without proper verification of the substitution, it is also possible that other deviations exist that could not be observed during this site visit.

Many penetrations exist in East and West facades, whereas North and South facades have few penetrations. Substantial equipment and penetrations exist on roof. Note perimeter walls are given as concrete in the structural drawings but were built as CMU.

East Façade (West façade similar)

South Façade (North façade similar)

Roof

If the maintenance building is to be incorporated into the long-term functioning of this facility, it is recommended that a more rigorous structural evaluation be performed. A seismic analysis of the structure is recommended to confirm conformance with current code practice, as seismic codes have changed substantially since this building's construction; this will be required if the building's use, occupancy or geometry are changed as part of the master plan. Such an analysis should incorporate as-built information such as the substitution of masonry for concrete walls described above.

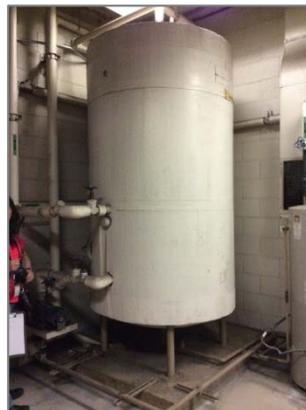
Large objects appear to be generally anchored, but falling hazards may still exist. Objects may slide off of shelving, a large water tank may not be sufficiently anchored, and an exhaust stack is anchored to a duct.

Tall water tank anchored to floor only

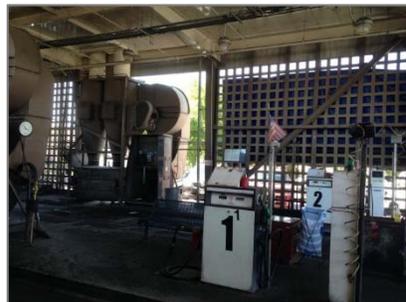
The structure appears to be generally in good physical condition. No significant material deterioration or foundation settlement was evident, though some paint flaking may lead to future corrosion. However, one of the steel braces appears to have been removed to allow for service equipment. The braces in this structure are proportioned to act in tension only; therefore, at least two braces are required along each frame line for a complete seismic system. One of the two braces does not exist along one of the brace lines. Seismic behavior may be erratic and not achieve the performance intended by design. The facility manager stated that this brace has never existed in his memory, which dates to a few years after construction. There is evidence that the brace was initially installed but cut free later.

Exposed steel structure. Light weight framing. Note missing seismic brace.

Missing seismic brace

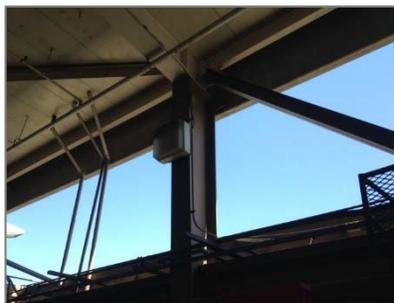
Top of brace connection

Ordinary concentric brace frame system used, with double channel braces. Braces are too slender to carry compression forces, so will behave as a tension-only system.
