# MASTER PLAN REPORT

**FAX Transit Operations & Maintenance Facility**  
Fresno FAX  
Fresno, California

November 21, 2014

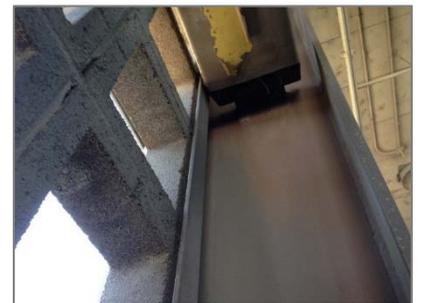
Masonry cladding bracing

Masonry cladding is detailed for out of plane bracing to steel structure, but a gap is provided to allow steel structure to move in-plane a limited amount without damaging cladding. Out-of-plane movements may be a concern, including buckling of braces.

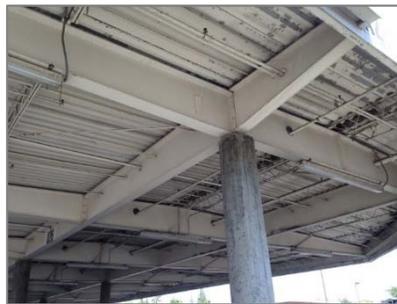
Typical top of column

Note paint flaking on metal deck.

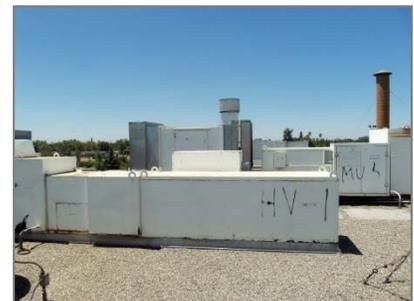
Typical Heat & Vent (H&V): HV-1 Shown

- HV-1: Rated for 5,400 CFM/8,100CFM; 5 horsepower (HP);460 Volt/3 Phase/60 Hz; Gas burner: 500 MBH; serving Inspection shop
  - ✓ Observation: Not running during site visit.

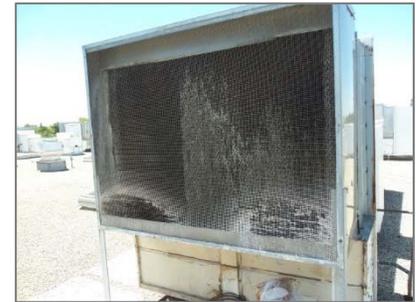
- ✓ Observation: Running at the time of the site visit. Water is not being distributed well among the evaporative coil.

HV-4 Evaporative Coil Damage

Based on the reconfiguration of the paint booth and prep area, it is recommended that the equipment serving this area be removed and redesigned. The following equipment is to be demolished and replaced with a central system or a packaged paint booth unit including equipment with mechanical system:

- MU-3,4,5, and 6
- HV-3 and HV-4
- EF-10, 16, 17, 24, 25, 26, 27, 28, 29, 30, 31, 32, 33, and 34

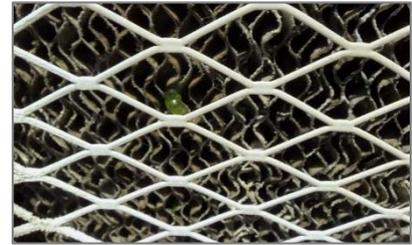
An evaporative cooler is located in lieu of EF-2 shown on original design documents. EF-2 was supposed to serve the inspection pit and hoist pits. This unit appears to be in poor condition and evidence of algae was seen on the evaporative coil.

Evaporative Cooler (not on original drawings)

Recommend replacing this system and modifying to serve the needs of the current space - PM Inspection. Currently only EF-1 serves the PM Inspection

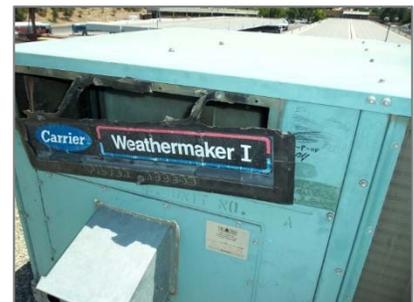
AC-1 DX Carrier Unit

- AC-1
  - ✓ Carrier Weathermaker I DX Unit 3,000 CFM; 3HP;460/3/60; Gas burner: 150 MBH; serving offices, toilet/locker rooms, lunch room and first aid room
  - ✓ Observation: Rust on top of condenser section and damaged fins.
- AC-2
  - ✓ Two to three year old new DX (R-410A) heatpump. Model: BBUZ-F030AA; serving two offices.
  - ✓ Observation: Unit in good working condition and minor maintenance is required.

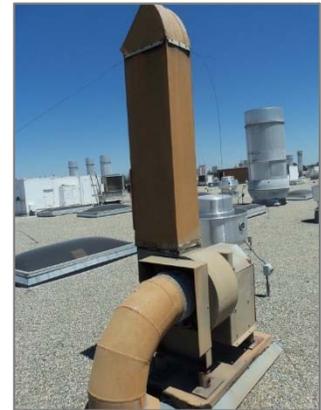
EF-9- Noisy Fan

Recommend that all EF's control be checked and documented. Depending on use and functionality, exhaust fan shall be evaluated to either be replaced with new high efficiency exhaust fans or motors replaced with high efficiency motors with variable frequency drives (VFDs).

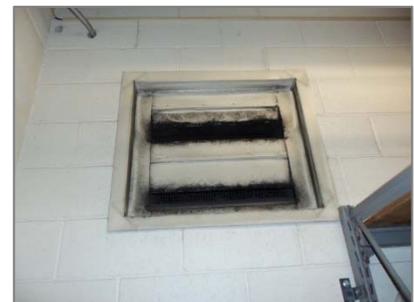
Grille in wall

We did not inspect the filters in HVs and MUs because they were not accessible but recommend to change based on dirt build-up on grille. See photo.

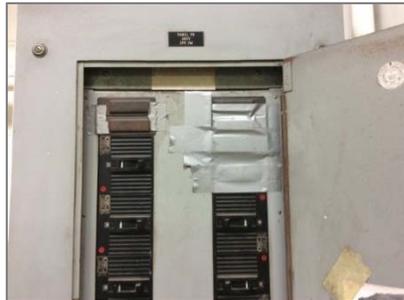
Panel 'PB' needs a proper cover plate instead of tape.

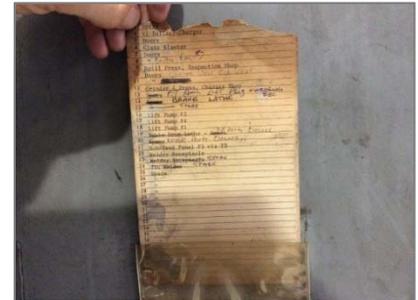
Proper schedules should be created

Panel schedules have handwritten corrections and some are falling apart. Updated printed schedules should be installed.

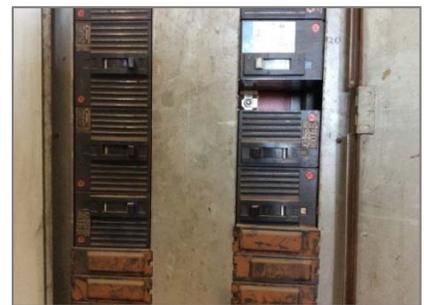
Panel 'PC' has exposed live conductors. A cover plate should be installed.

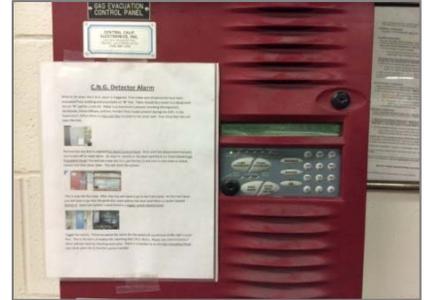
Gas Evacuation Control Panel

The 'Gas Evacuation Control Panel' produces regular alarms signals that force evacuations and a fire department visit. The system should be inspected and serviced as needed.

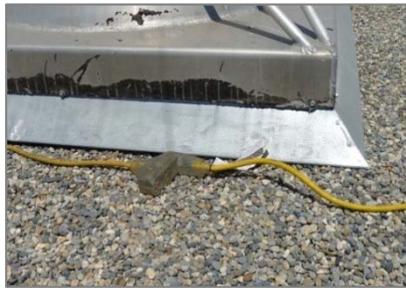
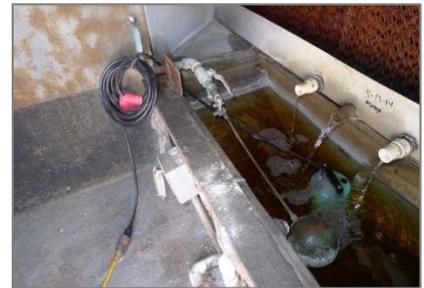
An extension cord on the roof provides temporary power to a small pump in a rooftop HVAC unit labeled '11V8'. The California Electric Code prevents this usage in Section 400.8.

Extension Cord on Roof

Extension cord power a small pump

The receptacle inside the HVAC unit '11V8' should be inspected and repaired so it can power the pump.

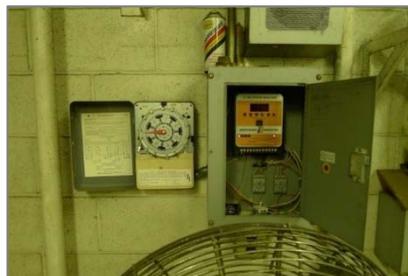
Controls equipment

Controls should be labeled as to which equipment it serves. Some controls equipment might be abandoned and should be removed.

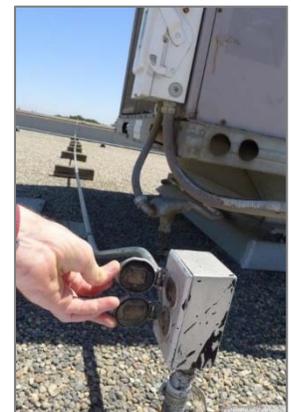
Rooftop Weatherproof Receptacle

The rooftop receptacles covers are weathered and may allow water to enter. The receptacle face shows signs of water damage. This particular receptacle shared conduit with the exterior lighting mounted on the roof. New waterproof covers should be installed.

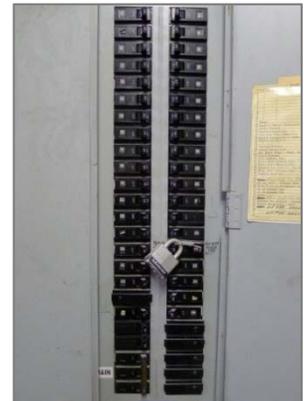
Panel 'P4'

Some breakers are fitted with trip locks to prevent an overcurrent event from tripping the breaker. These are to be used for fire alarm circuits only and should not be used to prevent nuisance trips. The circuit shown in this image is label as “New 2nd Floor Office Plugs” and should be investigated. Newer breakers can trip even if in held in the “ON” position per CEC 240.80. It is unknown if these breakers are up to that standard.

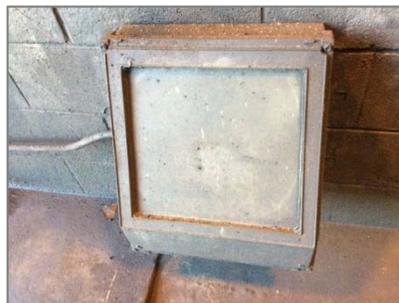
Lighting fixtures and controls throughout the building are outdated. We recommend replacing fixtures that need repair with modern equivalents. Many of the spaces are supplemented by day light though open garage doors or skylights. We believe that the existing lighting levels may cause issues at night or days when the weather prevents leaving garage doors open. Some area like the shop or paint booth should have higher levels of illumination because of the detailed tasks being carried out. The area labeled “Dismantling Parts and Cleaning” is prone to getting dirty and should be cleaned regularly to maintain proper illumination levels.

Light Fixture Dirty in Area '111'

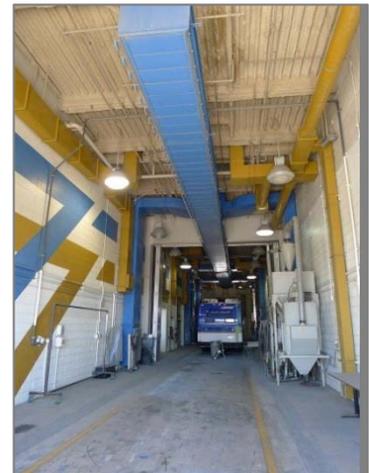
Paint Room With Garage Doors Open

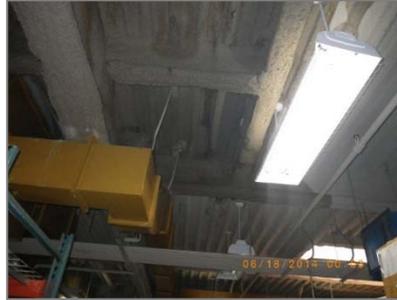
Leaky roof (under a roof Air handling unit which is leaking)

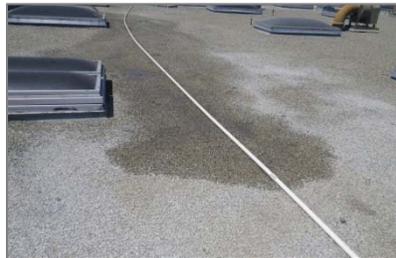
There is standing water on the roof from leaky Mech. system - indicating insufficient roof slope or roof has not been installed properly.

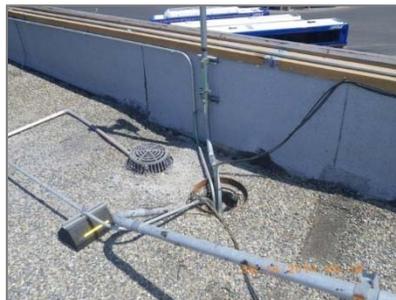
Overflow roof drain was used as conduit for cables. We recommend rerouting the cable and return the overflow roof drain to its intended usage.

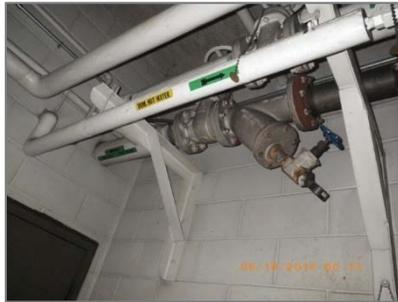
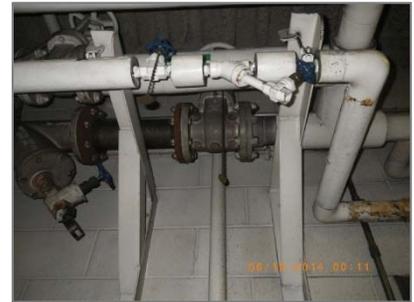
Domestic water does not have backflow preventer for each individual building.

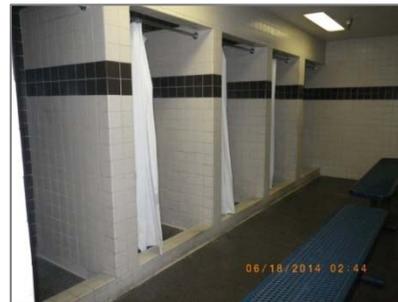
Restrooms seem to be not ADA compliant. Reconfiguration to address this issue.

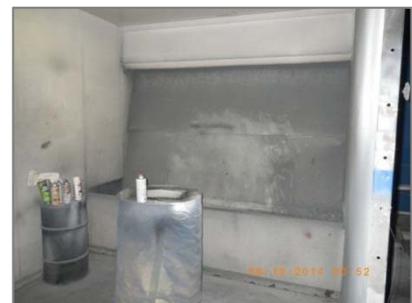
There is a wet filter system for a small fixed paint booth to the exhaust; it is currently not working and not in use. We recommend replacing the wet filter system with dry filters if the filter system will be required in the future.

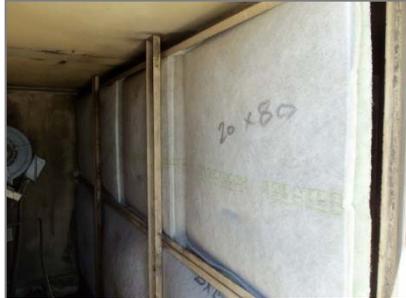
Prefilters in the Units

Filters do not appear to fit within the filter bank. Recommend upgrading the filter type used in the units.

Recommend that the existing air-handlers be properly sealed and cleaned immediately. These units shall be replaced with two new units for the remodeled and retrofitted space.

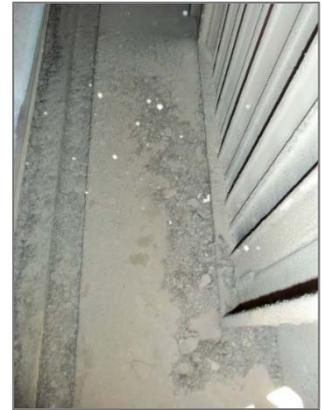
Before the filters: dirt in the units

There is dirt within the units and recommend to clean, if units are to remain.

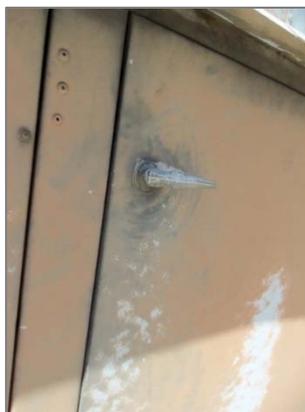
Leaky Access Doors

Currently there is a significant amount of air leaking from the access doors at the fan section of the unit. Recommend using a gasketed door to seal.

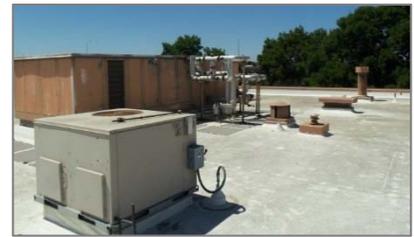
York Model D1NH024N03606C

This unit is at least 10 years old based on equipment tag. Uses R-22, which is a refrigerant that has been phased out. We recommend replacing this equipment and disposing of properly.

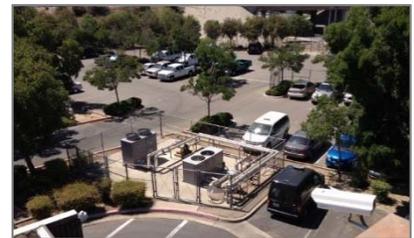
Chiller Yard is located adjacent to the building. There are two air cooled chiller. Both chillers have been having issues with tripping. Contractors have not been able to resolve issues with chillers. Potential issues: (a) communication between newer direct digital controls (DDC) and outdated pneumatic controls or (b) issues with part-load conditions causing tripping.

Based on the master plan schedule, the air-cooled chillers will be between seven to nine years old when this phase begins to go into design; typical equipment lifespan is 20-25 years therefore it is recommend that chiller system be

commissioned properly to diagnose issue of failure. Recommend to fix any damaged piping insulation in the immediate future and clean the condenser section of CH-1.

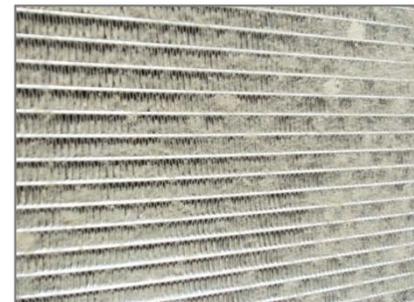
CH-1 Condenser Section blocked. Could lead to tripping if air path is blocked.

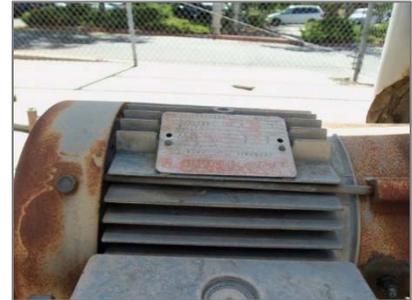
Exterior Chilled Water Pump  
Damage- CH-2

One pump motor recently replaced, other one has not been.

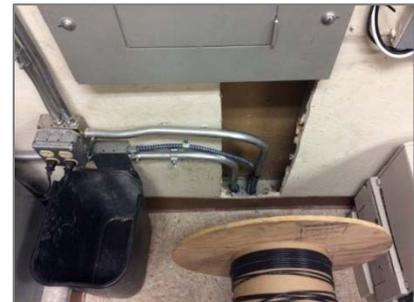
Utilities - Room 210

The room is a shared space and an effort should be made to mark off the required working clearances of the electrical equipment. User should remove combustible materials and prevent obstructions like the cable reel in the photo. The open wall shows that some minor electrical work has been done since the construction. Fire block may be required here and the hole in the wall should be patched.

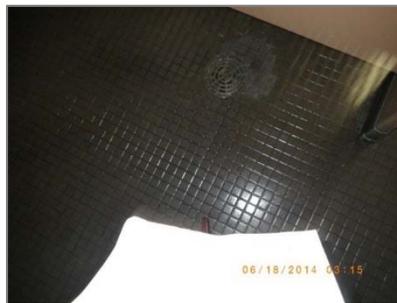
One of the water closets in one of the restrooms is leaking.

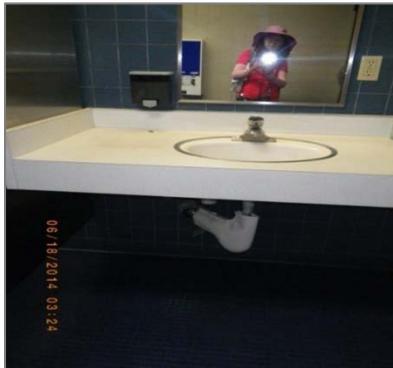
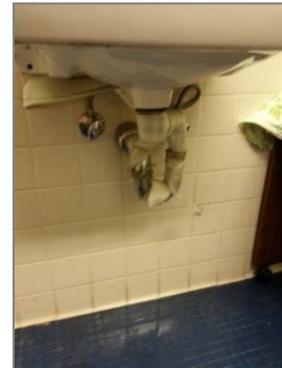
The faucet and drain are leaking in Women's restroom.

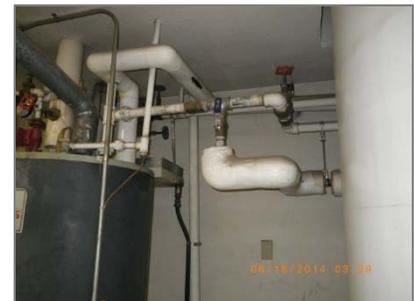
The Temperature and Pressure relief valve discharge pipe is piped up for steam vent and only a very small 1/4 inch) pipe extended to drain. This is a safety issue. We recommend replacing this small pipe to the same size of the relief valve discharge and piped to drain for safe Temperature and Pressure relief.

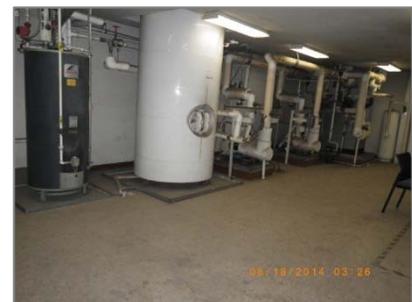
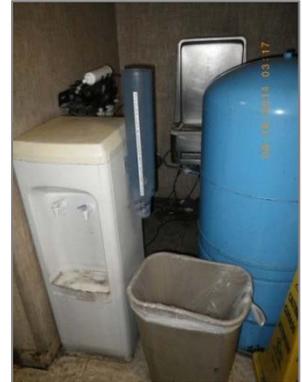
'Solar pre-heating' system for domestic hot water system is incomplete. There is a tank, with piping from ceiling and circulation pump, but there is no solar panel on the roof. The incomplete system is piped to pre-heat the domestic water to the heaters. It seems that the

valves are open - this 'solar' system is currently connected to the hot water system. Further investigation is required to decide either to disconnect the 'solar' system from domestic water system to prevent contamination or if they are in good condition, they can be completed and put into use.

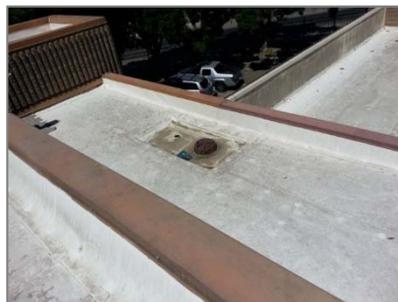
Overflow drain of the new addition are missing strainers. We recommend adding strainers.

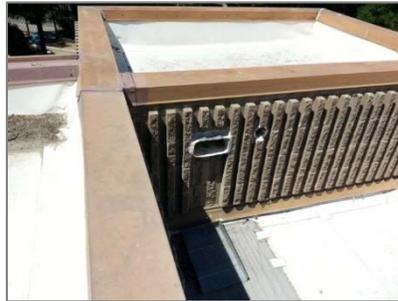
Overflow scuppers seem undersized (should be the same size as the primary).

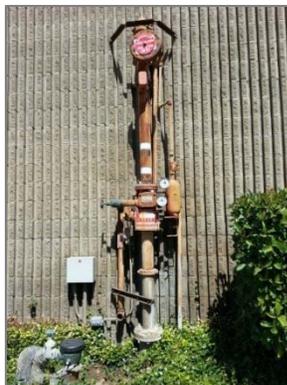
Building is fully sprinklered with no standpipe. Floor control valve is located at exterior - it shows signs of corrosion.

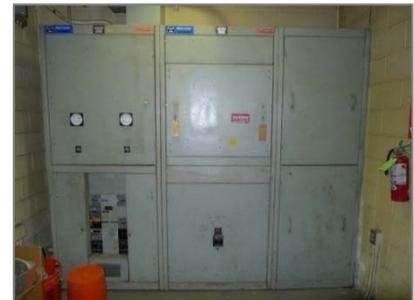
The Main Switchboard

We recommend replacing this Main switchboard. A newer switchboard rated between 1000A and 1200A with 1000A main breaker is recommended. A GE switchboard is used at the Maintenance building and we would recommend a GE Spectra Integrated Switchboard which would combine many of the existing transformers and panels in to one unit. This switchboard serves the bus wash island, the admin/ops buildings, and the future vaulting additions.

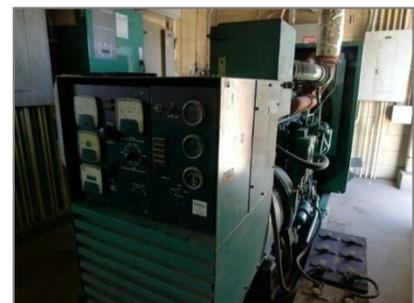
Bus Wash Generator

A generator installed in the electrical room in the bus wash island building. The last date of service was May, 20, 2014 when a voltage regulator was replaced. The service log suggests annual visits with load bank tests have been performed. No monthly testing logbook was found.

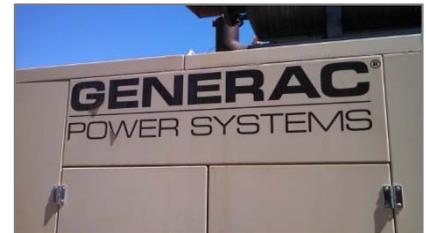
Generac Generator

A generator was discovered that was not shown on any of drawings provided. Its connection points were not discovered during the site visit. It was noted that the generator is 277/480, 3 phase, and is rated at 600kW/ 750kVA. It was manufactured in July 2005 and is installed near the CNG compressors, adjacent to the bus wash island.

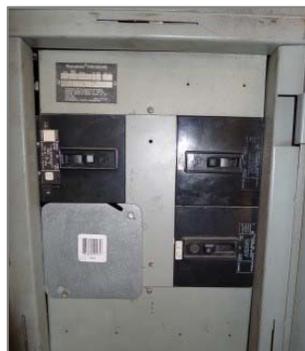
Makeshift cover plate

Panel 'A' contains an unlisted part which is being used as a cover plate. Source and install proper cover plate.

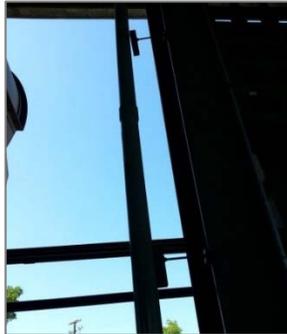
Storm water piping is not properly supported. We recommend fixing the supports.

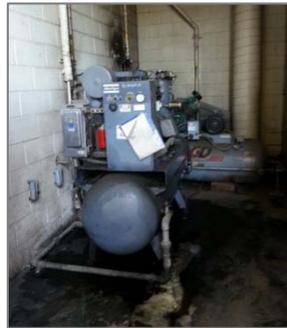
There is no floor drain/floor sink near the compressor for condensate. We suggest provide proper drainage for this area.

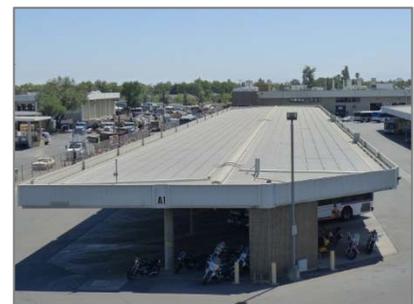
Canopy Solar Panels

The solar panel installation was not directly accessible at the time of the visit. The panels were observed from the roof of adjacent buildings and appeared to be dirty. Cleaning panels would produce more energy, which should be monitored before and after cleaning.

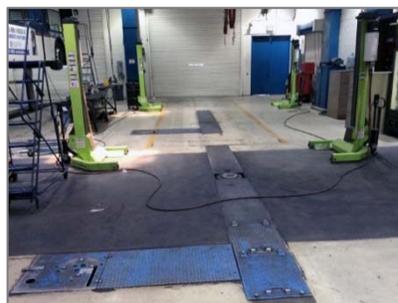
Non-Operating Lift - Repair Bay - 3

- In-ground bus lifts are drive-on or axle-engaging.
- Lifts are original to building construction but work was done to them.
- Over time, lifts had had multiple repairs.
- Some lifts have broken and their controls removed; see *Appendix A - Existing Maintenance & Service Equipment Photo Inventory & Assessment*.
- Broken in-ground repair bays use portable lifts.
- Replace in-ground lifts with modern axle-engaging lifts. Remove old lift pump stations to free up floor space.

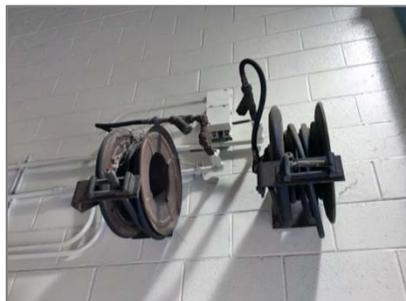
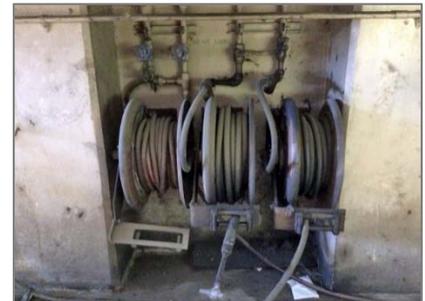
Inspection Shop Reels

Lubrication hose reels observed throughout the repair and inspection bays had visible wear on the reels, flexible hoses and connections between the hard tubing and reels. Fluid buildup observed on the majority of reel banks was consistent with the age of the system. Lubrication reels, hoses and dispensers within the Inspection Pits were either not working or in a considerable wear state.

- Fluid supply pumps in fair operating order however given the opportunity, replace with new and keep old as backups.
- Hose reels, dispensers and connections are worn or not working. Replace with new.
- Inspect the fluid management system for correct operation. Update software as necessary.

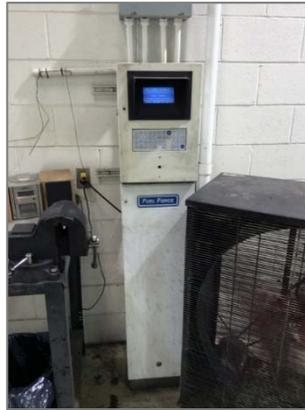
Fleet Watch Fuel Force Fluid Management System was observed operating in the Inspection Shop and West Repair Bays presumably monitoring use of Engine Oil, Gear Oil and Automatic Transmission Fluid.

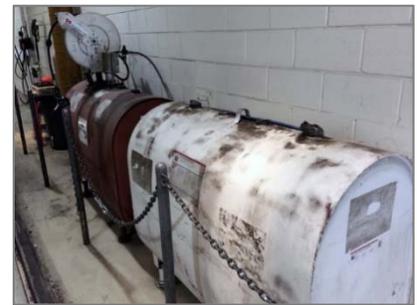
Inspection Shop Tanks

Inspection Shop also has additional above ground storage tanks with for SAE 15w-40 Engine Oil (currently not hooked up) and Diesel Engine Oil with tank mounted pump and reel dispenser.

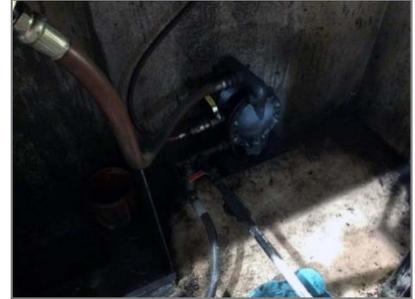
Waste Oil Pump

Within the Inspection Shop, Waste Engine Oil is collected through a rolling drain pan in the Inspection Pit that is connected to a waste oil pump located in the lower level. The waste engine oil is pump from the Inspection Pit underground to an exterior 2,000-gallon underground storage tank located adjacent to and west of the building. There is also a connection from the oil filter press located on ground level, to the underground waste oil tank.

- Rolling drain pain damaged. Replace with new.
- Replace waste oil pumps and collection sump with new.
- Repair leaks or clean area near oil filter press.

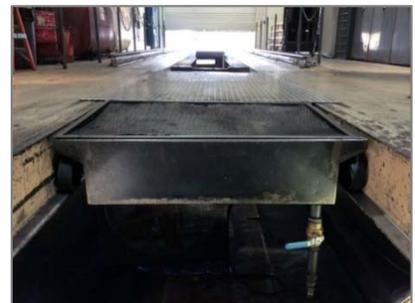
Rolling Drain Pan

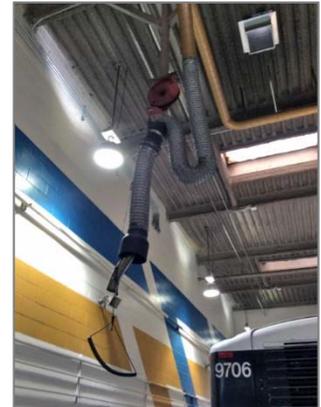
Operational Hose Drop

West Repair Bays and Inspection Shop. The vehicle exhaust system was designed for manual start and stop through column mounted push button controls. The majority of tail pipe exhaust hose drops were in disrepair and not used. Some tail pipe hose drops were observed intact. These were observed to have been replaced with CNG capable hoses.

- Replace all tail pipe hose drops with individually operated modern hose reels capable of handling both CNG exhaust temperatures.
- Provide exhaust hose reels for all repair and inspection bays.

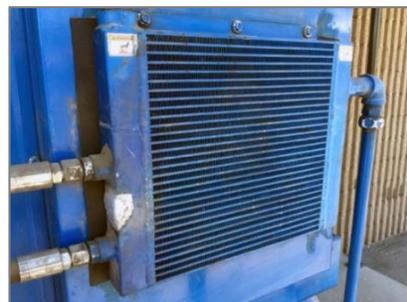
Radiator Repair

the repair and inspection bays are through wall mounted convenience outlets mentioned or through wall, column, or overhead mounted hose reels. A large number of wall/ column mounted convenience outlets were observed turned off or disconnected because they were either inaccessible (located behind portable equipment or shelving). Many were however observed in sufficient operating order. Many outlets contain components by different manufacturers. Further, compressed air hose reels were generally in good condition. There was no complaints heard and no deficiencies observed in the compressed air distribution piping, or air compressor equipment. Although, the east air compressor that is water-cooled, contained repaired damage to its radiator.

- Replacement equipment should consist of a filter/regulator and lubricator (where appropriate), blow-down “drip” leg, and quick coupler.
- Evaluate system air dryers. Potentially replace or add air dryers.
- Repair air compressor radiator.

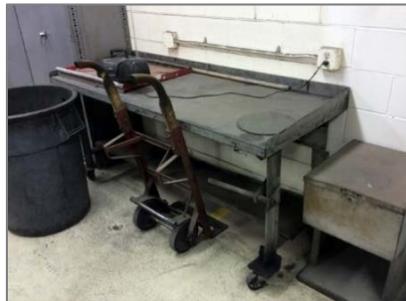
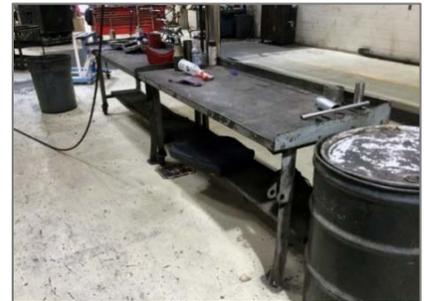
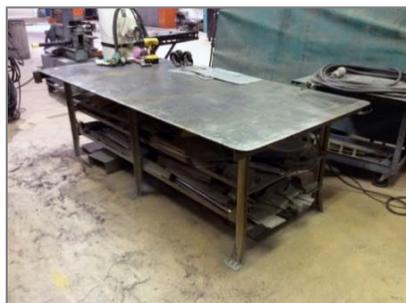
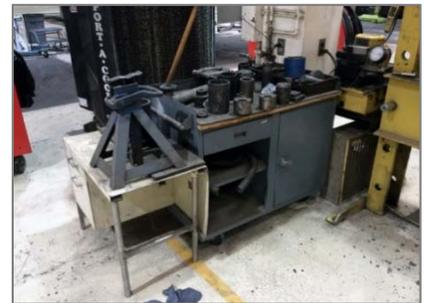
Workbench

the facility, there are other smaller workbenches that are essentially base cabinets with working surface tops, some contain drawers. All workbenches look to be original to the building’s construction; most are operational although some are damaged.

Given the opportunity, replace the workbenches with new and reduce the amount of furniture to only those necessary, located where they will facilitate efficient use.

- Reduce quantity of workbenches and working surfaces cabinets
- Replace with new equipment.

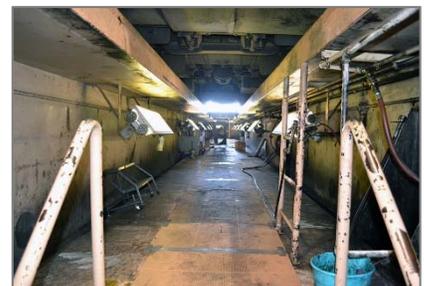
Inspection Pit

The Inspection Shop consists of the entire north end of the building, is one long bay containing a drive-on lift to the west and a long inspection pit to the east. The drive-on lift is broken and not being used. We were told that this bay was used for A/C repair in the past. A overhead fall-protection cable was observed in the bay. Consequentially, the west end of the inspection shop is currently underutilized. The inspection pit is heavily used. Its layout provides proper ingress and egress to and from the lower level. Opening protection is through guard post and chain and tire guides. The guard post and chain system was observed being used however, this type of system may pose an obstruction to mechanic's movement and is often removed, resulting in an unprotected opening. Further, the tire guides may be a tripping hazard to mechanics working above. The lower level passages are ventilated and lit and large enough for stand up desks for the mechanic's use. The pit area itself contains oil drip debris. A rolling waste oil drain pan and a rolling bridge jack were located within the inspection pit opening. The drain pan contains minor grating damage. Additionally, there is a stainless steel moveable pit bridge. The bridge contains visible welded repairs. Most vehicle lubrication fluid and compressed air hoses, outlets and dispensers within the Inspection Shop are damages, leaking or not in service.

- Clean and refinish the interior of the inspection pit.
- Provide updated lighting in the pit
- Fluid Reels need replacing.
- Rolling drain pan is damaged
- Consider replacing the pit opening post and chain protection and wheel guides with modern pit protection devices.
- Remove unused equipment.

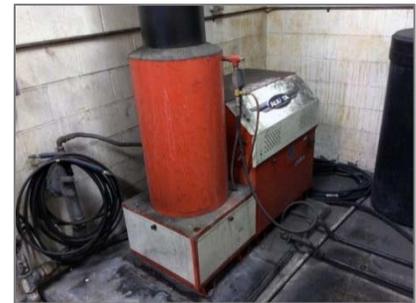
The cleaning bay condition was dirty as expected. In a bay where grease and other debris are cleaned away, a residue is typically left on the surrounding surfaces and equipment. Compressed air outlets and hose reels located on the walls in the bay contained heavy build-up. Periodic pressure washing is desired to keep the bay tidy. Further, the door to the cleaning equipment room was observed open allowing the interior of the room to collect greasy film.

High Pressure Hot Water Washer  
- Not Performing

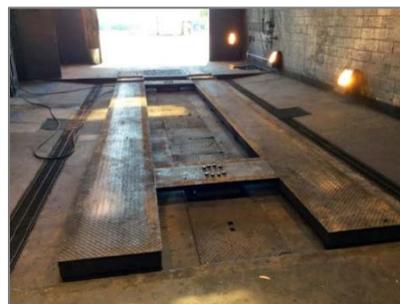
Platform Lift

The current vehicle lift looks original to the building's construction. Lift equipment badges and control labels were not found. As previously discussed, the lift may be at load capacity. In addition to loading capacity, the use of the lift is also limited by its physical dimensions. Complaints were heard that the high-pressure hot water washer does not supply hot enough water and does not clean well. It is recommended to replace equipment in the future build-out of the proposed chassis wash and component cleaning bay.

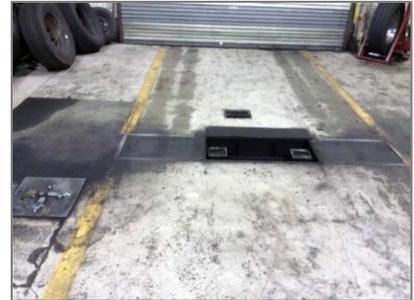
Tire Shop Lift

Buses are serviced with in-ground single-post axle-engaging lifts. Of the two lifts within the Tire Shop, only one is accessible. Because of this, buses being serviced only pull into the bay part-way. The other half of the bus sticks out of the bay onto the apron. Repairing tires this way is inefficient as to service both axles, either the technician has to pull the bus out of the bay, turn the bus around, then pull back in; or the technician has to use a portable jack to lift one of the axles. With both axles lifted at once within the bay, the technician can simply walk around the bus.

- Reduce the quantity of tires being stored on-site.
- More tire storage is necessary to provide efficient working space.
- Single-post lift is being blocked leading to inefficiencies.
- Proper administrative area is needed.

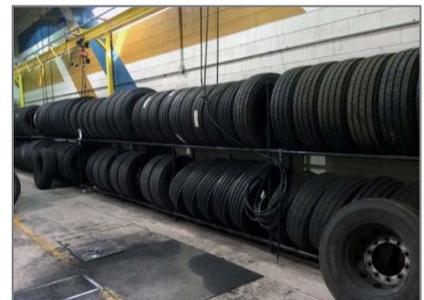
Tire Rack & Hoist

New and used and both mounted and un-mounted tires are generally stored within the tire shop. FAX stated that the Contractor is storing more tires on-site than allowed. Tires were also observed stacked outside adjacent to the Tire Shop on the bus apron. Tires are stacked at the interior of the bay blocking one of the single-post in-ground lifts. In addition to blocking one of the single-post lifts, stacked tires are prone to topple over when struck or during an earthquake. Along the south wall of the shop, a permanently fixed two-tiered tire rack is capable of holding up to 98 tires. The rack is custom built and anchored to the floor and block wall. Tires are accessed from the rack by overhead 500-lbs. hoist that runs the length of the rack on a monorail track. The tire rack, overhead track and hoist are fairly new additions and are in good condition.

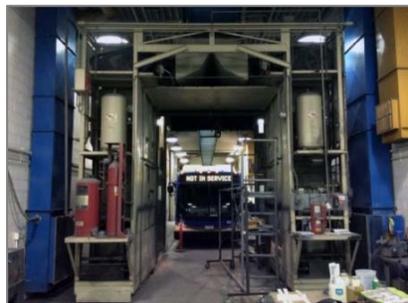
Rolling Paint Booth

- Rolling paint booth not functional and inhibiting use of long painting bay.
- Paint prep being performed in frame-pulling bay is causing dust and fume migration into adjacent areas.
- Majority of Metal Shop equipment being utilized.
- Drop table lift being utilized but aging and not replaceable.
- Some parts painting booth components not operating.

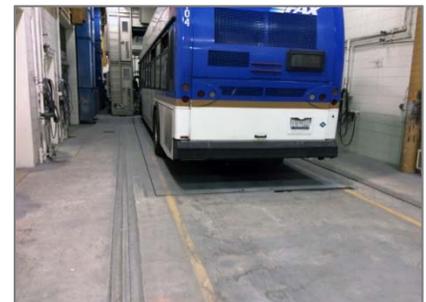
While not being used, the rolling paint booth is currently permitted requiring a yearly renewal. FAX plans to decommission this booth. The bus drop table within this area is in use. While FAX desires to keep the drop table function, similar equipment is no longer manufactured. Therefore, in the interim before FAX acquires 60-foot buses, the drop table will be used for standard length buses.

Bus Drop Table

- Maintenance Building (Level 1)
  - ✓ Paint booth location has been modified to allow continued use of existing drop table. Note: Drop table is at the end of its life cycle and needs to be replaced/reconditioned (no available replacement). Replacement cost is not part of this Master Plan.

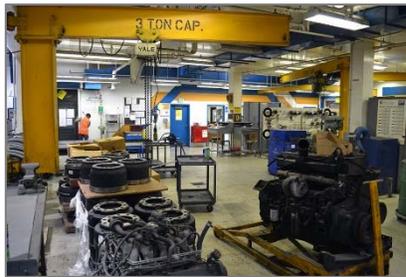
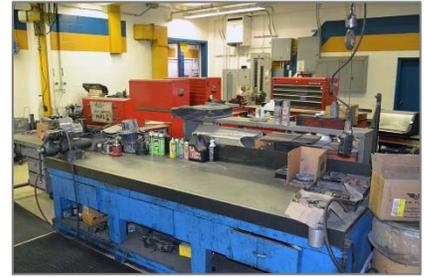
Unit Rebuild & Machine Shops

Large portion of these areas are being used for storage in the sense that the equipment, workbenches and miscellaneous components are not being used and essentially stored. Some of the larger equipment is rarely occasionally used. As expressed in the master plan, remove underutilized equipment and workbenches and repurpose the area. The Dismantling and Parts Cleaning area is currently being used for hand washing and parts washing with a large part of the room for storage.

- Areas are underutilized
- Cranes are operational. Leave operational and in-place if possible.
- Repurpose areas as expressed in the master plan.

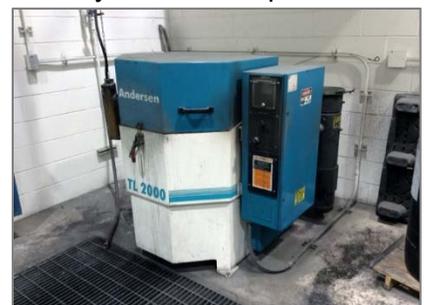
Parts Washer - Not Operational

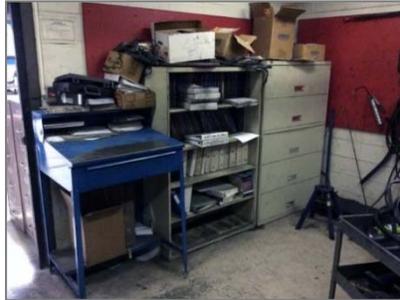
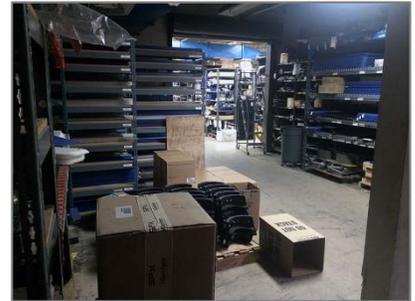
Manual & Tool Storage

FAX supplied tools are securely stored within the Tool Room (originally the Radiator Shop) and within the Tool and Manual Storage room. Both rooms are adjacent to the repair bays. Storage equipment within these rooms is in poor condition. Physical repair manual storage is no longer required as repair manuals are electronic and accessible through centrally located computer workstations and printers.

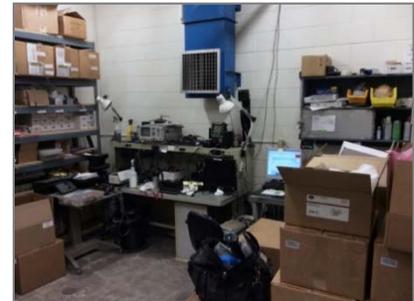
Electronics Repair Shop

The Electronics Shop is that room used to repair and store electrical and technology components used on the bus. The shop is secure and located at the southwest end of Repair Bay-3. Furniture and storage equipment within this shop is in poor condition.

As the Master Plan presents, it is desirable to have both of these shops located adjacent to a repair bays that could be used for the repair of the specific components. Both shops and storage would also be housed in a shared but secure room.

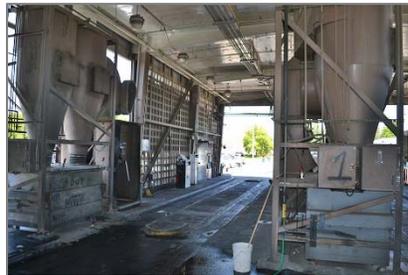
Fueling Lane Showing Plated Pit Opening & Cyclone Vacuum

Part of the original design involved lower level inspection pits. The pit openings were in each fueling lane. Personnel access to the pits was through stairway located on the southwest corner of the building. Since then, the pit openings have been plated over and the pit cavities house underground piping, exposed within the cavity. The stairway is still accessible and open. Standing rancid water was observed within the bottom of the pits.

Parts of the original construction also included a central vacuum system with overhead distribution hoses and hose drops and the lanes. Over time, the central vacuum system was removed and replaced with two standalone cyclone type door blower systems. These systems require a person to walk through the bus with a broom or compressed air wand moving debris to the front door, that is then sucked up into the door blower system and deposited into dumpsters located at the base of the machine. The cyclone systems are severely worn and aged. Using compressed air wands to move debris to the front of the bus commonly results in sand getting into the electronics and dash board of the bus. Those problems were mentioned as occurring here.

- Underground inspection pits holding water.
- Hose reels worn.
- Cyclone vacuum systems worn and at end of life cycle.
- Personnel spaces lacking
- See Fueling Assessment section below for further fueling discussion

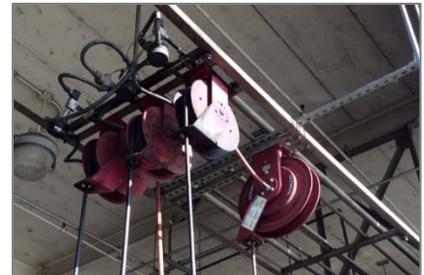
Hose Reels

There are two fueling lanes accesses from the east. Both lanes contain CNG and diesel fuel dispensers, Engine Oil, Engine Coolant, Automatic Transmission Fluid, and Compressed Air Dispensers. There is an above ground storage tank with tank mounted pump and dispenser for Diesel Engine Oil accessible to both lanes. Current hose reels show wear and leakage similar to

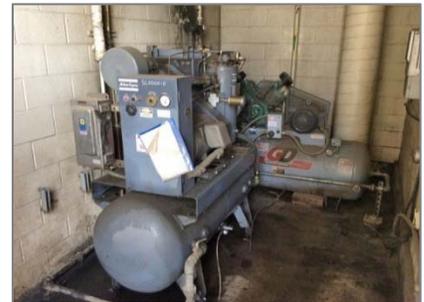
Air Compressors

those in the Maintenance Building. Originally, underground storage tanks were located south of the building storing the lubrication fluids, diesel, and leaded and unleaded gasoline. Lubrication fluids and petrol is now stored in newer underground storage tanks located east of the building. Compressed air is supplied from air compressors located within the Compressor

Room. These compressors are aging and given the opportunity, should be replaced.

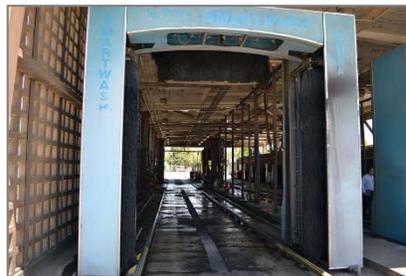
Rolling gantry washers have many moving parts requiring much maintenance. While the existing equipment are of good quality, based on its projected age at master plan implementation, and given the opportunity, a drive through bus washer with blowers and water reclamation is recommended.

- Fare Vaulting - Construct new fare vaulting room addition and associated support spaces.
- Bus Washers - Phased replacement with new rolling bus washers and water reclamation system. New wash equipment to be located within bus wash bay.

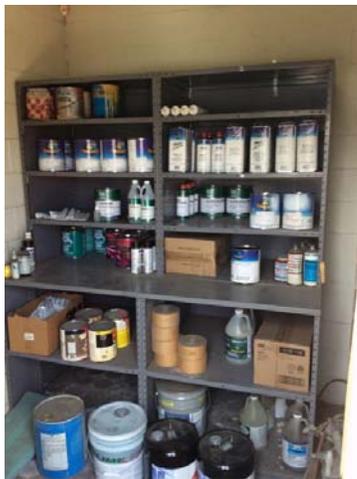
227

Paint Storage, Room 123

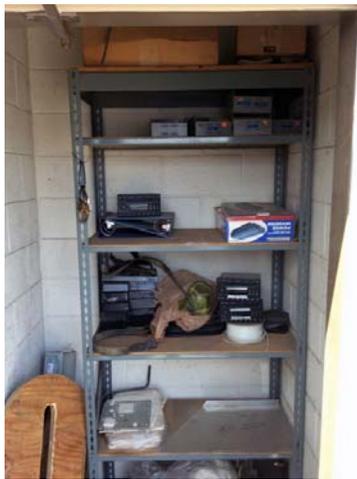
228

Radio Storage, Room 125

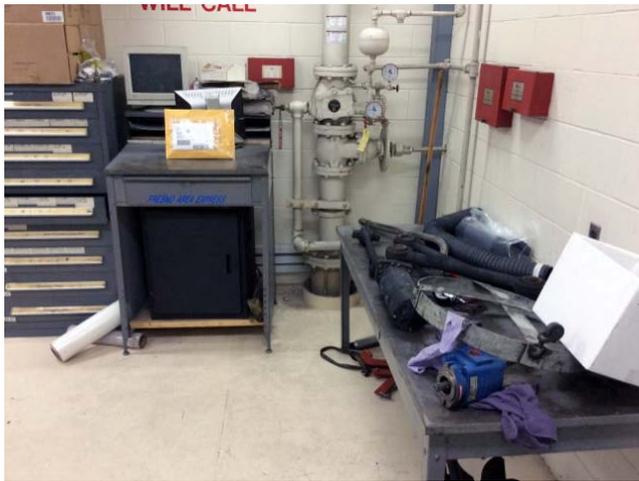
229

Parts Storage, Room 126 & 133

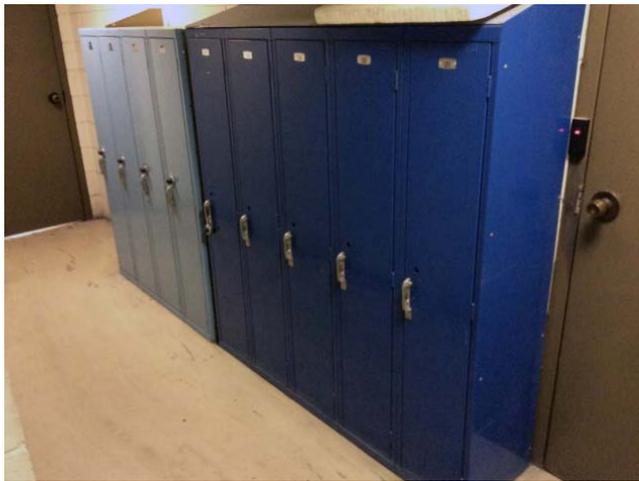
250

Corridor
