FACILITY CONDITION ASSESSMENT

CITY OF FRESNO MUNICIPAL SERVICES CENTER

2012 G Street

EMG

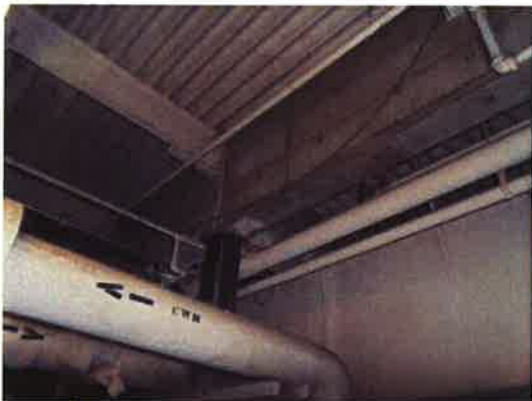
Photo #15: Building A floor/ceiling structure

- The superstructure is exposed in some locations, which allows for limited observation. Walls and floors appear to be plumb, level, and stable. There are no significant signs of deflection or movement.
- There is significant evidence of steel deck deterioration due to rust at Building A in the basement mechanical room below the fountain. The rusting as shown in the photograph above is 5 to 10 square feet where the decking rests on the concrete basement wall. The rusting is likely caused by a failure of the waterproofing between the fountain above and the metal decking. A moderate level of cracking was observed at the concrete paving to the south and east of the fountain. Cracking in sidewalks is typically due to settlement of soils.
