**ANALYSIS OF BROWNFIELD CLEANUP
ALTERNATIVES**

Former Berkeley Building
887 Fulton Street
Fresno, California 93721

December 5, 2025

Prepared by:
Stantec Consulting Services Inc.
601 SW 2nd Avenue, Suite 1400
Portland, Oregon 97204

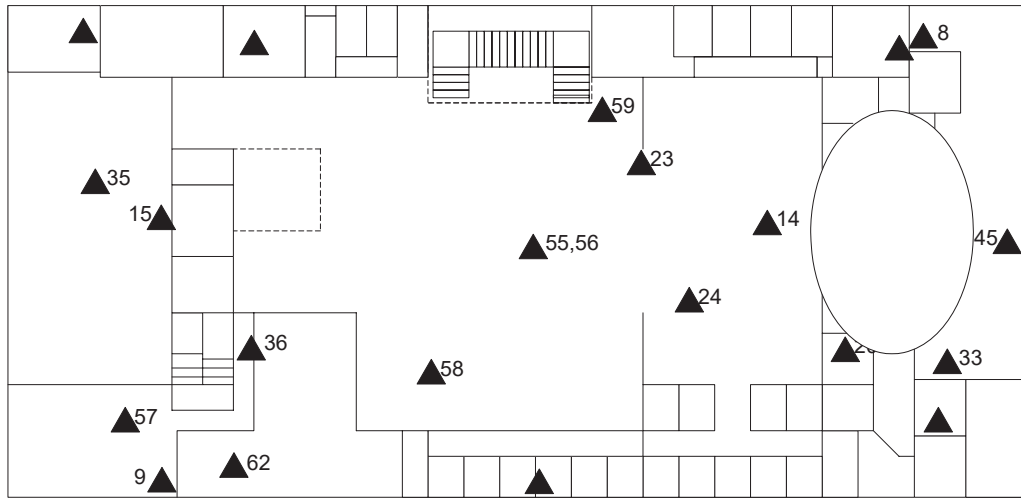
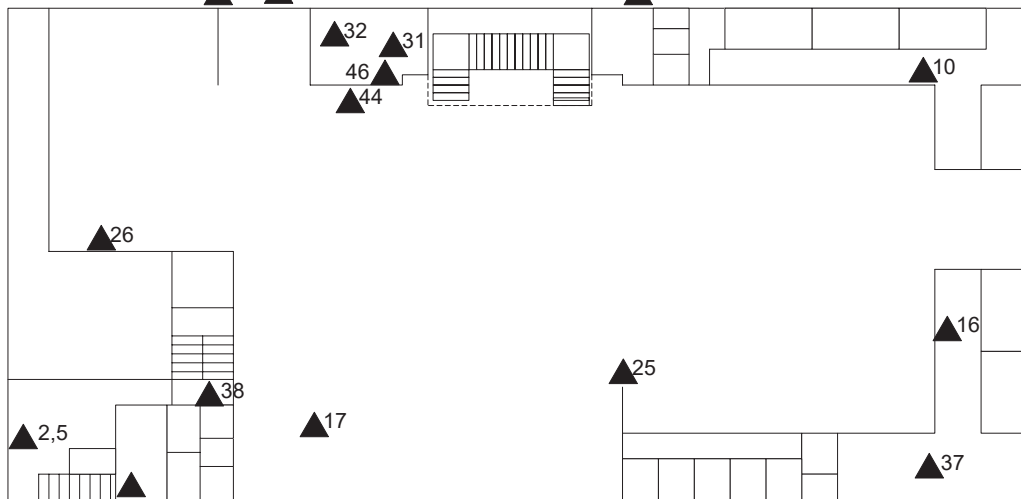
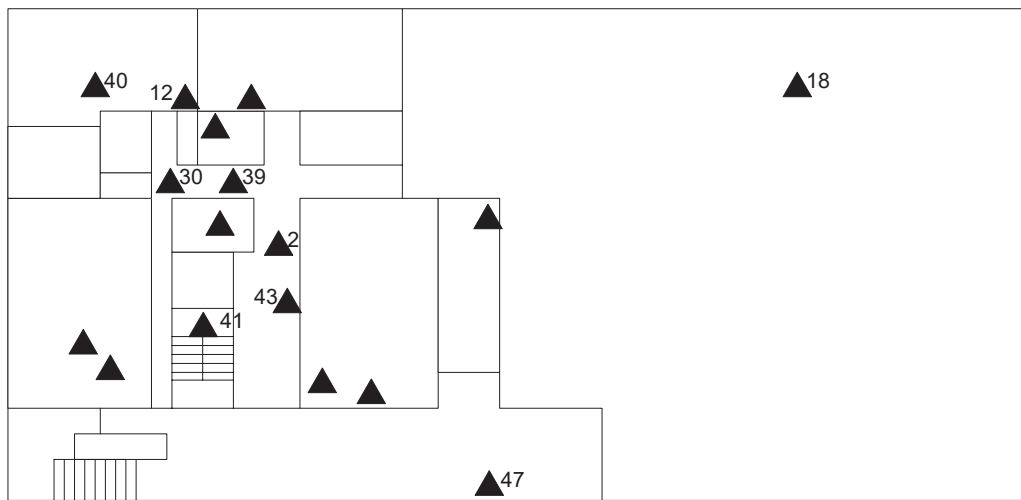
NA = Not applicable
 NC = Not calculated
 ND = None detected
 Trace = Less than one percent (<1%) chrysotile asbestos

F = Fair condition
 G = Good condition
 NF = Non-friable
 FR = Friable

Second Floor

First Floor

Basement Level

Table 2.1 below presents a sample number, material description, sample location, the ACM content, material condition and estimated quantity of the material.

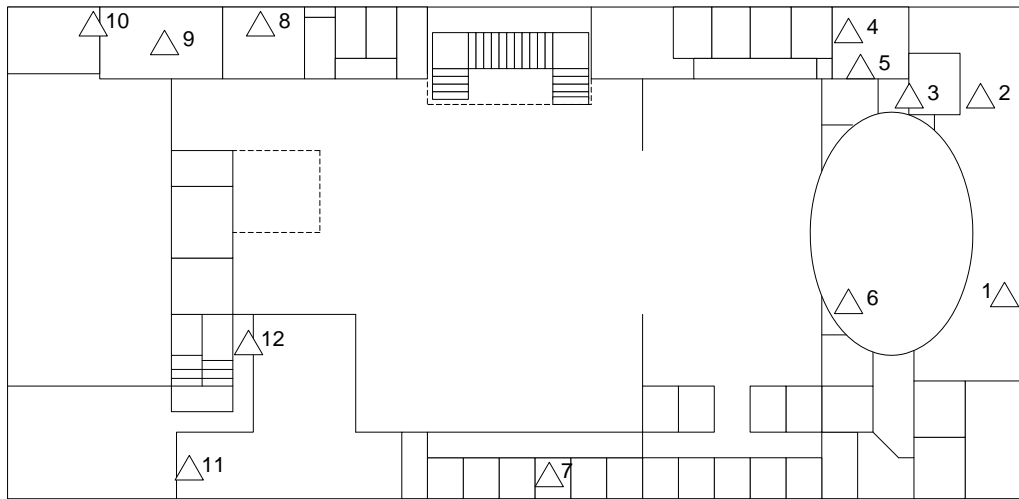
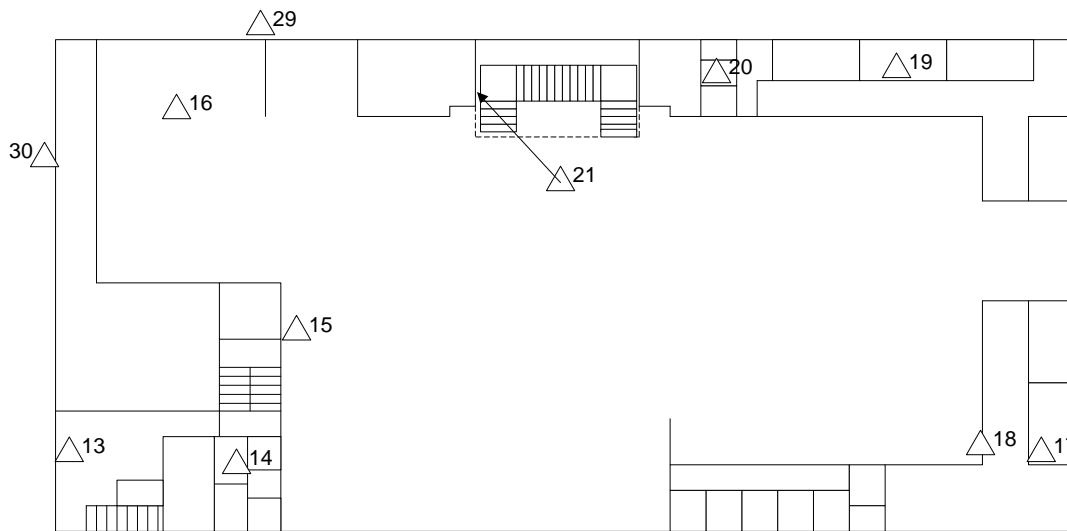
Bold text items are considered Lead-based paint

Italic text items are considered Lead-containing paint

Second Floor

First Floor

Basement Level

The lead-based paint survey consisted of a visual inspection and sampling of painted surfaces throughout the two floors of the building on the Subject Property. The purpose of the inspection was to provide information regarding lead in paint as it pertains to employee exposure and demolition debris disposal. Representative samples of the painted surfaces were collected by Krazan for laboratory analysis. Additional suspect painted surfaces may be present in areas that were inaccessible, unsafe to inspect, or obscured from view during the sampling process. Two of the 31 collected samples contained lead greater than 0.5% (the EPA definition of a lead-based paint) as shown in Table 2.2 below.
