State of California — The Resources Agency  
DEPARTMENT OF PARKS AND RECREATION  
**PRIMARY RECORD**

Page 1 of 3 Resource name(s) or number (assigned by recorder) 4191 N. Blackstone Ave.

**P1. Other Identifier:** Guarantee Savings & Loan

**\*P11. Report Citation:** (Cite survey report and other sources, or enter "none")  
*Fresno Bus Rapid Transit (BRT)*

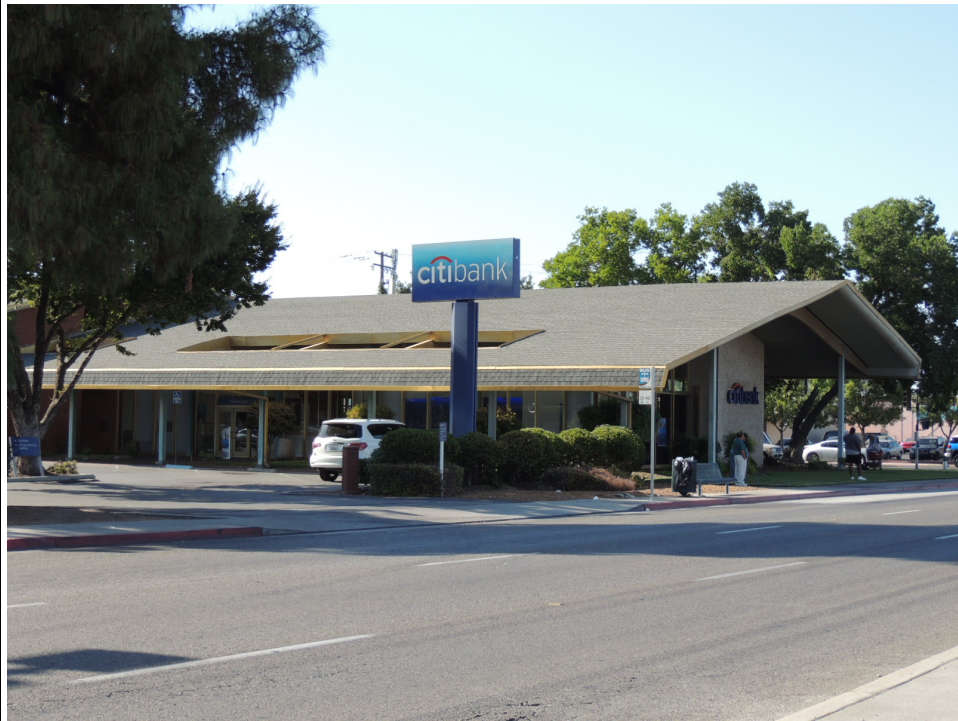
P5a. Photo

This property is located on the southwest corner of North Blackstone Avenue and East Ashlan Avenue and contains a one- and two-story commercial bank building constructed ca. 1957. The Mid-Century Modern style bank has an irregular rectangular plan with asymmetrical low-pitched gable roofs and masonry cladding. The roofs are clad with asphalt shingles and have turned-down eaves with enclosed plaster soffits. The eastern portion of the building, which contains the main banking room, facing Blackstone Avenue, has floor-to-ceiling metal frame windows on three sides with a monumental masonry wall at the northeast corner. The roof here is supported by curved glue-lam beams and metal posts and has four openings in the overhang of the southern portion. There is a ceramic tile mural on the west wall of the banking room that can be seen from the exterior. The western portion of the building is two-stories and clad with red brick and bands of metal frame windows. There is a covered open-air stairwell at the west end of the building leading to a second story open-air walkway overlooking an enclosed landscaped patio with brick screen walls. An oversized sculpture of an abacus on wood posts supports a roof overhang at the north side of the building. The building has surface parking on the south and west sides with a stand-alone flat roof cement plaster (stucco) clad drive-through pavilion with red brick pilasters in the south parking area. The building appears to have had few alterations since its construction and has high integrity.

**P5b. Photo:** (view and date)  
Northwest; August 15, 2012
