State of California — The Resources Agency
DEPARTMENT OF PARKS AND RECREATION
PRIMARY RECORD

Resource name(s) or number (assigned by recorder) 1101 Fulton Mall

P1. Other Identifier: Helm Building

HISTORIC RESOURCES INVENTORY

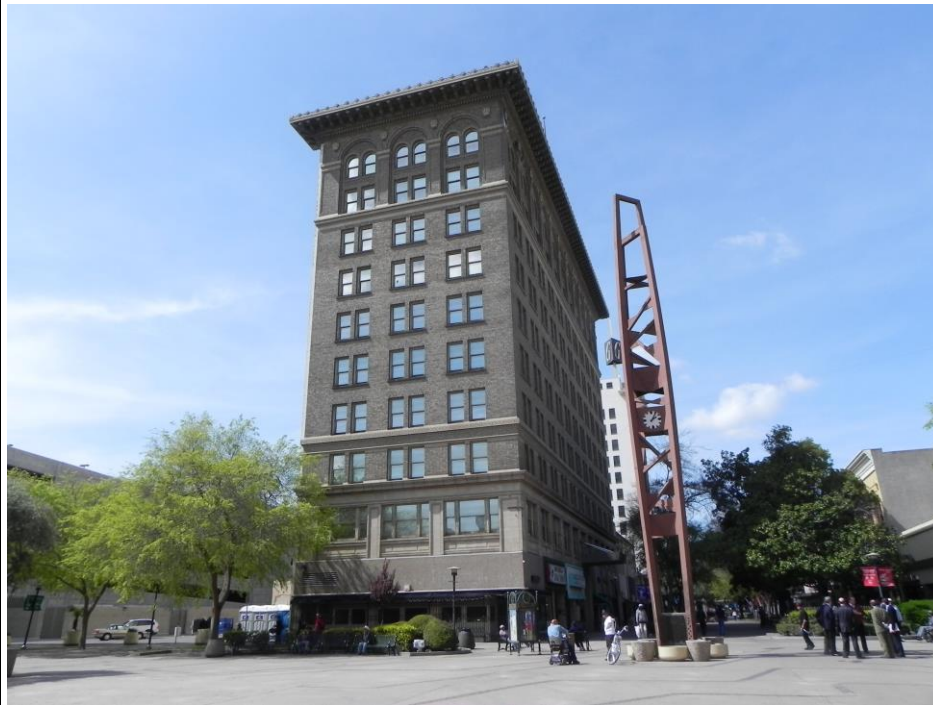
P5a. Photo

This property is located at the northwest corner of Fulton Mall and Mariposa Street and contains a ten-story office building constructed in 1914. Renaissance Revival in style, it is constructed of steel reinforced concrete with brick cladding. It has a rectangular plan and a flat roof with boxed eaves and decorative brackets. It has a tri-partite composition, with the sections separated by prominent belt courses. Fenestration consists of symmetrically arranged pairs of double-hung wood sash windows. The windows on the top story have arched openings. The ground story has storefront windows that have been altered. The building has good integrity.

P5b. Photo: (view and date)
East elevation.
March 29, 2012.

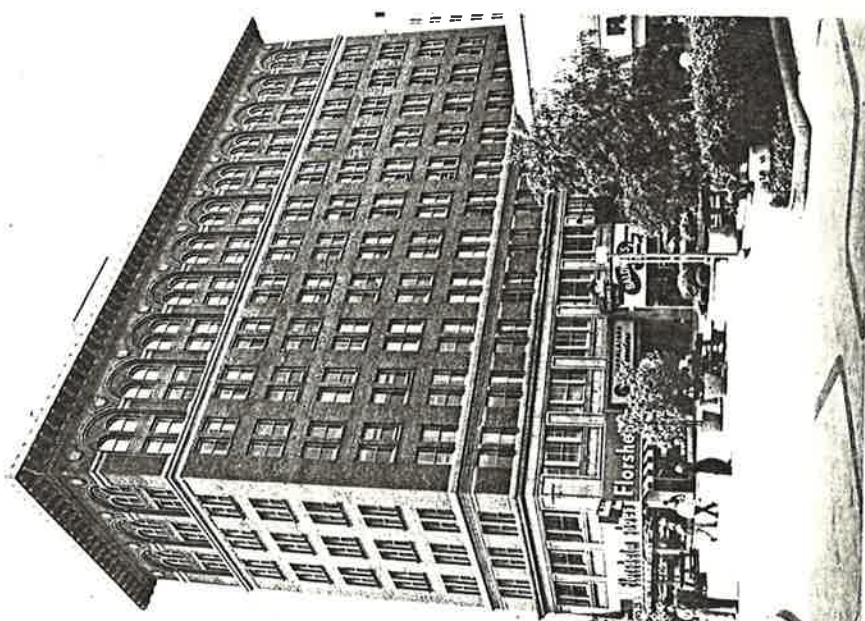
Ten story steel and concrete office building - first and second floors with terra cotta panels and decoration topped by a frieze with cornice. Third floor brick with terra cotta course and frieze. Fourth thru eighth floors in one composition. A strong belt cornice and the top two floors cap the building with round arch spring blocks, trim units, etc., are capped finally by a large overhanging intricate renaissance revival cornice on the exposed side. The bottom floors are decorated per tenant requirements - not helping the building as an historic or architectural prize.
