HISTORIC RESOURCES INVENTORY

1.	Common name: St. John's Cathedral						
2.	Historic name, if known: Same						-
3.	Street or rural address 2814 Mariposa Street						
	City: Fresno, California	ZIP:	93721	County:	Fresno		
4.	Present owner, if known: Roman Catholic Bisho	o of	FresnoAdd	Iress: 2814 Ma	riposa Str	eet	
	City: Fresno, California	ZIP:_	93721	Ownership is:	Public	Private	[x]
5.	Present Use: Roman Catholic Cathedral	Origin	nal Use: <u>Sa</u>	me			_
	Other past uses: None

Project Purpose

The purpose of this project is to secure our historic buildings located at Mariposa and R St. in Fresno, Ca. The buildings consist of the following. St. John's Cathedral (101 years old) and an adjacent rectory where the parish priest resides. The Roman Catholic Diocese of Fresno has instructed Valley Wrought Iron to design and build a 7 foot high arched security fence around the perimeter of the cathedral, rectory and the adjacent parking lot. The design will also include the addition of one (1) new decorative brick columns to be placed at the corner of "R" Street and Mariposa Street to match what currently exist. To gain entry and provide access to all, 4 powered gates and two non-powered

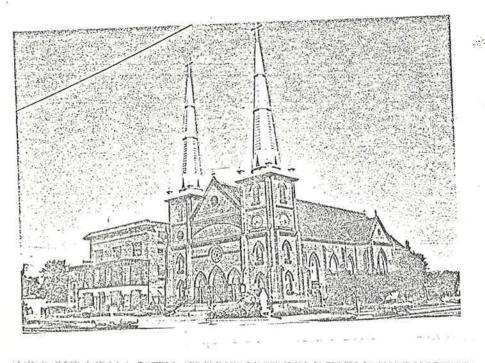
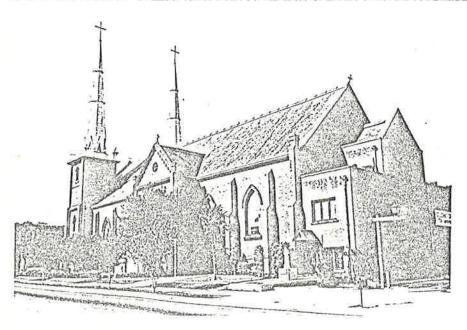
Large red brick structure in typical early-christian church plan; ie nave with side aisles, small transept, apse, narthex and twin towers at entry elevation. Tri-partite entry. Gothic arched windows and doors but round arch openings in bell towers. Small rose window on west end. All windows filled with stained glass. Aluminum colored spires. Ornate interior. One building in a complex of 3. Buttressing of corners and walls handled very simply as are most of the details.

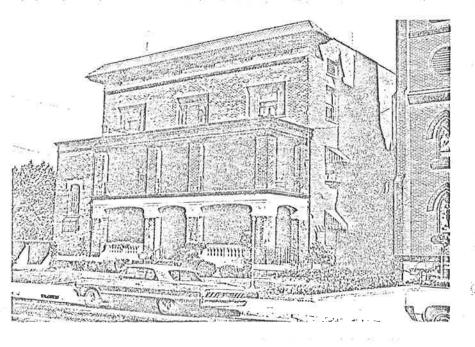
Three story red brick building. One of 3 in the cathedral complex. Red barrel tile fascia at parapet on Mariposa frontage. All decorative items limited to Mariposa Street frontage. All other facades plain brick walls with double hung windows. Two story portico with brick columns and applied decoration at first floor, and top of third floor. Building is in good condition - well maintained.

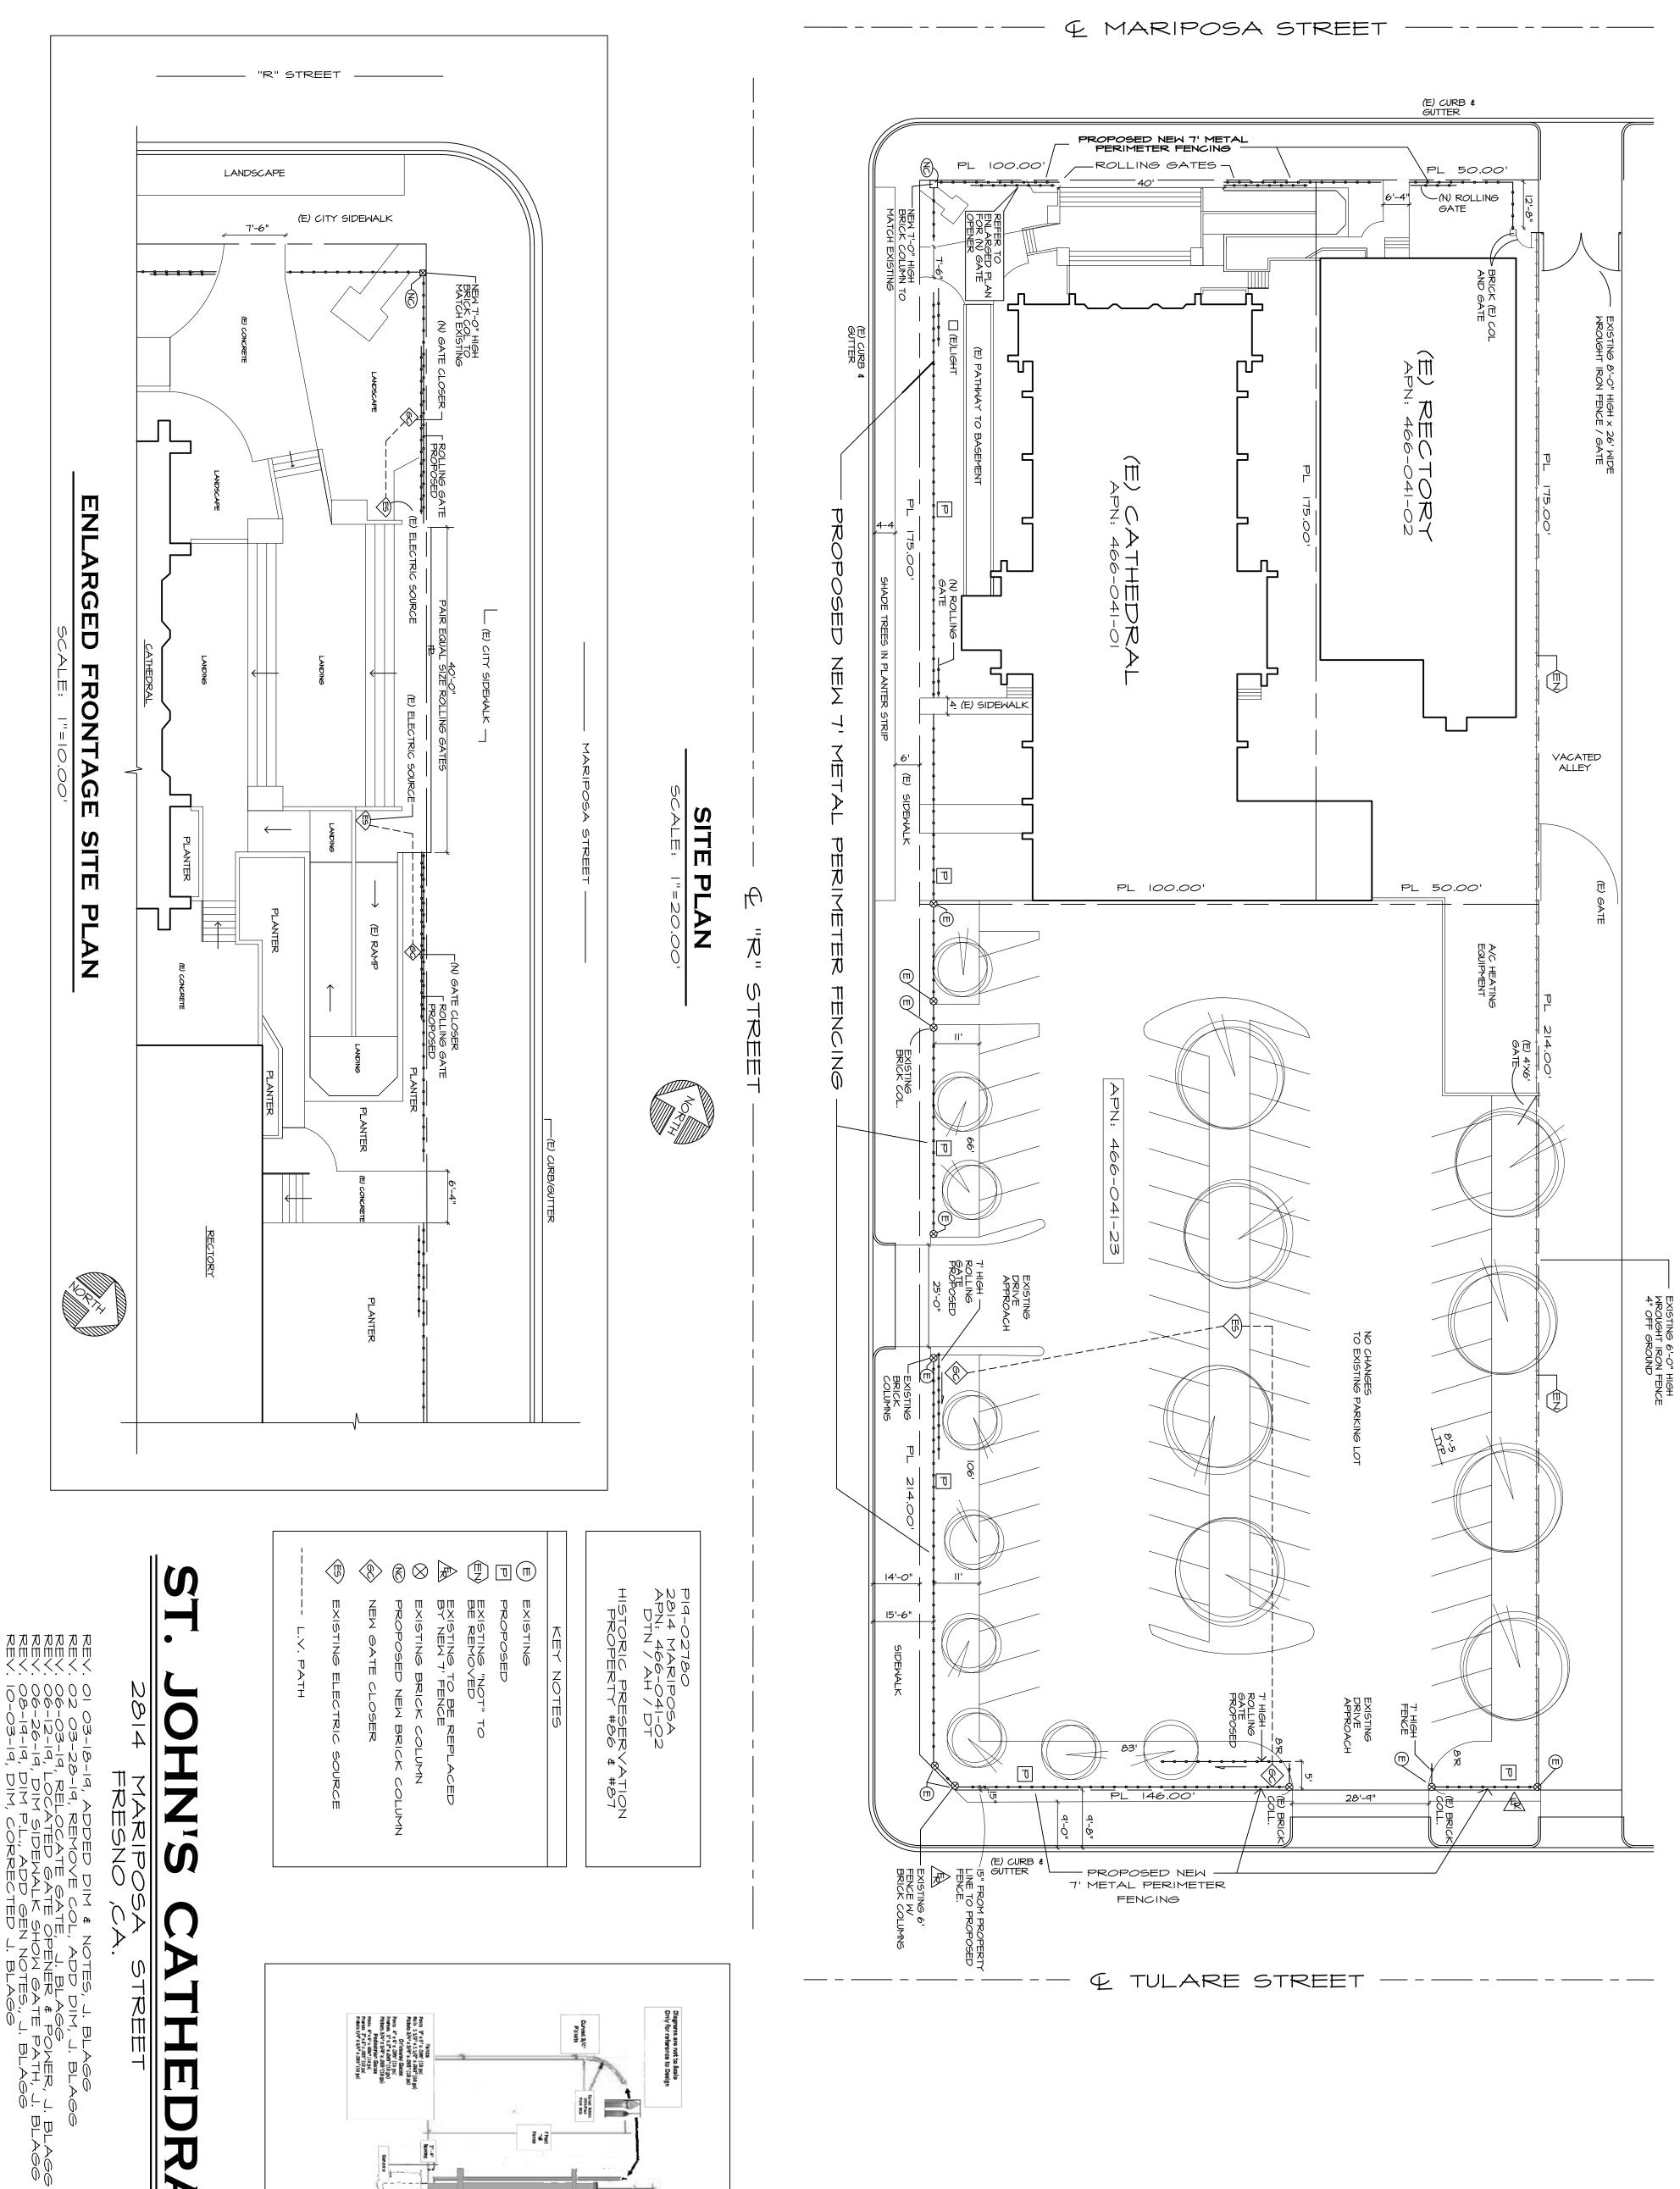
NOTE: GATES LOCATION APPROVED BY "ANDREW BENELLI", ASSISTANT DIRECTOR, PUBLIC WORKS. REPAIR ALL DAMAGED AND/OR OFF-GRADE CONCRETE STREET IMPROVEMENTS AS DETERMINED BY THE CONSTRUCTION MANAGEMENT ENGINEER PRIOR TO OCCUPANCY.

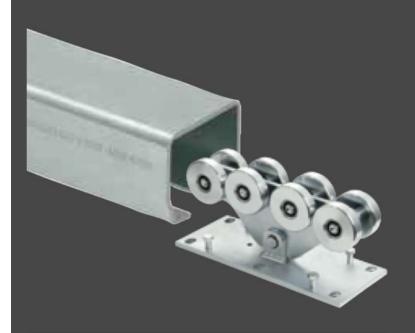
y duty system can handle almost all sliding gate applications. Sealed bearings and covered rollers avoid many of the usual maintenance and efficiency problems due to weather elements. They also help comply with UL325 and ASTM F2200 gate safety standards.

hai technical innovation in the system, as compared to a *traditional sliding gate*, lies in the fact that the entire gate is cantilevered off the ground without any rollers traveling on the ground. This allows for free movement of the gate in uneven ground conditions and reduces the wear and tear on the gate and on any installed gate automation. The sealed bearings on the carriage assembly require no maintenance or lubrication. Besides, it gives the gate a nice clean look with minimal visible hardware. This engineered solution also reduces the length of the counterbalance resulting in a smaller overall gate length.

- Higher weight capacity
- Works with any gate material
- Smaller overall gate length
- Reduces load on gate operator
- Low maintenance

- Minimal visible hardware
- Cost effective compared to traditional cantilever hardware
- Easy to install
- Durable even for high traffic applications
