FACILITY CONDITION ASSESSMENT

CITY OF FRESNO MUNICIPAL SERVICES CENTER

2012 G Street

EMG

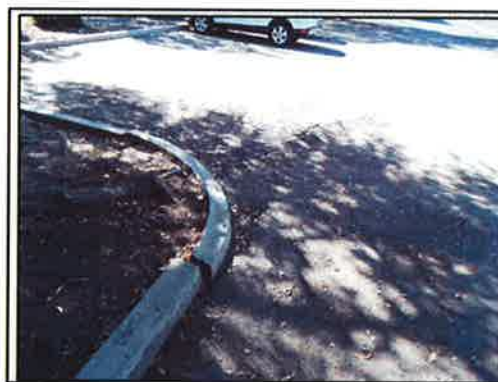
- The property does not have a dedicated paving repair and maintenance contractor. On site personnel (Fresno Streets Department) maintain the paving and flatwork.

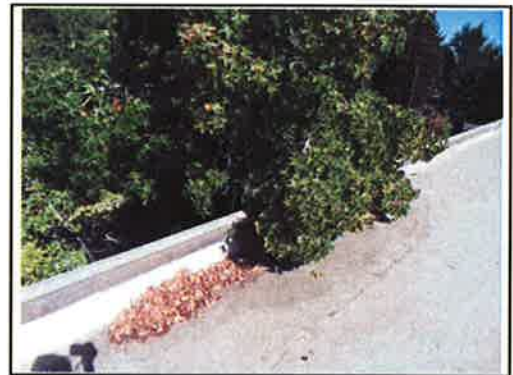
- The topography and adjacent uses do not appear to present conditions detrimental to the property.

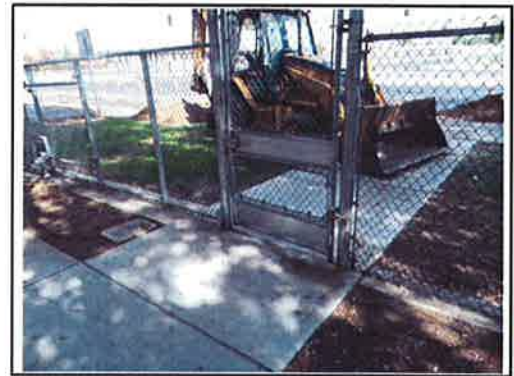
- The property and building identification signs are in good condition. Routine maintenance will be required during the assessment period.
- The exterior site and building light fixtures are in good condition. Routine maintenance will be required during the assessment period.
- The site fencing is in good condition and will require routine maintenance during the assessment period. Scraping and painting is considered to be routine maintenance.
- The dumpsters are owned and maintained by the Sanitation Department. The dumpster enclosures, slabs, and gates are in good condition and will require routine maintenance during the assessment period.

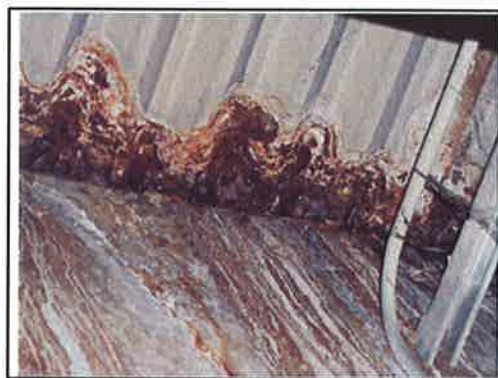
- The superstructure is exposed in some locations, which allows for limited observation. Walls and floors appear to be plumb, level, and stable. There are no significant signs of deflection or movement.
- There is significant evidence of steel deck deterioration due to rust at Building A in the basement mechanical room below the fountain. The rusting as shown in the photograph above is 5 to 10 square feet where the decking rests on the concrete basement wall. The rusting is likely caused by a failure of the waterproofing between the fountain above and the metal decking. A moderate level of cracking was observed at the concrete paving to the south and east of the fountain. Cracking in sidewalks is typically due to settlement of soils.

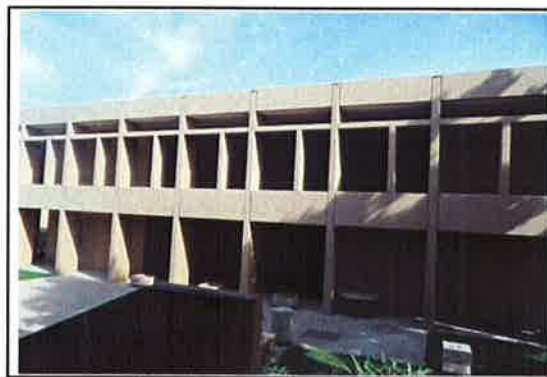
- The exterior finishes are in good condition. Painting and patching will be required during the assessment period. The cost of this work is included in the Replacement Reserves Report.
- Minor cracks were observed in some of the concrete wall panels. These should be monitored and patched on a regular basis as part of routine maintenance.
- The sealant is flexible, smooth, and in good condition and will require routine maintenance during the assessment period.

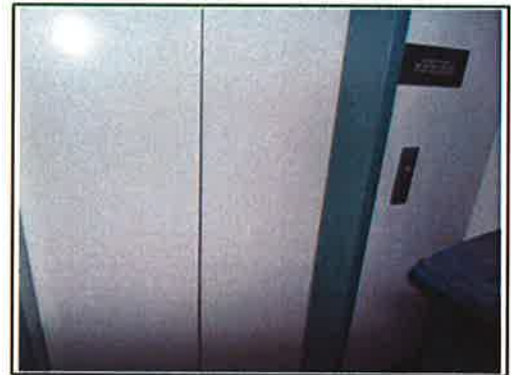
- The elevators are serviced on a routine basis. The elevator machinery and controls are the originally installed system.
- The elevator appears to provide adequate service. Based on its estimated Remaining Useful Life (RUL), some of the elevator equipment will require replacement during the assessment period. The cost of this work is included in the Replacement Reserves Report.
- The emergency communication equipment in the elevators appears to be functional but does not meet the requirements of the ADA Accessibility Guidelines.
- The finishes in the elevator cabs appear to be in good condition. Based on their estimated Remaining Useful Life (RUL), some of the cab finishes will require replacement during the assessment period. The cost of this work is included in the Replacement Reserves Report.

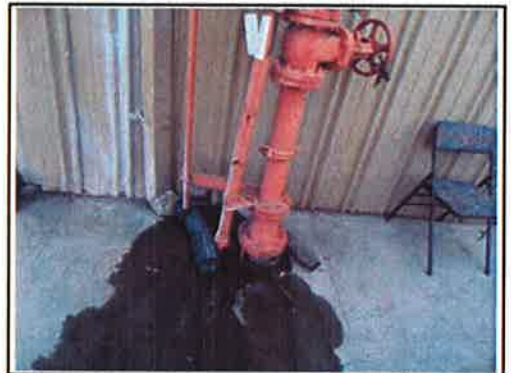
- The fire sprinklers are inspected on an annual basis by Cosco Fire Protection. Inspection stickers were observed on the fire sprinkler risers.
- The fire sprinklers appear to be in good condition and are inspected by a qualified contractor on a routine basis. At the time of our review, the fire sprinkler riser at building S had water leaking around the base of the pipe as shown in the photograph above. This riser should be investigated to determine if the leak is from the fire sprinkler line or a pipe internal to the building. The water bill review identified in Section 5.1 should also provide information on water leaks as this bill will show no water usage on a fire sprinkler system under normal operation. The fire sprinklers will require routine maintenance during the assessment period.

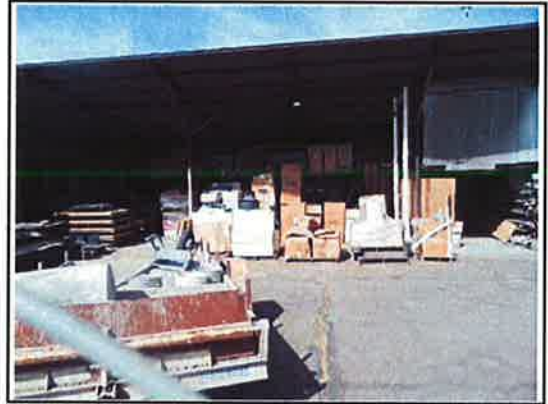
- The storage shelter is in good condition and will require routine maintenance during the assessment period.
- The guard station is in good condition and will require painting during the assessment period.

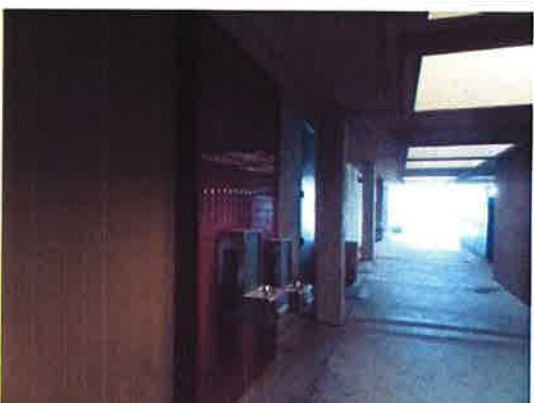
Photo #36: Ceramic tile is utilized at some exterior walls

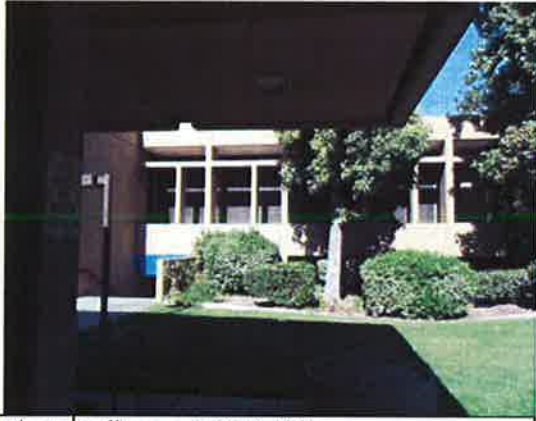
Photo #37: Soffit near TOC Building

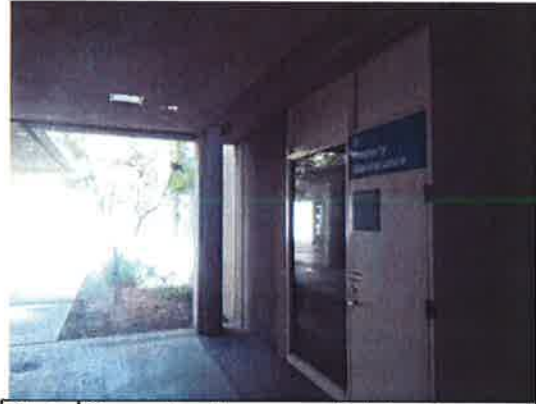
Photo #38: Covered walkway near Building B

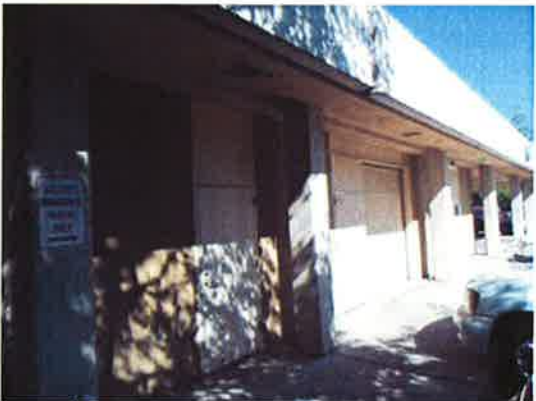
Photo #39: Building C exterior

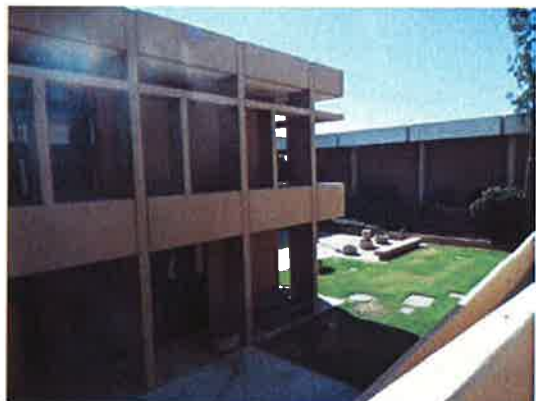
Photo #40: Building A

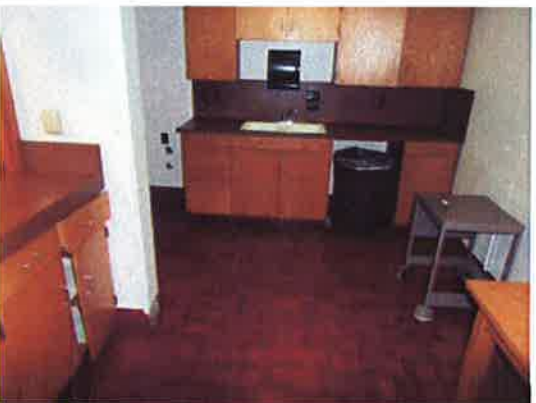
Photo #41: Kitchen at Building A

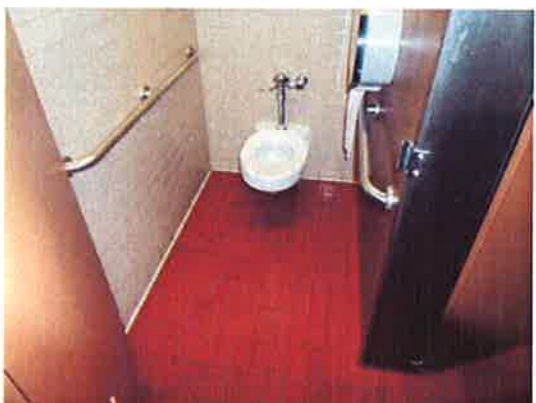
Photo #42: Restroom at Building A, unisex single user restrooms are provided at this building

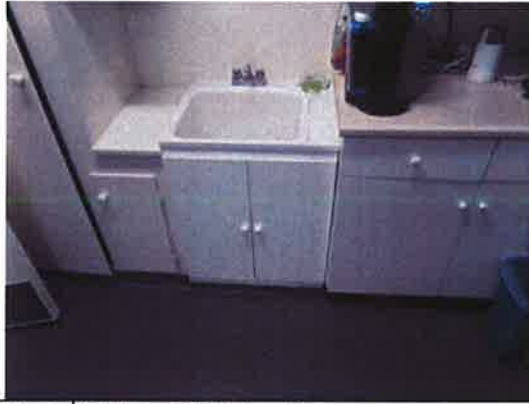
Photo #43: Kitchen at Building C

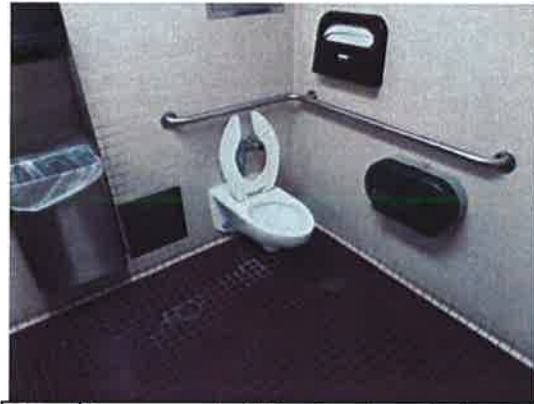
Photo #44: Restroom at building A, unisex single user restrooms are provided

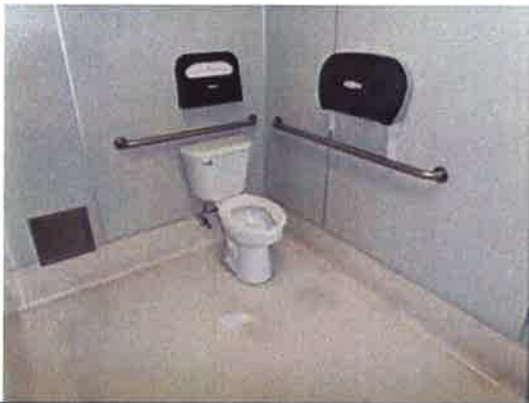
Photo #45: Restroom at Building E1

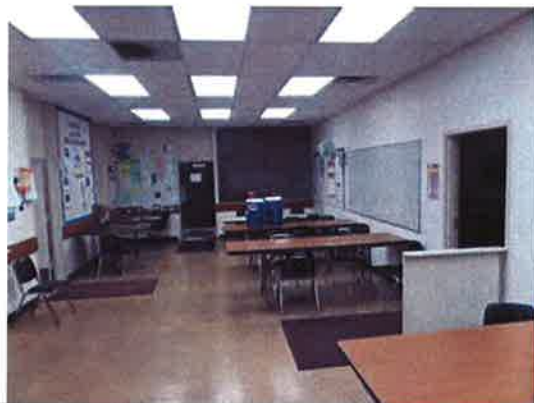
Photo #46: Building E1 interior

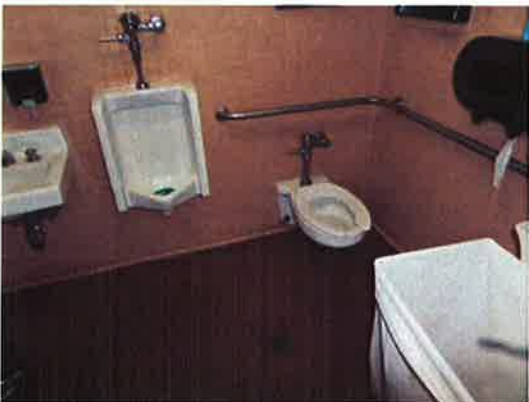
Photo #47: Restroom at Building E requires pipe wrapping and lever handles at lavatory

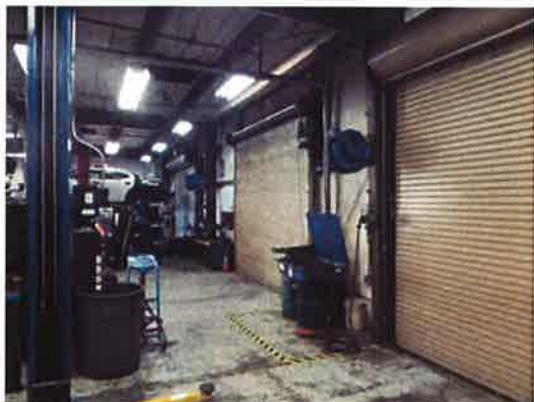
Photo #48: Interior at Building W

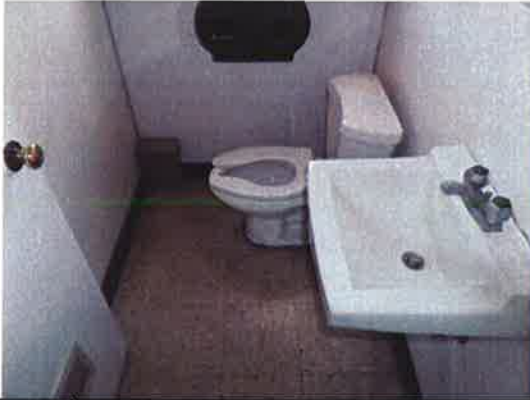
Photo #49: Restroom at Building Y

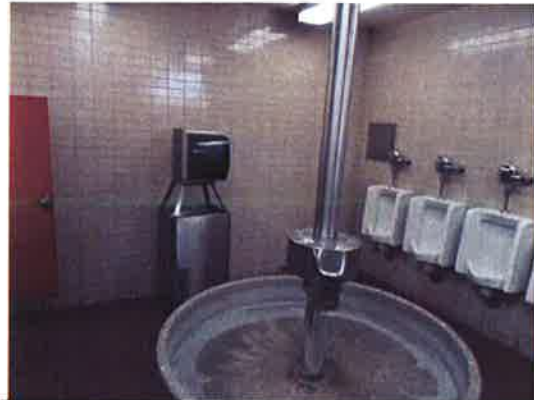
Photo #50: Restroom at Building D

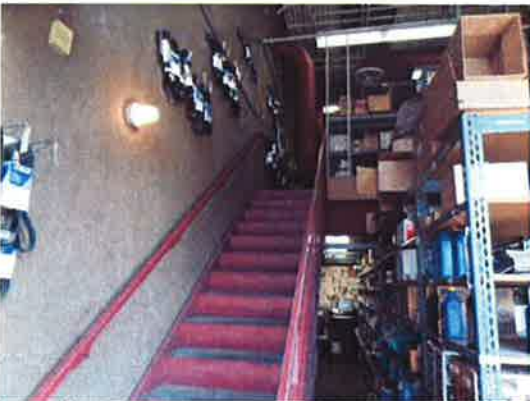
Photo #51: Interior at Building F

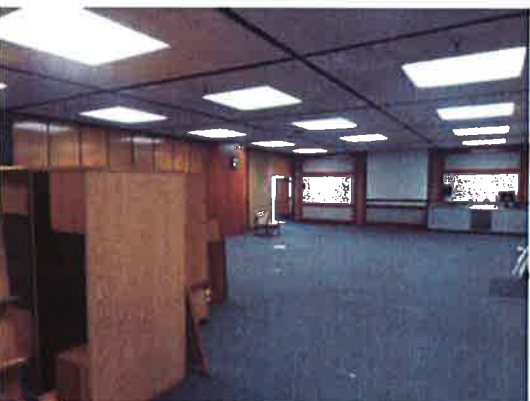
Photo #53: Interior at Building A

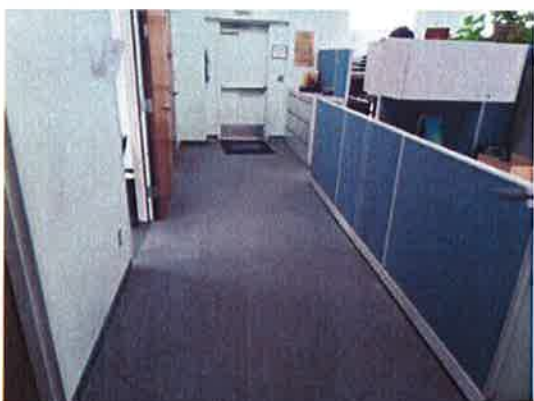
Photo #54: Interior at Building S2

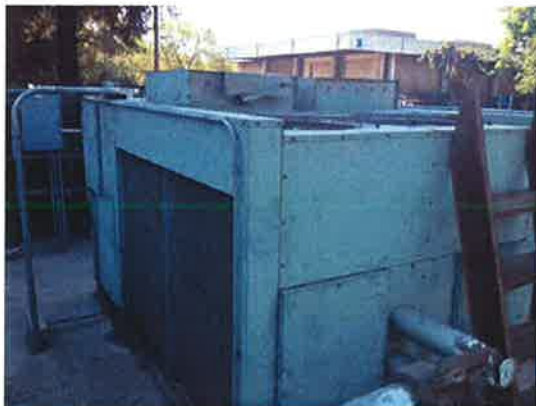
Photo #55: Air Cooled chiller for Building A

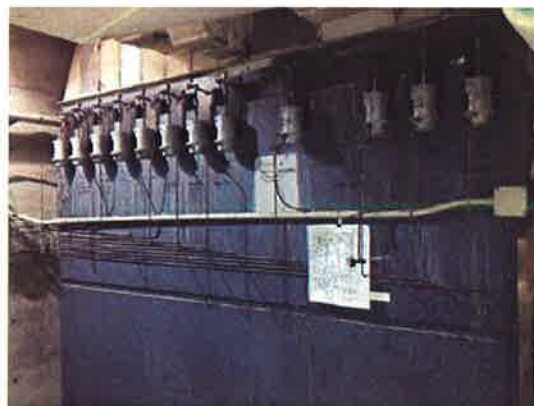
Photo #556: Boiler for Building A

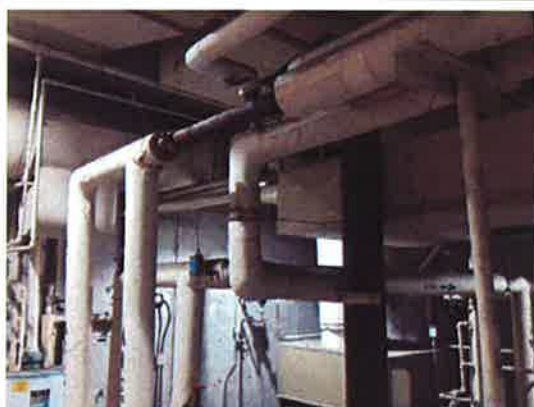
Photo #578: Insulated water lines in Building A Basement

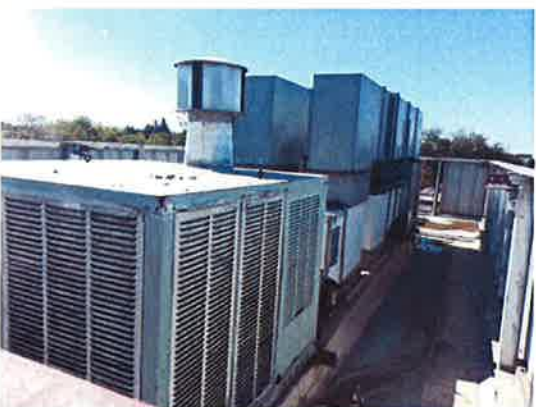
Photo #589: Site built unit at Building B

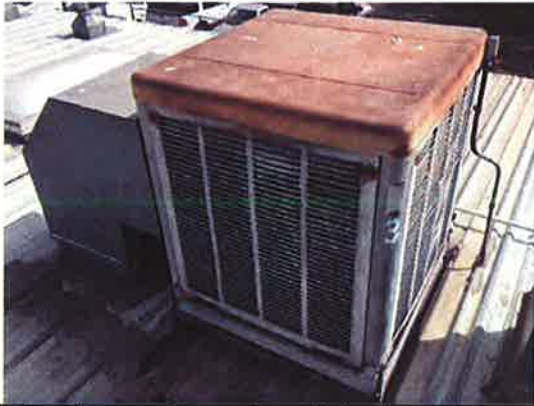
Photo #61: Evaporative cooler with fan duct at Building F

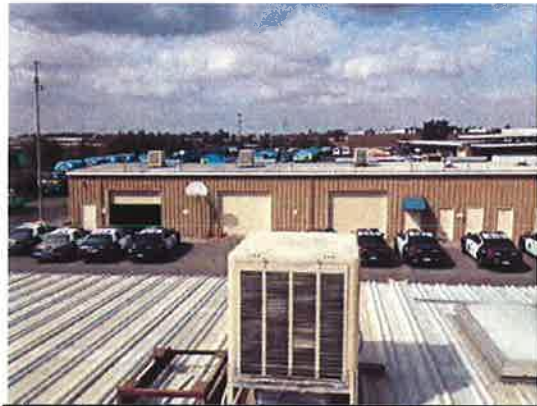
Photo #62: Evaporative cooler at Building X

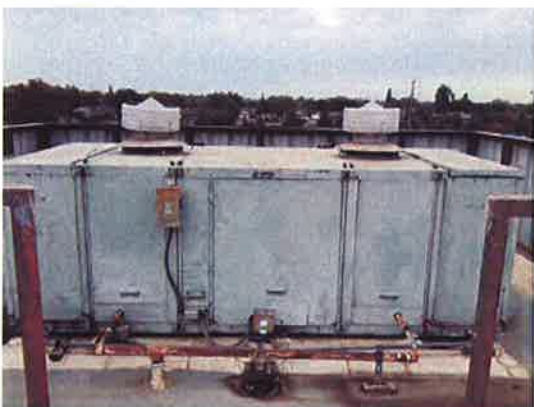
Photo #63: Original site built unit at Building F

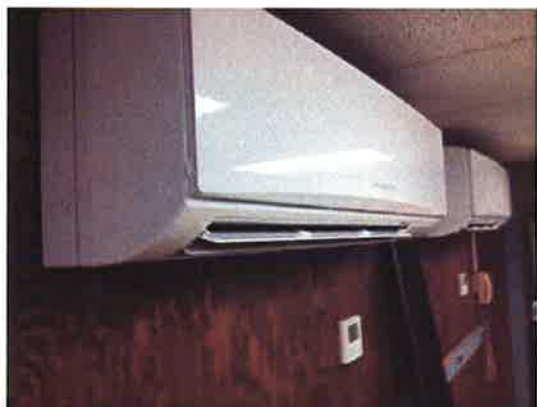
Photo #64: Cooling unit at Building I

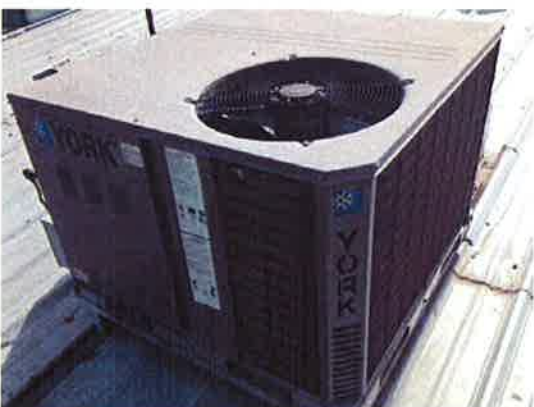
Photo #65: Typical newer package unit
