**735, 739, and 741 H Street,
Fresno, California**

**Analysis of Brownfield Cleanup
Alternatives**

March 23, 2023

Project No.: 185755542

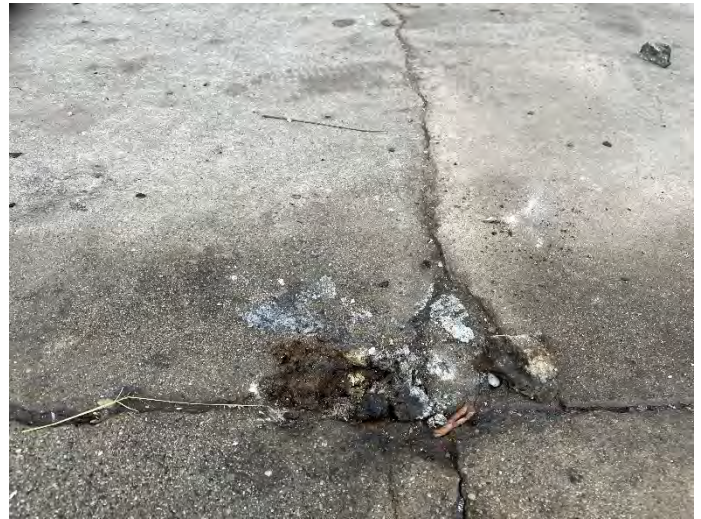
Loading Dock Concrete - Damaged

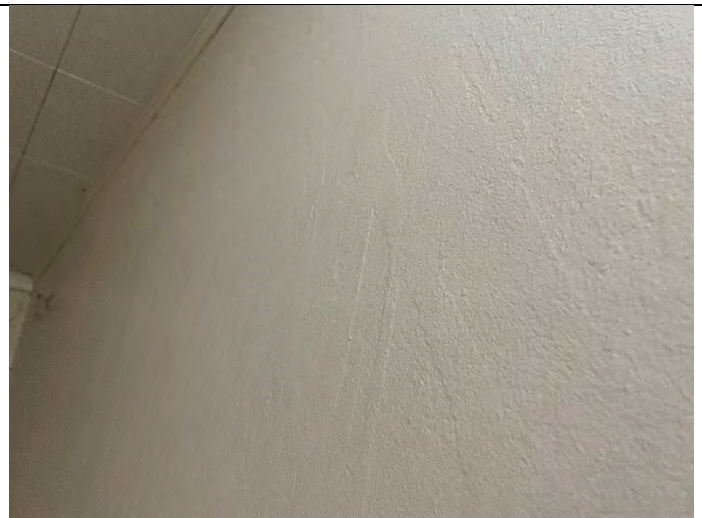
Drywall – Skip Trowel Texture

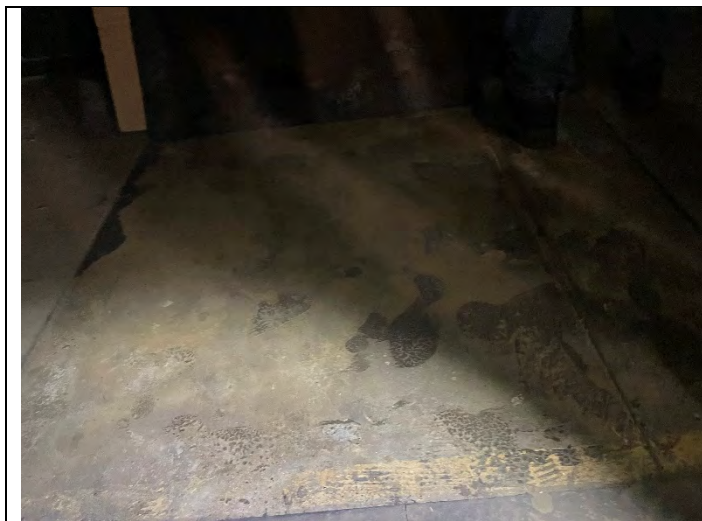
Black and Yellow Mastic Under Floor Tile

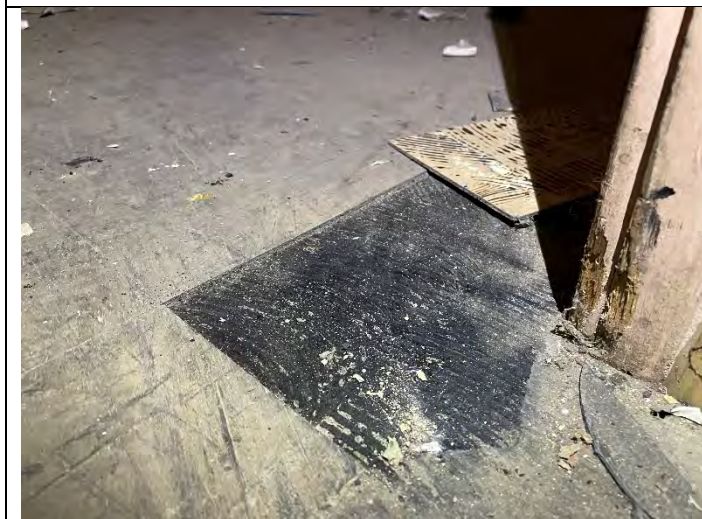
9-inch Vinyl Floor Tile w/ Black Mastic

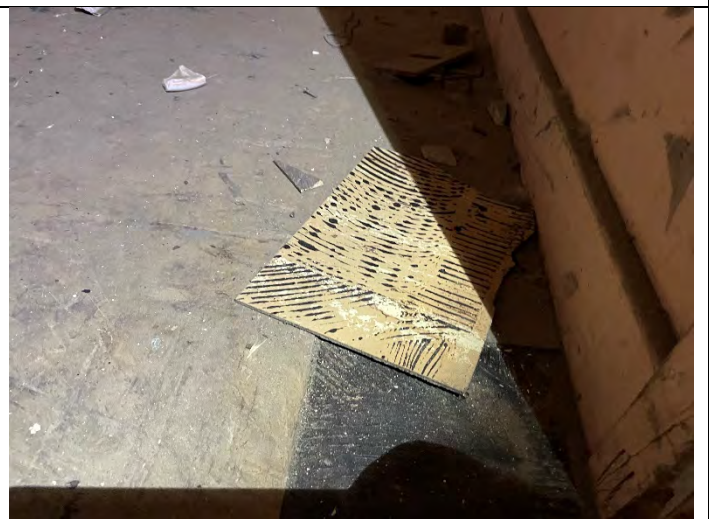
9-inch Vinyl Floor Tile w/ Black Mastic

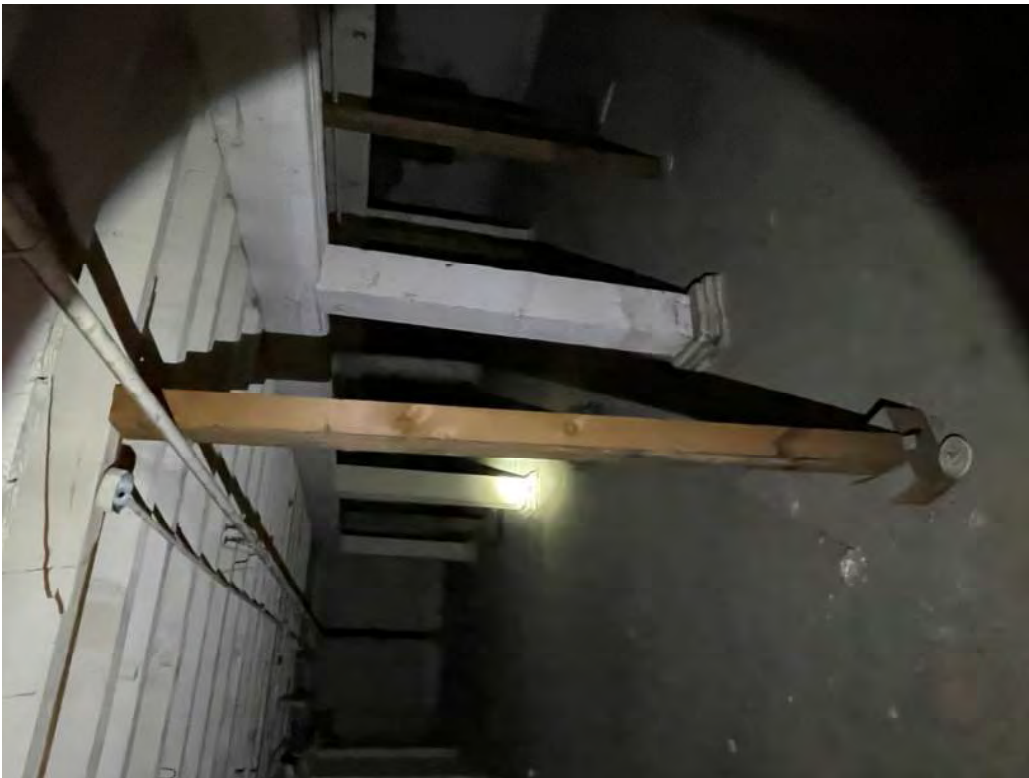
PHOTO #
26

COMMENTS : An added post at a broken floor joist.
